Ref 23207 – Kirland Manor, Bodmin

DESIGN AND ACCESS STATEMENT

ON: KIRLAND MANOR, BODMIN, PL30 5AA
FOR: MS CAITLIN DEAN
DATE: SEPTEMBER 2023
PREPARED BY: A JOHNSON
CHECKED BY: J A TAYLOR B.Sc (Hons) AssocRICS

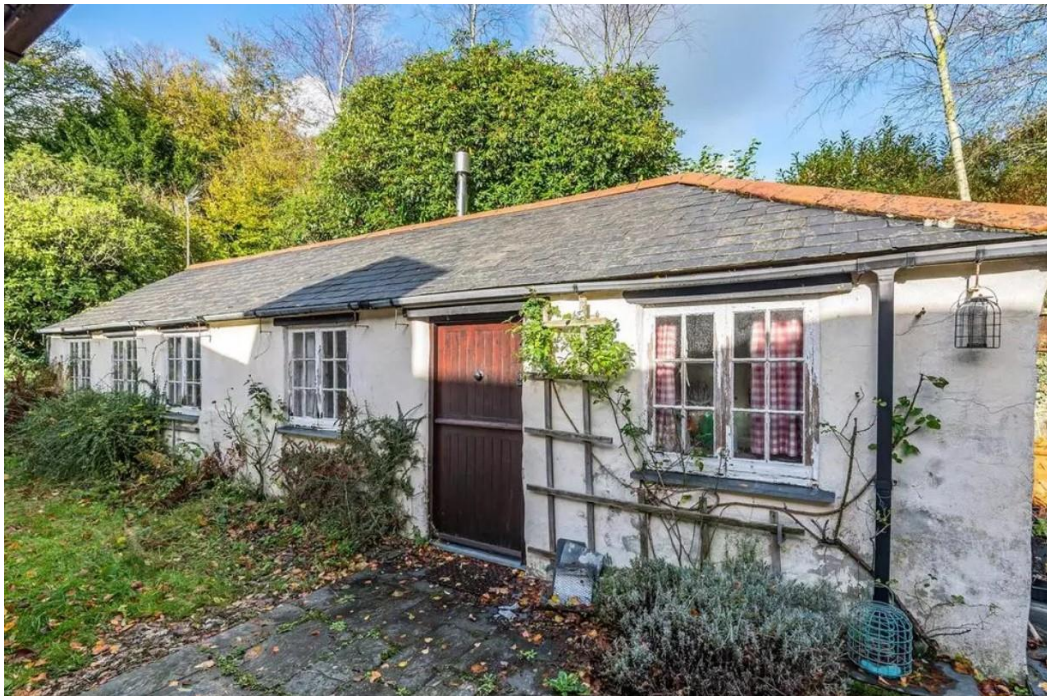
Figure 3 – Photograph showing Annexe South elevation.

Single glazed windows to the annexe are in a poor state of repair, with rotten timber frames and failing paintwork. All Annexe widows are to be replaced with single glazed sliding sash with white timber frames.

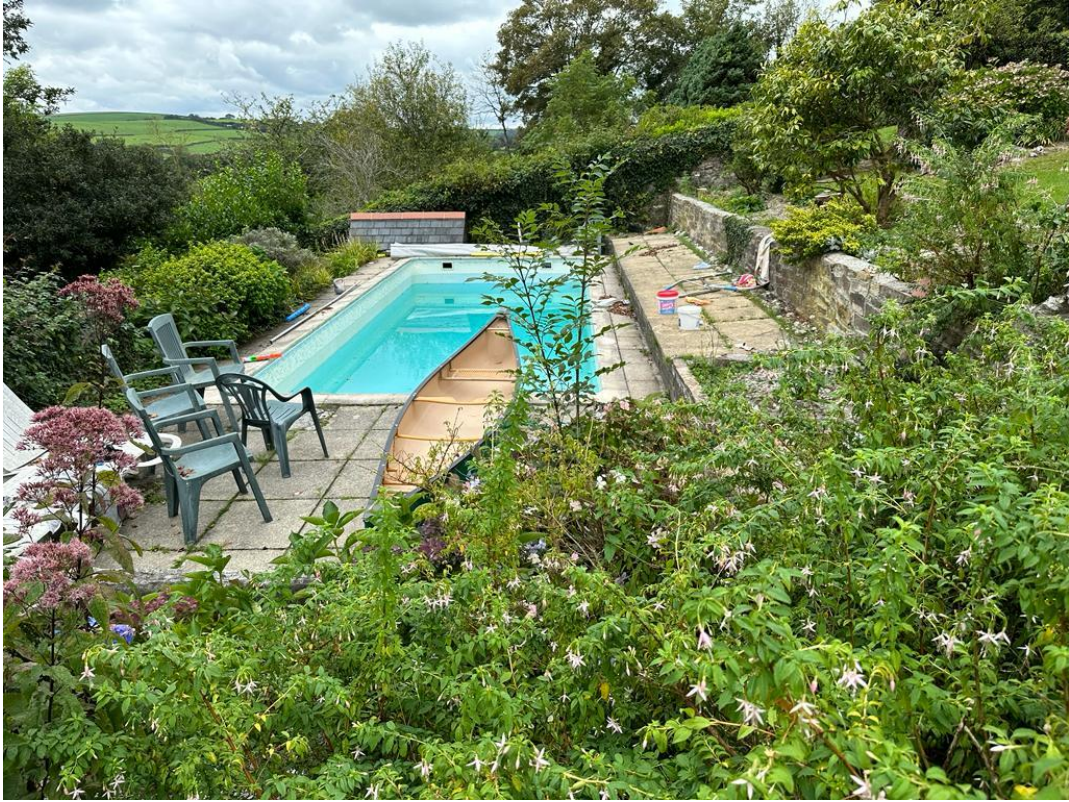
Figure 4 – Photograph showing existing pool area.

Replacement external pool to match existing size and position.

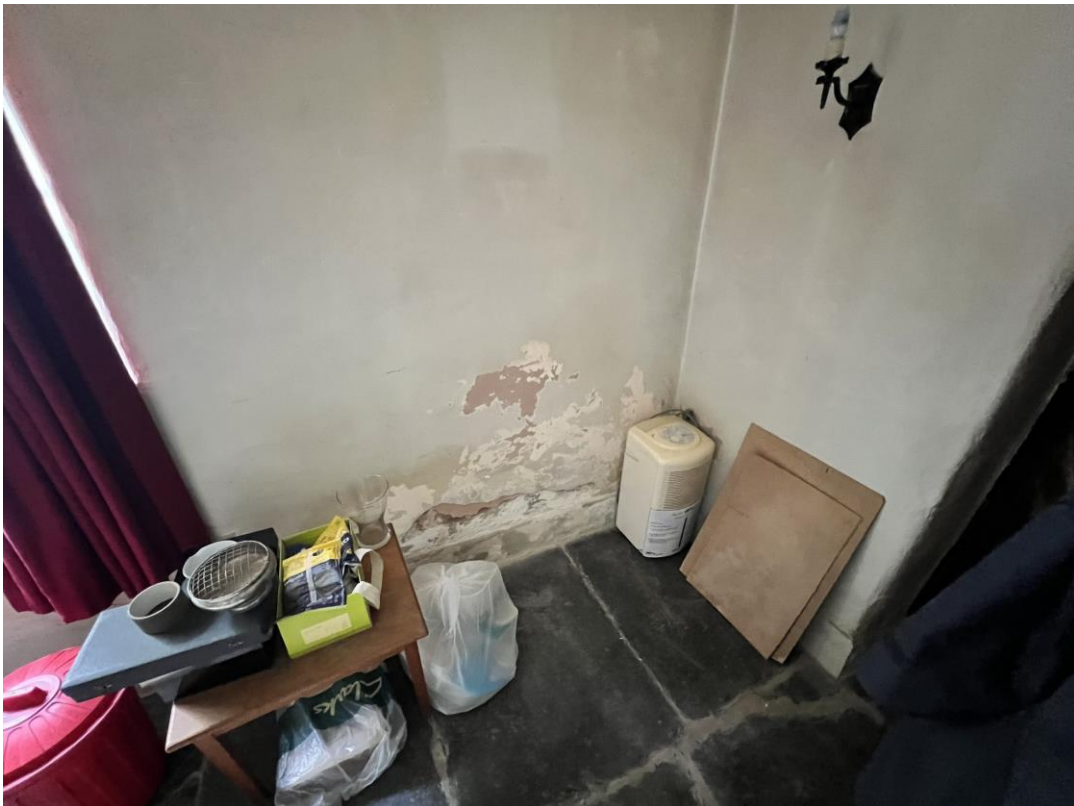
Figure 5 – Photograph showing damp staining and plaster blistering.

The North elevation of the building is to be stripped of concrete render and re-finished with a lime-based render, to help alleviate existing damp issues.
