Historic Impact Assessment

East Lodge Screen Wall, Dyrham Park Masonry Repairs

East Lodge
Dyrham Park
Dyrham
Nr Bath
SN14 8ER

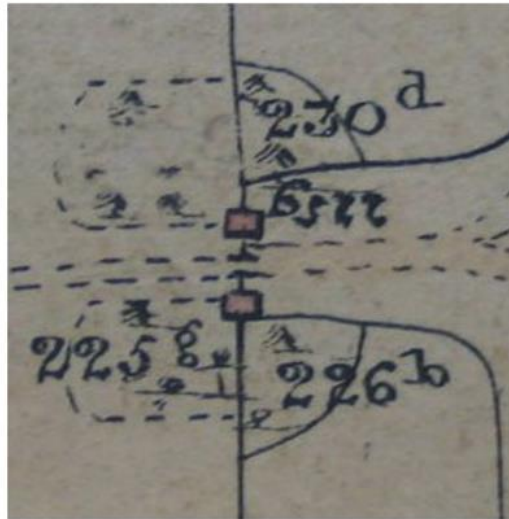
1843 tithes survey

A survey of 1843 also shows the east gate flanked by two square buildings, with the south and north gate houses connected by a straight boundary extending from the midpoint of their opposing walls, which might represent a gate structure, with boundary walls extending north and south.

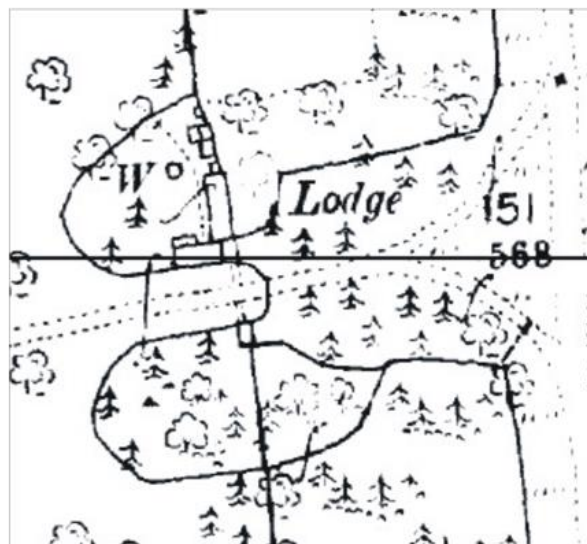
1882 Ordnance Survey

Sometime between 1843 and 1882, the northern gatehouse was augmented by ancillary structures and the vehicular entrance to the park was reconfigured to its present arrangement

The 1882 map suggests there was a narrow linear structure adjoining the north face of the screen wall that remained extant until 1903 at least. This would not have been a glasshouse (Heaton 2018), but might have been a potting shed or similar, which suggests that the screen wall was also the south wall of a garden. The vertical joint within the rubble masonry of the north face of the garden screen wall might mark the eastern extent of that ancillary structure, which in turn suggests either that it was built into the wall or that the western 4.60m of the wall has been created or rebuilt after its demolition.
