**10 Llwyncelyn Terrace, Coelbren,
Neath, Powys, SA10 9PA
Bat Survey Report for Mr J. Evans**

Report type	Bat Survey Report
Report reference	IG202310LlwynhelynTerrace
Site	10 Llwynhelyn Terrace, Coelbren, Neath, Powys, SA10 9PA
Grid reference	SN 84019 11881
Client	Mr J. Evans
Date(s)/time(s)/type(s) of survey(s)	Scoping survey: 12 th July 2023 Dawn re-entry survey: 13 th July 2023 between 03:10 and 05:15
Surveyor details	Scoping survey: Mr Glyn Lloyd-Jones, Natural Resources Wales Licence number S091520/1 Activity surveys: as above with assistance from Ms Bonnie Illingworth
Architect	Mr O. Lloyd, Ferndale Architectural Solutions Ltd

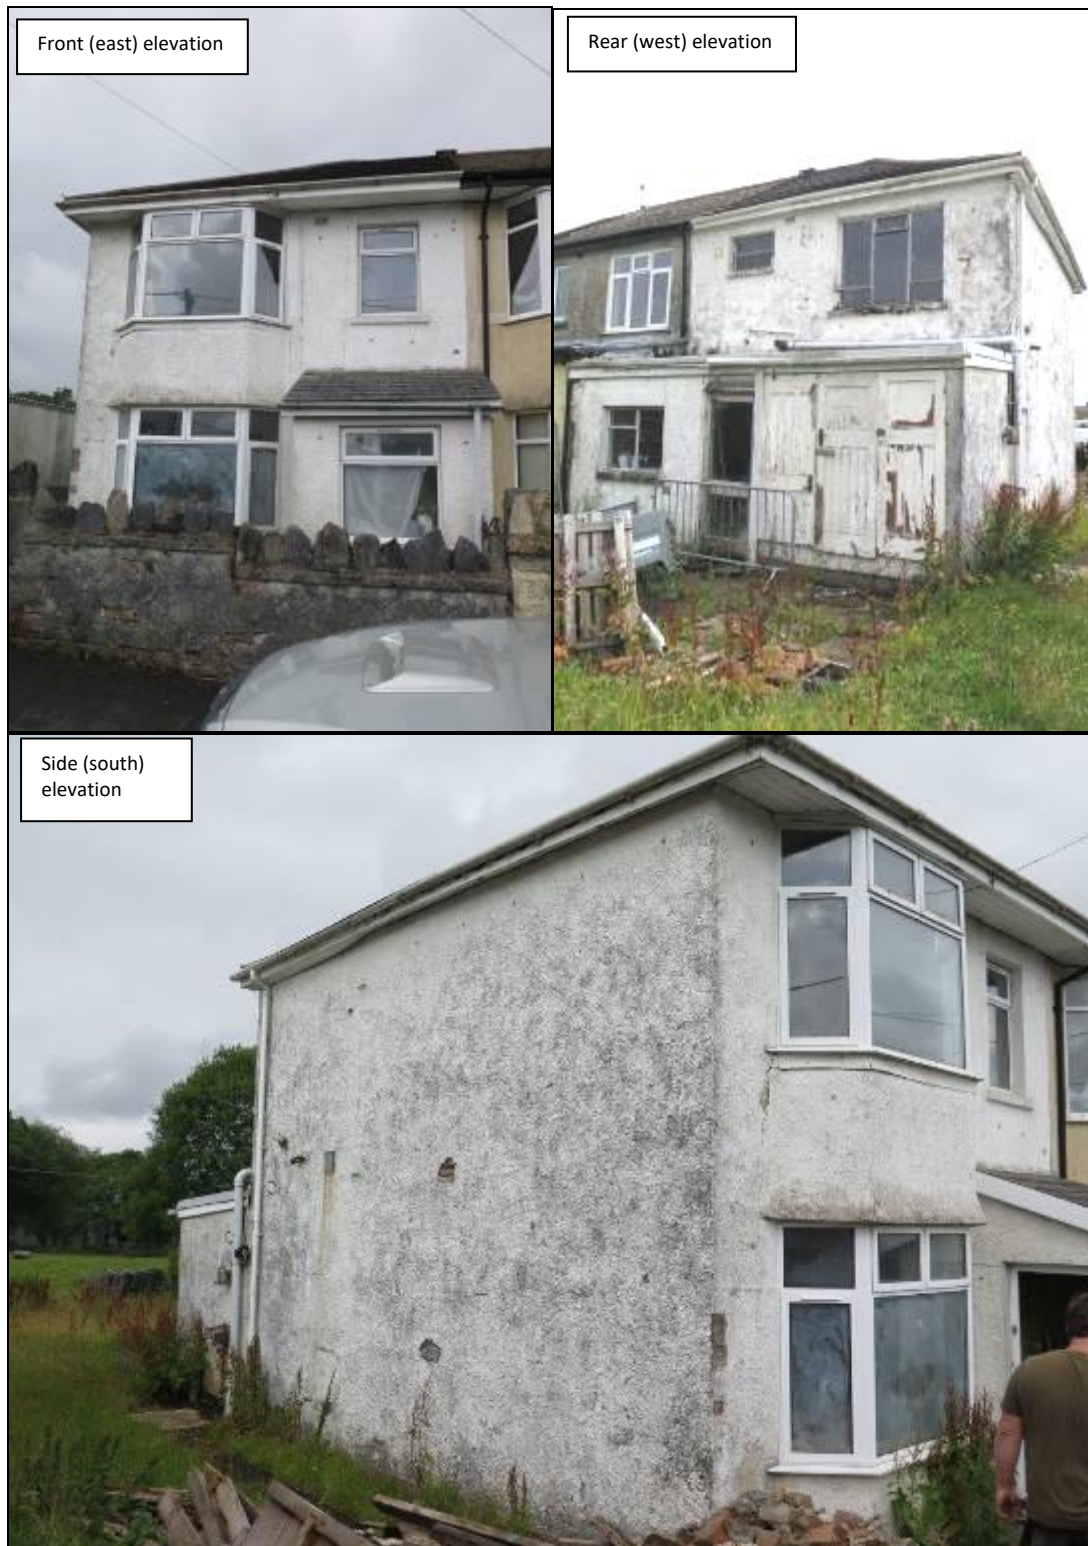
The property is a semi-detached, east facing, two-storey dwelling with a porch to the front and a single storey extension to the rear that is subject to proposed plans for a two storey side extension and a single storey rear extension. It is constructed of brick (the extension is block with some timber doors) walls that have been rendered and painted with the main roof being hipped tile while the porch has a monopitch slate roof, and the rear extension has a flat roof. Aesthetically it is currently in poor condition but it has previously been well maintained and is well-sealed.

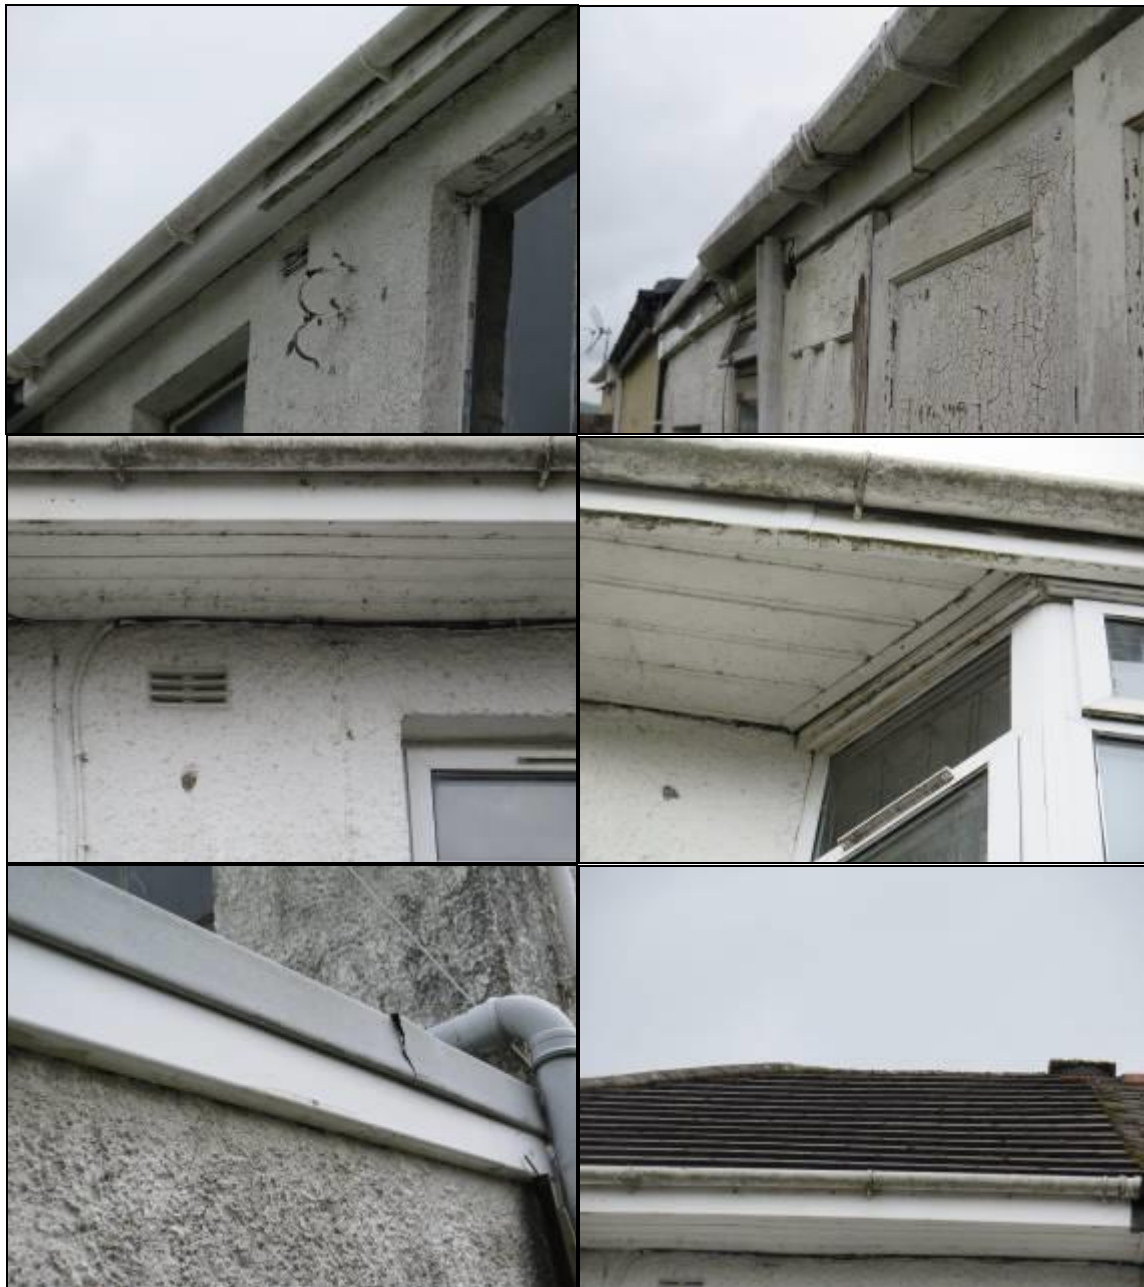
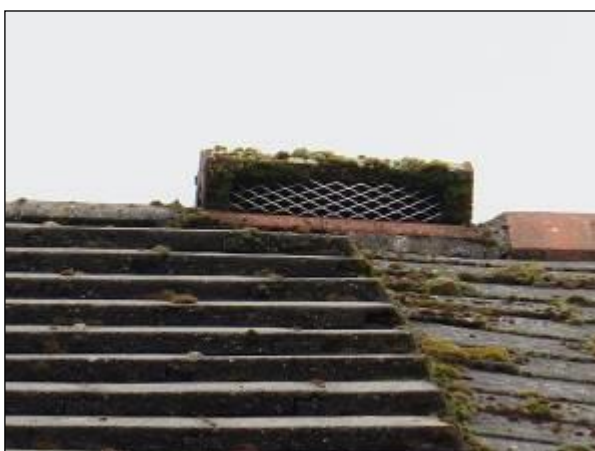
exploitable gaps under the flashing.

The walls have some missing render but this has not created any potentially exploitable gaps but while the uPVC soffits/fascia are predominantly tight to the walls there are one or two small gaps present. In addition, while the timber framed sections of the uPVC/timber frames windows and doors are beginning to rot they are all intact and remain closed when not in use with no gaps around the frames. Further, the roofs are in good condition within no missing/slipped/damaged slates or tiles, no raised ridge tiles (the vent on the ridge has mesh on it), no damage to the flat roof, and no potentially

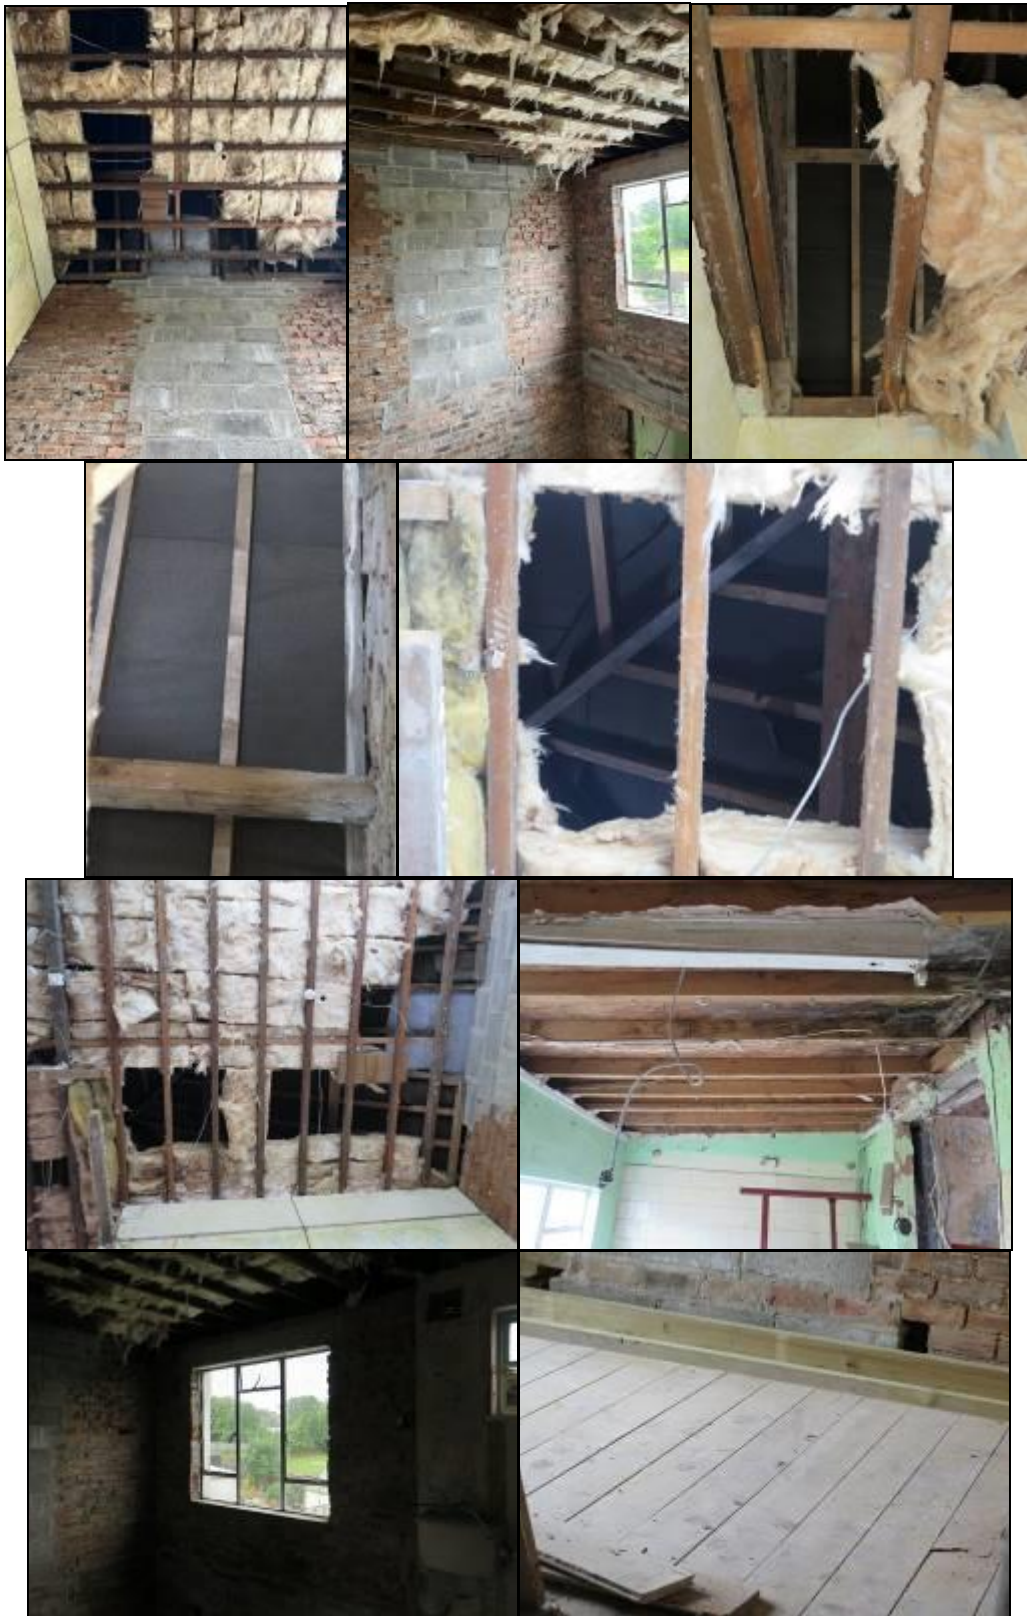
Internally, many of the ceilings have been stripped so the building is naturally light within; thus, reducing any potential for day roosting. However, using the equipment available it was possible to ascertain that the predominantly bitumastic felt lined roof is in good condition with no damage with no visible natural light seen to enter either through the roof or at wall tops (noting that there are potentially exploitable gaps in the brickwork). Careful examination of all areas found is dust and debris present in places as well as undisturbed cobwebs, but **no live or dead bats or their signs (e.g., droppings, urine stains or smells) were found anywhere either externally or internally.**
