**A1122 Allen Gallery and  
Gardens Project**

Heritage Statement  
October 2023

**PRITCHARD**  
ARCHITECTURE

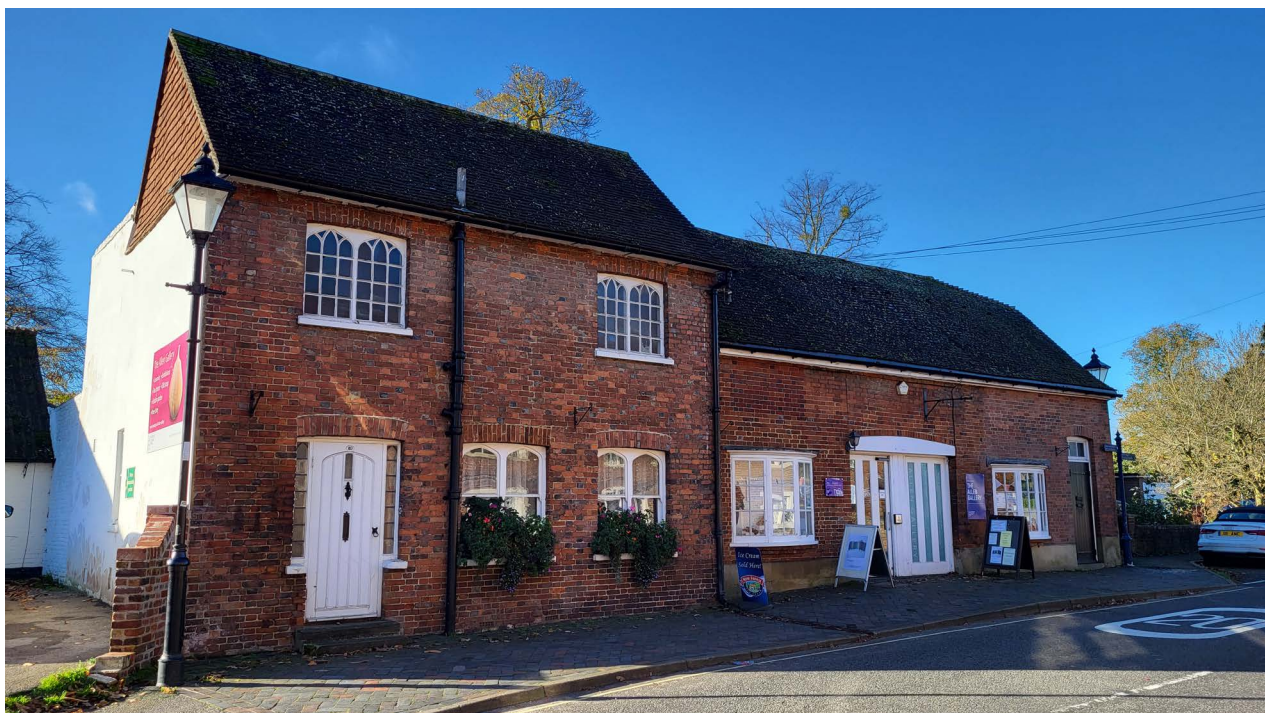
*Street Elevation of the No. 10 & 10a Church Street*

No.10 Church Street is a two storey building of three bay brick construction in Flemish Bond with burnt headers, with a clay tiled pitched roof and cast iron gutters and downpipes. The four windows and door on the principal elevation are formed with shallow brick arches. The first floor windows are timber framed four-centred arched gothick windows, whereas the ground floor windows are timber sashes of a later date. The original front door to No. 10 (no longer used) is a timber boarded door with 2 side lights, accessed via two concrete steps. The south east gable end is rendered at ground and first floor level with tile hanging to the gable; there is a single timber framed casement window to the ground floor.

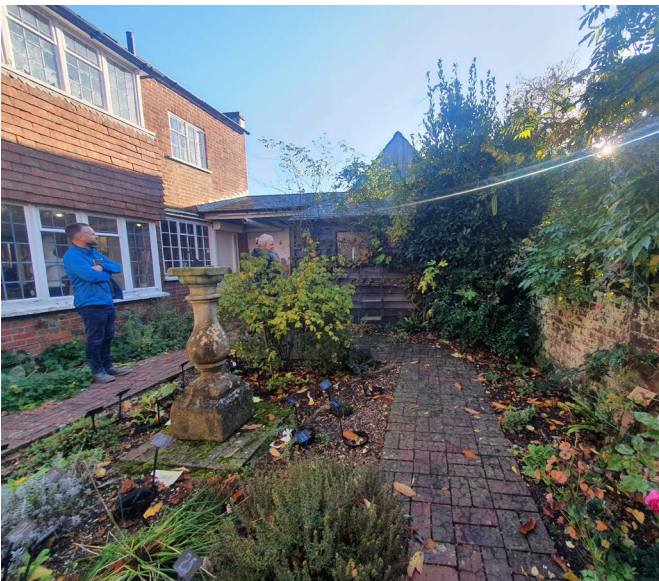
Rear of No. 10

To the rear of the building is a flat roofed projecting extension in stretcher bond brickwork, which has a two storey clay tile hung bay with timber framed leaded casement windows. Adjacent to the bay there are metal framed casement windows to ground and first floors and an external modern timber boarded door with metal security shutter mounted over. Abutting the rear of No.10 and running at a right angle is a timber framed lean-to structure with the brick boundary wall forming the rear wall of the structure. It has a shallow pitched slate roof, and is open sided where it abuts the main building and enclosed to the south west. The exposed timber roof structure is historic with the enclosed area formed of modern timber stud walls with black timber weatherboarding. This outbuilding houses the only toilet facilities on the site. It has a modern timber framed window and modern timber boarded doors.

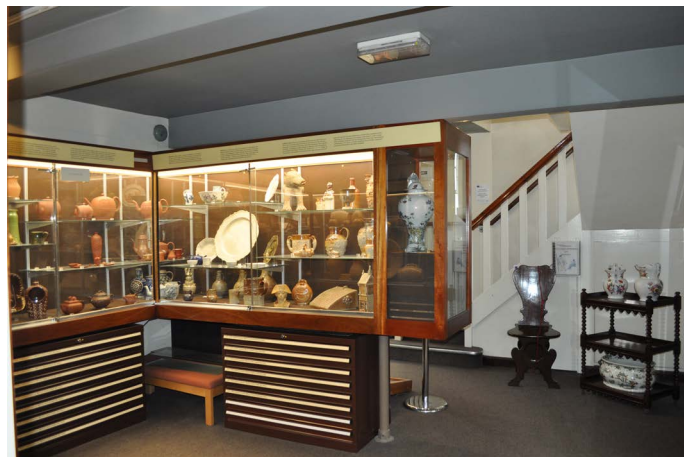
Ground floor of No. 10

Internally the windows to the street elevation are blocked up with exhibition display cases. The remaining windows and doors that are not blocked by display cases either have painted metal security grilles or surface mounted security roller shutters. There is a modern timber stair to the south east of No. 10.

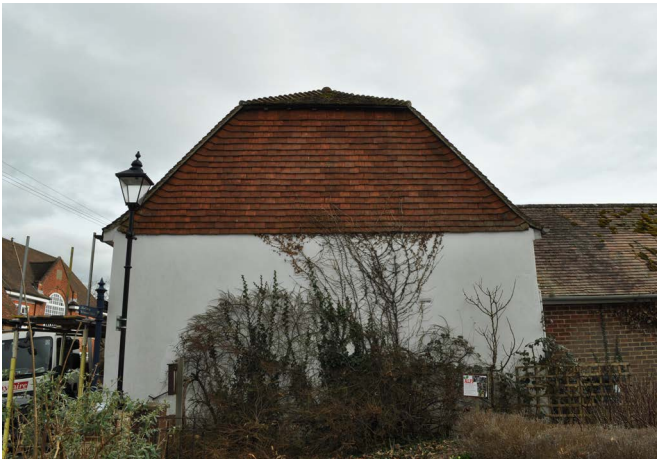
North west elevation

Directly abutting No.10 is the C19th former stable and coach house (No. 10a). No.10a is of brick construction in Flemish Bond with burnt headers to the eastern end of the street frontage, and Flemish Garden Wall Bond to the western end. It has a clay tiled half hipped roof. The street elevation has two timber framed curved oriel windows with three casements, each with six panes. The original front door to No. 10a (no longer used) is a timber boarded door with an overlight. The main entrance to the museum is via the old carriageway, this has been infilled with a modern timber framed glazed screen and door. The north west gable end is rendered at low level with tile hanging to the gable. No. 10 a has been heavily altered and extended to the rear with a brick built single storey extension with clay tiled pitched roof built in 1979. This houses a purpose built exhibition space and links back to the historic carriageway via a flat roofed infill with large modern automatic glazed door that leads out onto the courtyard. The link has a stable brick floor that may be original to its use as a carriageway.

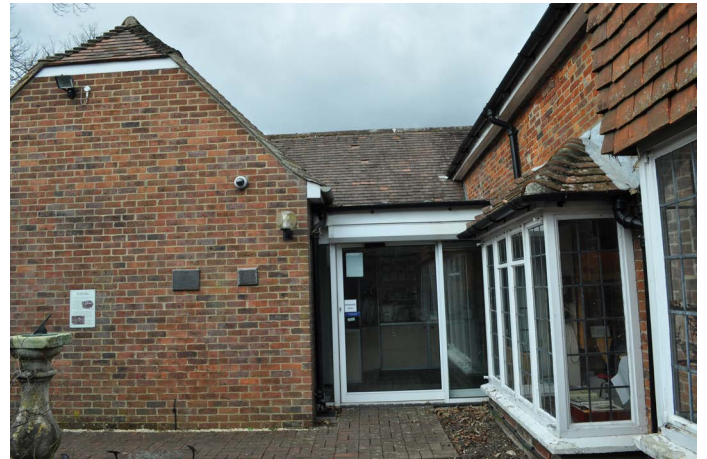
Modern extension and link building

The modern extension has painted blockwork walls that have an internal plasterboard lining at eaves level and exposed timber trusses with pine t&g boarding to the ceiling, which has been covered with a fire retardant fabric. There is a single glazed timber framed slot window to the rear elevation with an ornate metal grille. Generally the windows and doors to No. 10a either have metal security shutters or painted metal grilles.

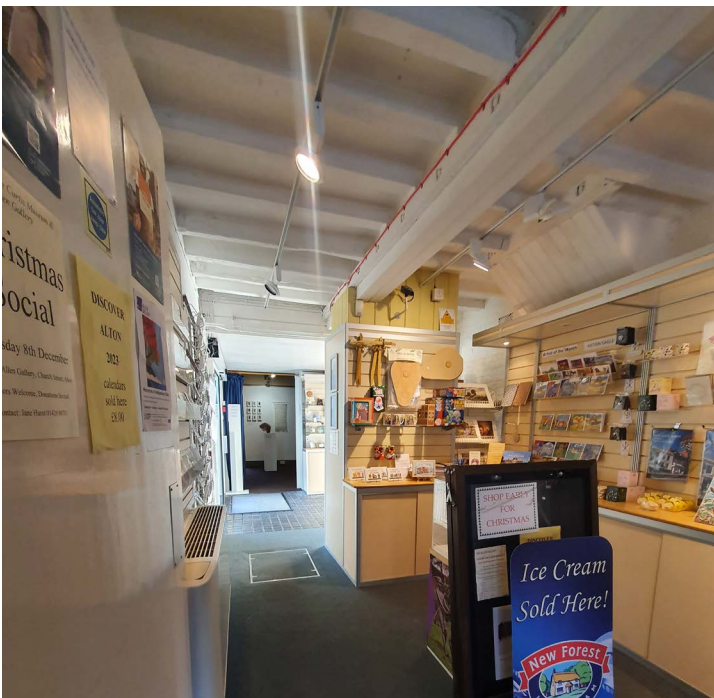
Entrance area and shop

The entrance area and shop is housed within the old carriageway and has painted brick walls, exposed historic timber beams that have been strengthened with steel angles, with lath and plaster infill. The gallery space to the south east of the entrance area also has exposed historic timber beams and joists with lath and plaster infill. The ground floor room to the north west of No. 10 is a double height space that houses the cafe; it has modern plasterboard and hardboard linings throughout and a modern timber stair to the first floor. The first floor of No. 10a is formed of two rooms, one a gallery space, the other accessed via some steps to one end of the gallery. There is a storeroom located within the loft space. The gallery space has exposed timber trusses and historic timber framing, and exposed brickwork to the original chimney breast to the shared wall with No. 10. Both the store and gallery have modern hardboard ceiling and wall linings.

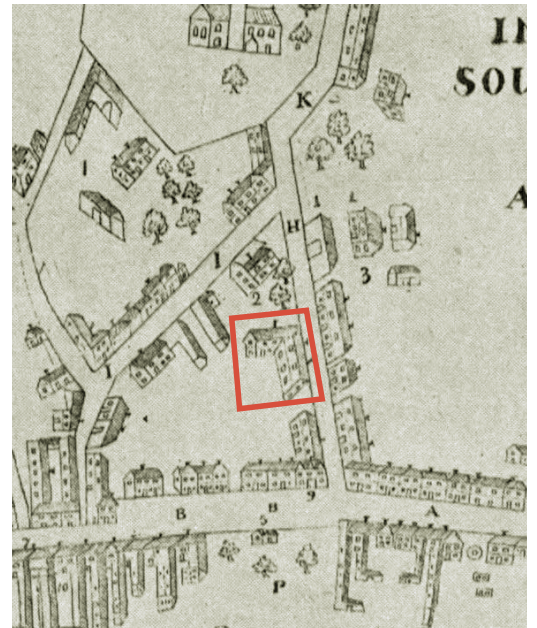
Excerpt of 1666 Knight Map of Alton  
Allen Gallery site highlighted in red

The 1666 Knight Map of Alton shows a house or houses in an L-shaped arrangement in the location of the current No.10 and No.10a Church Street. It appears to have had a double frontage to the street and there is a wing to the north and extending beyond the rear elevation.

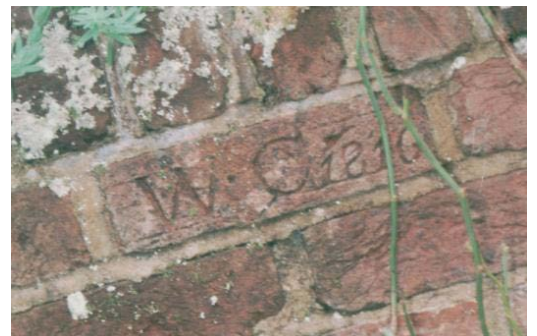
1816 date brick to garden wall

In 1816, a wall was constructed between the garden of No.4 High Street and the yard of No.10 church street as demonstrated by the dated brick that still remains in the wall today. The dividing wall is visible on the Tithe map of 1842, which also suggests that the gardens of 10 and 10a were taken into the curtilage of No.4 High Street but retaining an access through the garden wall to the yard of No.10.

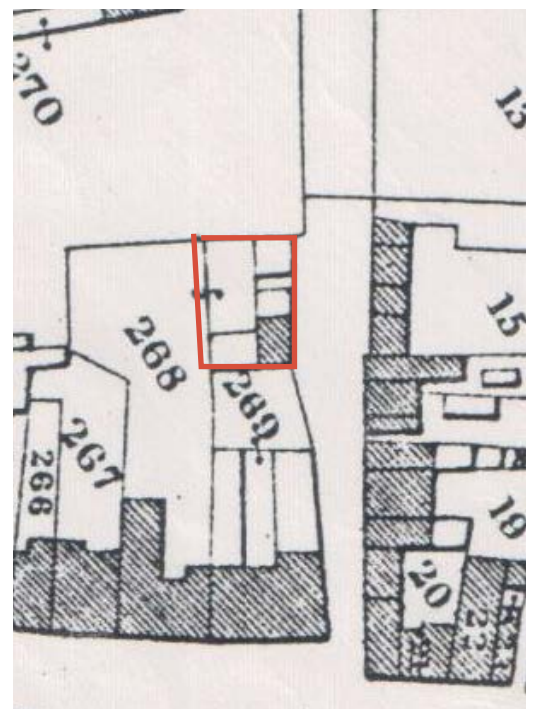
Excerpt of 1842 Tithe Map  
Allen Gallery site highlighted in red

In 1839 Surveyors for the Tithe Commissioners looked at the property and saw that 'considerable alterations had been made. This is also shown on the Tithe Map of 1842. *The house had been reduced to a cottage (No. 10) occupying only a third of the frontage nearest to the Crown, with an outbuilding behind it, possibly the extension present in the plan of 1770. From William Hugh Curtis's description of the buildings it seems to have been a cow byre. The doctor's groom lived in the cottage, and adjoining it was a coach house. Beyond that was a stable with a wide gateway between them leading to a cobbled yard. Above, a long and ample loft linked the two buildings. The land at the rear beyond the yard had been taken into the garden of 4 High Street.*' (Article by Georgina Smith)

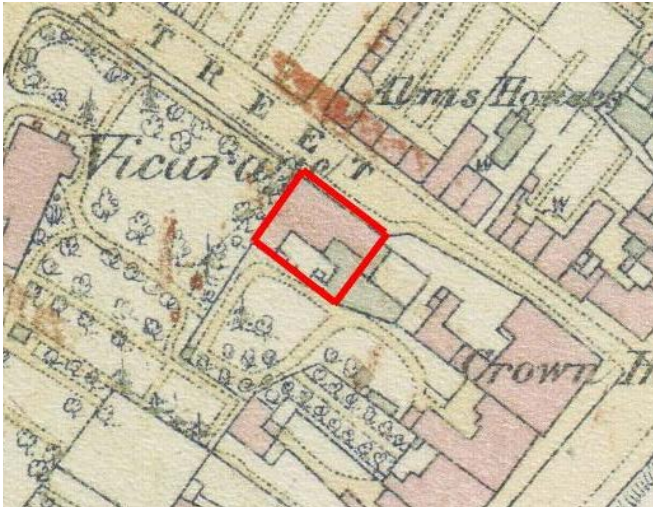
1870 OS Map - Allen Gallery site highlighted in red

The 1870 OS map shows that since 1842 a second coach house and stable had been added within the rear yard. At the turn of the century the stable provision became unnecessary and the buildings were turned into cottages.

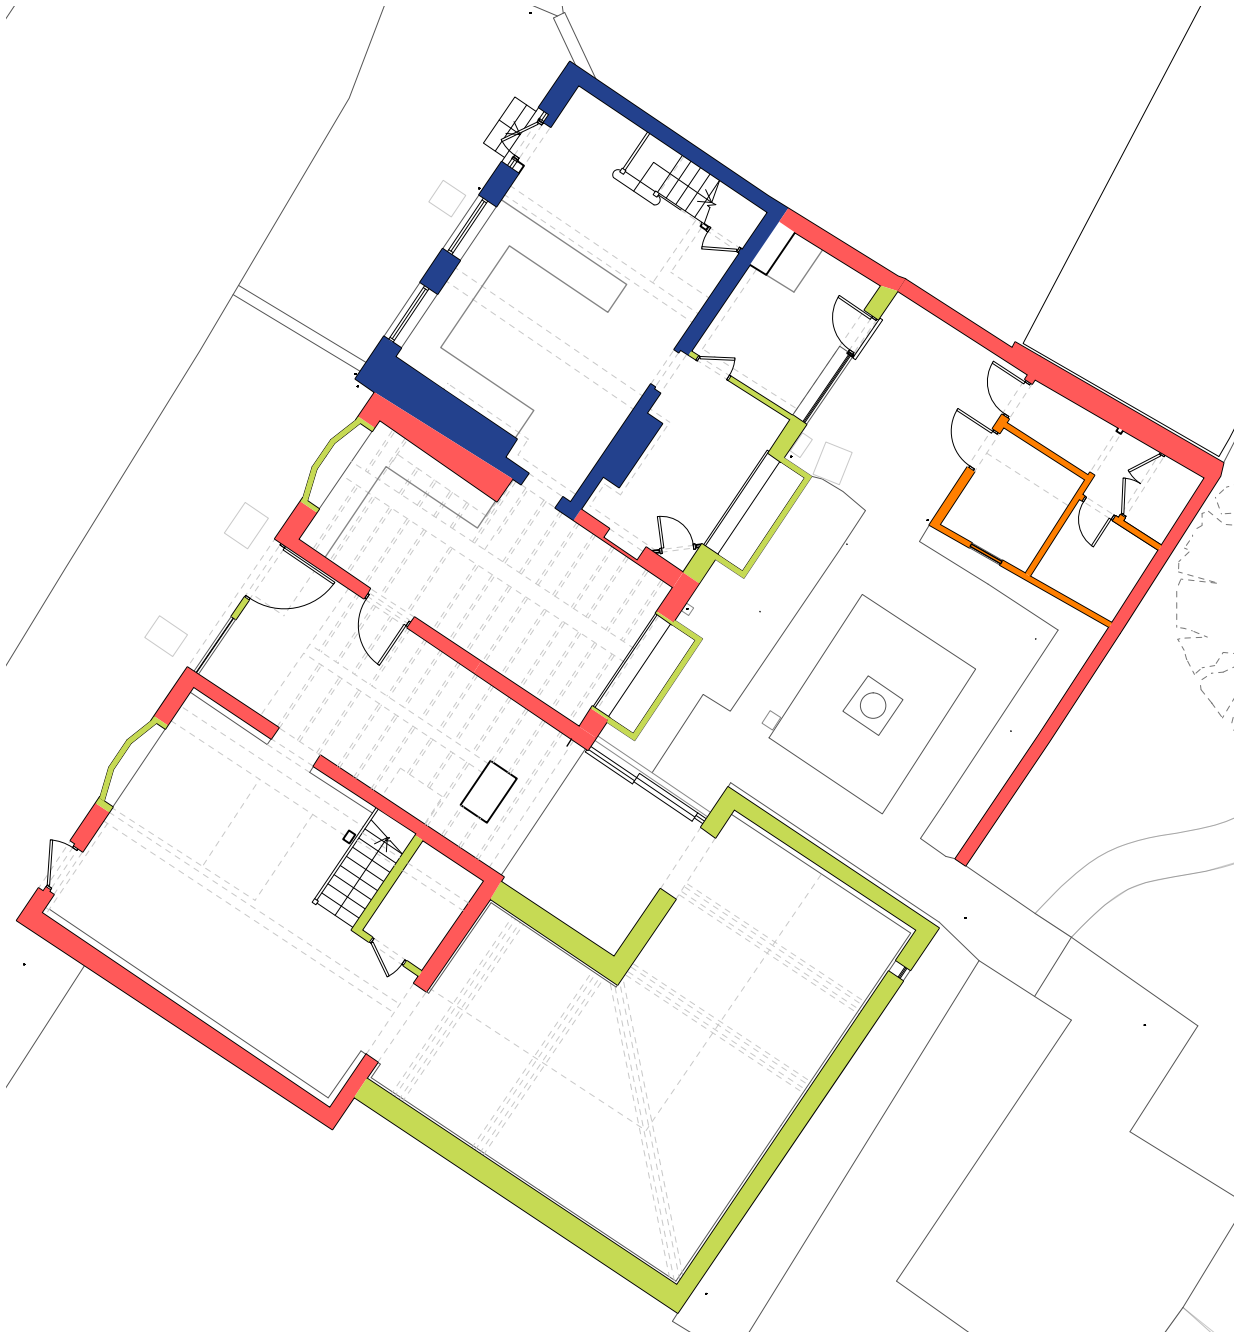
Ground Floor Plan

**Building Chronology**

18th Century	19th Century	20th Century	21st Century
