# Factual Site Investigation

Leachate Treatment Plant, Joint Stocks Landfill,  
Coxhoe

Durham County Council

S220506

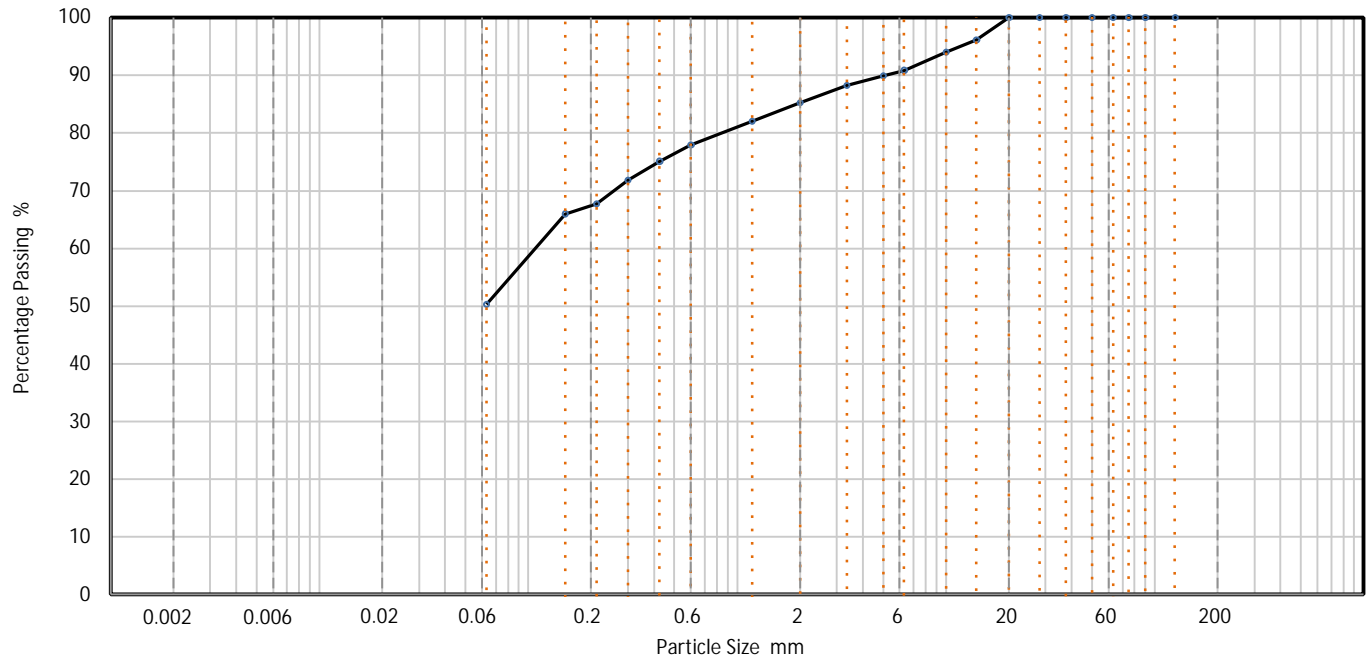
Hole	BH01	Lab sample ID	SLMK2022071454
Depth (Top)	m 5.00	Test Method	BS 1377 - 2 : 1990 Clause 9.2
Depth (Base)	m	Soil Description	Slightly Gravelly, Very Sandy CLAY
Sample type	B

Sieving		Sedimentation	
Particle Size mm	% Passing	Particle Size mm	% Passing
125	100		
90	100		
75	100		
63	100		
50	100		
37.5	100		
28	100		
20	100		
14	96		
10	94		
6.3	91		
5	90		
3.35	88		
2	85		
1.18	82		
0.6	78		
0.425	75		
0.3	72		
0.212	68		
0.15	66		
0.063	50

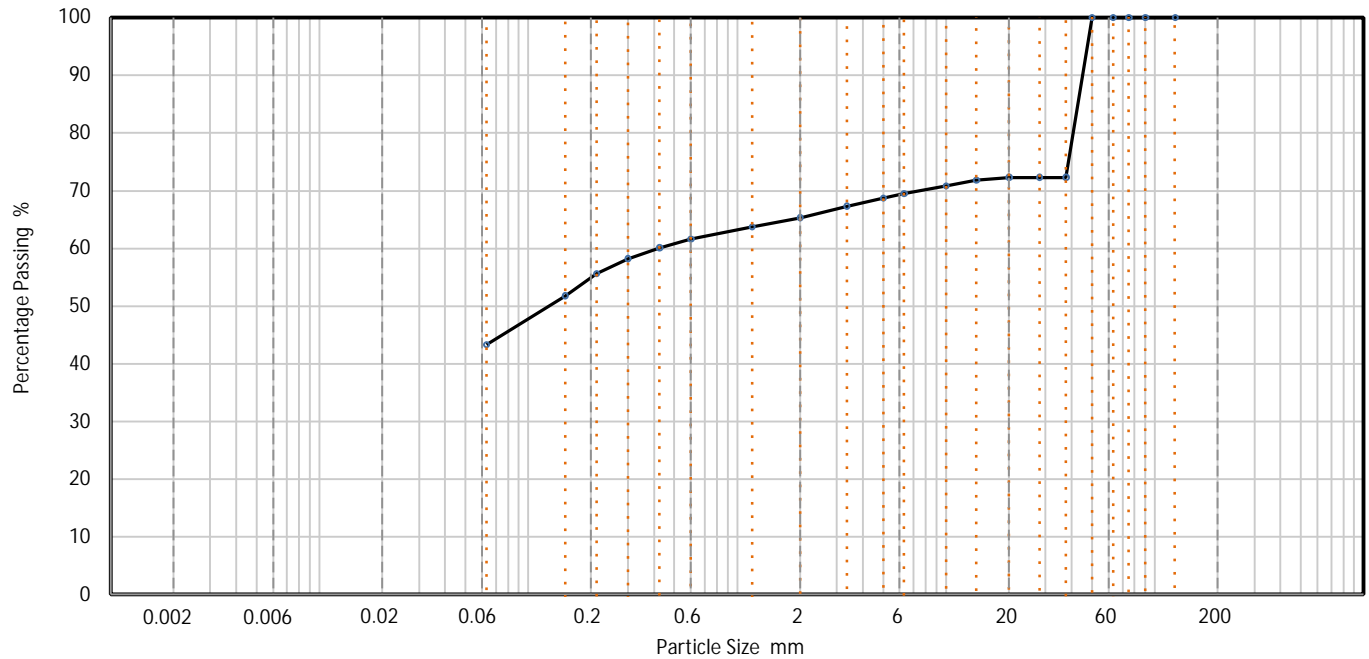
Hole	BH02	Lab sample ID	SLMK2022071459
Depth (Top)	m 7.50	Test Method	BS 1377 - 2 : 1990 Clause 9.2
Depth (Base)	m	Soil Description	
Sample type	B

Sieving		Sedimentation	
Particle Size mm	% Passing	Particle Size mm	% Passing
125	100		
90	100		
75	100		
63	100		
50	100		
37.5	72		
28	72		
20	72		
14	72		
10	71		
6.3	70		
5	69		
3.35	67		
2	65		
1.18	64		
0.6	62		
0.425	60		
0.3	58		
0.212	56		
0.15	52		
0.063	43

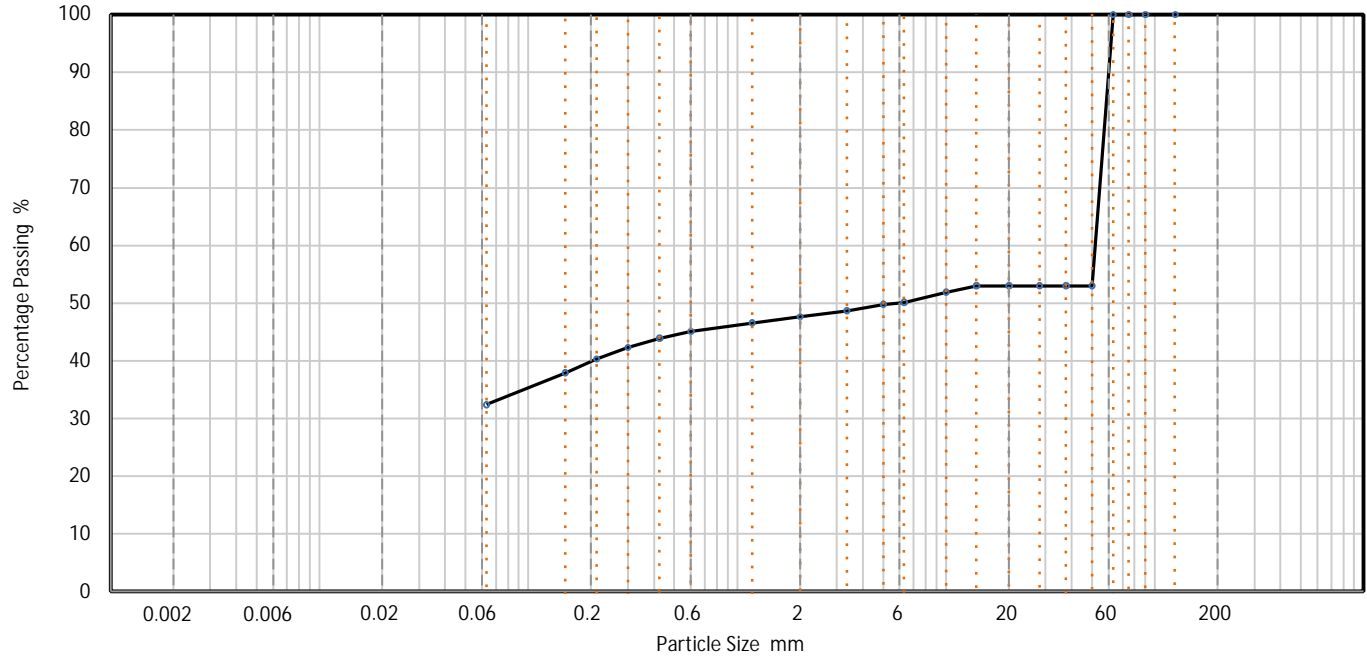
Hole	BH04	Lab sample ID	SLMK2022071464
Depth (Top)	m 3.00	Test Method	BS 1377 - 2 : 1990 Clause 9.2
Depth (Base)	m	Soil Description	
Sample type	U

Sieving		Sedimentation	
Particle Size mm	% Passing	Particle Size mm	% Passing
125	100		
90	100		
75	100		
63	100		
50	53		
37.5	53		
28	53		
20	53		
14	53		
10	52		
6.3	50		
5	50		
3.35	49		
2	48		
1.18	47		
0.6	45		
0.425	44		
0.3	42		
0.212	40		
0.15	38		
0.063	32

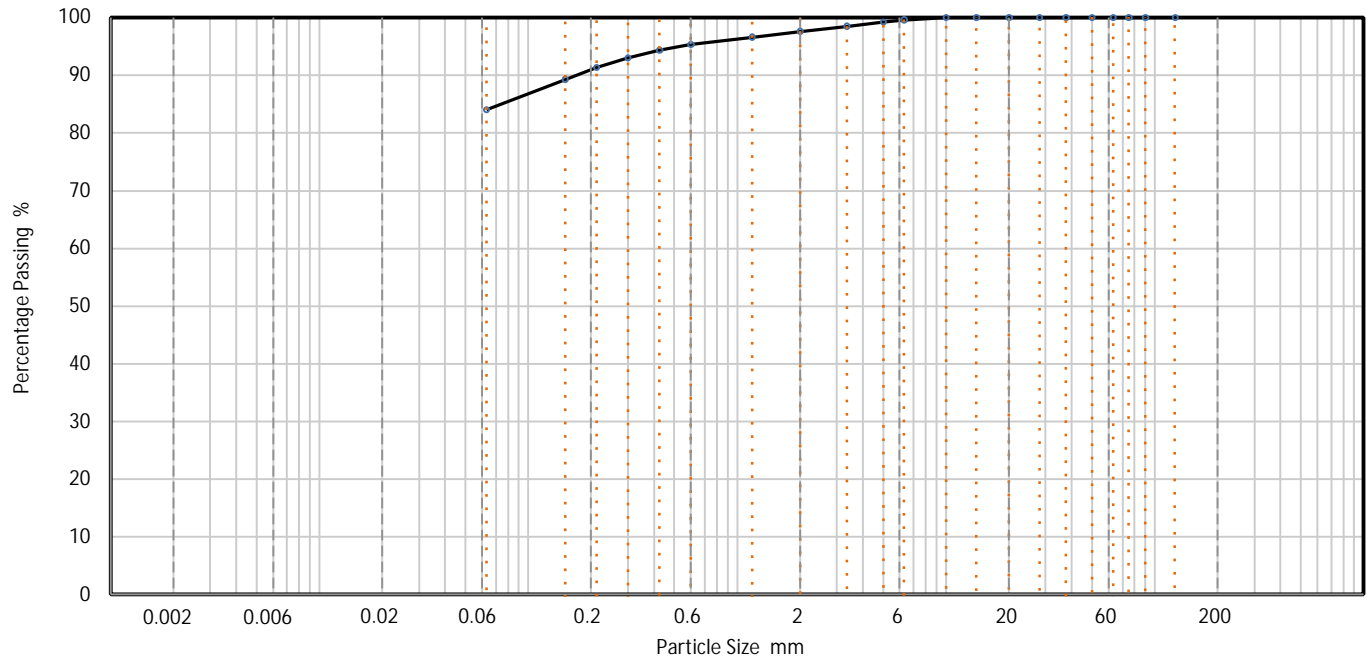
Hole	BH04	Lab sample ID	SLMK2022071467
Depth (Top)	m 10.50	Test Method	BS 1377 - 2 : 1990 Clause 9.2
Depth (Base)	m	Soil Description	Slightly Gravelly, Slightly Sandy, CLAY
Sample type	U

Sieving		Sedimentation	
Particle Size mm	% Passing	Particle Size mm	% Passing
125	100		
90	100		
75	100		
63	100		
50	100		
37.5	100		
28	100		
20	100		
14	100		
10	100		
6.3	100		
5	99		
3.35	99		
2	98		
1.18	97		
0.6	95		
0.425	94		
0.3	93		
0.212	91		
0.15	89		
0.063	84

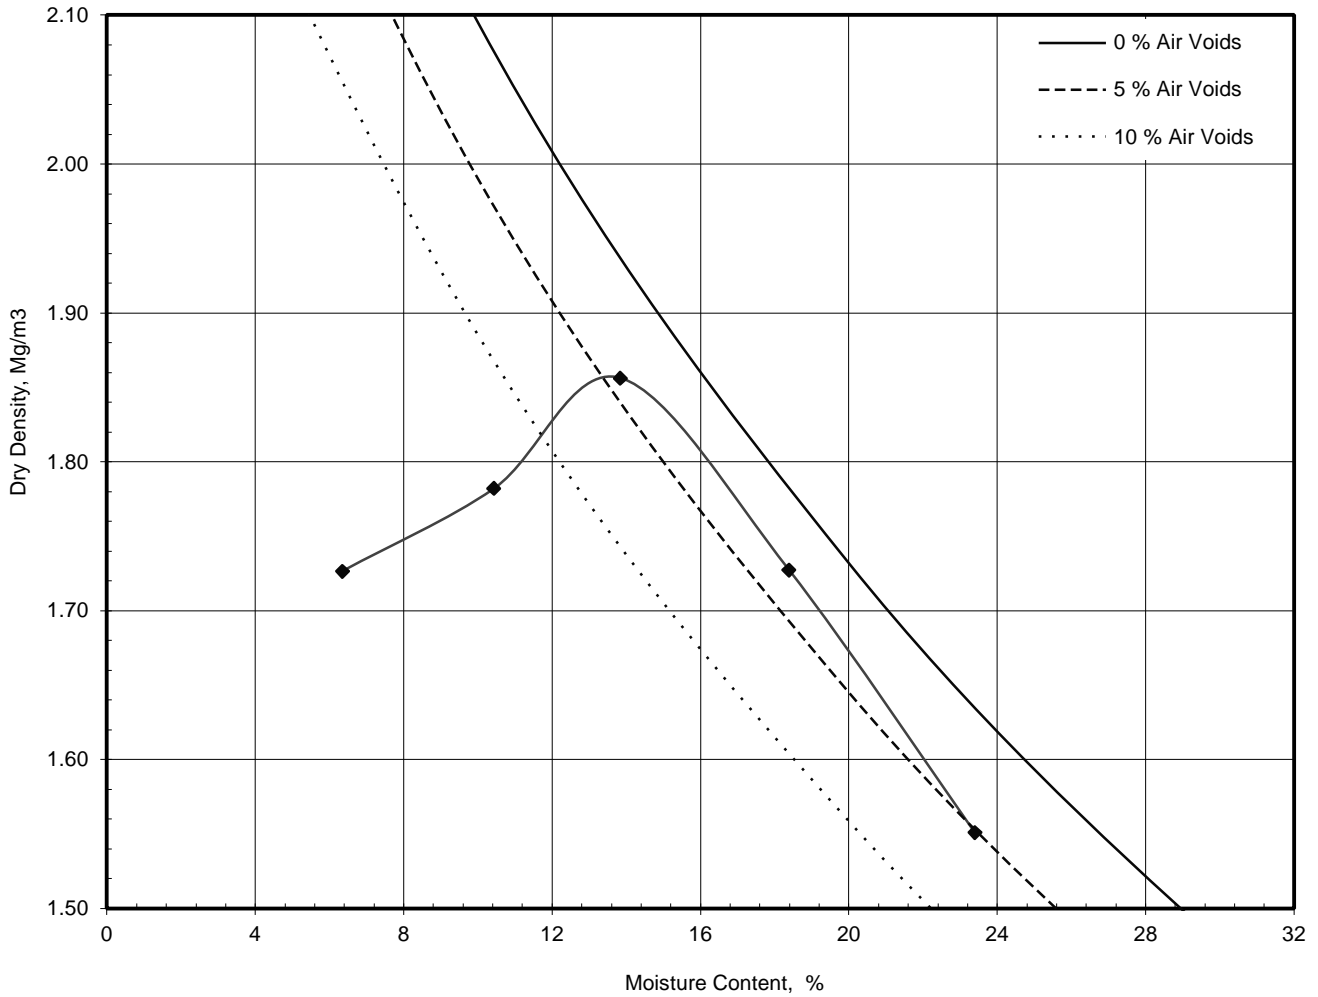
Site Name	<b>S220506</b>	
Soil Description		
Specimen Ref.	1	Specimen Depth
Test Method	BS1377:Part 4:1990, clause 3.3, 2.5kg rammer

Mould Type	1 LITRE	
Samples Used	Single sample tested	
Material Retained on 37.5 mm Sieve	%	0
Material Retained on 20.0 mm Sieve	%	3
Particle Density - Assumed	Mg/m <sup>3</sup>	2.65
Natural Moisture Content	%	
<b>Maximum Dry Density</b>	Mg/m <sup>3</sup>	<b>1.86</b>
<b>Optimum Moisture Content</b>	%	<b>14</b>

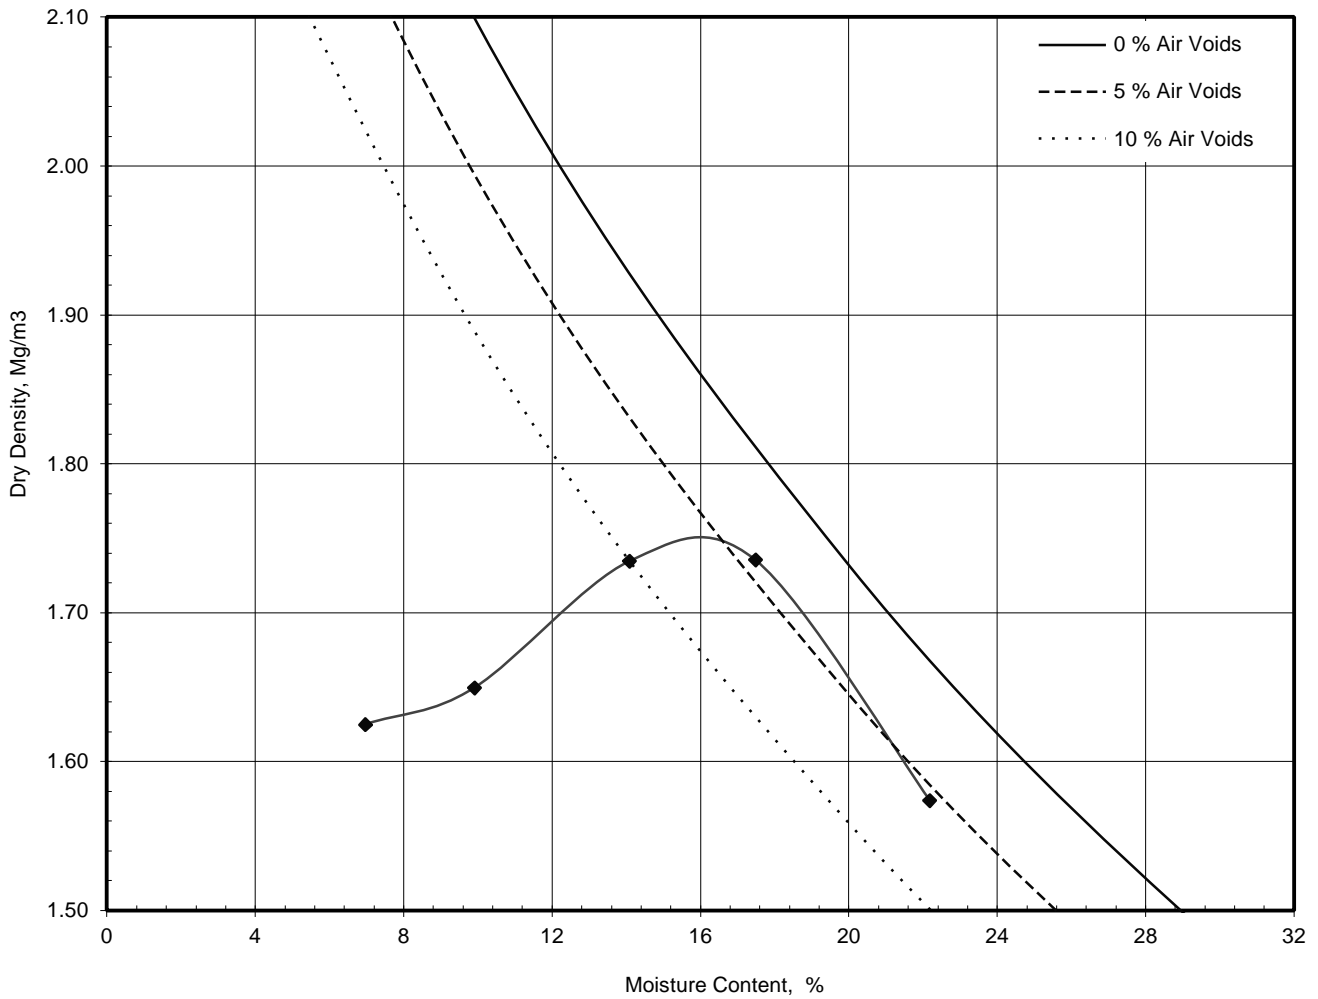
Site Name	<b>S220506</b>	
Soil Description		
Specimen Ref.	1	Specimen Depth
Test Method	BS1377:Part 4:1990, clause 3.3, 2.5kg rammer

Mould Type	1 LITRE	
Samples Used		
Material Retained on 37.5 mm Sieve	%	0
Material Retained on 20.0 mm Sieve	%	1
Particle Density - Assumed	Mg/m <sup>3</sup>	2.65
Natural Moisture Content	%	
<b>Maximum Dry Density</b>	Mg/m <sup>3</sup>	<b>1.74</b>
<b>Optimum Moisture Content</b>	%	<b>17</b>

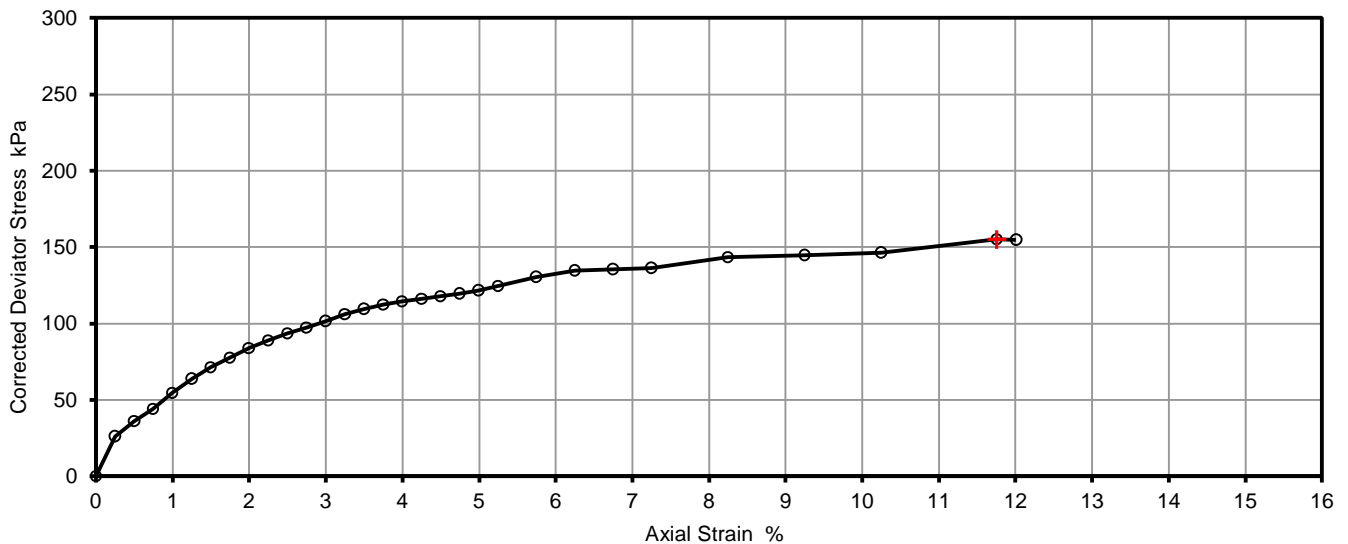
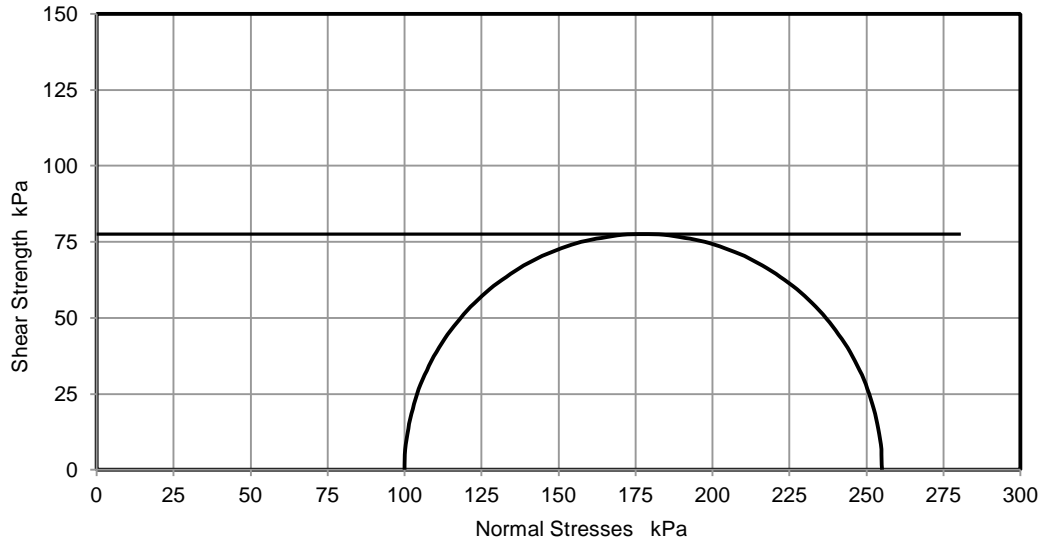
Test Number	1
Length	201.0 mm
Diameter	103.0 mm
Bulk Density	2.05 Mg/m <sup>3</sup>
Moisture Content	31.0 %
Dry Density	1.56 Mg/m <sup>3</sup>

Rate of Strain	1.0 %/min
Cell Pressure	100 kPa
At failure	
Axial Strain	11.8 %
Deviator Stress, (σ <sub>1</sub> - σ <sub>3</sub> ) <sub>f</sub>	155 kPa
Undrained Shear Strength, c <sub>u</sub>	78 kPa ½(σ <sub>1</sub> - σ <sub>3</sub> ) <sub>f</sub>
Mode of Failure	Compound

Deviator stress corrected for area change and membrane effects

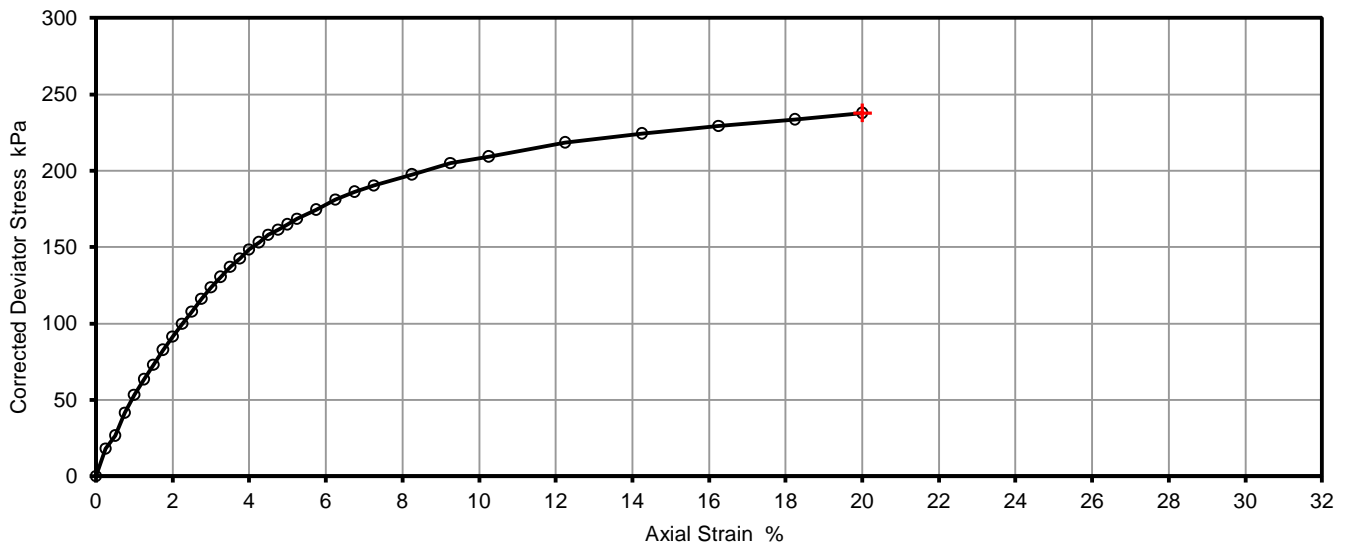
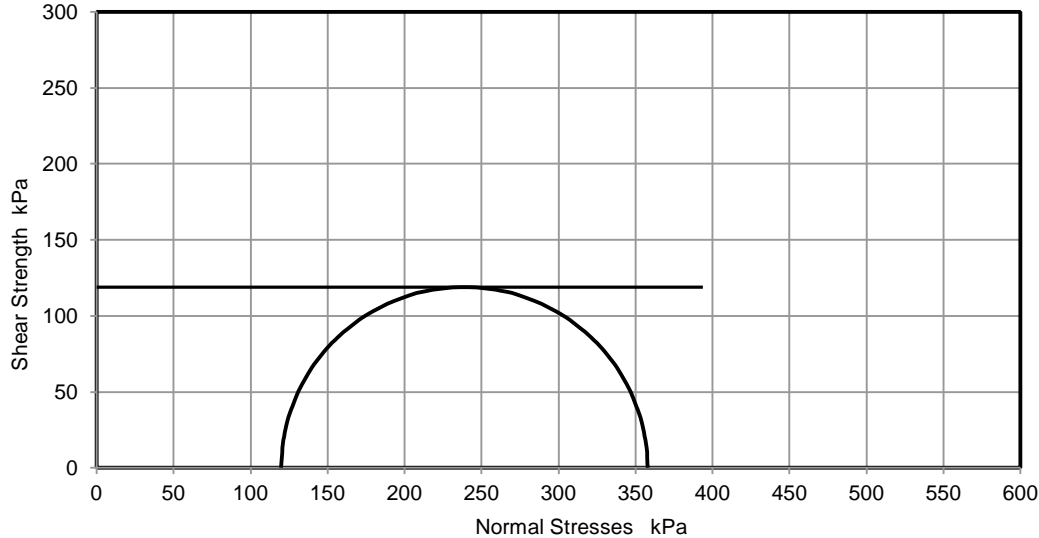
Test Number	1
Length	202.0 mm
Diameter	103.0 mm
Bulk Density	2.13 Mg/m <sup>3</sup>
Moisture Content	16.8 %
Dry Density	1.83 Mg/m <sup>3</sup>

Rate of Strain	1.0 %/min
Cell Pressure	120 kPa
At failure	
Axial Strain	20.0 %
Deviator Stress, ( $\sigma_1 - \sigma_3$ ) <sub>f</sub>	238 kPa
Undrained Shear Strength, $c_u$	119 kPa $\frac{1}{2}(\sigma_1 - \sigma_3)_f$
Mode of Failure	Plastic

Deviator stress corrected for area change and membrane effects

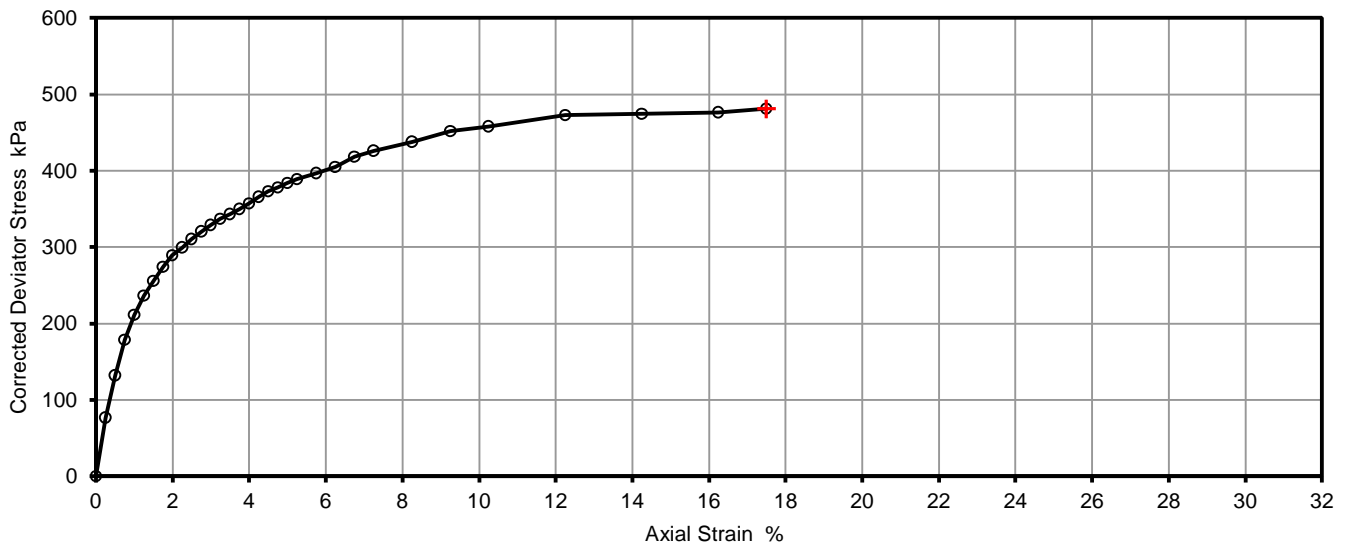
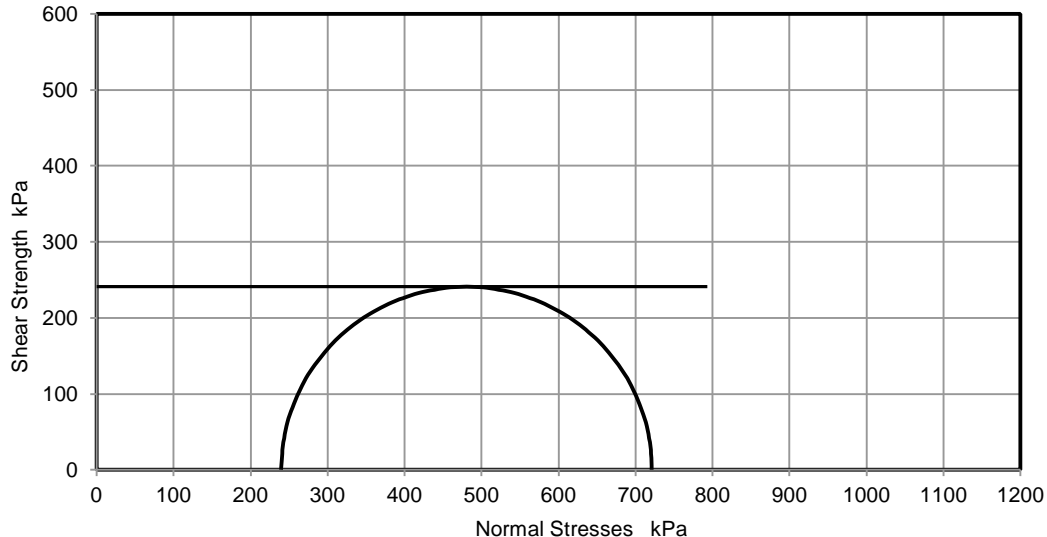
Test Number	1
Length	202.0 mm
Diameter	101.0 mm
Bulk Density	2.19 Mg/m <sup>3</sup>
Moisture Content	13.2 %
Dry Density	1.94 Mg/m <sup>3</sup>

Rate of Strain	1.0 %/min
Cell Pressure	240 kPa
At failure	
Axial Strain	17.5 %
Deviator Stress, ( $\sigma_1 - \sigma_3$ ) <sub>f</sub>	481 kPa
Undrained Shear Strength, $c_u$	241 kPa $\frac{1}{2}(\sigma_1 - \sigma_3)_f$
Mode of Failure	Plastic

Deviator stress corrected for area change and membrane effects

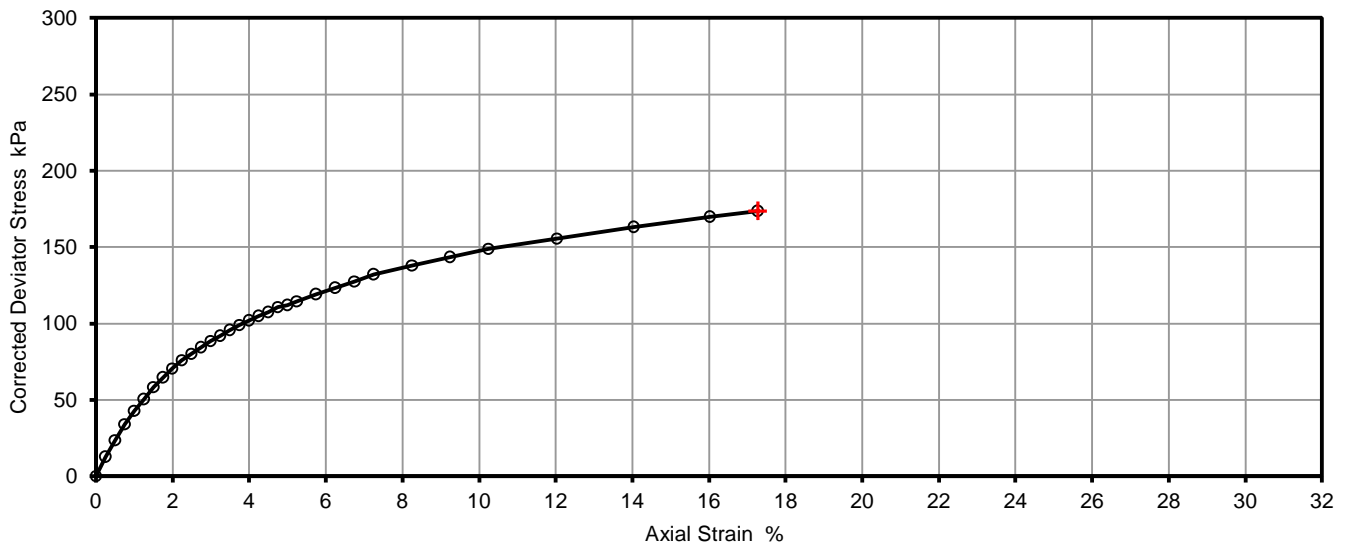
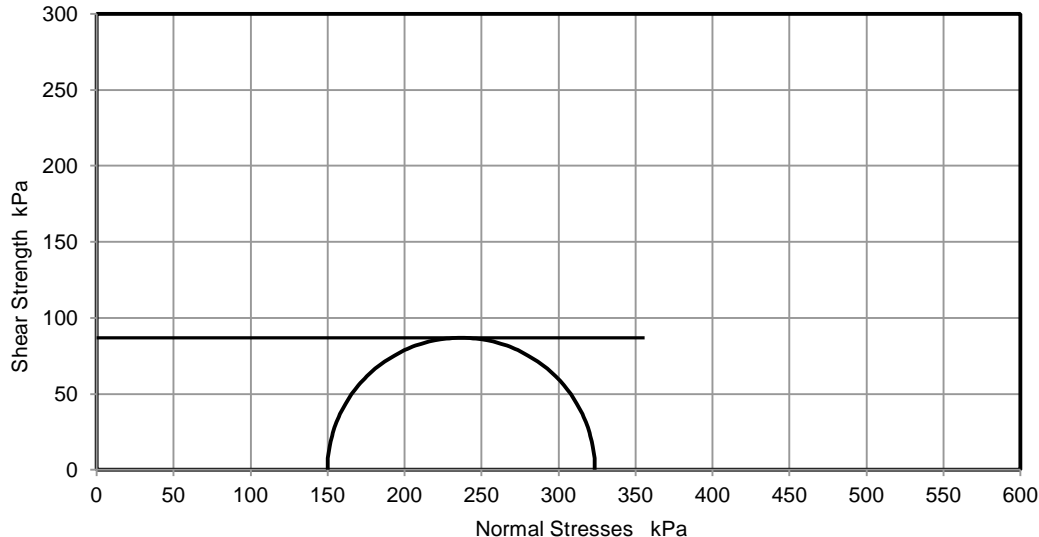
Test Number	1
Length	200.0 mm
Diameter	102.0 mm
Bulk Density	2.17 Mg/m <sup>3</sup>
Moisture Content	16.8 %
Dry Density	1.86 Mg/m <sup>3</sup>

Rate of Strain	1.0 %/min
Cell Pressure	150 kPa
At failure Axial Strain	17.3 %
Deviator Stress, (σ <sub>1</sub> - σ <sub>3</sub> ) <sub>f</sub>	174 kPa
Undrained Shear Strength, c <sub>u</sub>	87 kPa ½(σ <sub>1</sub> - σ <sub>3</sub> ) <sub>f</sub>
Mode of Failure	Compound

Deviator stress corrected for area change and membrane effects

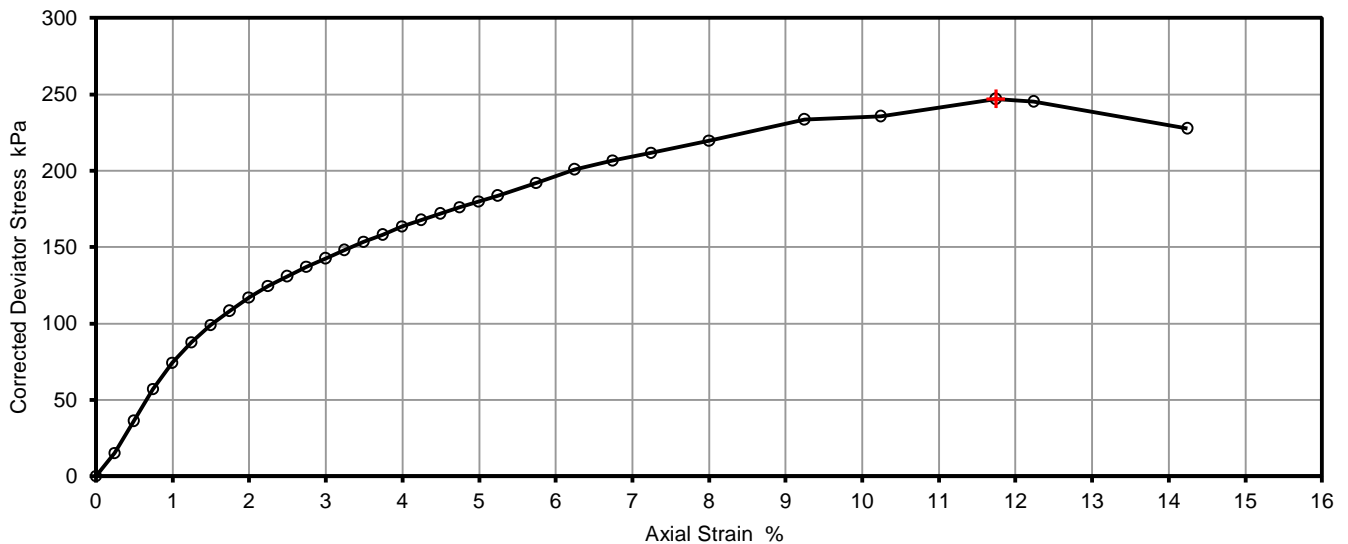
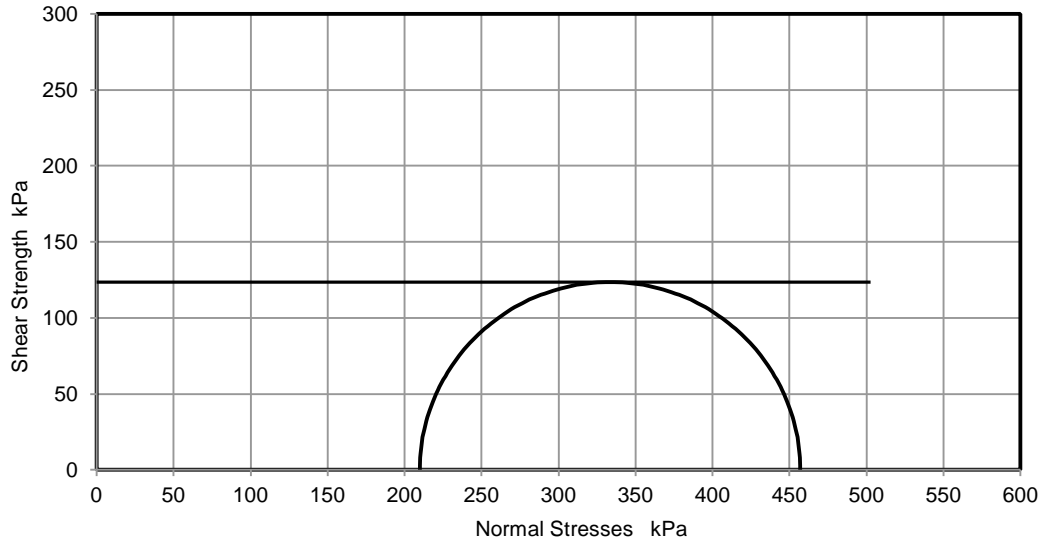
Test Number	1		
Length	200.0	mm	
Diameter	103.0	mm	
Bulk Density	2.08	Mg/m <sup>3</sup>	
Moisture Content	20.6	%	
Dry Density	1.73	Mg/m <sup>3</sup>	
Rate of Strain	1.0	%/min	
Cell Pressure	210	kPa	
At failure	Axial Strain	11.7	%
	Deviator Stress, ( $\sigma_1 - \sigma_3$ ) <sub>f</sub>	247	kPa
	Undrained Shear Strength, $c_u$	124	kPa $\frac{1}{2}(\sigma_1 - \sigma_3)_f$
	Mode of Failure	Compound

Deviator stress corrected for area change and membrane effects

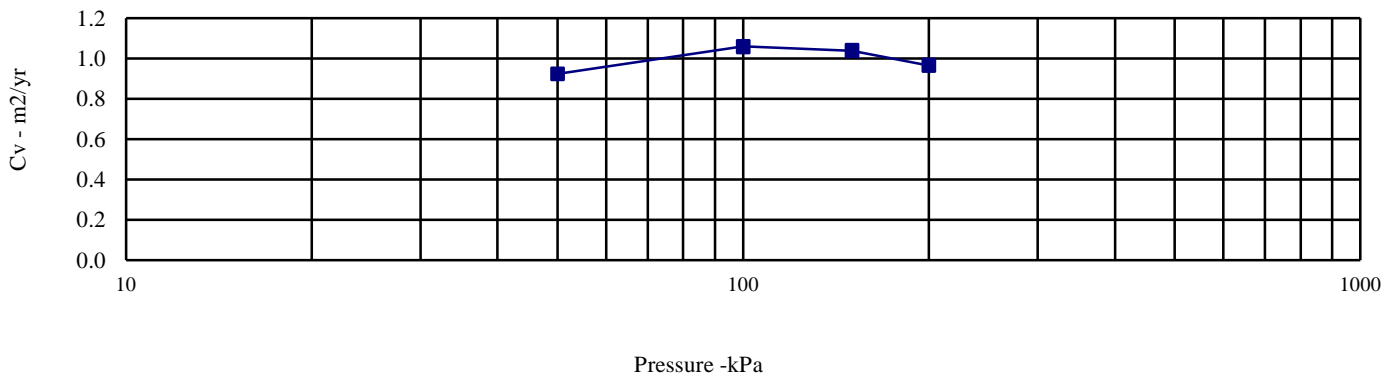
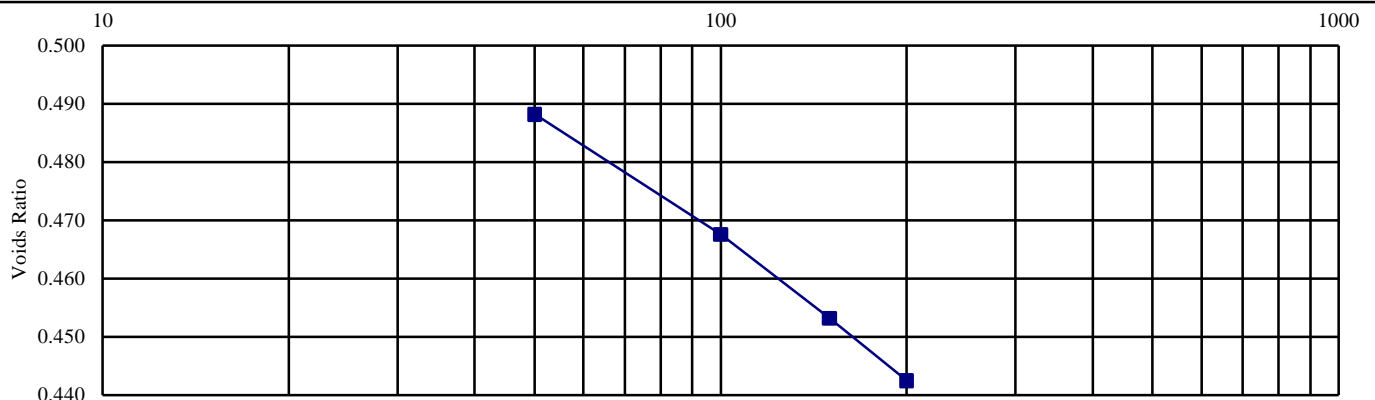
Initial Conditions		Pressure Range		Mv	Cv	Specimen location	
Moisture Content (%):	20	kPa		m2/MN	m2/yr	within tube:	Top
Bulk Density (Mg/m3):	2.07	0	50	0.628	0.924	Method used to	
Dry Density (Mg/m3):	1.72	50	100	0.278	1.060	determine CV:	T90
Voids Ratio:	0.536	100	150	0.196	1.039	Nominal temperature	
Degree of saturation:	98.4	150	200	0.147	0.966	during test ' C:	20
Height (mm):	20.012	Remarks: Pre-Saturated					
Diameter (mm)	74.99						
Particle Density (Mg/m3): Assumed	2.65

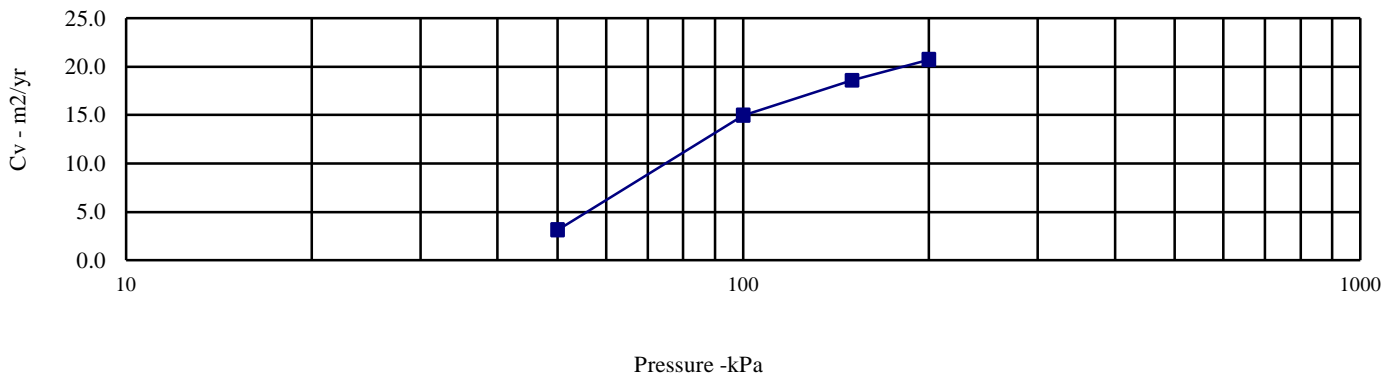
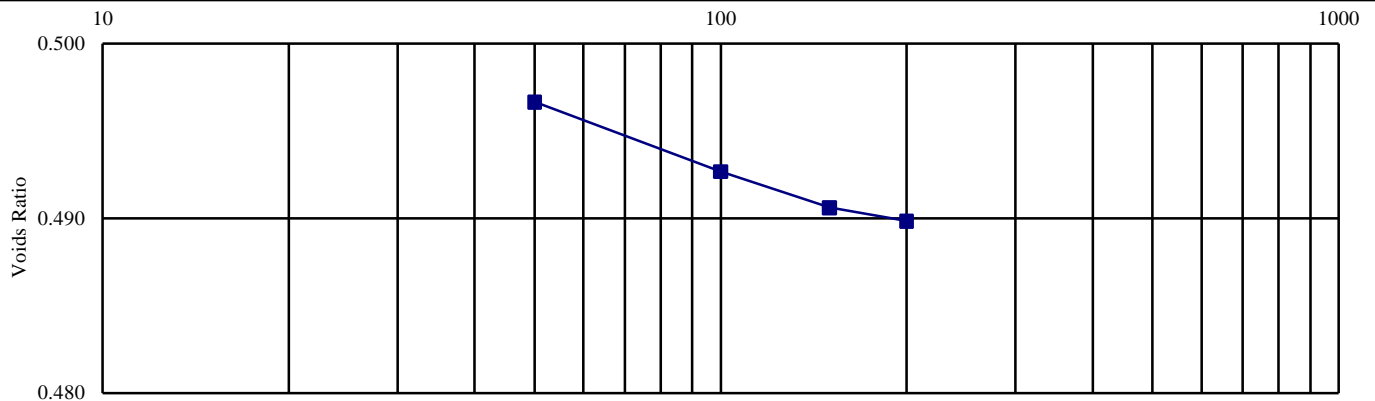
Initial Conditions		Pressure Range		Mv	Cv	Specimen location	
Moisture Content (%):	20	kPa		m2/MN	m2/yr	within tube:	Top
Bulk Density (Mg/m3):	2.06	0	50	0.517	3.143	Method used to	
Dry Density (Mg/m3):	1.72	50	100	0.053	14.962	determine CV:	T90
Voids Ratio:	0.536	100	150	0.028	18.590	Nominal temperature	
Degree of saturation:	96.8	150	200	0.010	20.741	during test ' C:	20
Height (mm):	20.03	Remarks: Post-Saturated					
Diameter (mm)	75.01						
Particle Density (Mg/m3): Assumed	2.65

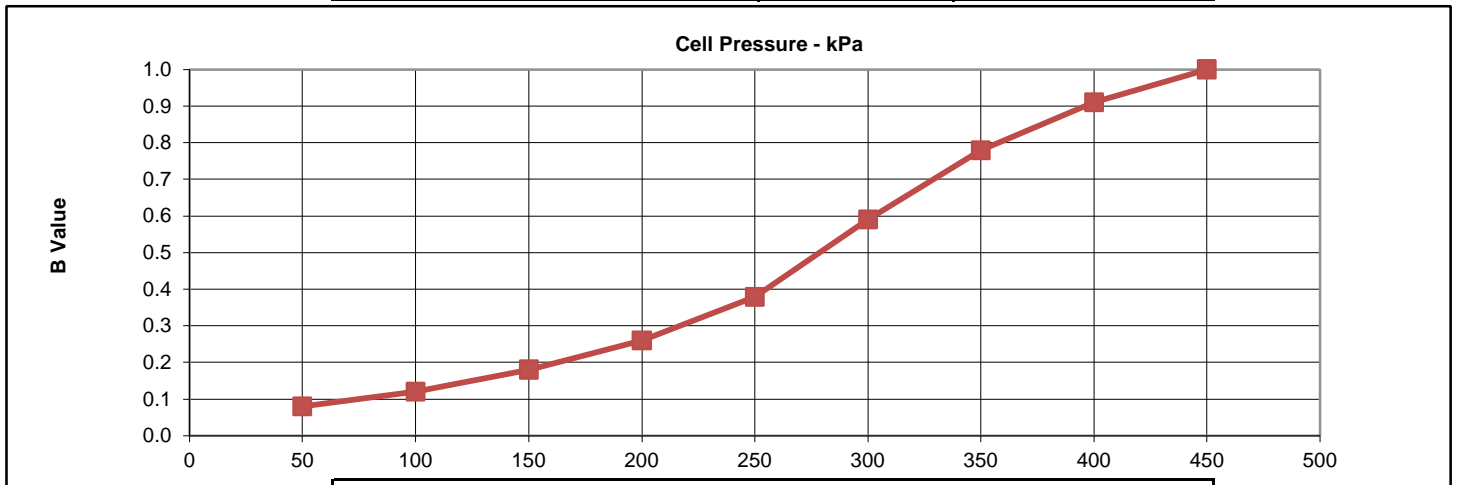
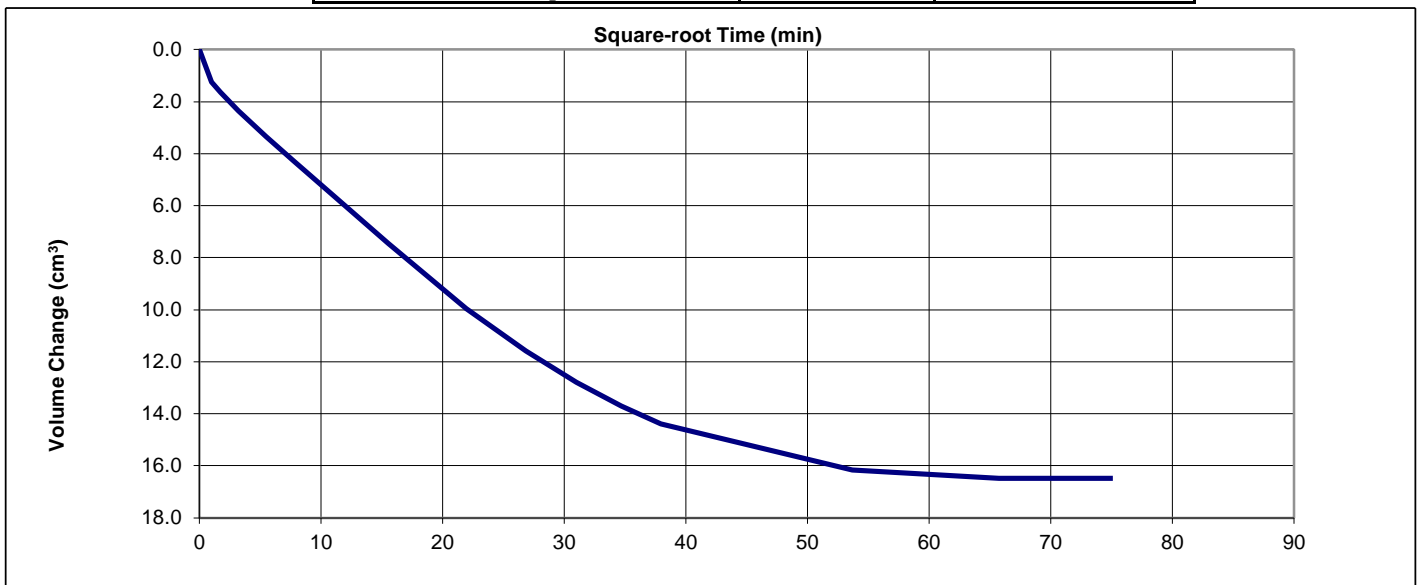
Specimen Details		
Hole Number		BH01
Sample Depth	m	6.00
Sample No.		
Grid Reference		
Lift Number		
Saturation		
Cell Pressure Incr.	kPa	50
Back Pressure Incr.	kPa	50
Differential Pressure	kPa	10
Final Cell Pressure	kPa	450
Final B Value	-	0.96

Consolidation		
Effective Pressure	kPa	150
Cell Pressure	kPa	550
Back Pressure	kPa	400
Final PWP	kPa	403
PWP dissipation	%	97

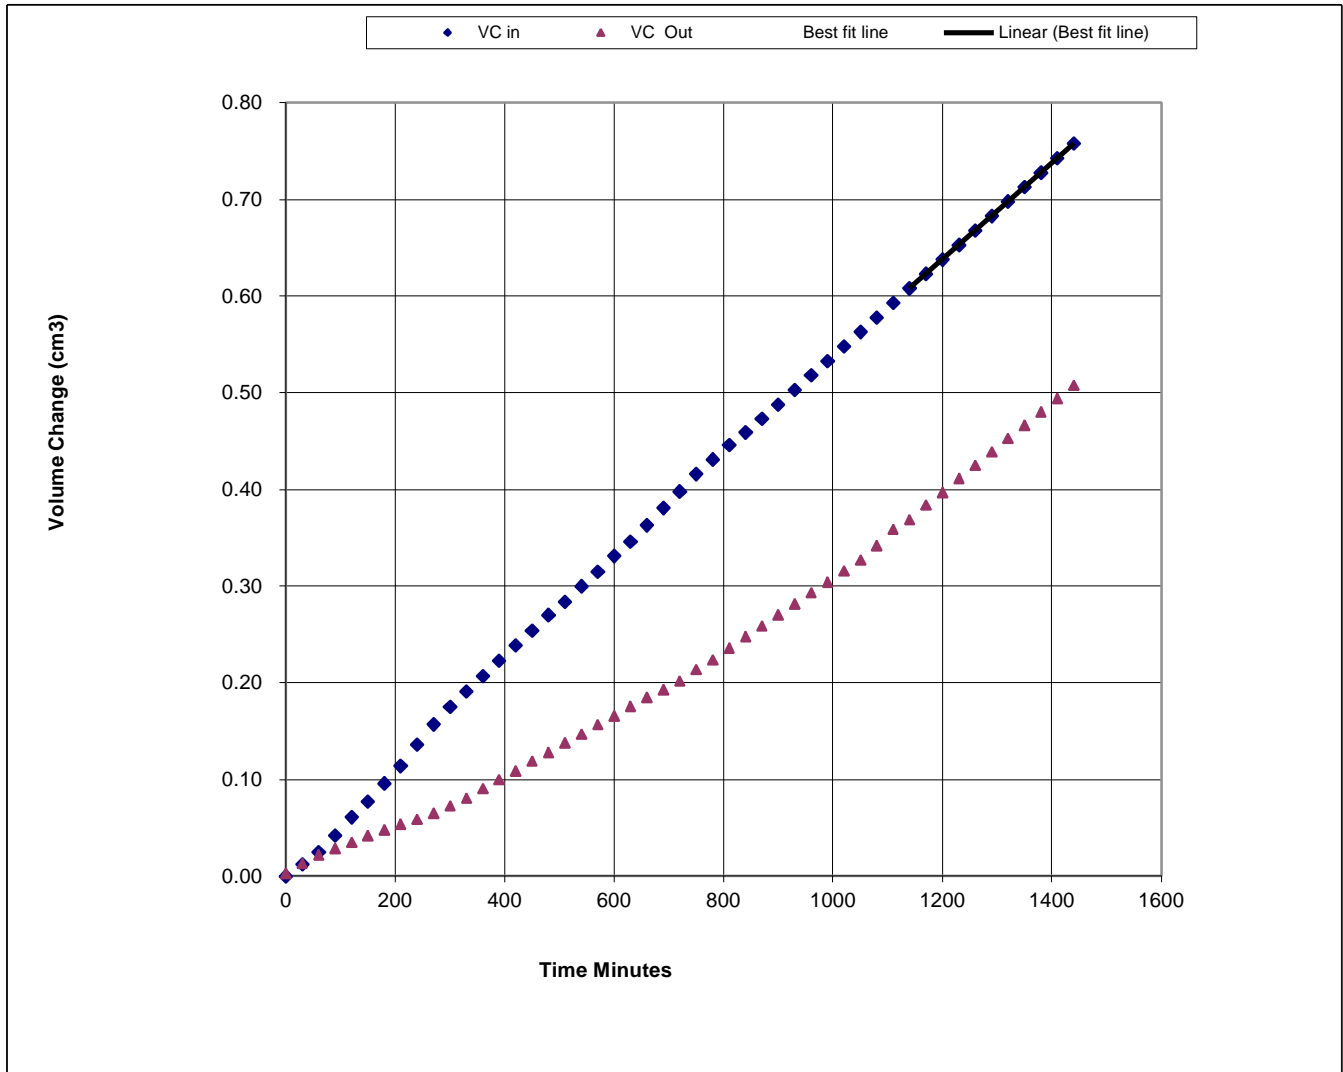
Permeability Stage		
Cell Pressure	kPa	550
Mean Effective Stress	kPa	150
Back Pressure Diff.	kPa	20
Mean Rate of Flow	ml/min	0.0005
Average Temperature	'C	20
Vertical Permeability K <sub>v</sub>	m/s	5.1E-11

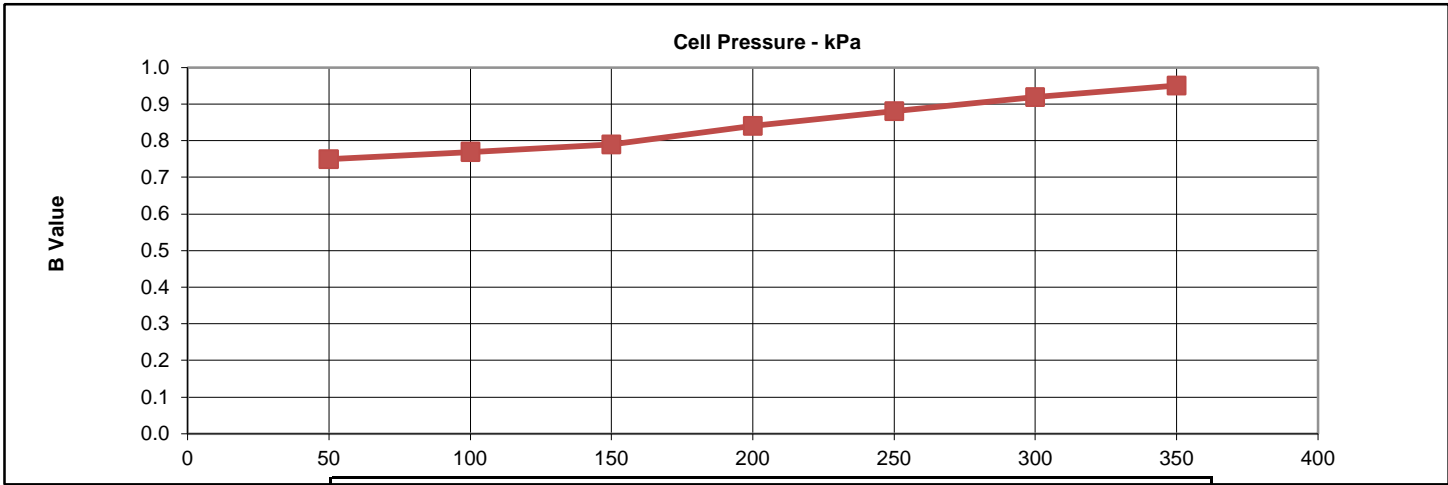
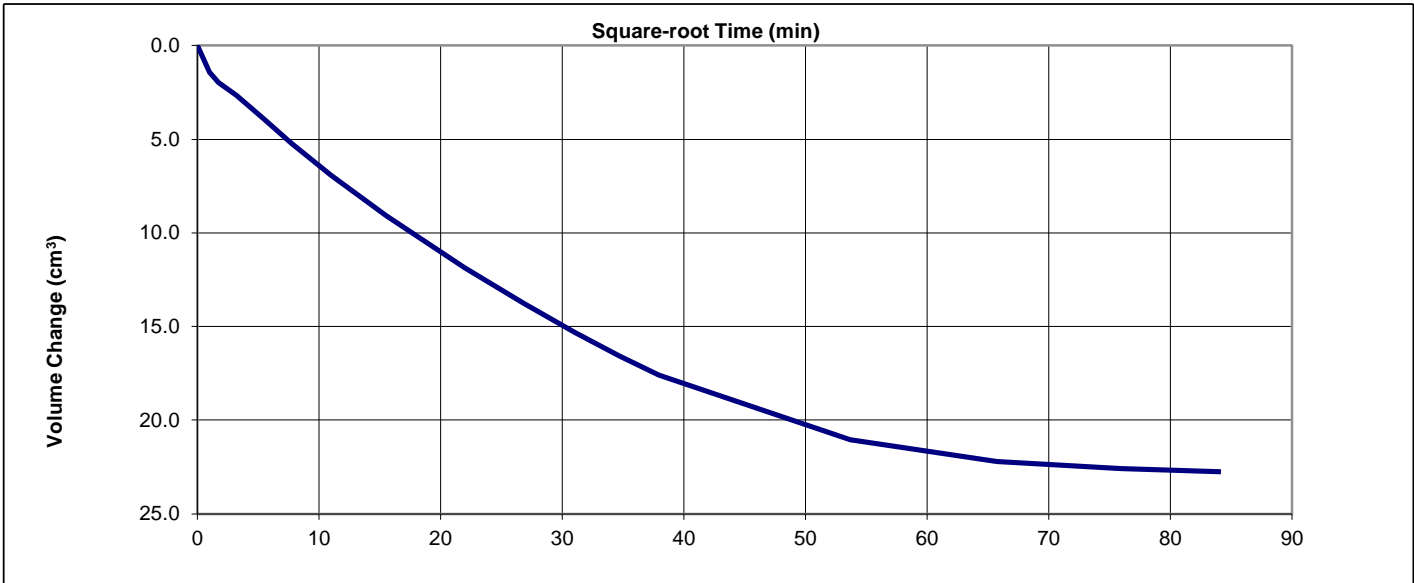
Specimen Details		
Hole Number		BH03
Sample Depth	m	9.00
Sample No.		
Grid Reference		
Lift Number		
Saturation		
Cell Pressure Incr.	kPa	50
Back Pressure Incr.	kPa	50
Differential Pressure	kPa	10
Final Cell Pressure	kPa	350
Final B Value	-	0.96

Consolidation		
Effective Pressure	kPa	200
Cell Pressure	kPa	500
Back Pressure	kPa	300
Final PWP	kPa	306
PWP dissipation	%	96

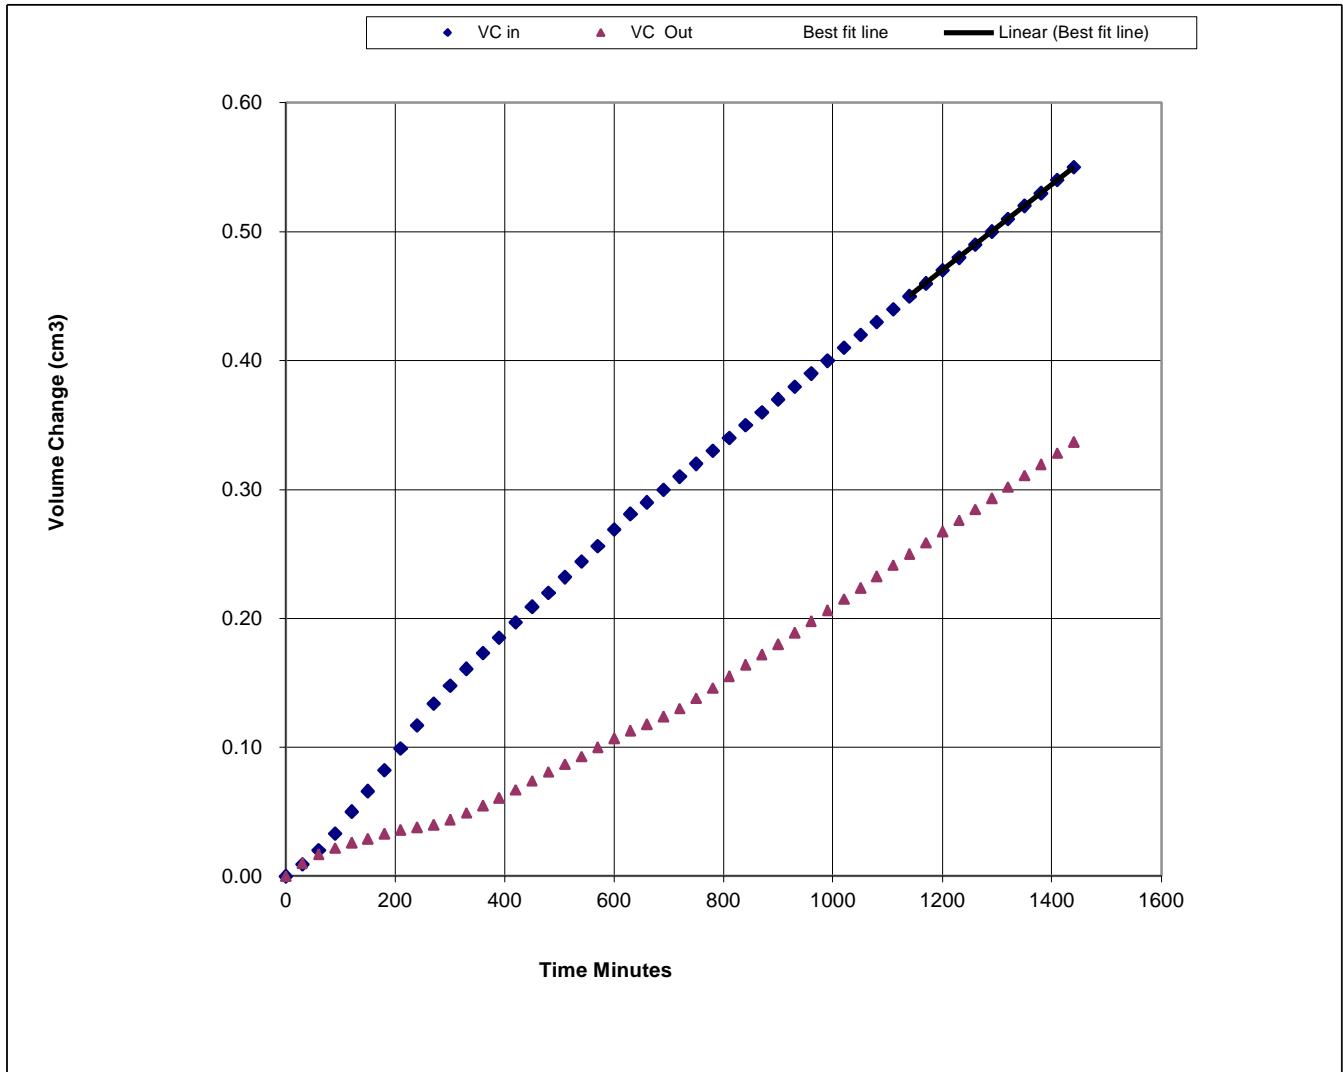
Permeability Stage		
Cell Pressure	kPa	500
Mean Effective Stress	kPa	200
Back Pressure Diff.	kPa	20
Mean Rate of Flow	ml/min	0.0003
Average Temperature	'C	20
Vertical Permeability K <sub>v</sub>	m/s	3.3E-11
