# Factual Site Investigation

Leachate Treatment Plant, Joint Stocks Landfill,  
Coxhoe

Durham County Council

S220506

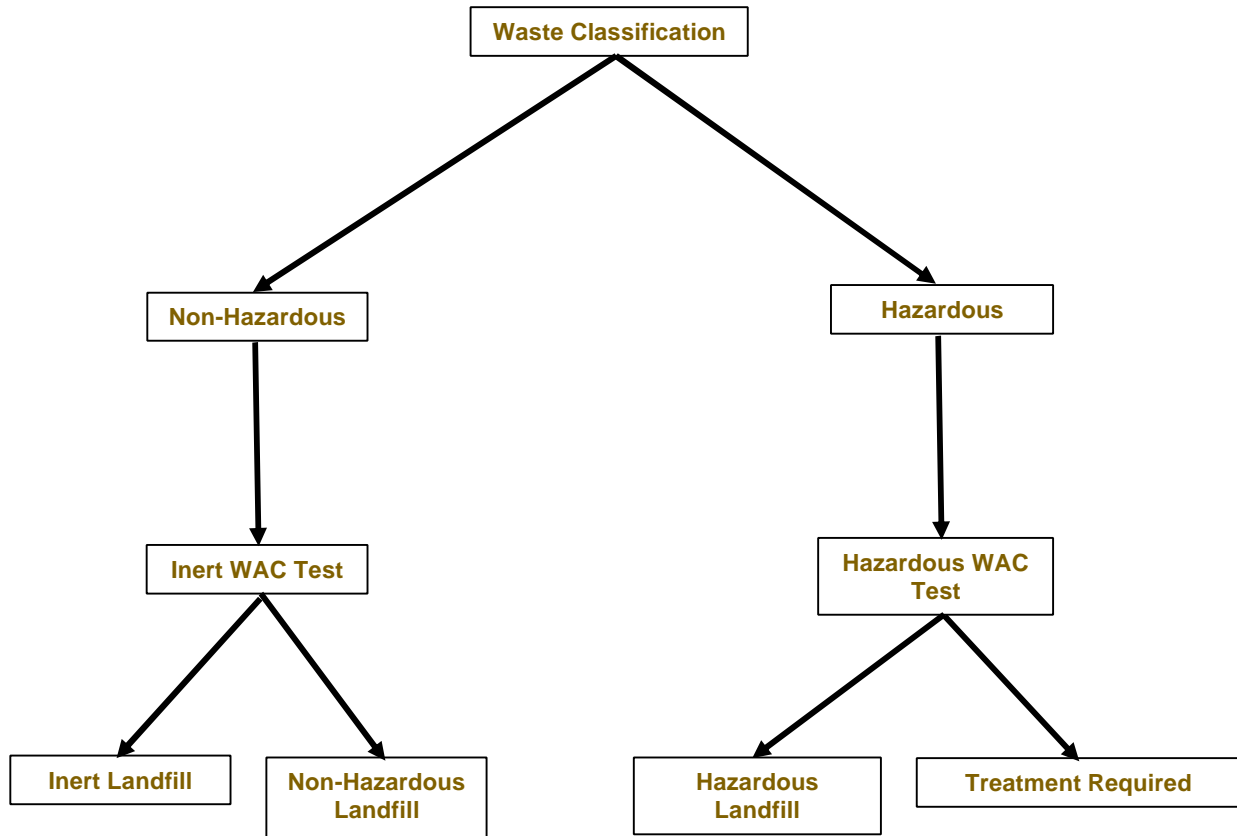
The below flow chart provides further information on the waste classification process.
