Extensions & Alterations at
10 Greenstead, Sawbridgeworth
for [REDACTED]

Tree protection

SCALE 1:100 at A2 DWG No. 2202.15

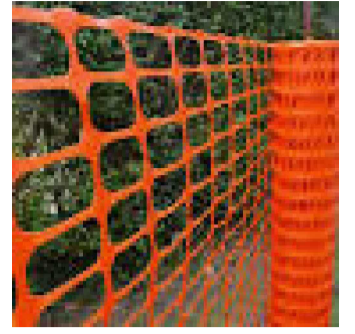
Orange barrier fencing secured with metal stakes

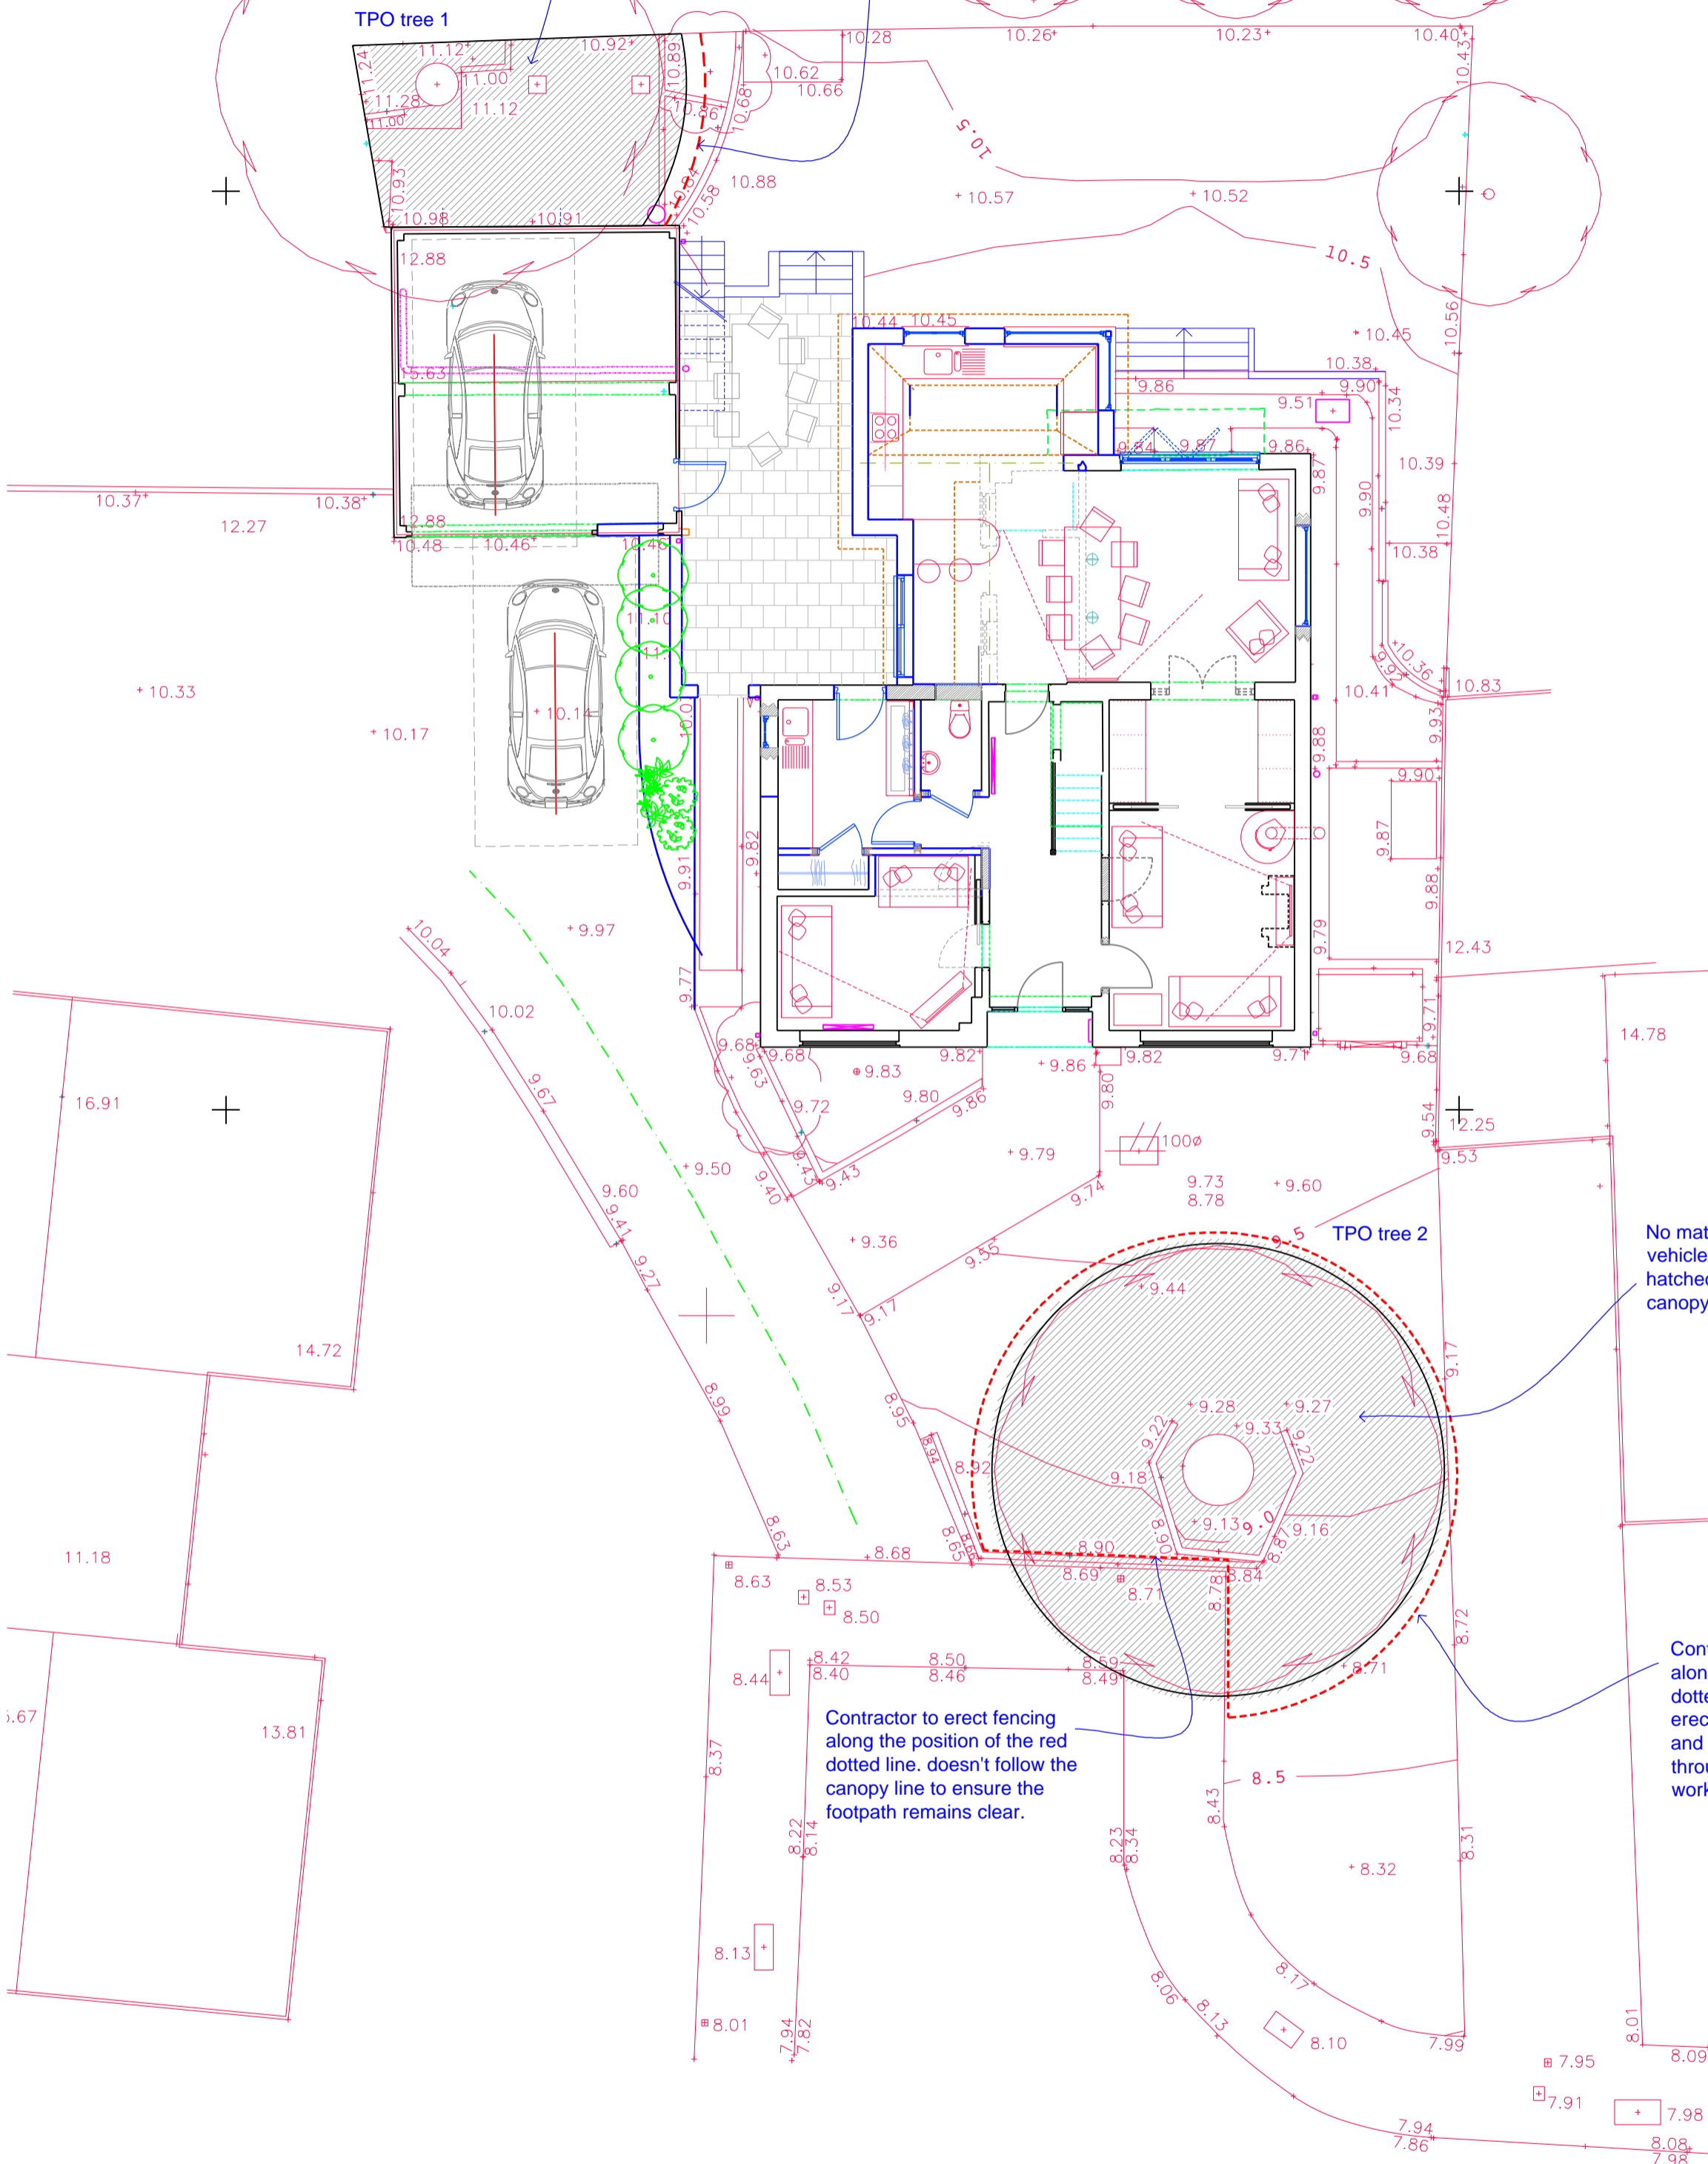
No materials or equipment or vehicles to be stored in the hatched area beneath the canopy of the tree

Contractor to erect fencing along the position of the red dotted line. doesn't follow the canopy line to ensure the footpath remains clear.

Contractor to erect fencing along the position of the red dotted line. Fencing to be erected prior to works starting and to be retained in place throughout the duration of the works
