# Shell Solihull Fuel Retail Station

Preliminary (Phase 1) site assessment report

Project no. 252860

AUGUST 2023

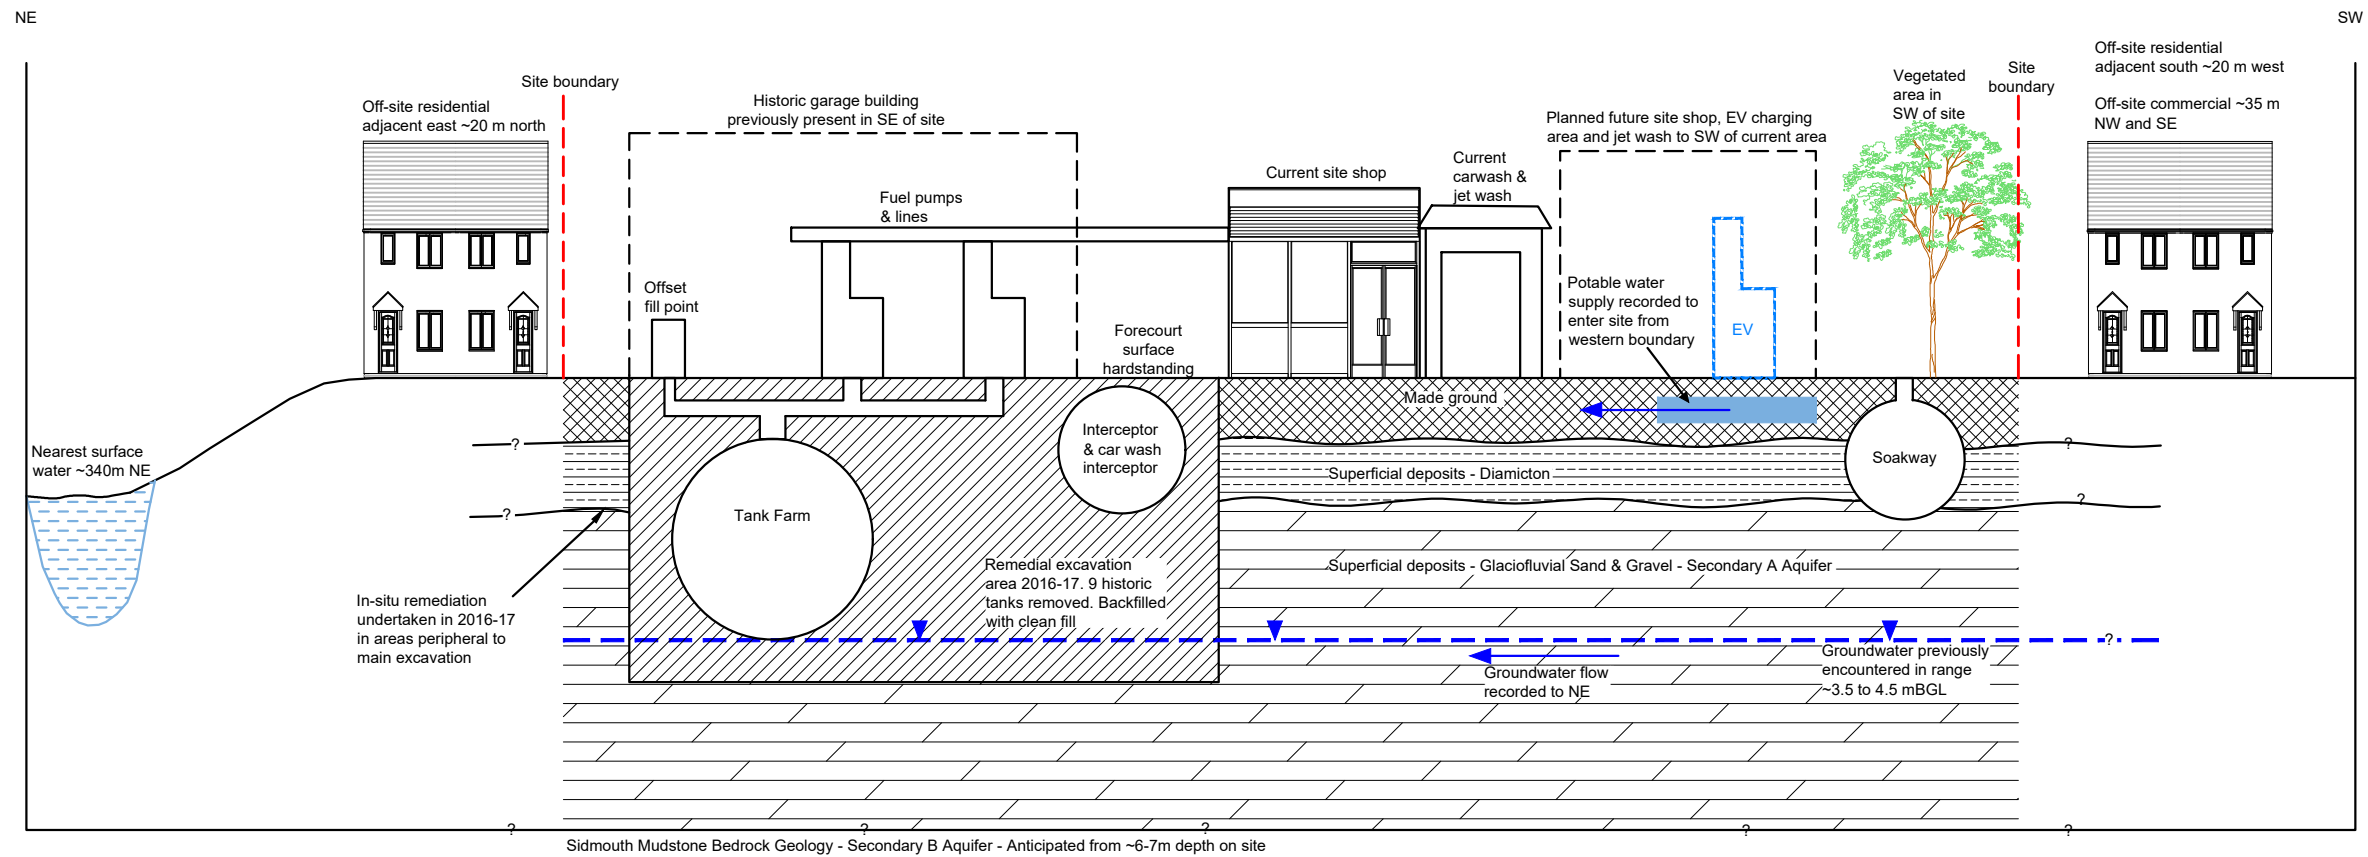
Sidmouth Mudstone Bedrock Geology - Secondary B Aquifer - Anticipated from ~6-7m depth on site

Potential Sources	Potential Pathways	Potential Receptors
<ul style="list-style-type: none"> <li>Petrol/diesel as light non-aqueous phase liquids (LNAPL) arising from potential losses from fuel storage tanks and fill</li> <li>Petrol/diesel as LNAPL arising from potential losses from dispensing infrastructure (underground fuel lines, pump)</li> <li>Petroleum hydrocarbon COPC arising from potential losses from surface drainage interceptors and drainage.</li> <li>Soil impacted with retail petroleum COPC.</li> <li>Dissolved phase retail petroleum COPC within groundwater.</li> <li>Soil vapour originating from retail petroleum COPC.</li> <li>Potential non-retail petroleum COPC arising from historical</li> </ul>	<ul style="list-style-type: none"> <li>Permeation of plastic pipework.</li> <li>Volatilisation and subsequent vertical and lateral migration of vapours via permeable strata / along backfill to service trenches.</li> <li>Leaching from unsaturated zone soils.</li> <li>Remobilisation.</li> <li>Lateral and/or vertical migration.</li> </ul>	<ul style="list-style-type: none"> <li>Workers in the site shop.</li> <li>Site users (including users of potential future EV charging facilities).</li> <li>The site's potable water supply.</li> <li>Groundwater within the superficial Glaciofluvial Deposits (Secondary A Aquifer) beneath the site.</li> <li>Residents in properties located from 0m south and west, and from 20m north and east of the site.</li> <li>Site users of clinic located 34m to the south-east of the site, and dentist office located 35m north-west of the site.</li> <li>Groundwater within the wider Secondary A aquifer (Glaciofluvial Deposits) beyond the site boundary.</li> <li>A surface water stream 340m north-east of the site.</li> </ul>

<p><b>Potentially Complete Pollutant Linkages identified Within Conceptual Site Model</b></p> <ul style="list-style-type: none"> <li>Retail and non-retail petroleum COPC in soil and groundwater – volatilisation and migration of vapours via permeable strata/service trenches – off-site residential receptors.</li> <li>Non-retail petroleum COPC in soil and groundwater – volatilisation and migration of vapours via permeable strata/service trenches – current and future site workers.</li> <li>Retail and non-retail petroleum COPC in soil – remobilisation – groundwater beneath the site.</li> <li>Retail and non-retail petroleum COPC in groundwater – lateral migration – groundwater within wider aquifer.</li> </ul>

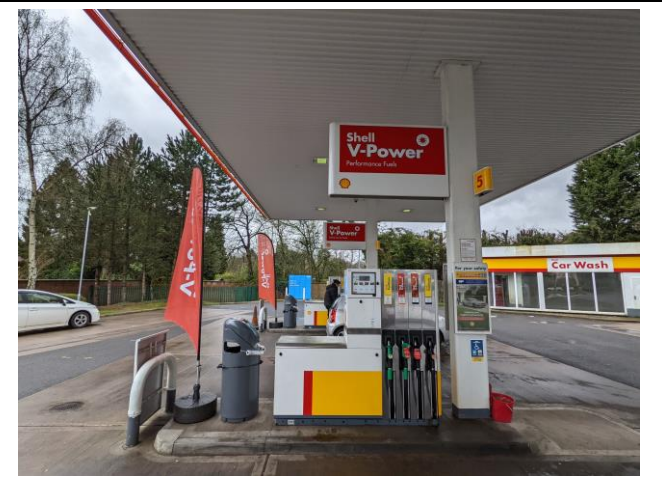
**D** View of pumps and car wash to the south

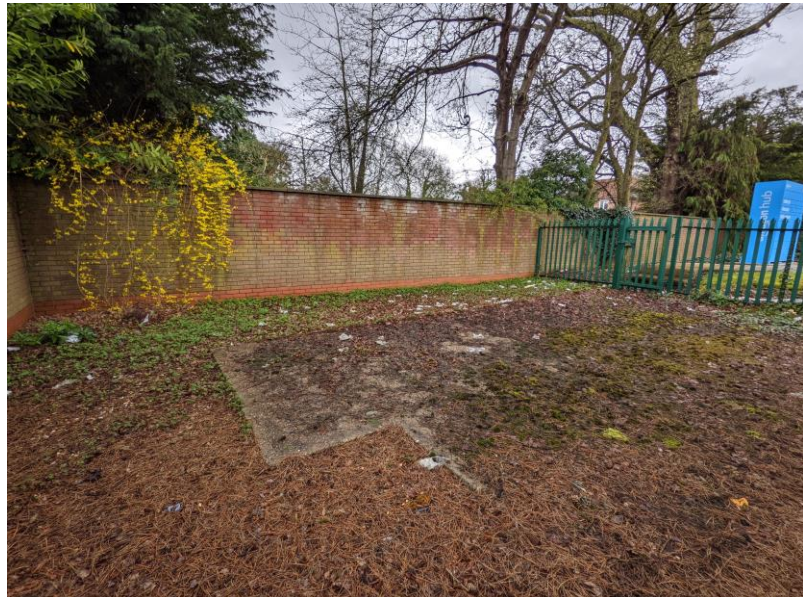
**Photo No.**  
4

**Direction photo taken:**  
South-west

**Description:**  
Inaccessible area in the south-west corner of the site (photo taken over separating wall)

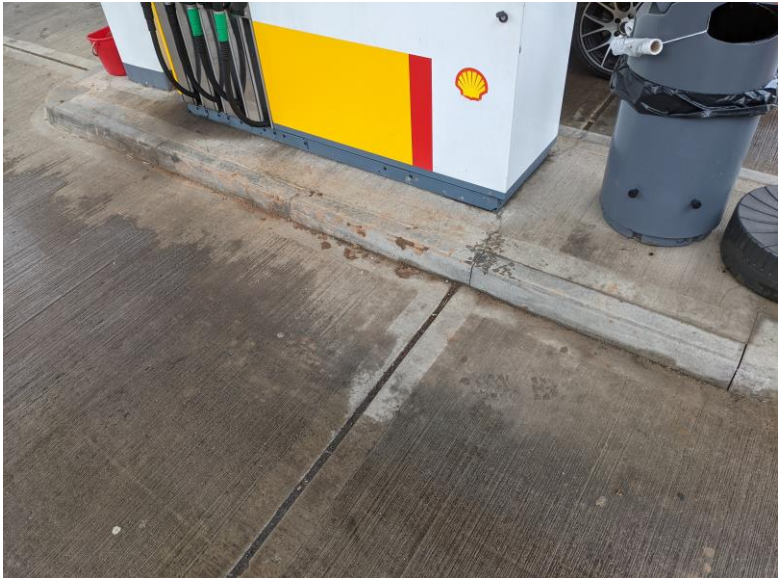
<b>Photo no.</b> 5	<b>Date:</b> 31-03-2023

The site forecourt was in observed to be in generally good condition, with rare fine cracks noted to some concrete hardstanding. Surface staining was noted around the forecourt fuel-dispensing islands.

<b>Direction photo taken:</b> North		
<b>Description:</b> Forecourt pump island condition – pumps 7/8.

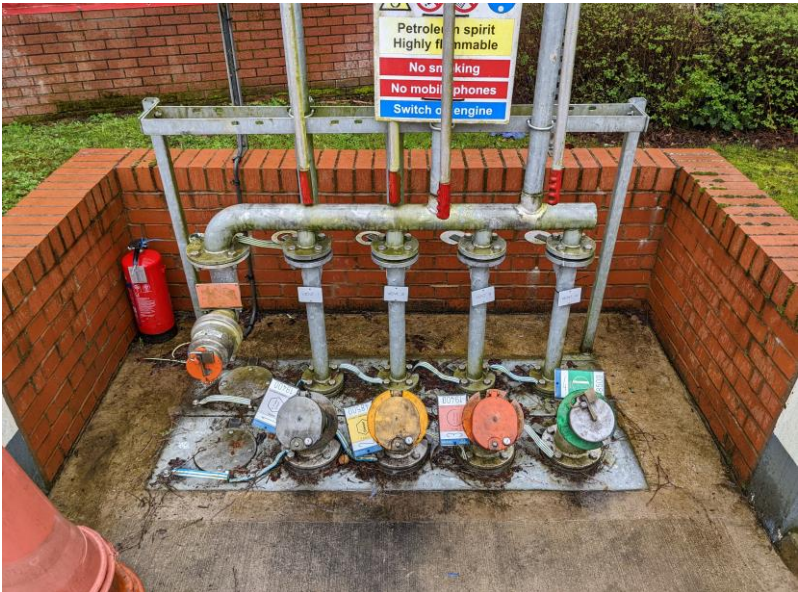
<b>Photo No.</b> 6	<b>Date:</b> 31-03-2023

Tank fill points were observed to be above ground and offset from the tanks, located along the eastern site boundary.

<b>Direction photo taken:</b> East		
<b>Description:</b> Offset fill point

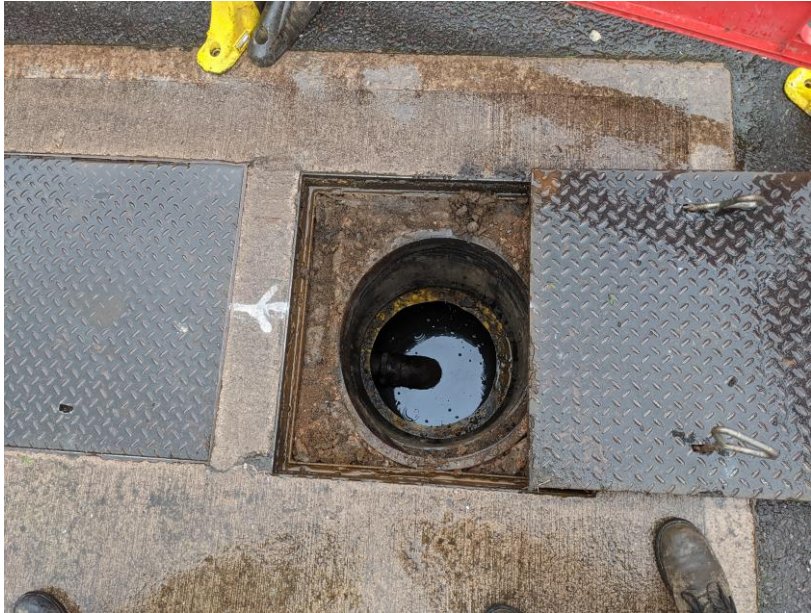
<b>Photo No.</b> 8	<b>Date:</b> 31-03-2023

<b>Direction photo taken:</b> N/A		
<b>Description:</b> Car wash intercepter – chamber 1

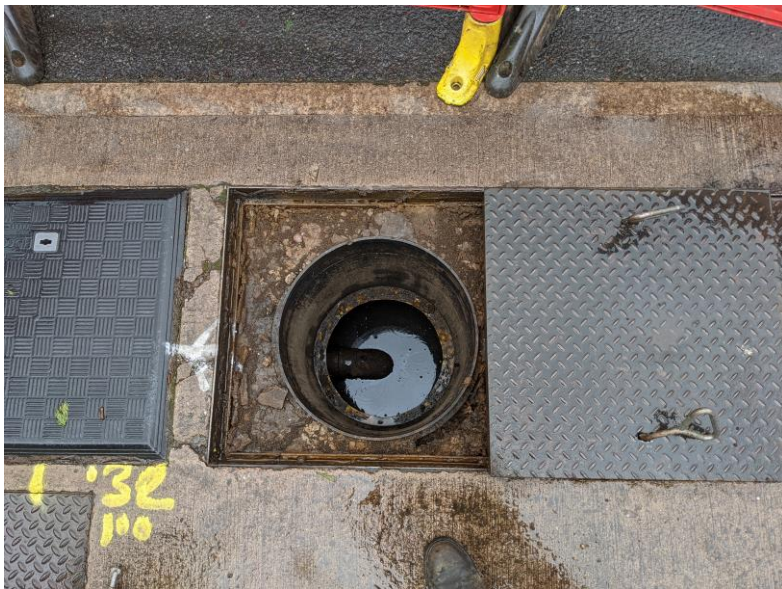
**Description:**  
Car wash interceptor – chamber 2

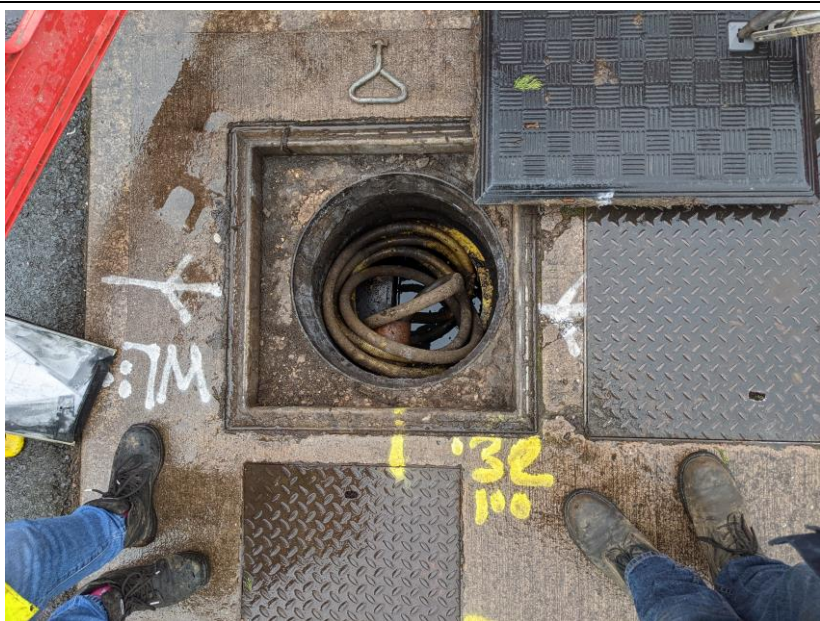
**Photo No.**  
10

**Description:**  
Car wash interceptor – chamber 3
