# Preliminary Ecology Appraisal

## Protected Species Survey (Bats)

**Location: 112 High Street  
Collingham**

Project:	112 High St, Collingham.  Planning application to erect 1no. dwelling and detached garage following demolition of storage building.		
Client:	Mr. Bailey		
Issue Date:	November 2023	Revision:	A
Document ID:	PEA/407/COL/1507		
Prepared by:	Kate Fytche-Taylor BSc Ecology Consultant		
Authorised by:	Oliver Fytche-Taylor Senior Consultant

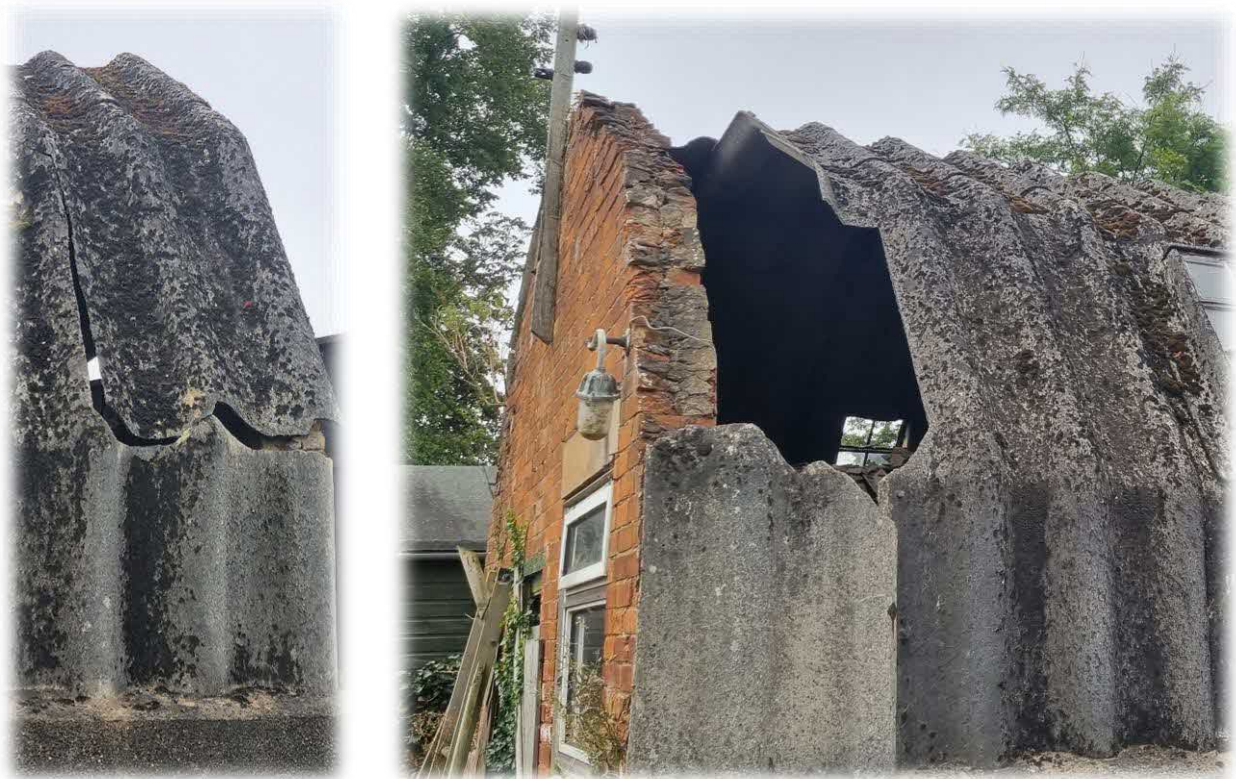
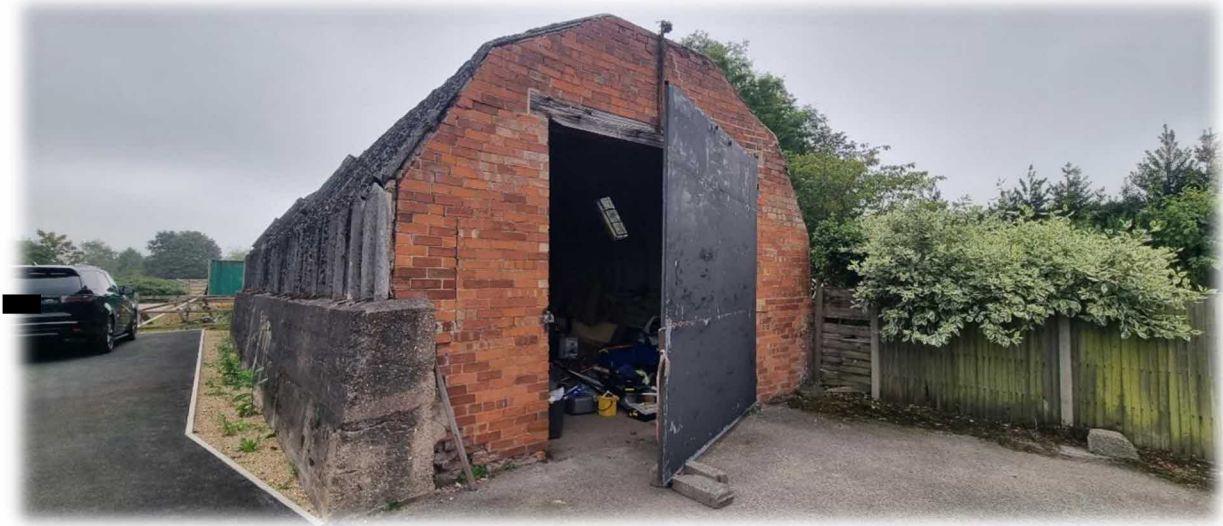
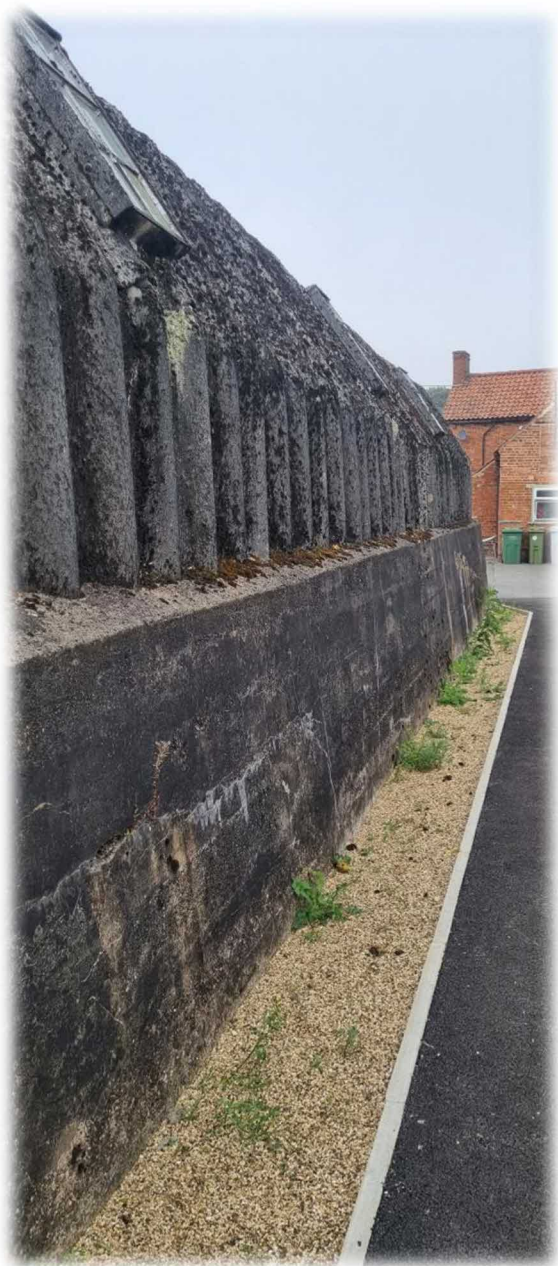
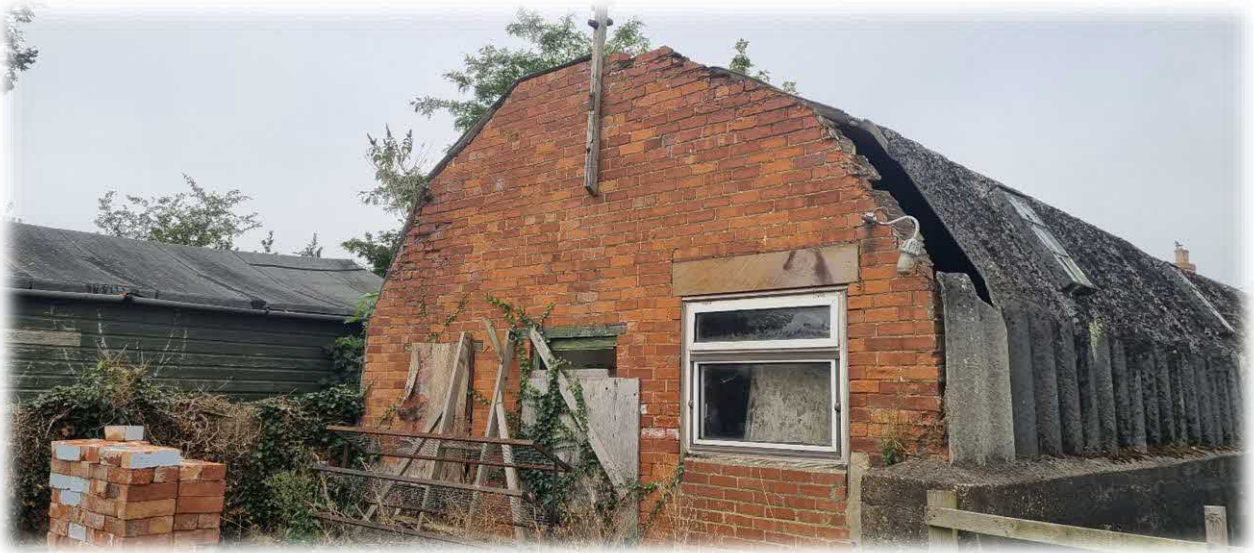
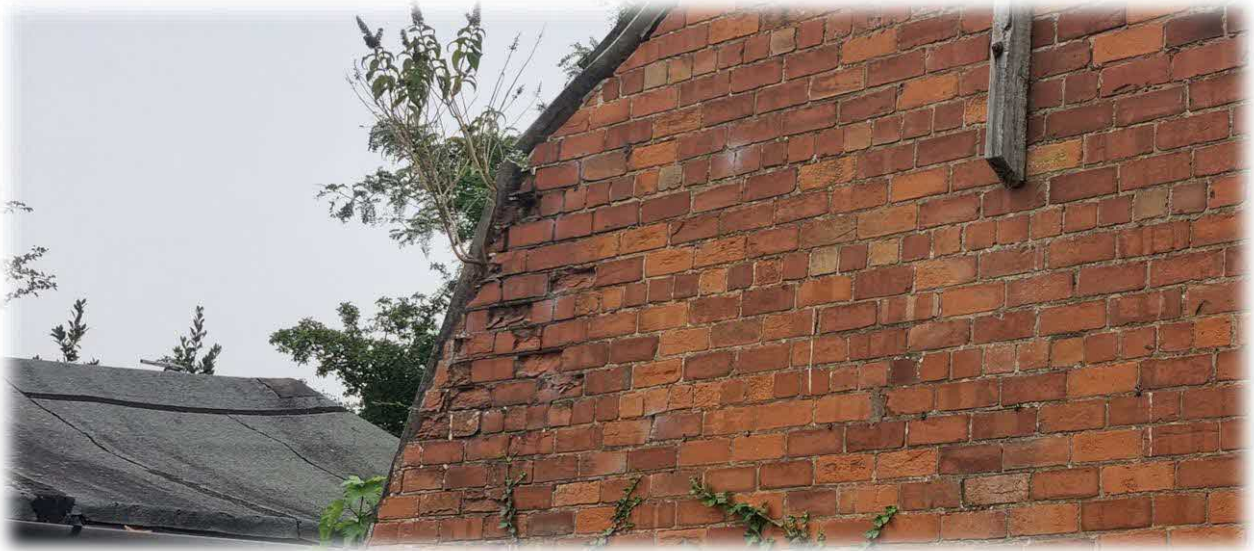
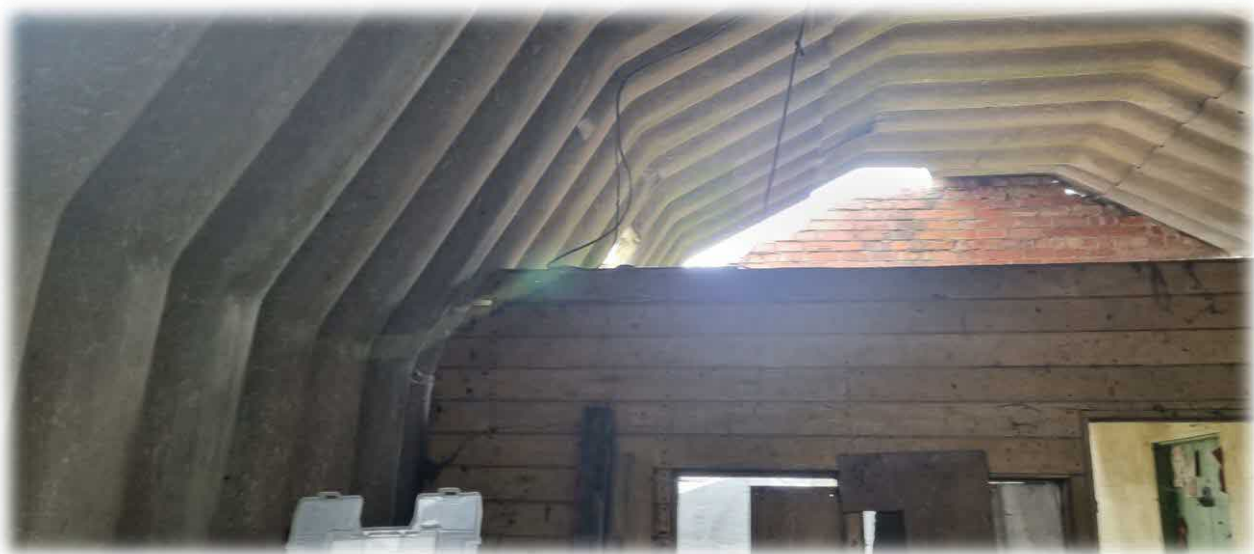
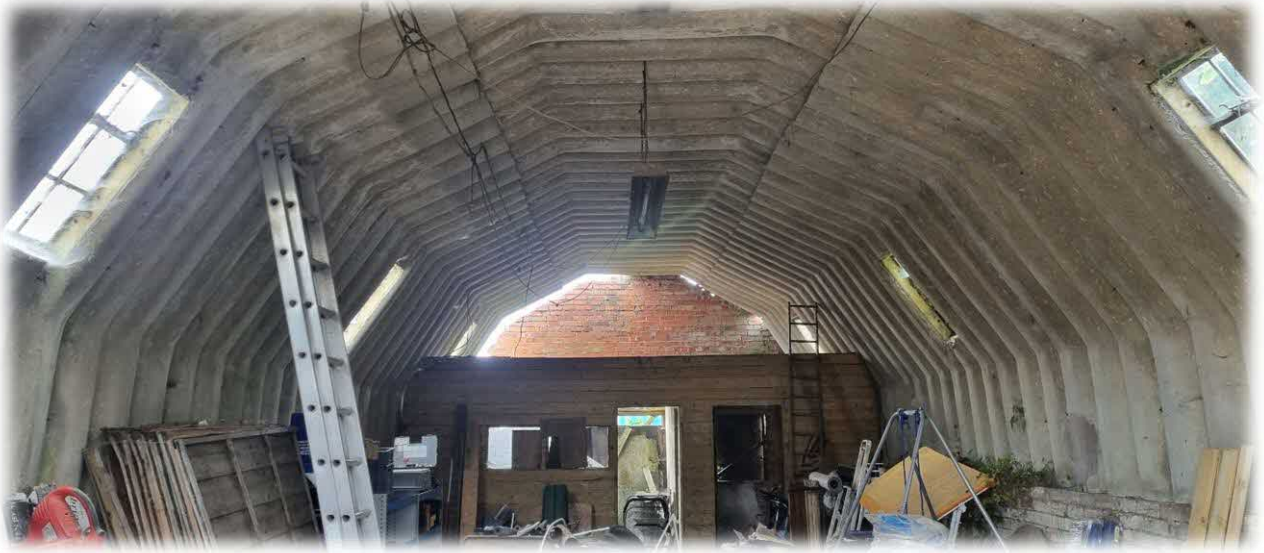
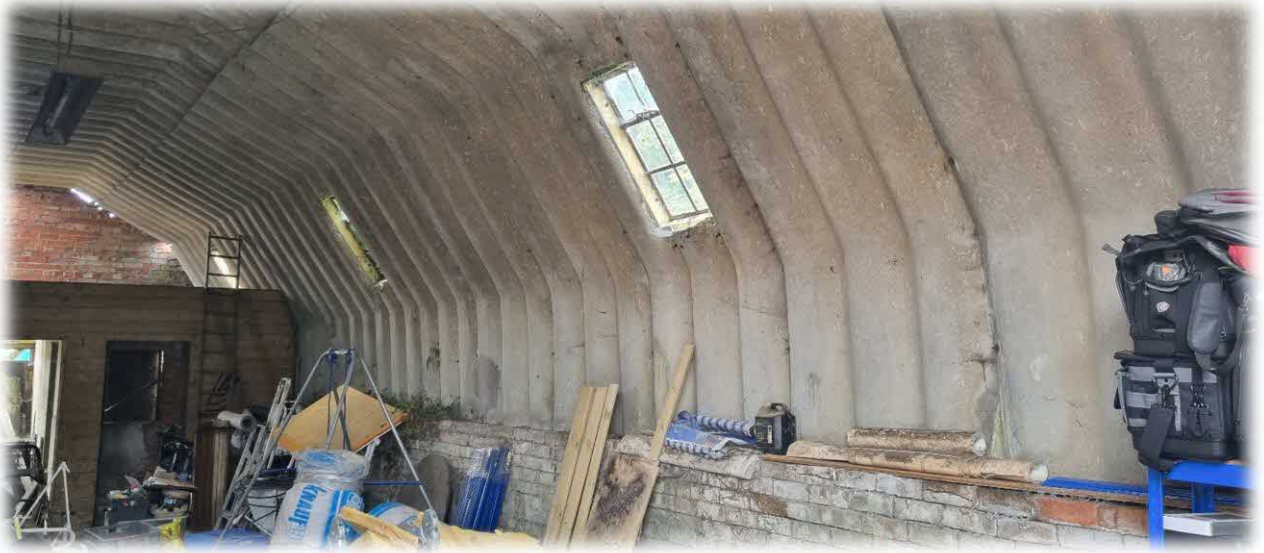
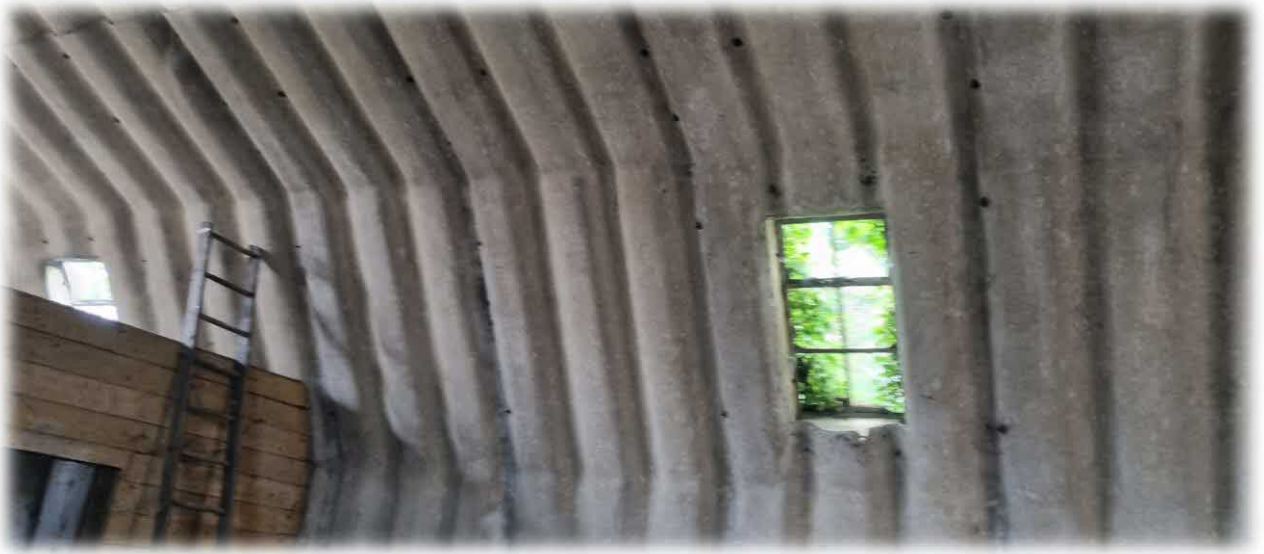
## 6.0 Site Photos (taken 05/09/23 during inspection visit to property)

The building itself is generally in a good state of repair with the exception of some visible cracks in the asbestos cladding and a minor, partial collapse to a part of the roof structure. Externally, the building is clad in asbestos sheeting and includes a number of glazed window openings.

The roof fabric and external cladding does not offer a suitable environment for the formation of covered roosts, and although the structural failure has resulted in a small opening in one corner of the building, the survey resulted in zero indication of any other bat activity, such as foraging.
