The Smock Windmill, Mill Hill, Swaffham Prior, Cambridgeshire, CB25 0JZ

HERITAGE STATEMENT

Draft 2, October 2020

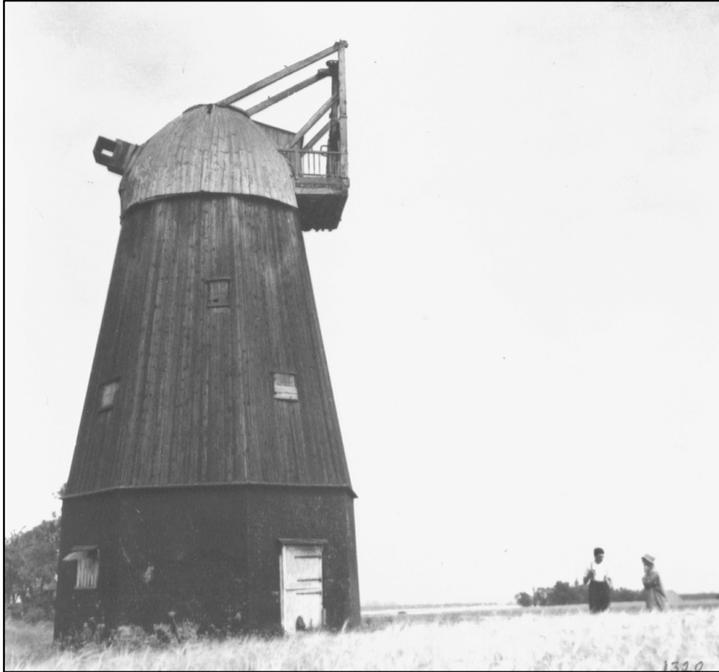
Figure 3: Swaffham Prior smock mill following the removal of the sails, photographed by Harry Meyer in 1935 (Mills Archive).

According to Simmons, in February 1928 a gale from the west destroyed the fantails of both mills within three minutes of each other. This disaster no doubt ended the mill's working life. A photograph taken by Rex Wailes in August 1932 shows the smock mill with shutterless sails and a smashed fantail.

Later that year the sails and fantail spindle were removed, although its internal machinery was left in position. The mill remained in this condition throughout the 1930s.

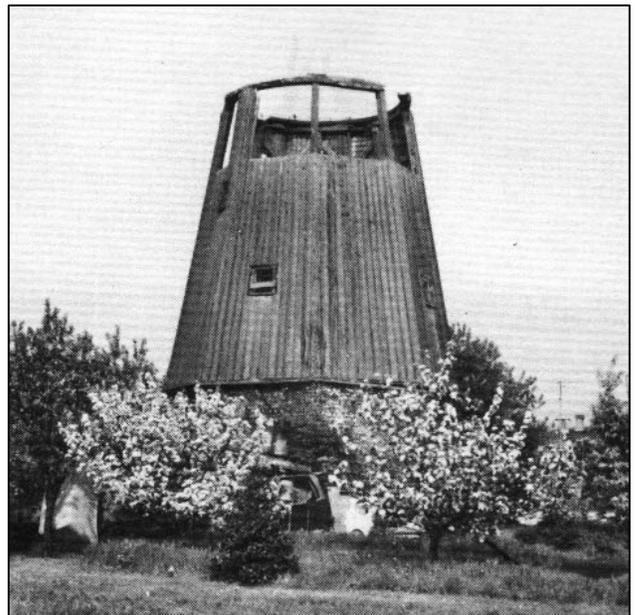
Figure 4: The derelict and roofless remains of the smock mill in 1971 (Mills Archive Arthur C Smith Collection).

At some time later – possibly during WW2 – the mill was stripped out completely leaving its tower without a roof and some of the upper framing exposed. In this condition the mill was photographed by intrepid mill surveyor Arthur C Smith in 1971.

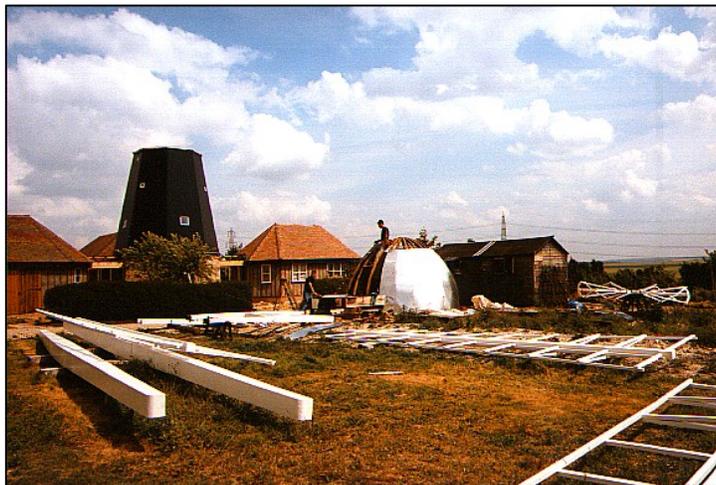
*Figure 4:
Reconstruction of the
cap and sails by R.
Thompson & Son in
progress, c1990 (UK
Mills website)*

Lincolnshire millwrights R. Thompson & Son of Alford in Lincolnshire were then called upon to complete the windmill's appearance. They provided a new domed roof of sheet aluminium, a new cast iron windshaft to replace the scrapped original, an 8-bladed 'skeleton' fantail and four shutterless sails.

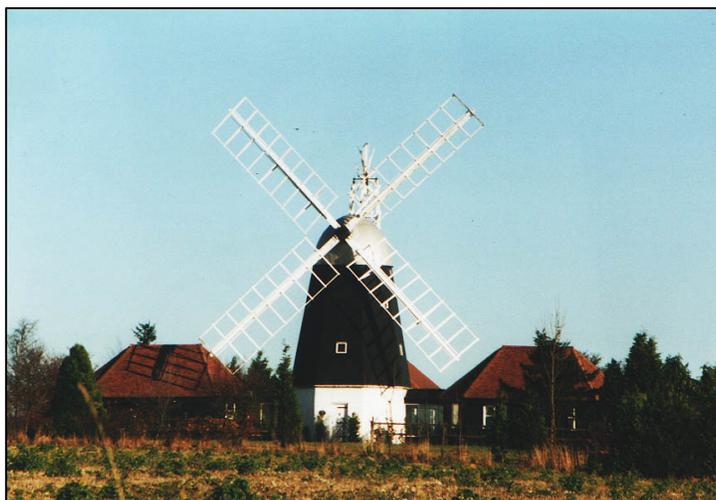
*Figure 5: The
completed residential
conversion in 1999.*
