## Contamination Investigation Report

at  
Penventon Farm Nursery, Lanner, Cornwall TR16 6AS

Reference: 20885/CIR Rev1.0  
May 2023

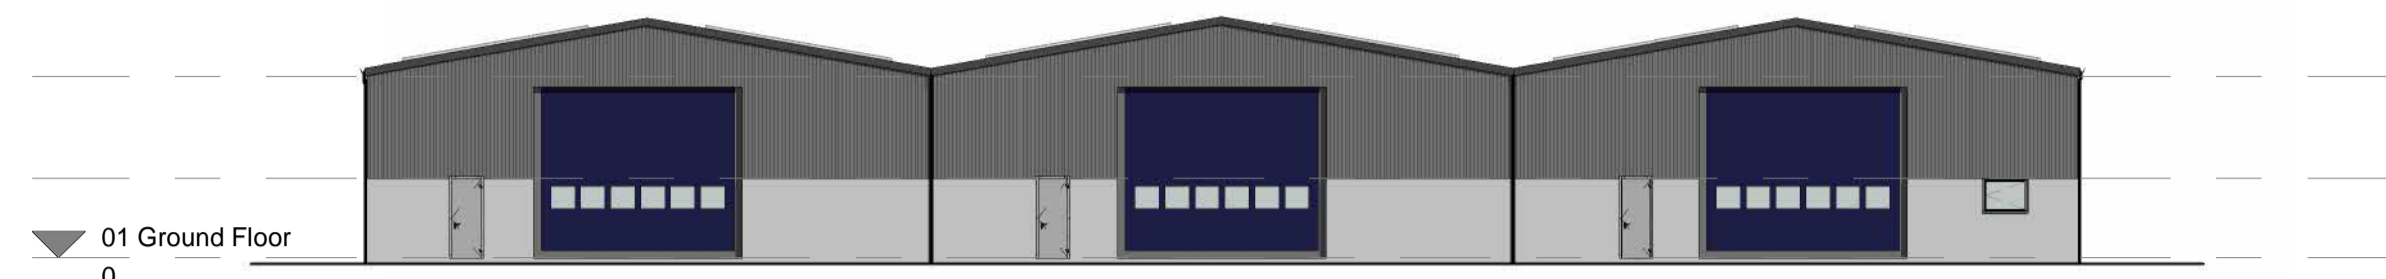
North Elevation

Roof: Trapezoidal insulated roof panels -Grey  
Walls: Fair faced concrete plinth / Trapezoidal insulated panels -Grey  
Rainwater Goods: Aluminium -Grey  
Metal Roller shutter doors -Blue -RAL colour tbc  
Metal personnel Doors -Grey -RAL colour tbc
