Munden Parva, Dane End, Hertfordshire

Bat survey and
assessment

Report ref.:
COU101/R001V2

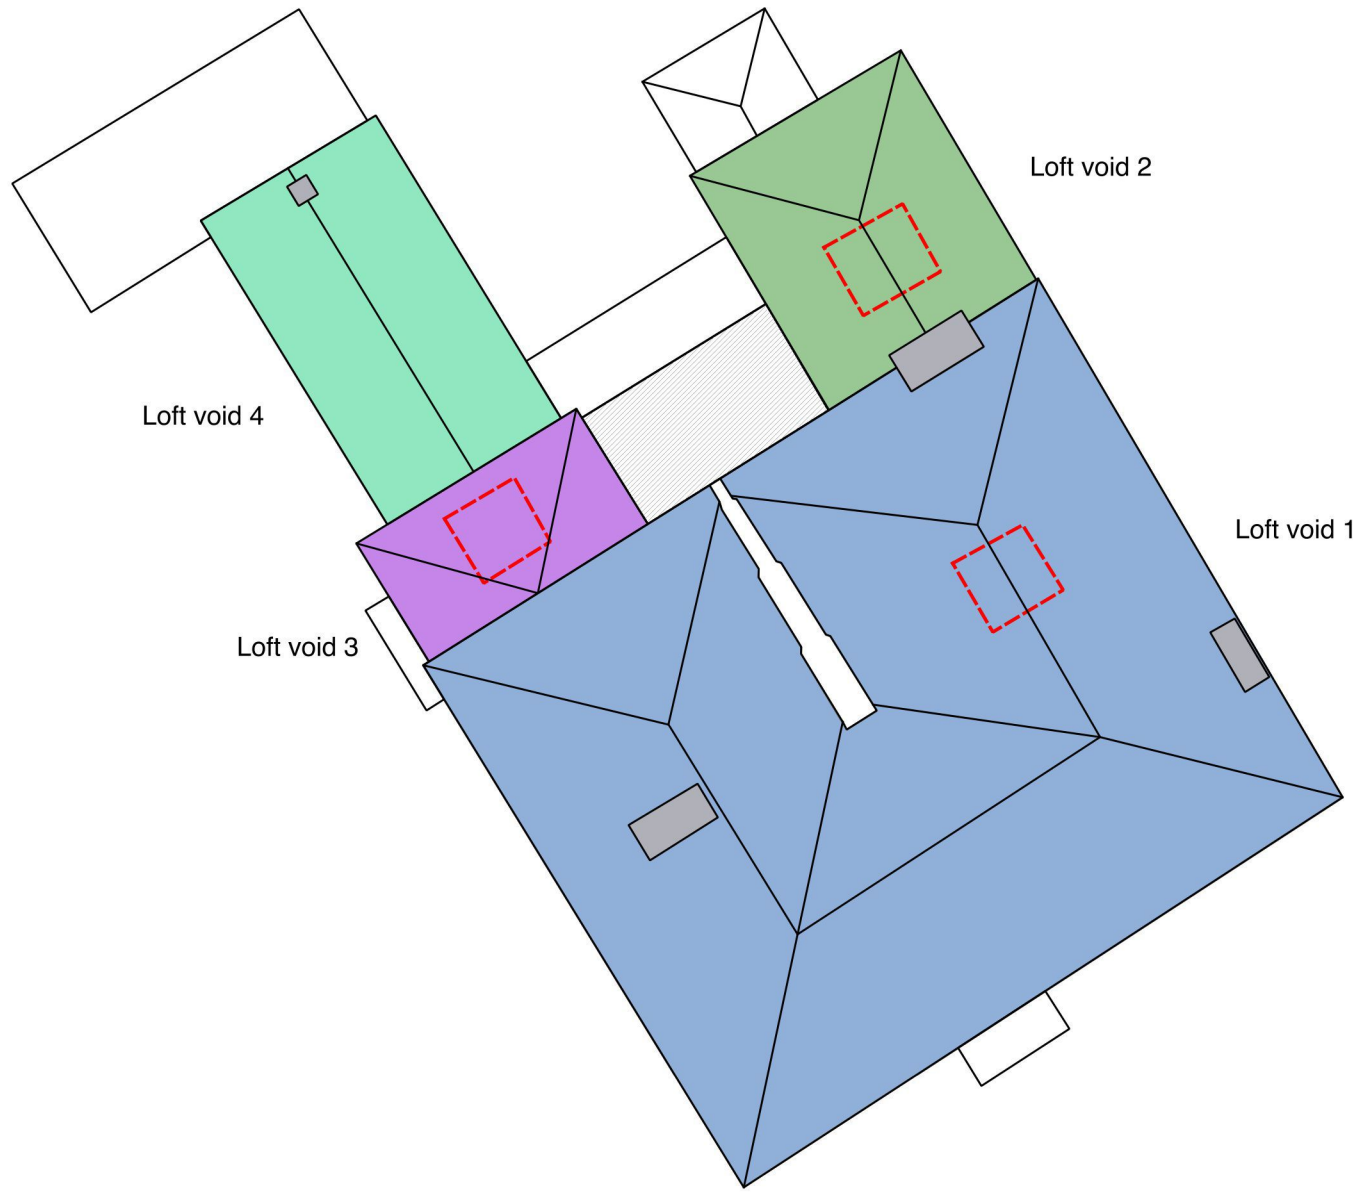
Figure 2.

- 2.2.3** A total of four bat roosts and four loft voids were identified at the property during the inspection (see Figure 2 in Appendix A). Loft void 1 comprises a large void with a number of brown long-eared bat droppings scattered throughout (Roost A)⁷. Loft voids 2 and 3 are smaller and incorporate low numbers of common pipistrelle droppings (Roost B and Roost C, respectively). Loft void 4 is a large, long void incorporating a lower number of scattered brown long-eared droppings (Roost D).

Location of loft voids and tell tales

roosting bats. The tell tales were checked for fresh evidence of bats on 11 July 2023 before being removed on the same date. The location of the tell tales is shown in Figure 2 in Appendix A.

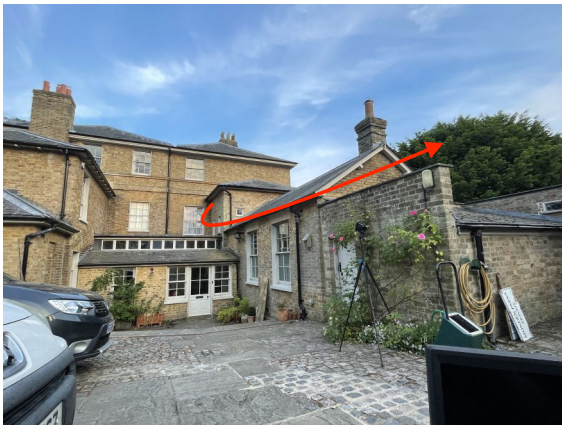
Roost C | 2 Common pipistrelles emerged from a gap in the eaves on the northern elevation of the property.

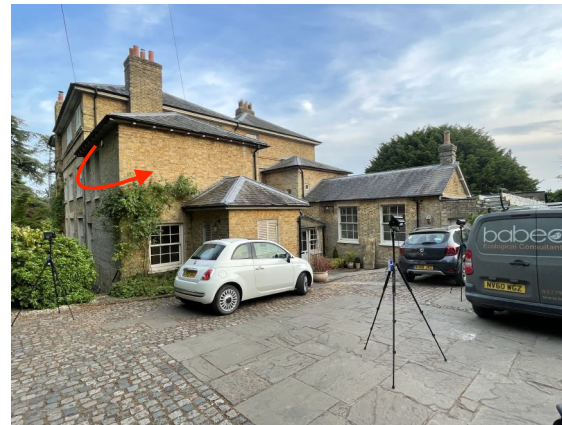
Roost B | 76 common pipistrelles emerged from a gap in the eaves on the eastern elevation of the property.

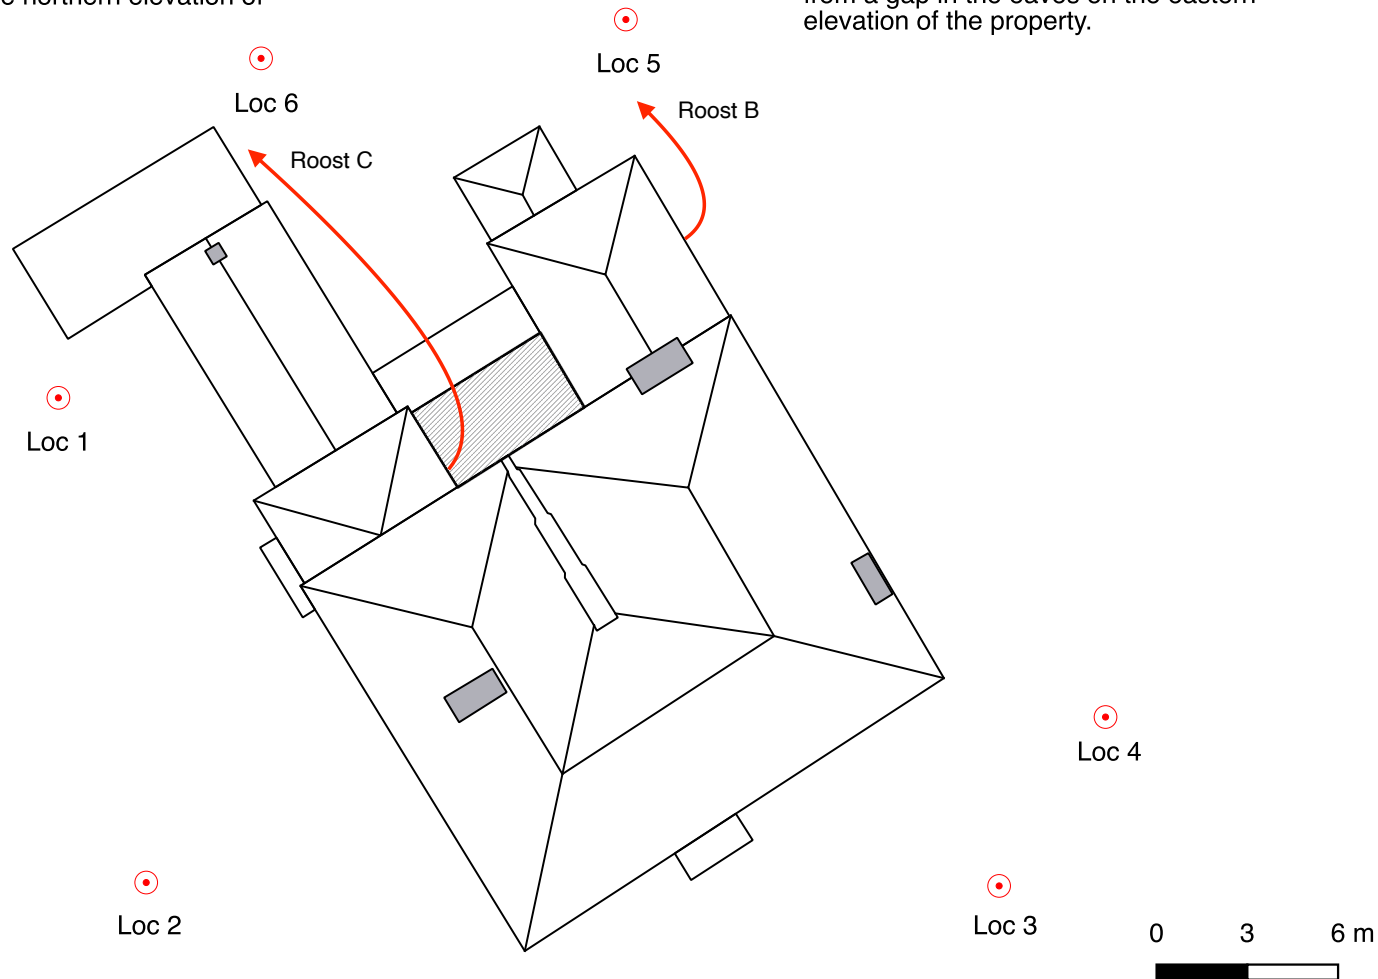
Figure 3.
Results of survey visit 1

- 4.1.1** Bats were recorded emerging and returning to roost to several features on the property during survey visits 1, 2 and 3, as detailed in Table 2 and set out in Figures 3, 4 and 5 in Appendix A, respectively. Surveyor locations are shown on Figures 3, 4 and 5 in Appendix A and incidental records of bat activity recorded during the surveys are provided in Table 2.

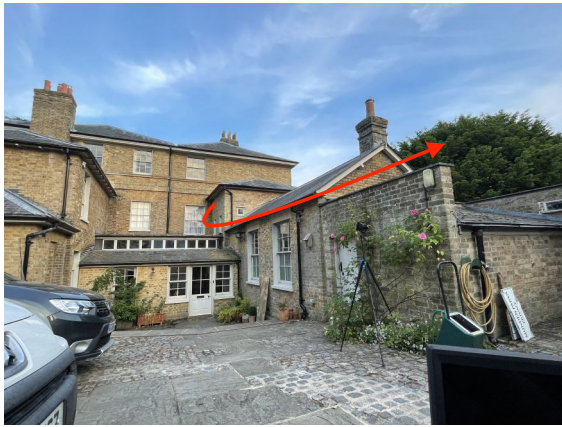
Roost C | 2 Common pipistrelles emerged from a gap in the eaves on the northern elevation of the property.

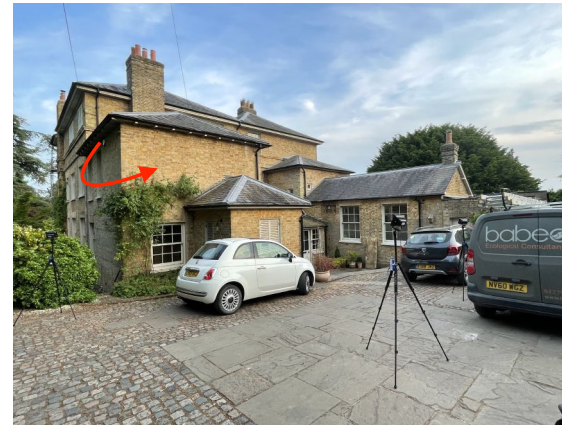
Roost B | 96 common pipistrelles emerged from a gap in the eaves on the eastern elevation of the property. Nine common pipistrelles returned to roost to the same feature.

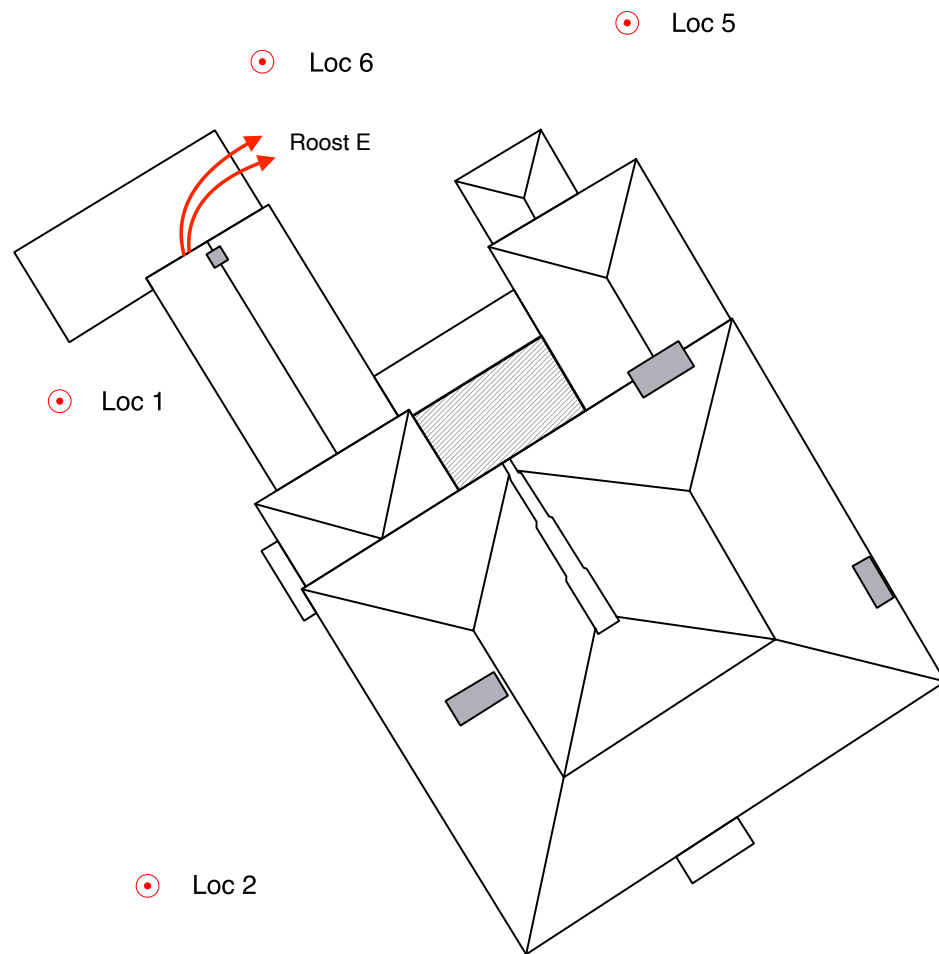
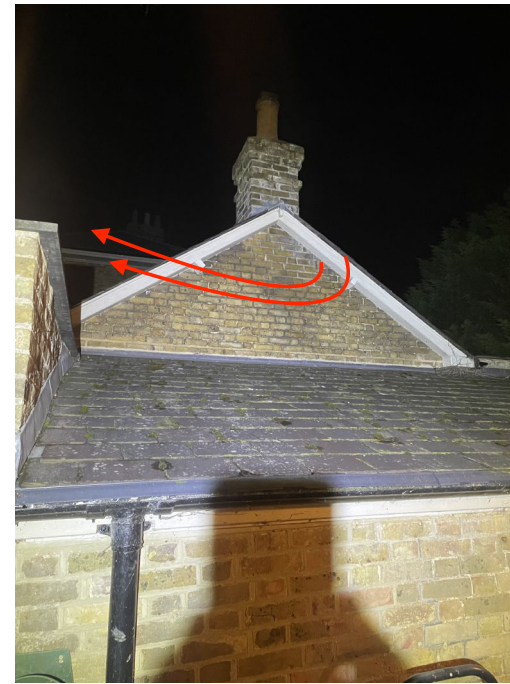
Figure 5.
Results of survey visit 3

<p>Roost E 11 common pipistrelles emerged from a gap between the soffit and wall and 34 common pipistrelles emerged from an adjacent gap under a roof tile during survey visit 3 on 31 July 2023. Two bats also returned to the same feature.</p> <p>No common pipistrelles emerged from Roost E during survey visit 1 or survey visit 2 on 12 June and 11 July 2023, respectively.</p>	Unknown, but most likely roosting location is in soffit and/or in crevice under roof tiles.	Two access points are present (gap between soffit and wall, and gap under adjacent roof tile).	Mod	<p>The results of the surveys indicate the presence of a second common pipistrelle maternity roost.</p> <p>Common pipistrelles often move irregularly between several maternity roosts within a small area during the maternity period, and as such, numbers at any one site can fluctuate markedly throughout this time.</p>

Roost E | 11 common pipistrelles emerged from a gap between the soffit and wall on the northern elevation of the property. 34 common pipistrelles emerged from an adjacent gap under a roof tile. Two bats subsequently returned to the same feature.

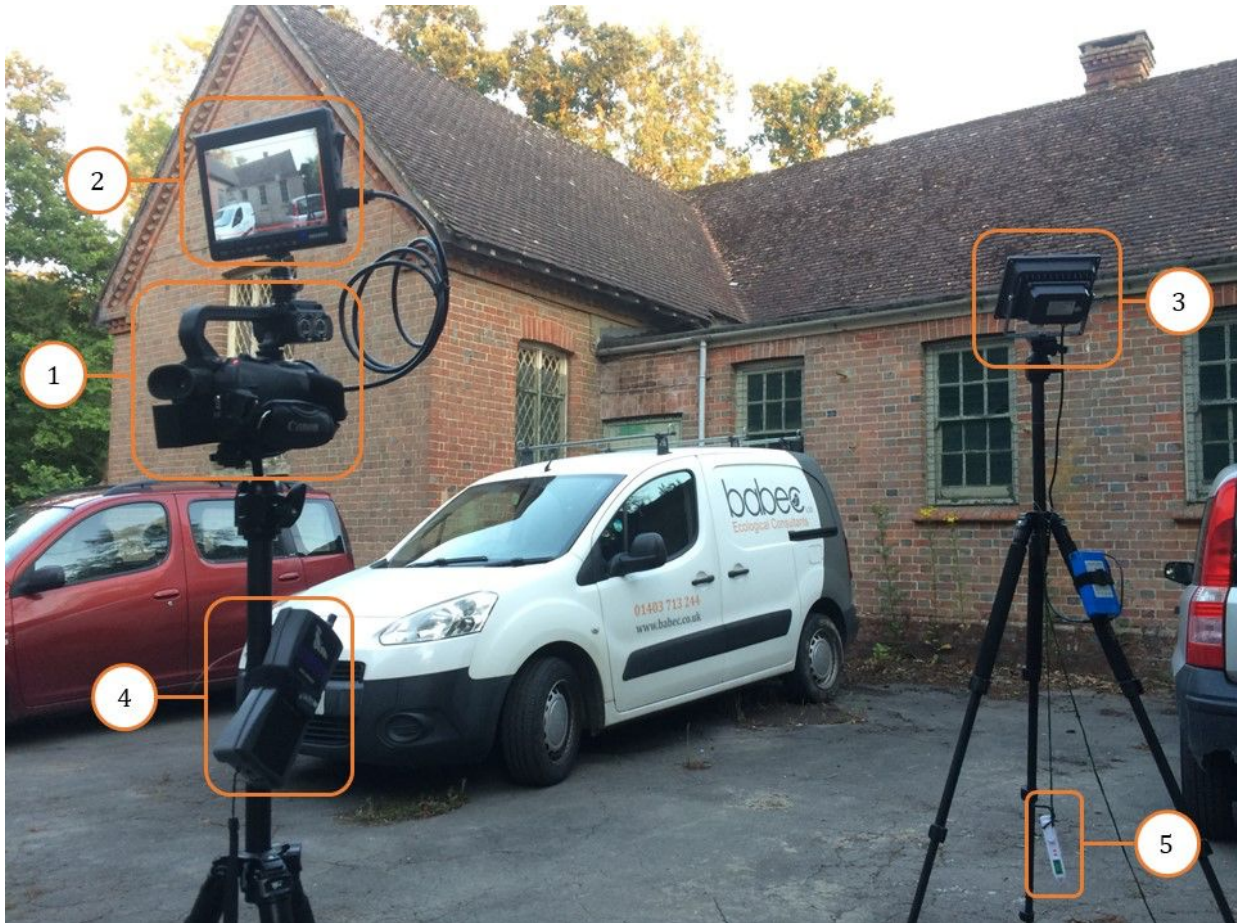
In accordance with Bat Conservation Trust’s interim guidance note¹⁷ on the use of night vision aids (NVAs), NVAs were used at each surveyor location on each survey visit unless stipulated in the survey limitations. NVAs comprised a Canon XA series video camera equipped with infrared lamps. Surveyors were also equipped with a full-spectrum Elekon Batlogger M bat detector. An example of the equipment used by Babec Ecological Consultants during emergence surveys is provided below:

1. Canon XA series camcorder 2. Screen 3. Infrared floodlamp 4. Batlogger-M 5. Thermometer
