Frewin Hall Ground Source Heat Pump

Oxford

Archaeological Evaluation and Watching Brief Report

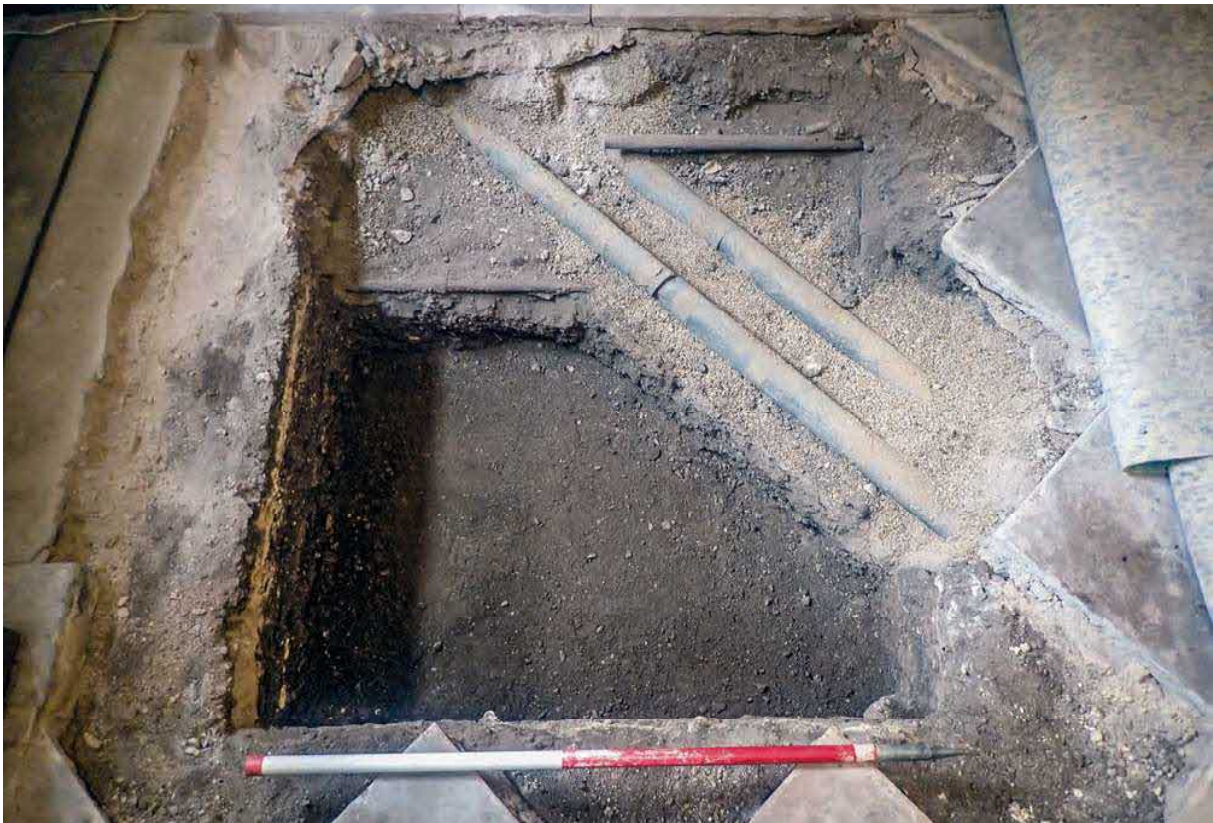
Plate 1: General view of Test Pit 1 (view to south)

3.4.1 Excavated to a maximum depth of 63.94m OD (0.55m bgl), the earliest deposit revealed in Test Pit 1 was a homogenous sandy silt deposit recorded as layer 5 (Plates 1 and 2). A few fragments of late medieval/early post-medieval ceramic building material (CBM) and a small sherd of late medieval pottery (*c* 1400-1625) were recovered from this deposit, which likely represents a garden soil. This was overlain by a thin lens of sandy lime mortar (4) and then a further deposit of apparent garden soil (3) which produced two small sherds of Brill/Boarstall ware (*c* 1400-1625) and two fragments of medieval roof tile. Sealing layer 3, and covering a large portion of the excavated area, was a 0.1m thick layer of firm, compacted mortar and crushed limestone (2). Representing one of the latest deposits in the sequence, this was probably a construction horizon related to the building of Frewin Hall. Overlying this deposit was a mixed layer of sandy silt and mortar (1), which served as the bedding layer for the flagstone floor of the building. A residual assemblage of pottery comprising St Neots ware, Medieval Oxford Ware and Brill/Boarstall Ware was recovered from this deposit, alongside a piece of clay tobacco pipe stem of 17th century date.

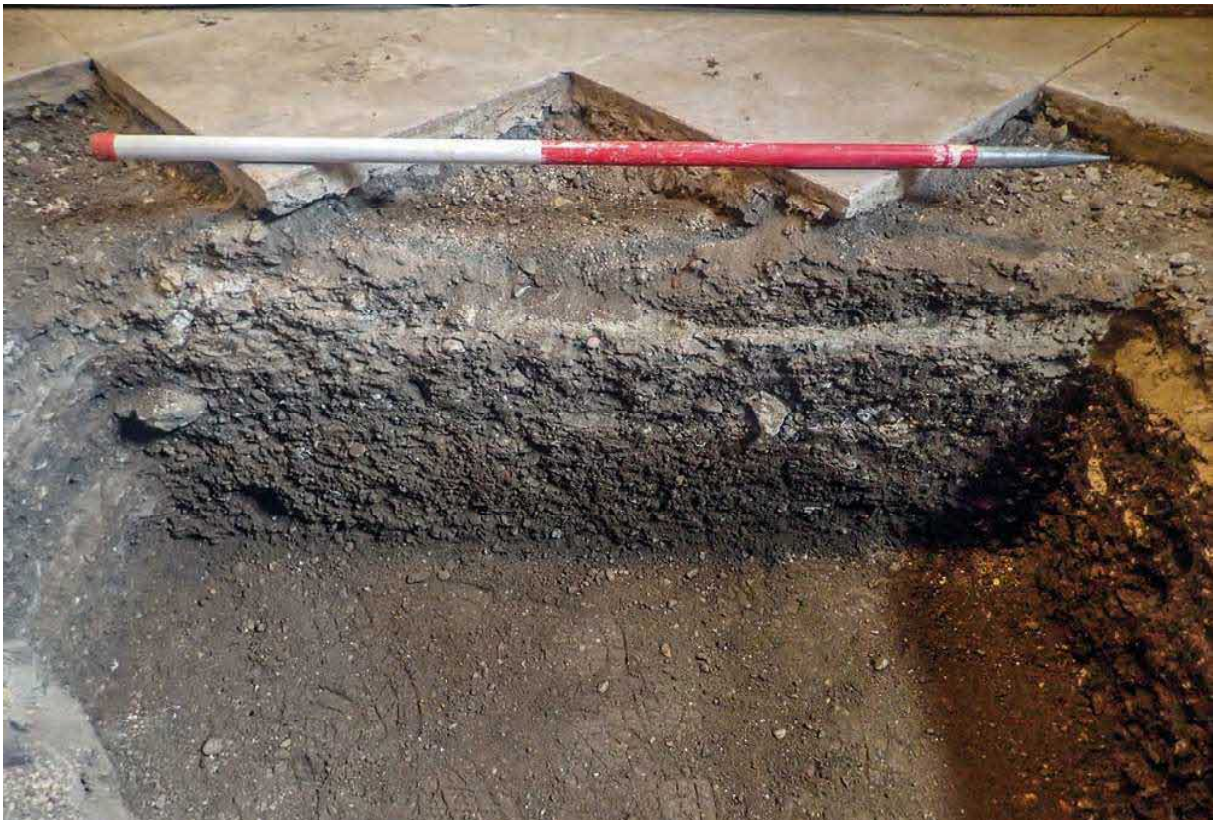
Plate 2: South facing section of Test Pit 1 (view to north)

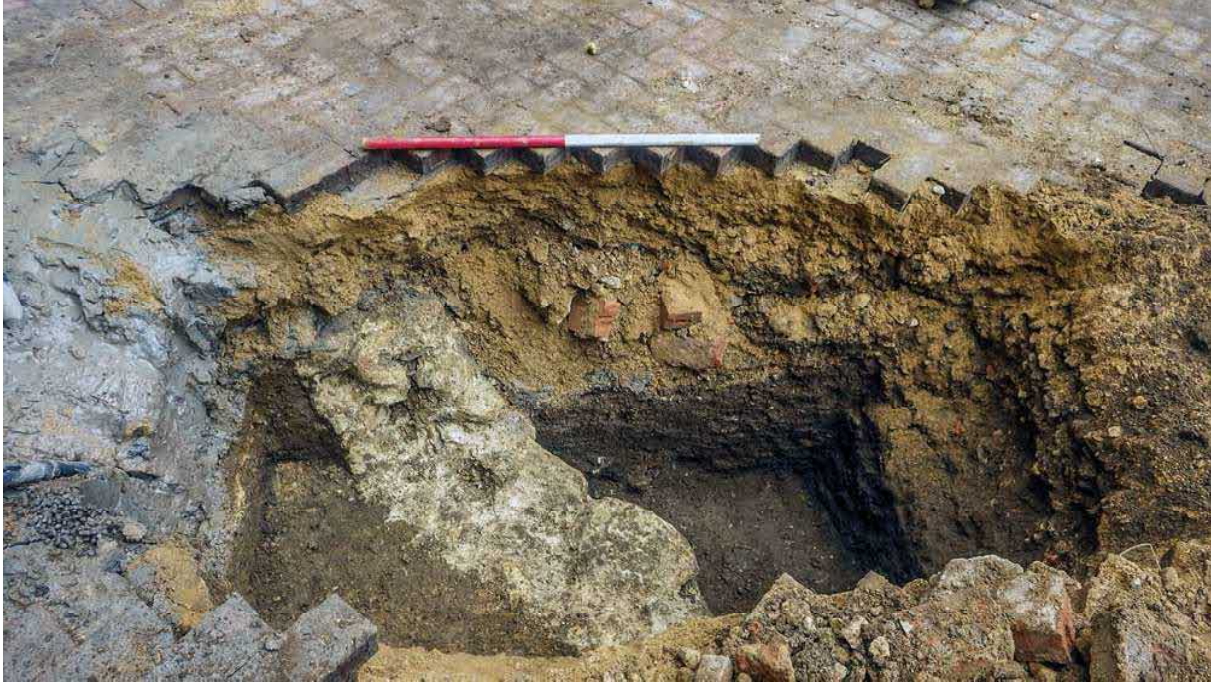
Plate 3: Section across Structure 7 and related deposits (view to west)

- 3.5 GSHP ducting trenches (Figs 2 and 4)
- 3.5.1 Within the ducting trench on the eastern side of the courtyard, a thick layer of homogenous grey brown garden soil (8) was observed at the base of the excavation. From this deposit three sherds of pottery were recovered, including post-medieval red earthenware (c 1550-1900), Raeren stoneware (c 1480-1550) and Medieval Oxford ware (c 1075-1300). It also produced two pieces of clay pipe stem of 17th century date and residual fragments of medieval CBM. Towards the south-east of the courtyard it was partially truncated by a broadly NNW-SSE aligned wall (7; Plate 3). It consisted of limestone rubble and lime mortar forming a structure up to 0.4m wide. The northern end of the wall appeared to have been truncated away, but at its southern end, three courses survived to a height of 0.5m, with the upper level at 64.14m OD. On its eastern side it appeared to be cut into further garden soils, but the western side was abutted by and overlain by a loose made-ground deposit of rubble (23; Fig. 4, Section 2).

4.2.2 Within the external courtyard, the shallow depth and limited dimensions of structure 7 would suggest this was little more than a garden wall, perhaps constructed to form part of a raised bed at the edge of the courtyard. Based on the assemblage of finds from the earlier garden soil (8), this was evidently constructed at some point after the late 17th century.

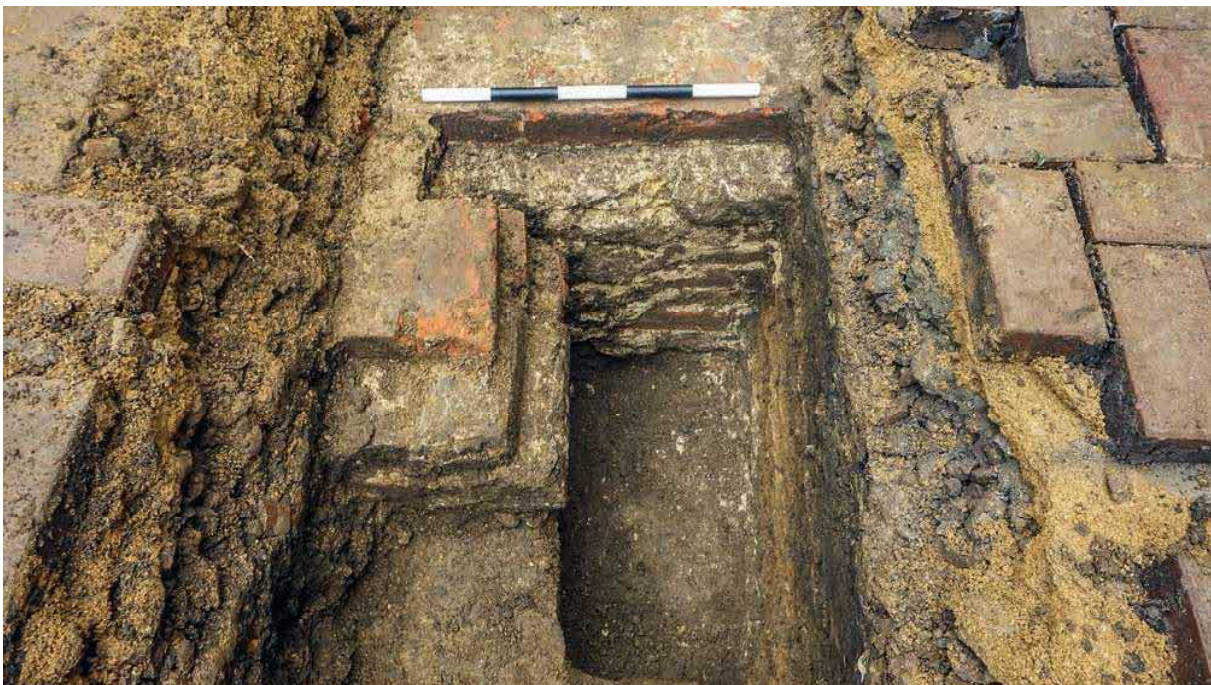
Plate 4: Overview of structure 6 (view to south)

- 3.5.3 At the southern end of the trench, soil layer 11 was truncated by the construction cut (9) for a second wall (6). Structure 6 comprised a 0.55m high stepped foundation constructed with both roughly hewn limestone blocks and bricks, with a soft lime mortar (Plate 4). The orangey red, unfrogged bricks measured 200x 100x 60mm. A total of eight courses were observed, including the uppermost course which stepped in approximately 0.08m. In plan, the wall was aligned ENE-WSW, with either an adjacent buttress or dogleg in its alignment, which extended out on its northern side. Overlying the backfilled construction cut and partially abutting the wall was deposit 22, which comprised a dark grey brown sandy silt, similar to the garden soils recorded elsewhere.

4.2.4 With the construction of Frewin Hall recorded in 1582, it is very likely that wall 6 was constructed at a similar date. This is further supported by the fact its position and alignment match that of a structure depicted on Loggan's 1675 view of Oxford, but it is not evident on the earlier maps by Agas (1578) or Hollar (1643). What is presumably the same wall is then more clearly depicted on the 1878 Ordnance Survey Town Plan of Oxford, which also includes the corner revealed in these excavations.
