Manor Farm Barn, Culkerton

Bat Activity Survey Report
Mr & Mrs Sanford

October 2023

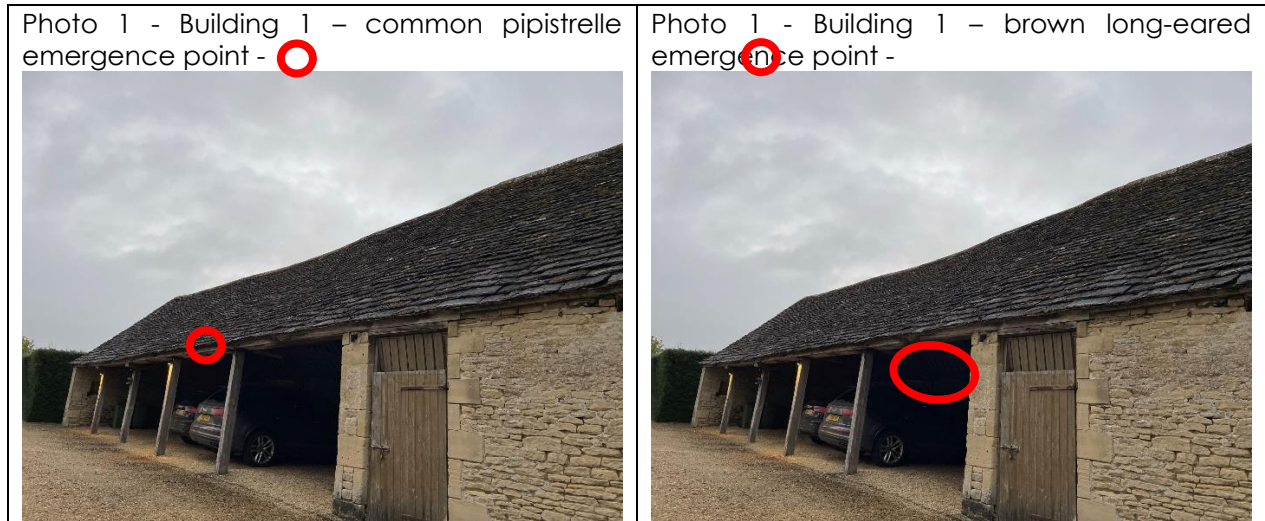
See Photos below for the roost/emergence points.

Building 1 – Manor Farm Barn; low numbers of common pipistrelle, a maximum of 3 during any one survey, were recorded emerging from the eave tile on the western elevation of the structure. Low numbers of brown long-eared bats, a maximum of 2 during any one survey, were recorded emerging from the open part of the structure. These results classify the roosts as a summer, day roosts for these species.

Subject to receiving planning approval, it will be necessary to apply for and obtain an European Protected Species Licence (EPSL) from Natural England under the conservation (Natural Habitats, &c) (Amendments) 2017 Regulations, to legally allow the proposed works to take place.

- Prior to any works taking place on site two Harlech woodstone bat boxes will be erected on trees or a building adjacent to the Site at a height at least 3m above the ground.
- The buildings on Site will be inspected by a Natural England C2 licenced ecologist immediately prior to any demolition/roof strip. The ecologist will use a flexible endoscope to assist with this survey. This includes all gaps and cracks in the external brickwork and stonework on Building 5.
- The "demolition" phase of the proposed development will take place between late March and late September.
- Should any bats be encountered during the supervised strip of the buildings they will be collected by the Natural England C2 licenced ecologist and moved to the pre-installed bat boxes.

- Bat box – the Harlech woodstone bat box will be retained as long term compensation for the loss of the roost which will be destroyed as part of the proposed works.
- Create a bat loft in Building 1, this should be W: 4.0m, L: 4.0m, H: 1.8m. Access should be created via the installation of two fascia entrances measuring W: 10cm, H: 4cm.
