Outbuilding at Silver Street Farm House, Silver Street, Coaley, GL11 5AX.

Preliminary Roost Assessment

December 2023

Project Number: 1835

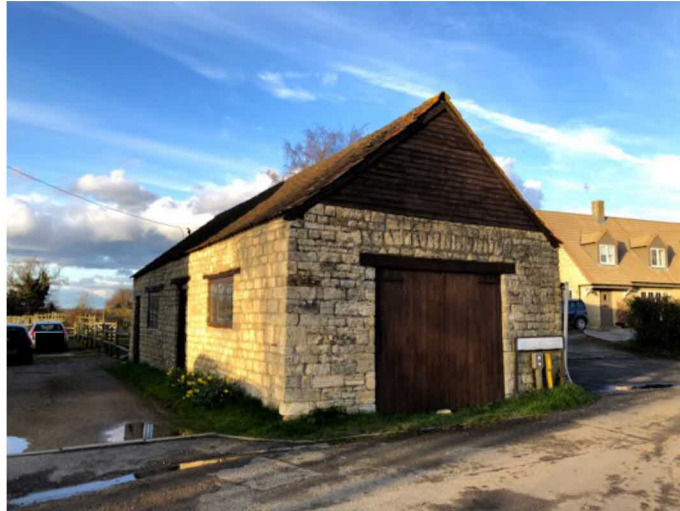
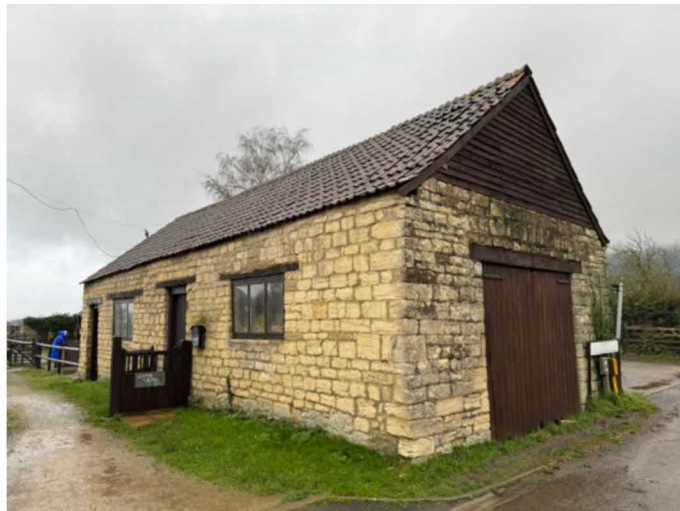
Photograph 1: Barn – west elevation and south gable (April 2018).

Photograph 1a: Barn – west elevation and south gable (December 2023).

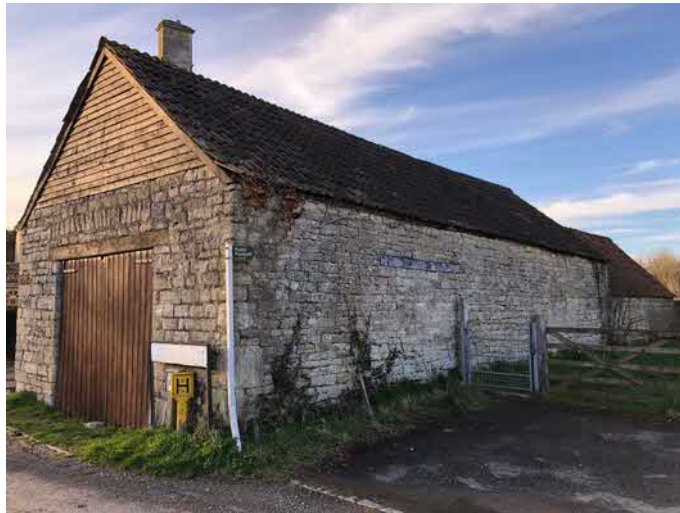
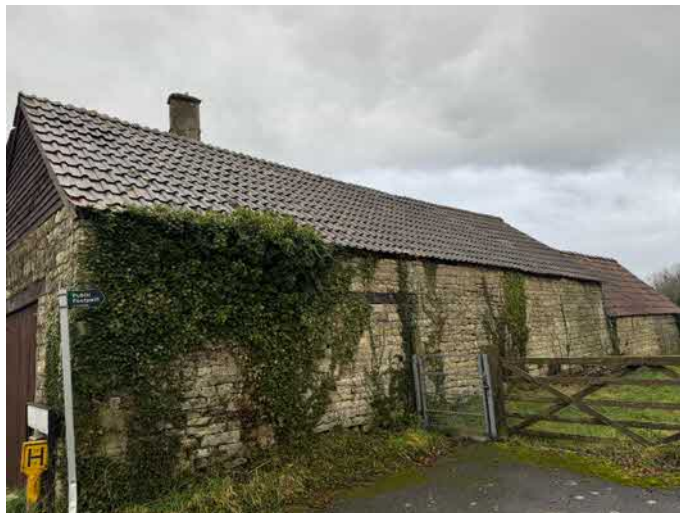
Photograph 2: Barn – south gable and east elevations (April 2018).

Photograph 2a: Barn – south gable and east elevations (December 2023).

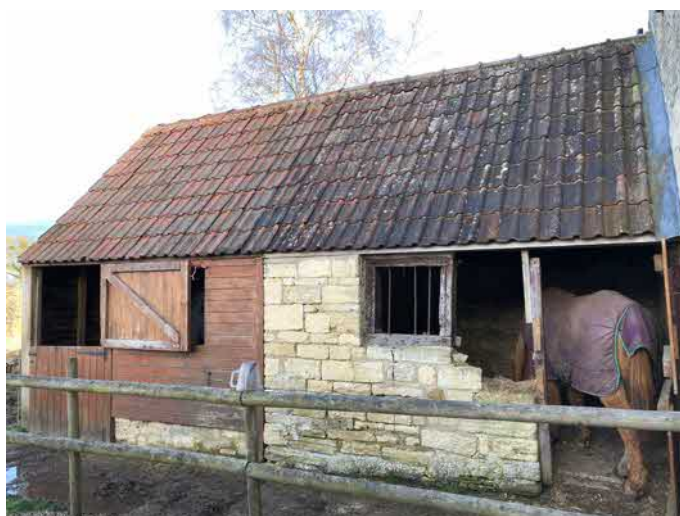
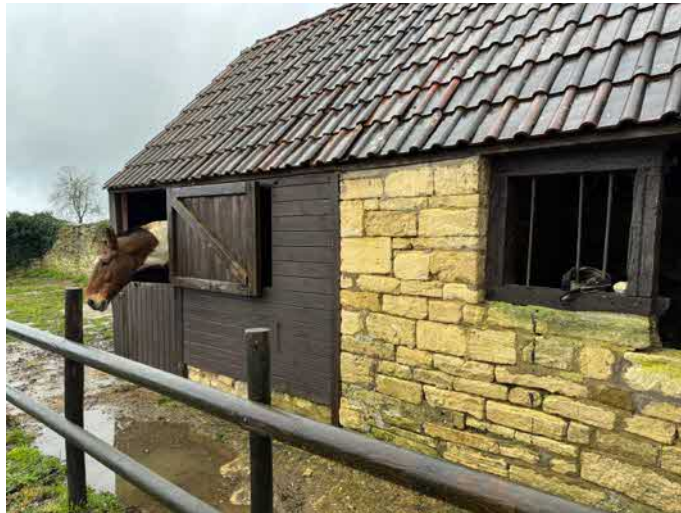
Photograph 3: Stable – west elevation (April 2018).

Photograph 3a: Stable – west elevation (December 2023).

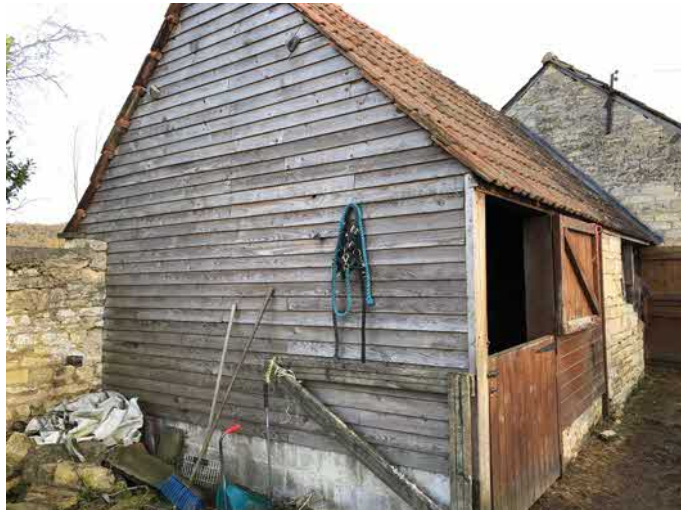
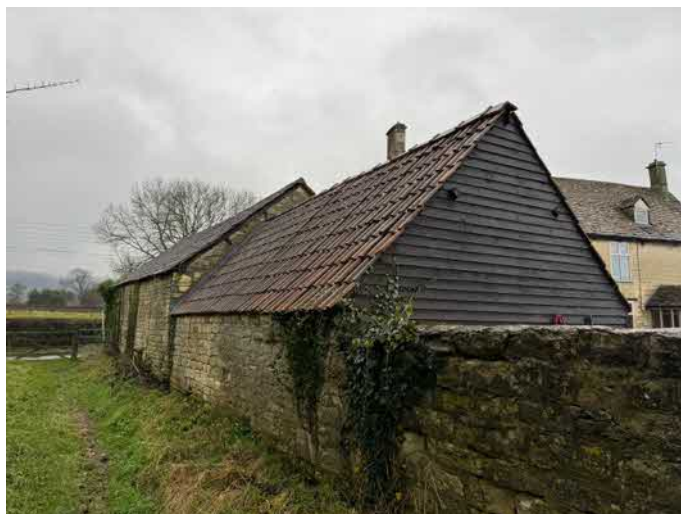
Photograph 4: Stable and Barn – north gables (April 2018).

Photograph 4a: Stable and Barn – north gables (December 2023).

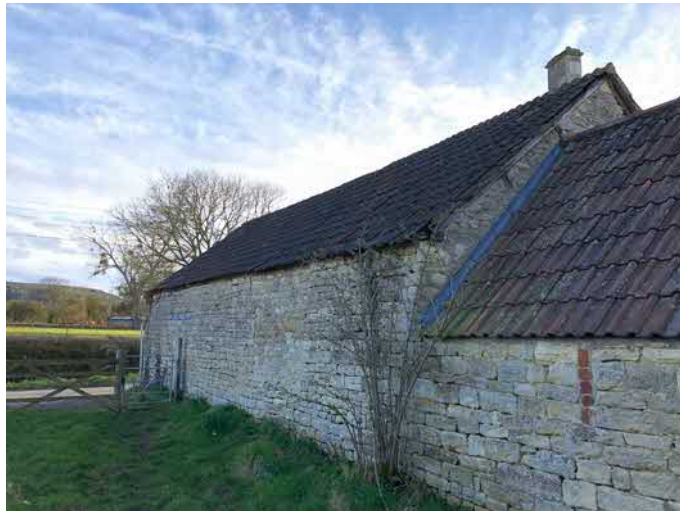
Photograph 5: Barn and Stable – east elevation (April 2018).

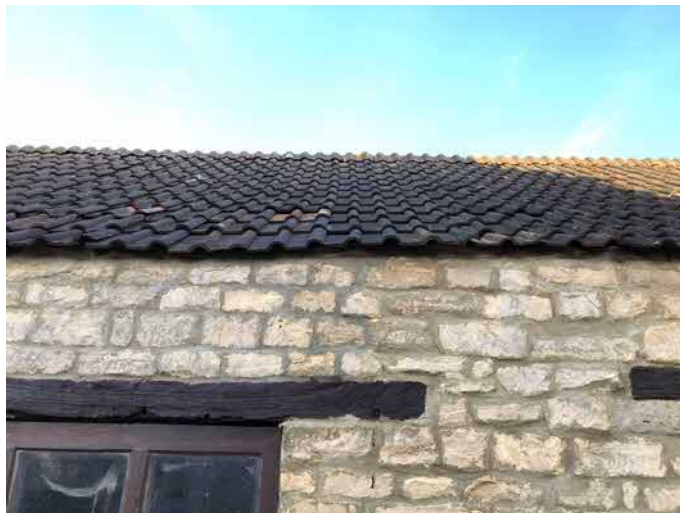
Access for Bats – Open stable doors into the stable, but potentially closed at night. Gaps around large door in the south gable end of the barn and timber weather boarding. Gaps under tiles, ridge tiles, and along the bottom row of tiles throughout. Small number of external holes/gaps in stone work. Gaps in internal stone work.

Photograph 6: Barn – gaps under tiles and ridge tiles providing direct access to the interior (April 2018).

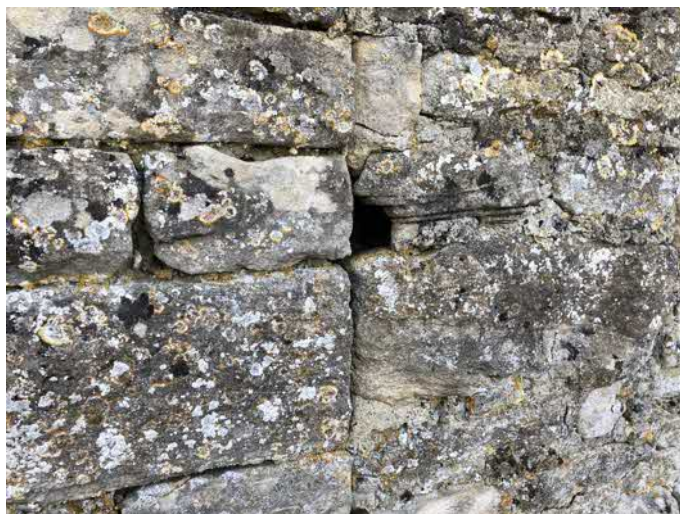
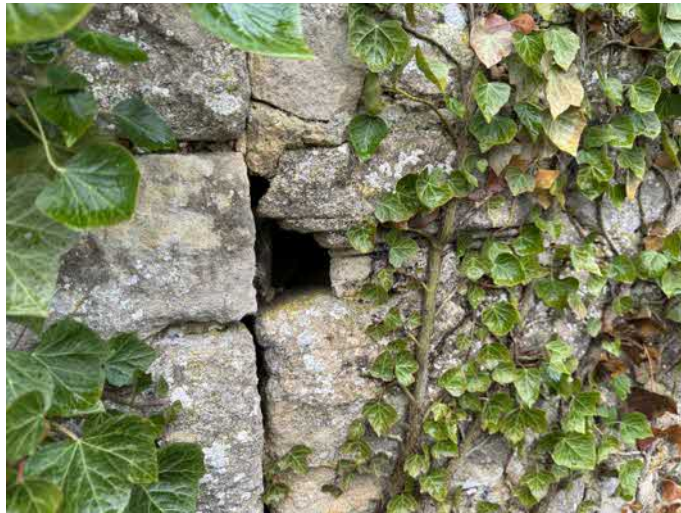
therefore a number of small gaps in the internal walls, along the tops of the walls and a small number of external holes/gaps, where mortar is missing, all for individual or low numbers of crevice-dwelling species. Gaps in the timber lintels also provide similar opportunities although most were heavily cobwebbed. A full inspection of these gaps including a small number that required an endoscope, did not find any evidence of roosting bats such as droppings or staining, and none of the gaps were found to extend into any more significant cavities within the walls. No evidence of night use such as droppings or feeding remains were discovered with nothing to indicate that such evidence would not have persisted. It is concluded that roosting bats are likely to be absent from this building but with only minimal potential for future use.

Photograph 7: Barn – one of a small number of holes in the external walls (April 2018).

Photograph 7a: Barn – one of a small number of holes in the external walls (December 2023).

- 6.11 All works should be carried out with care and vigilance for bats. All cracks and crevices in the walls should be carefully inspected prior to repair/repointing in order to ensure that bats are absent and do not become trapped and the contractor advised to adhere to the following procedures in the unlikely event that bats are found during works:

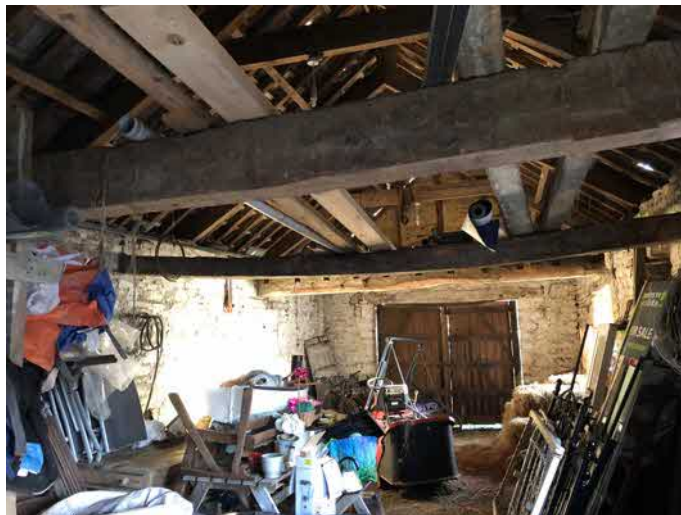
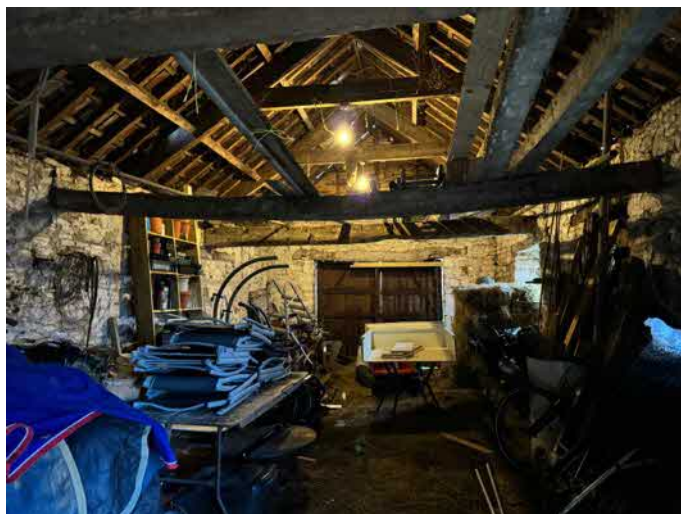
Internal – Barn open throughout with no enclosed roof voids. Stable divided in two but open to the roof with no roof voids. Bare Cotswold stone and weather board walls. Unlined roof supported by traditional timbers including rafters, principal rafters, and beams. Stables in active use. Barn currently used mainly for informal storage with regular use of north end only where horse feed is stored

Photograph 8: Barn – interior (April 2018).

Photograph 8a: Barn – interior (December 2023).

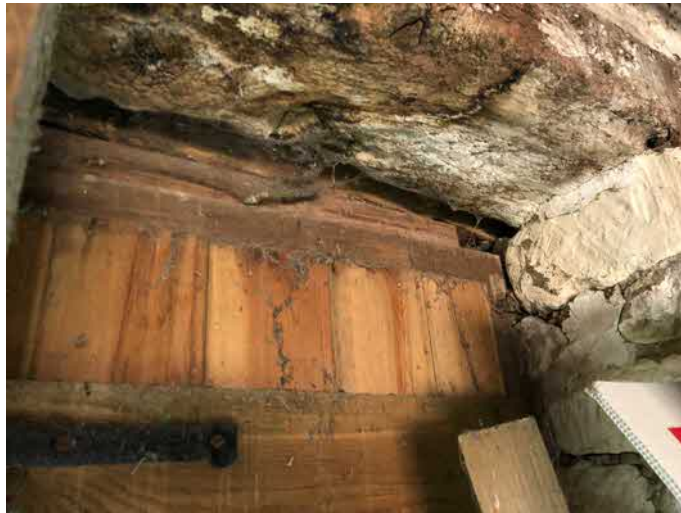
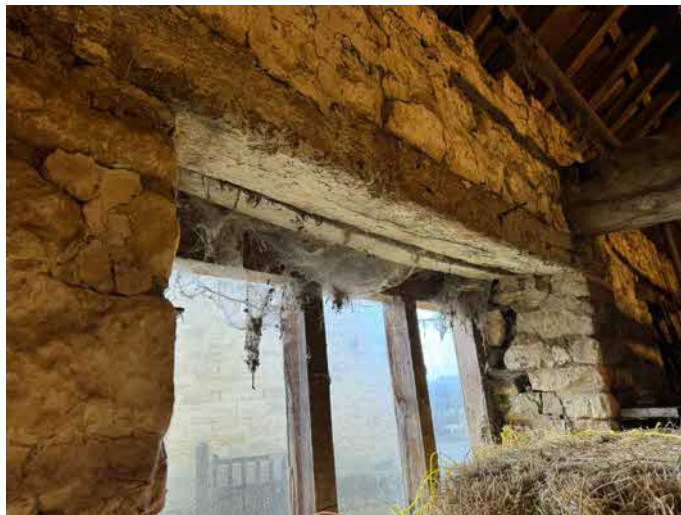
Photograph 9: Barn – gap in timber lintel – heavily cobwebbed and no evidence of use (April 2018).

Photograph 9a: Barn – gap in timber lintel above window – heavily cobwebbed and no evidence of use (December 2023).

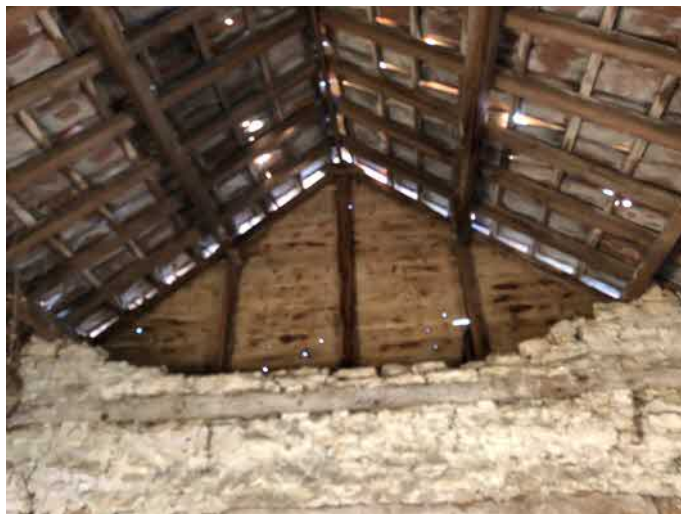
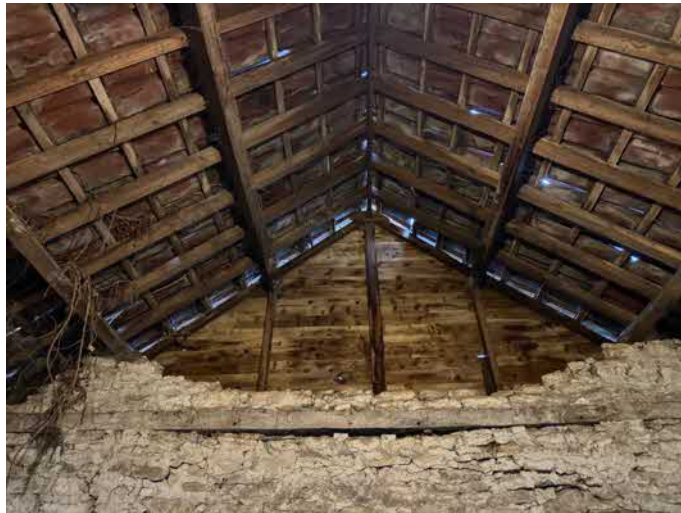
Photograph 10: Barn – south gable interior – gaps provide direct access to interior but no potential roosting sites (April 2018).

Photograph 10a: Barn – south gable interior – gaps provide direct access to interior but no potential roosting sites (December 2023).

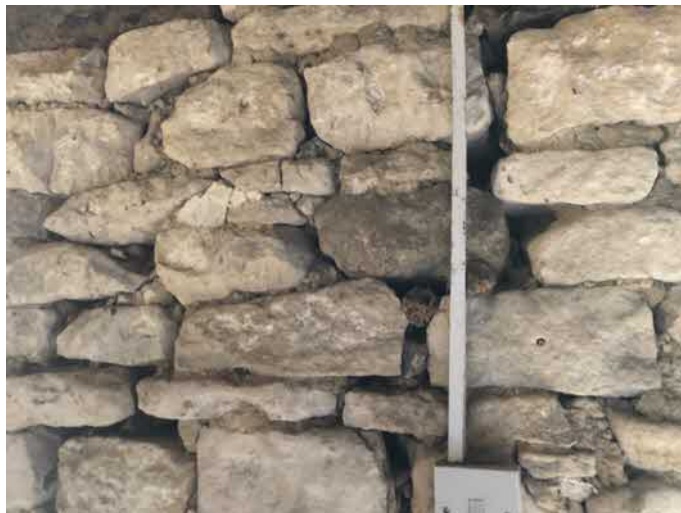
Photograph 11: Barn – gaps in interior walls (April 2018).

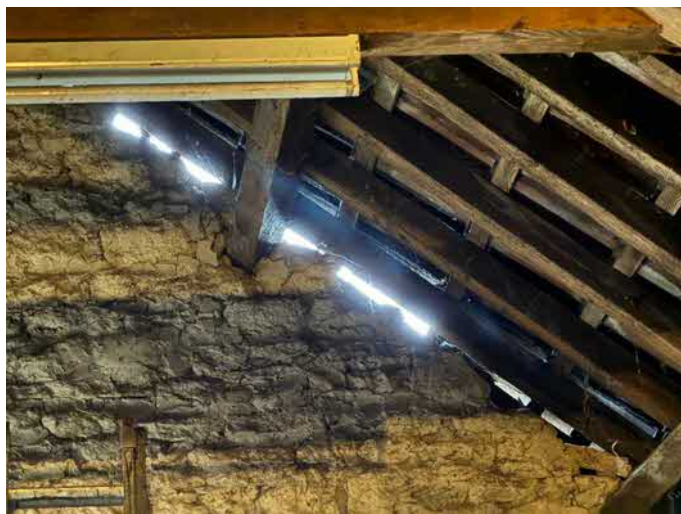
Photograph 11a: Barn – large gaps between the roof and top of the north gable wall (December 2023).
