CCTV Upgrades – Westminster Reference Library, 35 St. Martin's Street, London, WC2H 7HP

Heritage, Design & Access Statement
Westminster City Council

November 2023

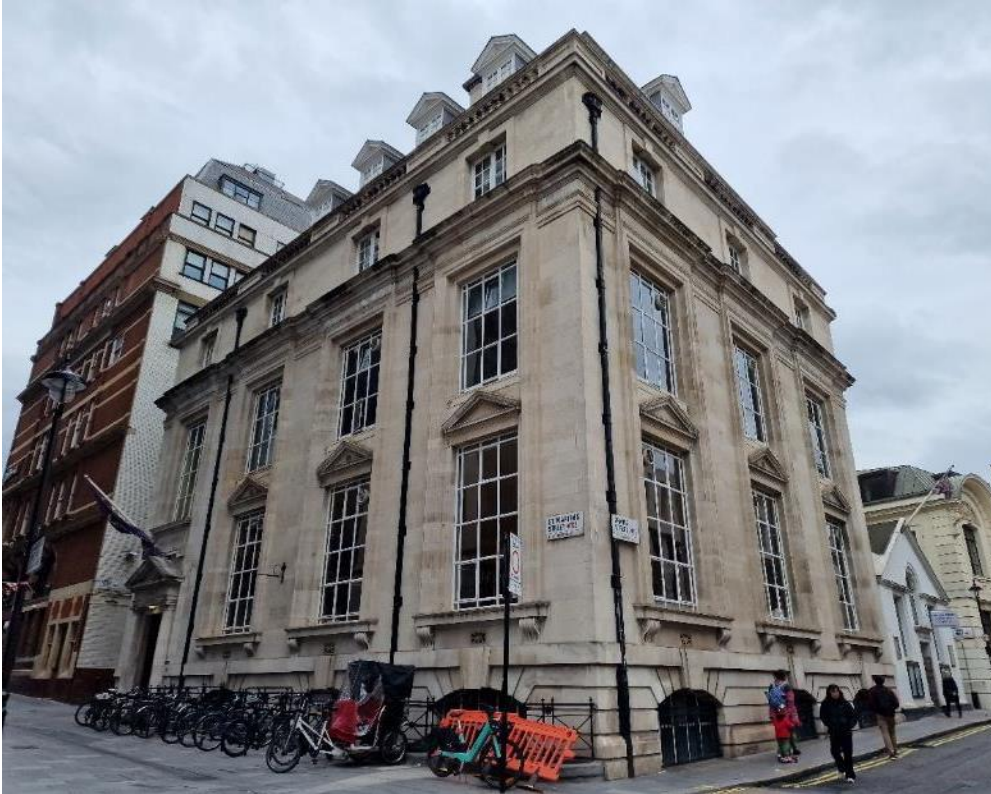
Westminster Reference Library – corner of St Martin's Street and Orange Street²

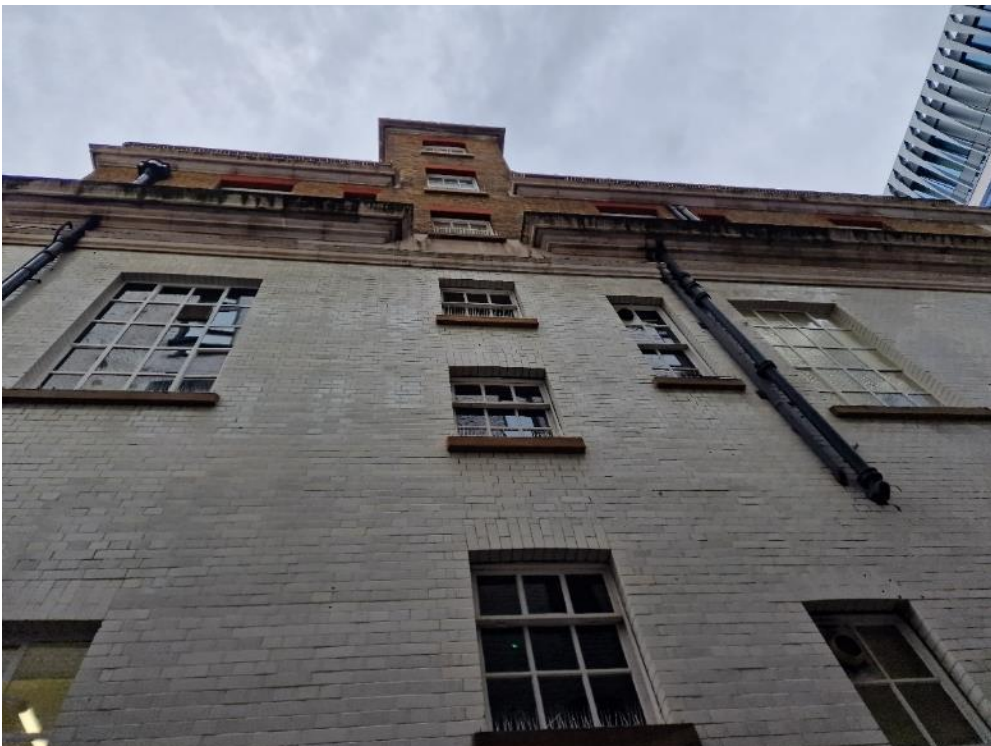
Westminster Reference Library – Long's Court façade³

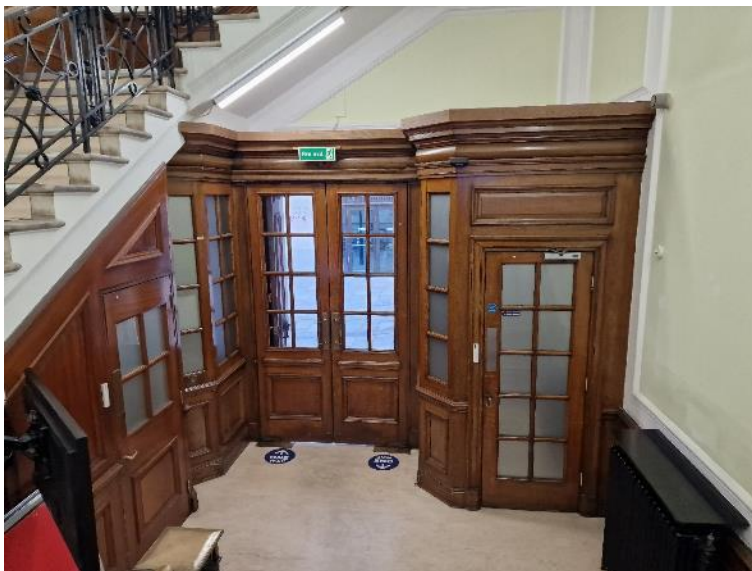
Entrance Hall

Polished wooden doors with glazed panels. Modern vinyl flooring. Painted and plastered walls.

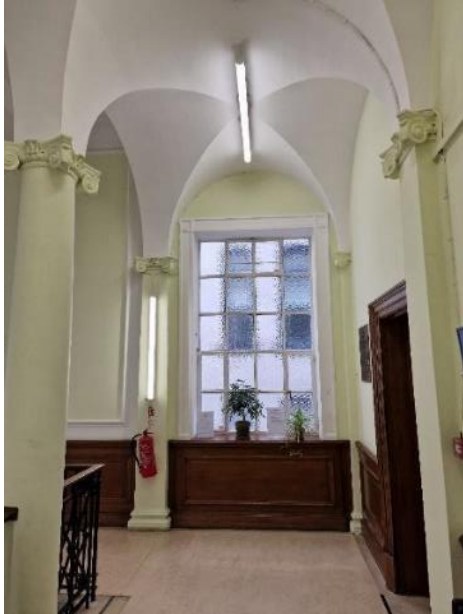
Ground Floor Vestibule

Arched plaster ceiling to vestibule with decorative bosses, plastered walls and vinyl-covered floor. Set of automatic wooden double doors lead into the Main Library space. Apparent Crittal-style window with obscured glass panes.

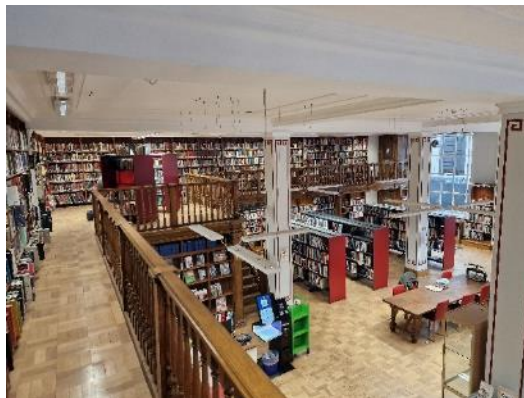
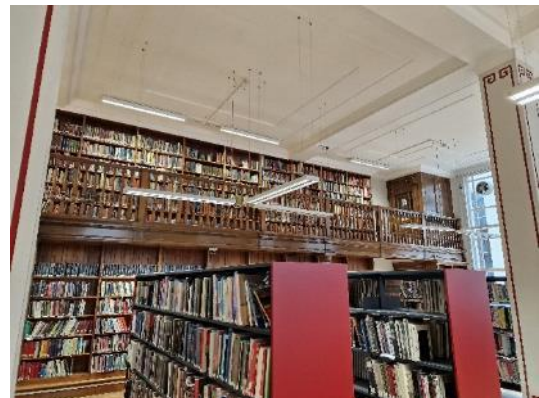
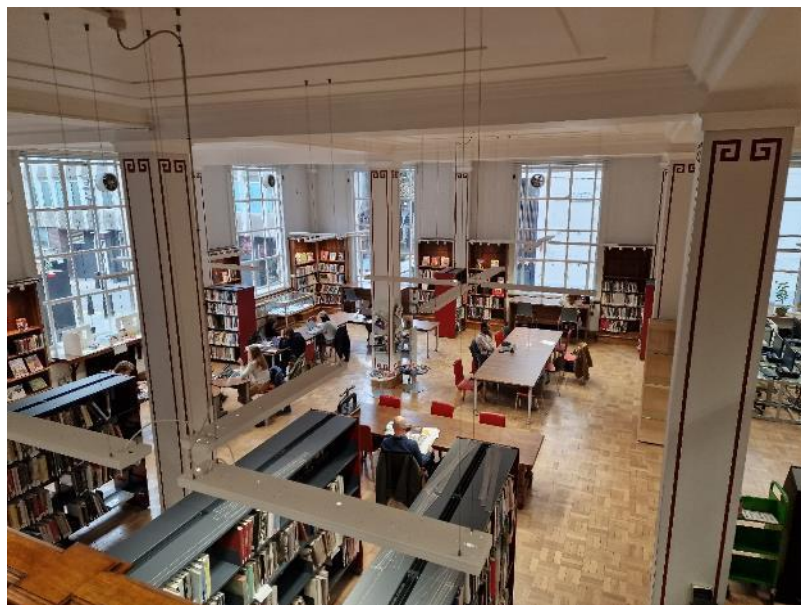
Main Library

Plaster ceiling with suspended modern ceiling lights throughout. Wooden parquet flooring. Plastered walls. Plaster-finished columns with maroon decorative motifs. Original polished wooden balconies and stairs, wooden balustrades, supported on polished wood columns. Crittal-style single-glazed windows. Four square columns with maroon Greek motifs.

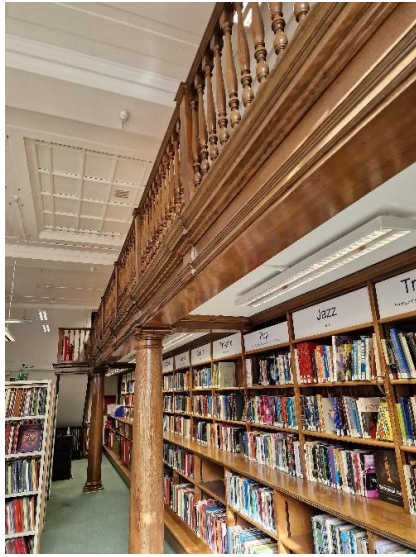
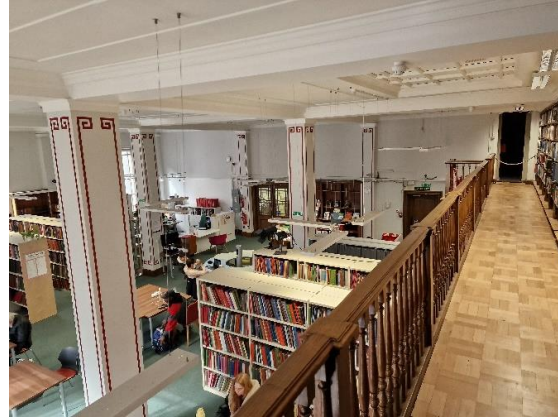
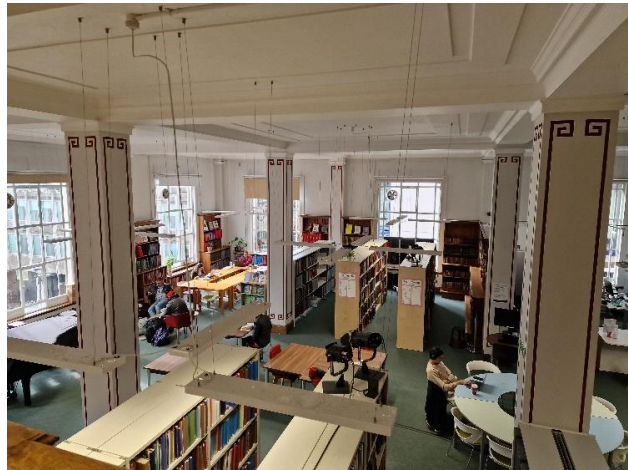
Music Library

Modern carpeted flooring to ground floor. Wooden parquet to balconies. Polished wooden balcony runs along one edge of the room. Supported on turned polished wood ionic columns – presumed original. Painted plaster walls and ceilings. Four square columns with maroon Greek motifs dominate the centre of the room.

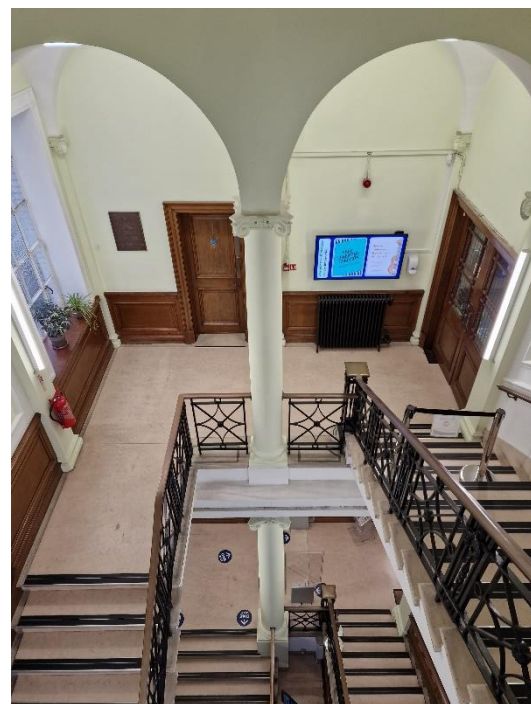
Main Staircase

Painted plaster ceilings and walls. Arches to landings supported by Ionic columns. Modern vinyl flooring. Polished brass rail to staircase with patterned metal balustrade. Wainscoting to rail height along staircase from ground to first floors. Likely original solid wood doors.

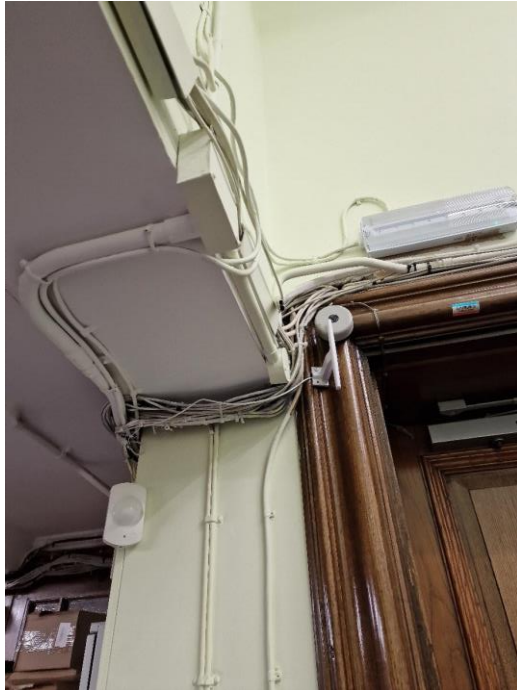
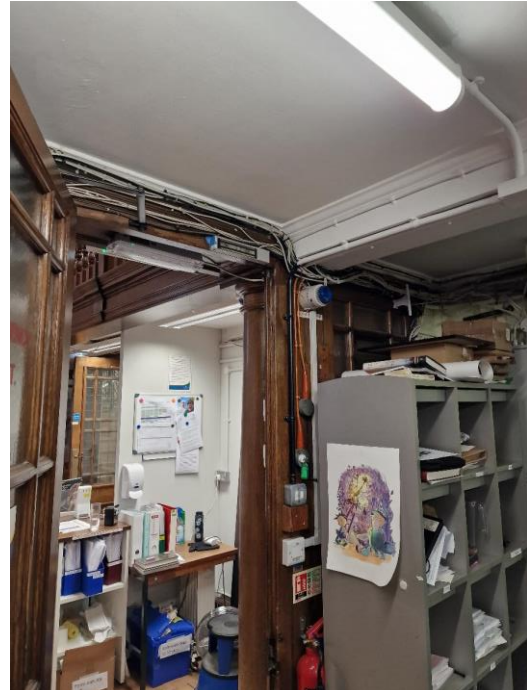
Librarian's Office (Ground Floor)

Painted plaster ceilings and walls. Carpet to floors. Apparently original polished wood doors and architraves. Numerous cables and junction boxes of various ages and styles affixed to walls, running through to rear staircase.

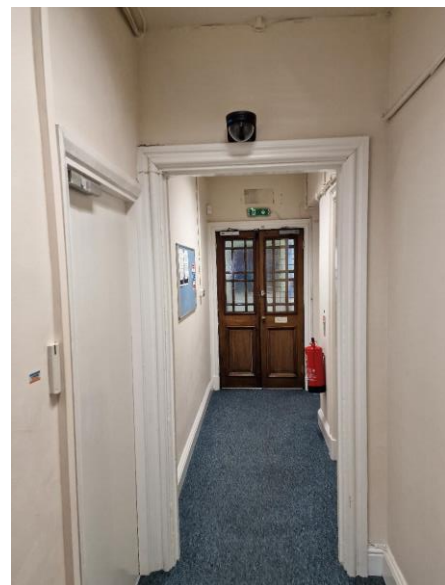
Third Floor Corridors

Modern carpet to floor. Plastered and painted walls and ceilings. Apparently original wooden doors with glazed panels. Modern light fixtures. Various cabling affixed to walls.

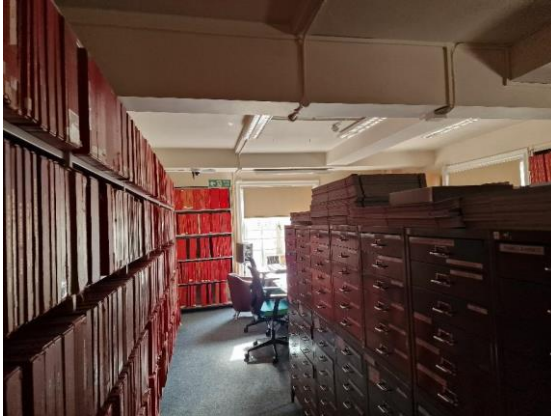
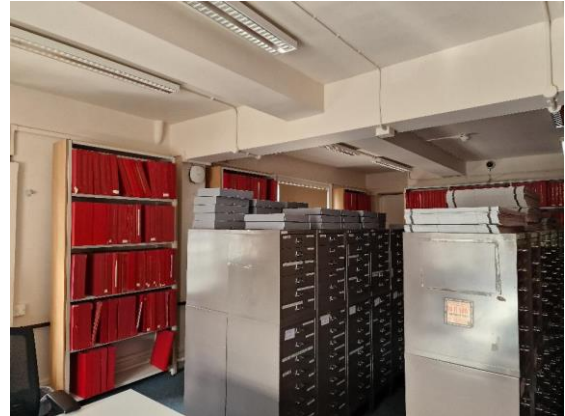
Third Floor Reading Room

Modern carpet to floors. Painted and plastered walls and ceilings. Strip lights to ceilings. Substantial metal filing cabinets to centre of room. Walls largely obscured by wooden shelving of modern construction.

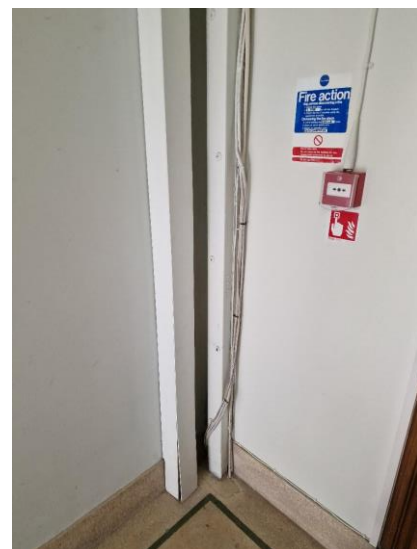
Rear Staircase

Plasterwork, painted, to walls and ceiling. Apparently original wooden doors and architraves. Extensive cabling to walls, some in conduits. Flooring appears to be of early composite-type, with basic patterning.

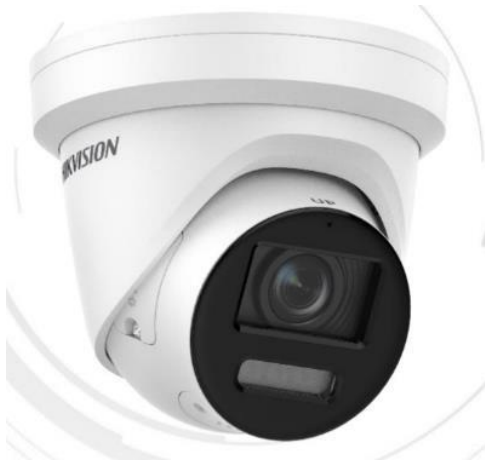
Sample image of a Hikivision 8MP ColorVu Strobe Light model as specified for all second floor cameras

- Camera: Hikivision 8MP ColorVu Strobe Light model or equal and approved
- Camera Location: Wall mounted at high level within the Main Library
- Camera Coverage: 88° area
- Coverage Purpose: Monitor & Observe

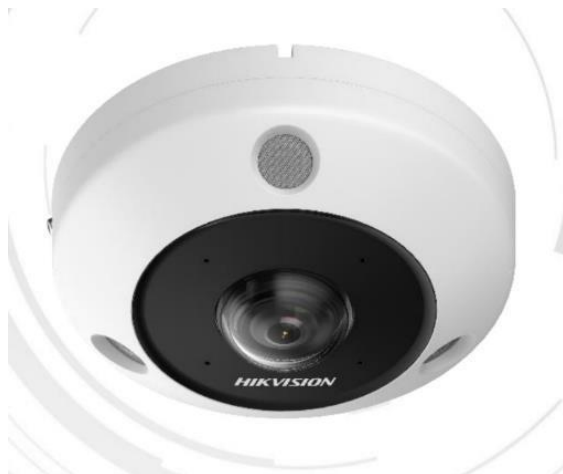
RLG-12 Main Library – Ground Floor

Sample image of a Hikivision 12MP DeepinView Fisheye Network Camera as specified for the Main Library ceiling centre.

- Camera: Hikivision 12MP DeepinView Fisheye Network Camera or equal and approved
- Camera Location: Ceiling mounted at high level within the Main Library. Note that due to numerous lighting hanging wires, FHP have suggested that the camera may need to be pendant mounted to ensure sufficient coverage. The appointed contractor will confirm on completion of their scoping survey.
- Camera Coverage: 180° area
- Coverage Purpose: Monitor & Observe

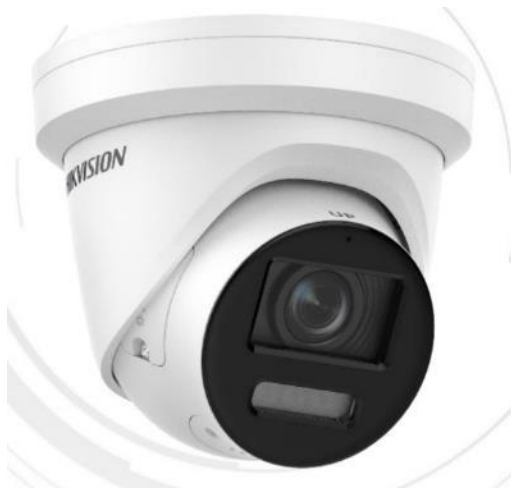
Sample image of a Hikivision 8MP ColorVu Strobe Light model as specified for all second floor cameras

- Camera: Hikivision 8MP ColorVu Strobe Light model or equal and approved
- Camera Location: Wall mounted at high level within the Music Library
- Camera Coverage: 88° area
- Coverage Purpose: Monitor & Observe

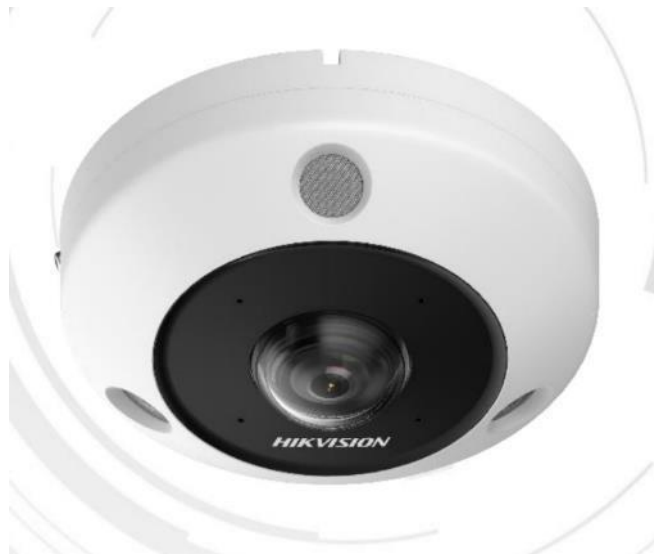
Sample image of a Hikivision 12MP DeepinView Fisheye Network Camera as specified for the Music Library ceiling centre.

- o Camera: Hikivision 12MP DeepinView Fisheye Network Camera or equal and approved
- o Camera Location: Ceiling mounted at high level within the Music Library. Note that due to numerous lighting hanging wires, FHP have suggested that the camera may need to be pendant mounted to ensure sufficient coverage. The appointed contractor will confirm on completion of their scoping survey.
- o Camera Coverage: 180° area
- o Coverage Purpose: Monitor & Observe

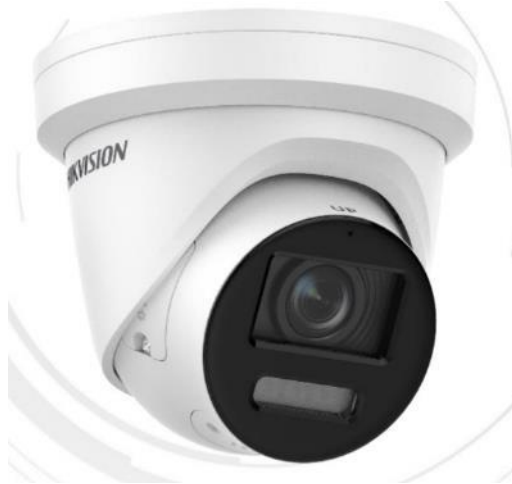
Sample image of a Hikivision 8MP ColorVu Strobe Light model as specified for all second floor cameras

- Camera: Hikivision 8MP ColorVu Strobe Light model or equal and approved
- Camera Location: Wall mounted at high level within the Book Storage
- Camera Coverage: 88° area
- Coverage Purpose: Monitor & Observe

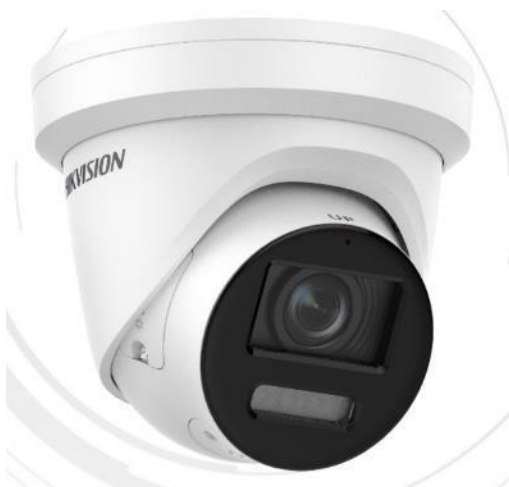
Sample image of a Hikivision 8MP ColorVu Strobe Light model as specified for the third floor camera

- Camera: Hikivision 8MP ColorVu Strobe Light model or equal and approved.
- Camera Location: Wall mounted at high level within the stairs
- Camera Coverage: 88° area
- Coverage Purpose: Monitor & Observe
- Cabling: To follow existing cabling routes as shown in Appendix B

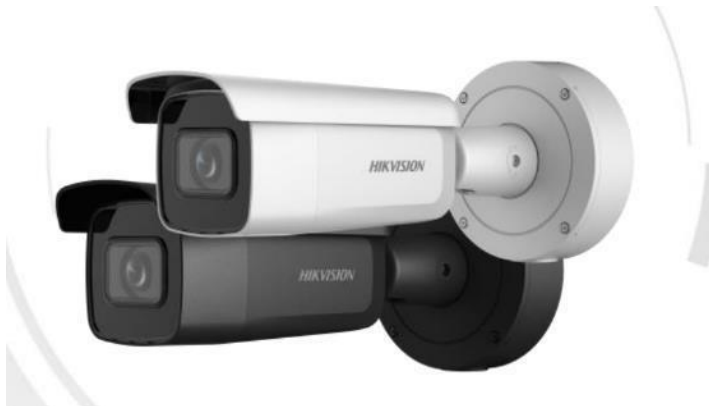
Sample image of a 4MP AcuSense Motorized Varifocal Bullet Network Camera model as specified for the single external camera to replace existing.

- Camera Model: 4MP AcuSense Motorized Varifocal Bullet Network Camera or equal and approved
- Camera Location: Wall mounted (location aligned with FHP Drawings)
- Camera Coverage: 108° area
- Coverage Purpose: Monitor & Observe
- IP Rated: IP67
- Camera Colour: White, to match existing camera and blend with glazed brickwork

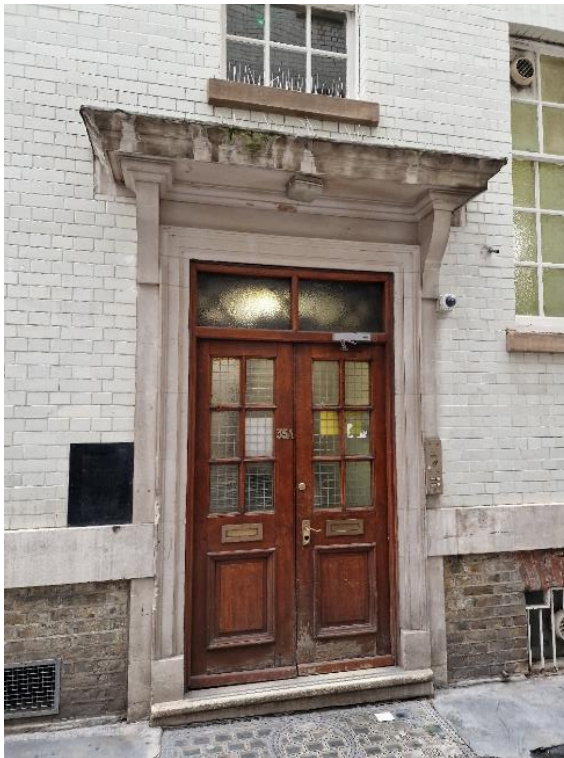
Long's Court entrance showing the existing camera in the upper-right of the image adjacent to the door moulding.

The proposed upgrade of the CCTV system includes the replacement of one external camera to the North façade fronting onto Long’s Court. All other camera works are internal. The single new camera externally will be located in the same position as the existing camera. Furthermore, it is only visible from a narrow field of view when looking down Long’s Court.

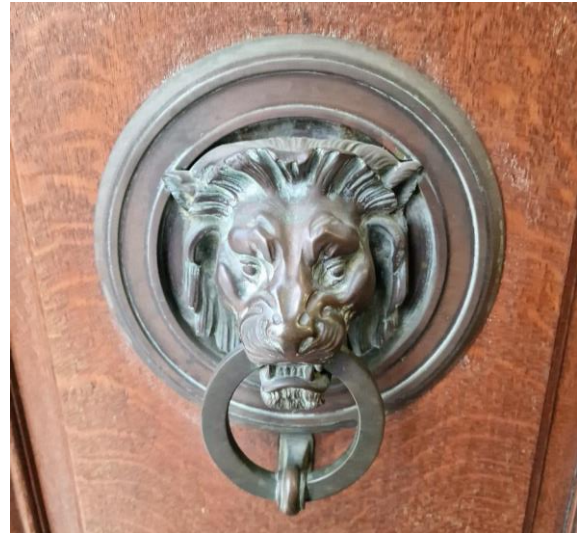
In and of itself, Westminster Reference Library has embodied architectural interest due to its pleasing Edwardian Baroque façade externally, featuring decorative stonework details such as pediments above each main window, rusticated lower portions to the ground floor stonework, and a pleasingly ordered arrangement of window openings and dormers. The double-height ground and first floors feature exceptionally large windows, enhancing the exterior whilst allowing light into the library rooms. Small details, such as the bronze lion's head door knockers to the main double doors, add character to the building.

The rear of the library, being a mixture of glazed white brick and yellow stock brick, is less aesthetically inspiring, although it still features some attractive detailing, including the carved stone architrave around the North exit onto Long's Court.
