Central Reference Library - CCTV Works

LISTED BUILDING CONSENT

Prepared For Westminster City Council

50 Issues Identified

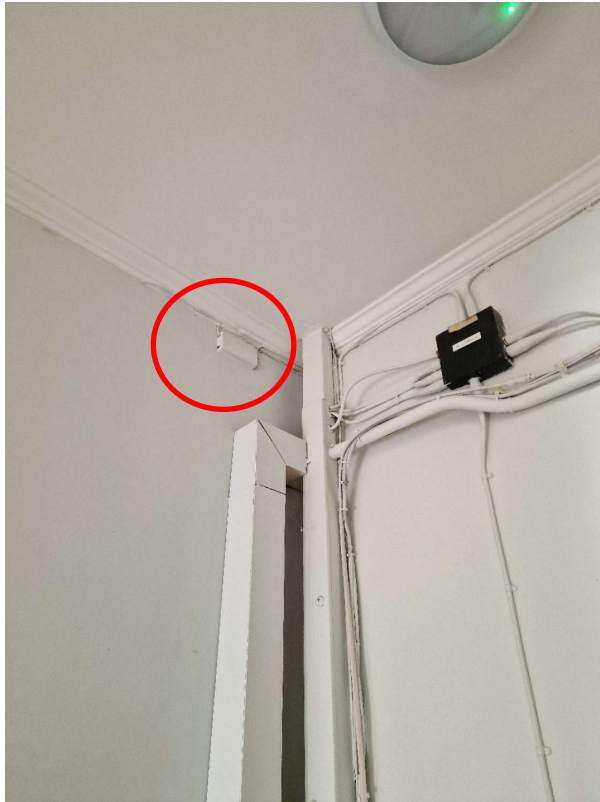
Figure Room Ref. RL03-08 - Stairs

**3F - Proposed - New CCTV
Camera To Stairwell**

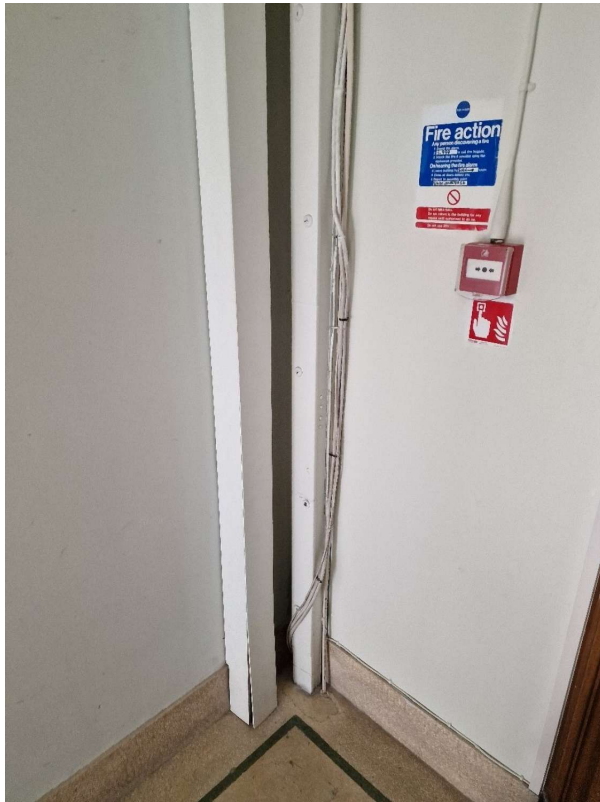
Figure Room Ref. RL03-08 Stairs

**3F - Existing Cable Runs &
Trunking To New CCTV Camera
Location**

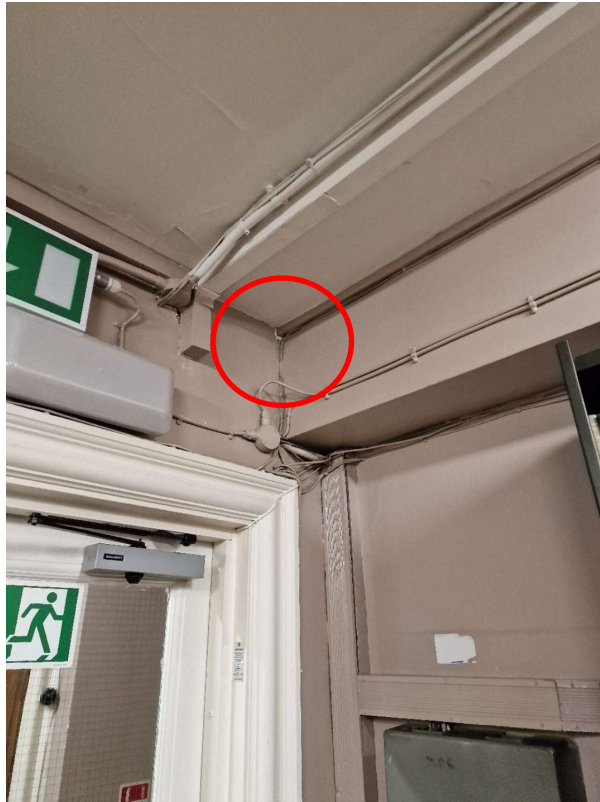
Figure Room Ref. RL02-02 - Book Storage

2F - Proposed - New CCTV Camera To Book Storage NE Corner

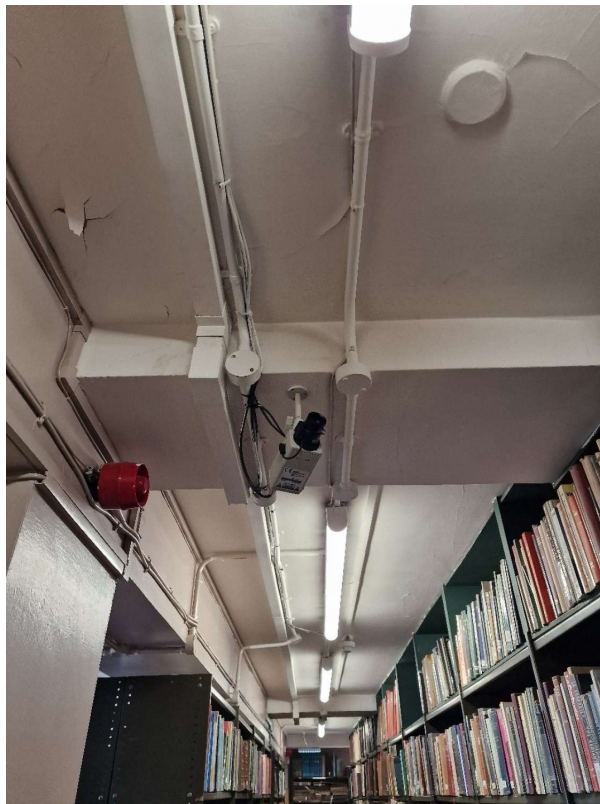
Figure Room Ref. RL02-02 - Book Storage

2F - Existing - Old CCTV Camera To Book Store Ceiling - To be Removed (Not on Plans)

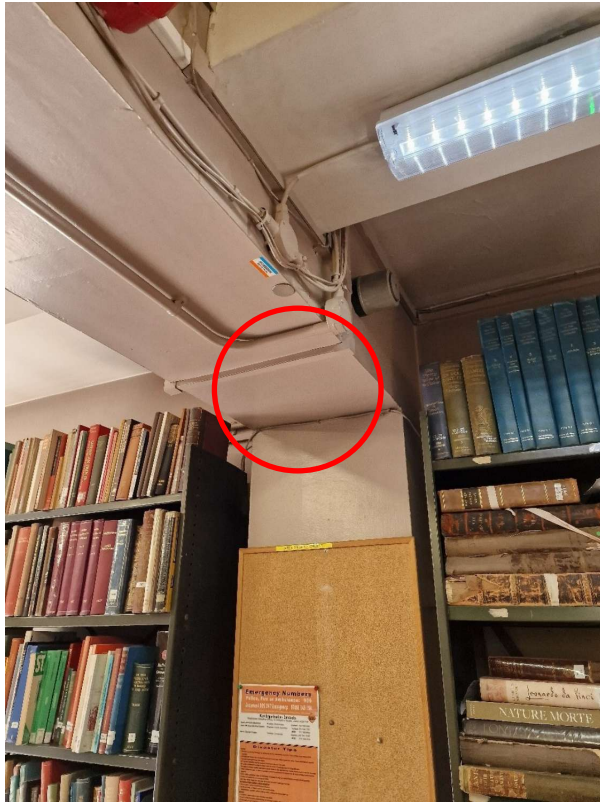
Figure Room Ref. RL02-02 - Book
Storage

**2F - Proposed - New CCTV
Camera To Book Storage South
Wall**

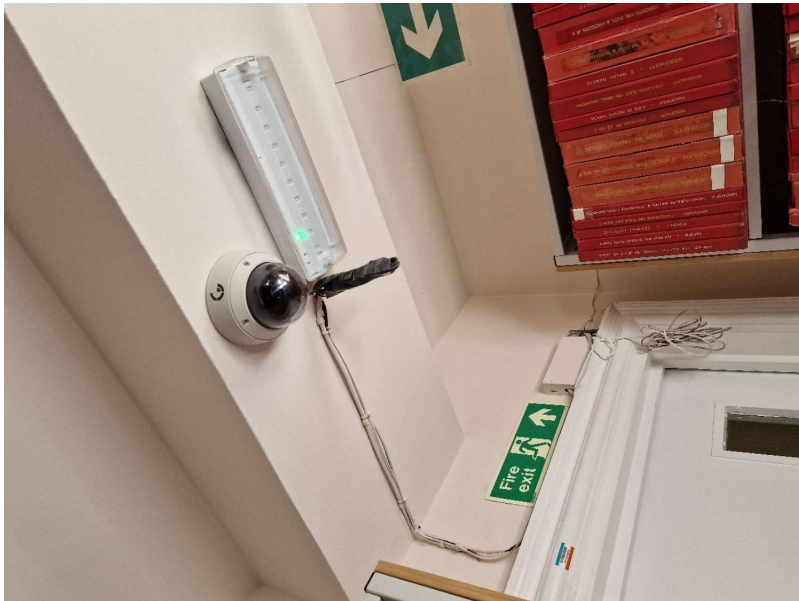
Figure Room Ref. RL02-14 - Library
Work Area

**2F - Existing - Old CCTV Camera
To Library Work Area SE Corner -
To be Removed (Not on Plans)**

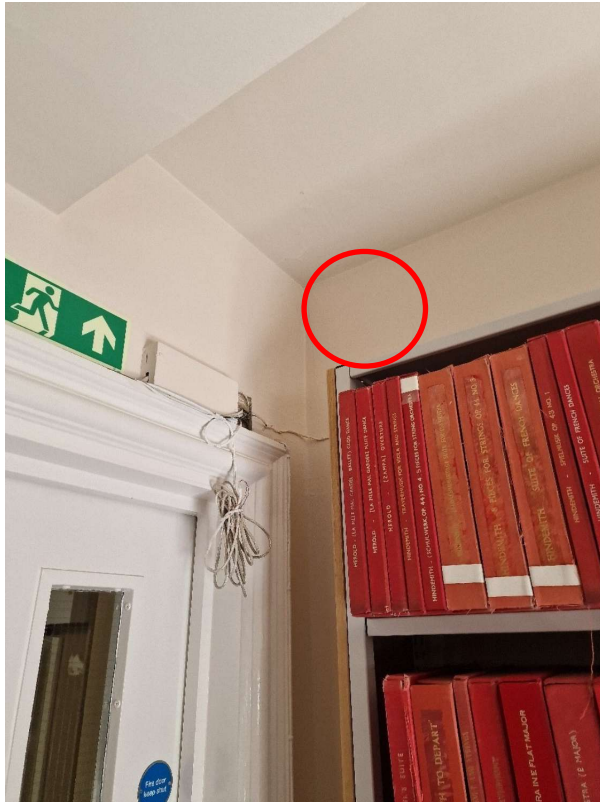
Figure Room Ref. RL02-14 - Library Work Area

2F - Proposed - New CCTV Camera To Library Work Area SE Corner

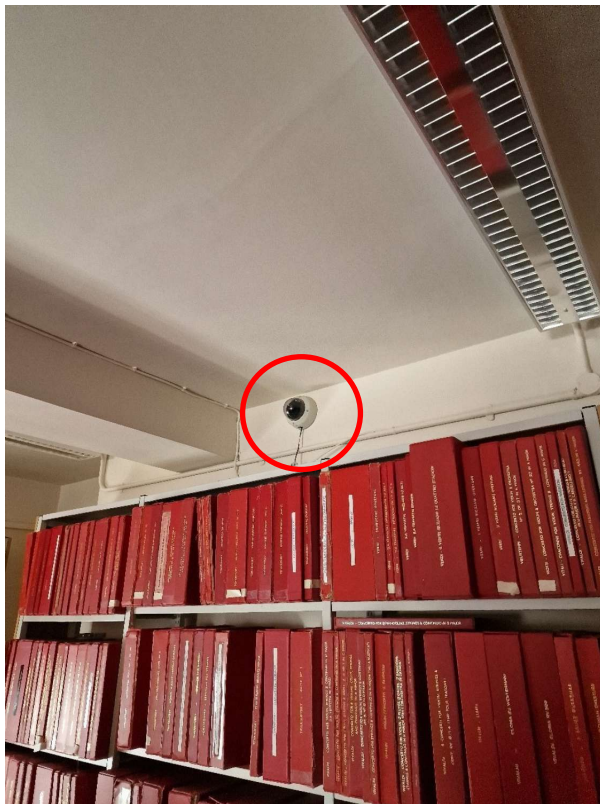
Figure Room Ref. RL02-14 - Library Work Area

2F - Proposed - Upgrade To Existing CCTV Camera To Library Work Area North Wall

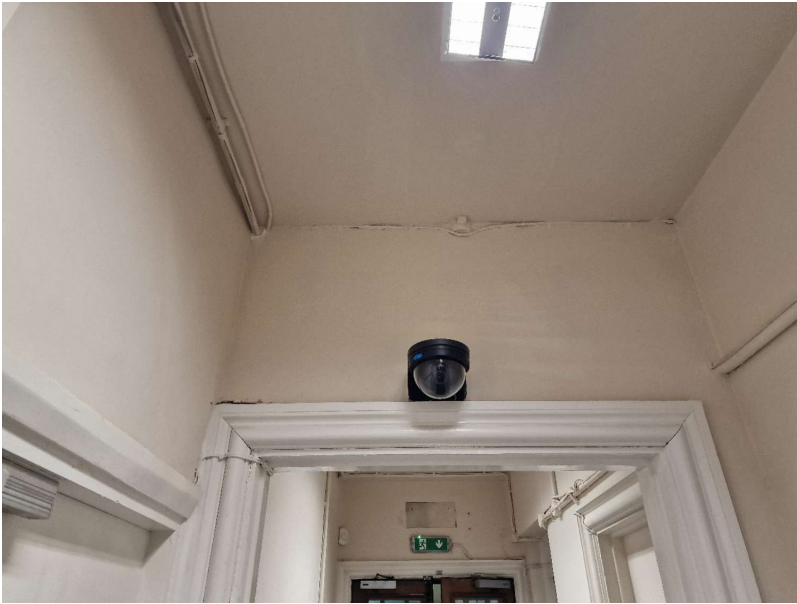
Figure Room Ref. 12-14 - Library Work Area

2F - Existing - CCTV To Library Work Area North Exit - To be Removed (Not on Plans)

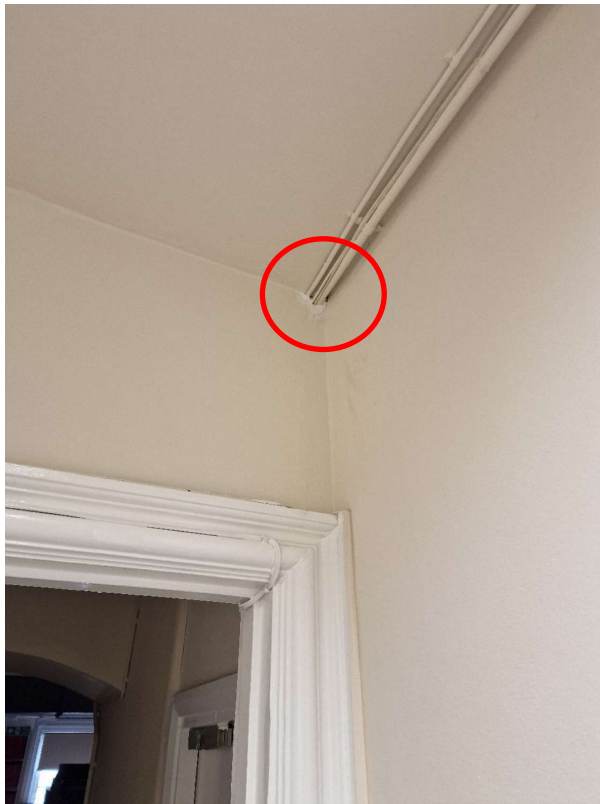
Figure Room Ref. RL02 -12 - Circulation

2F - Proposed - New CCTV Camera For Circulation Exit

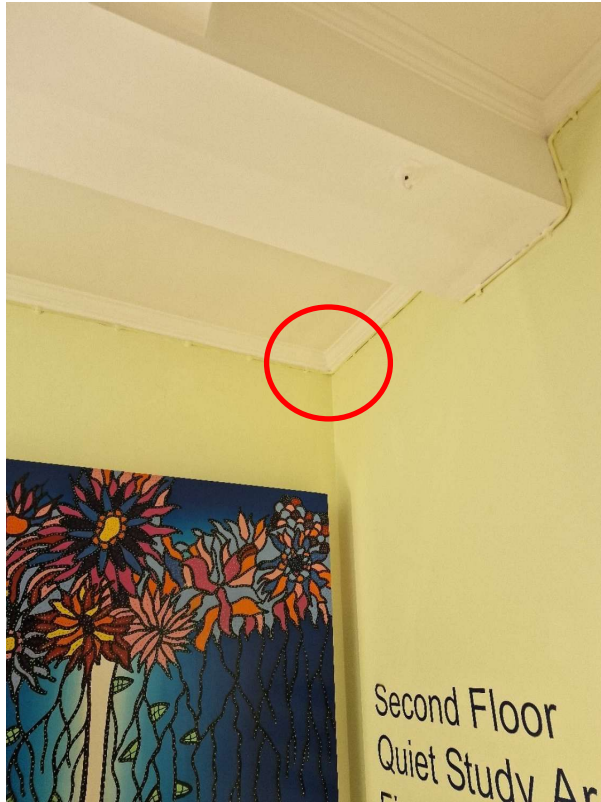
Figure Room Ref. RL02- 11 - Stairs

2F - Proposed - New CCTV Camera For Main Stairwell NE Corner

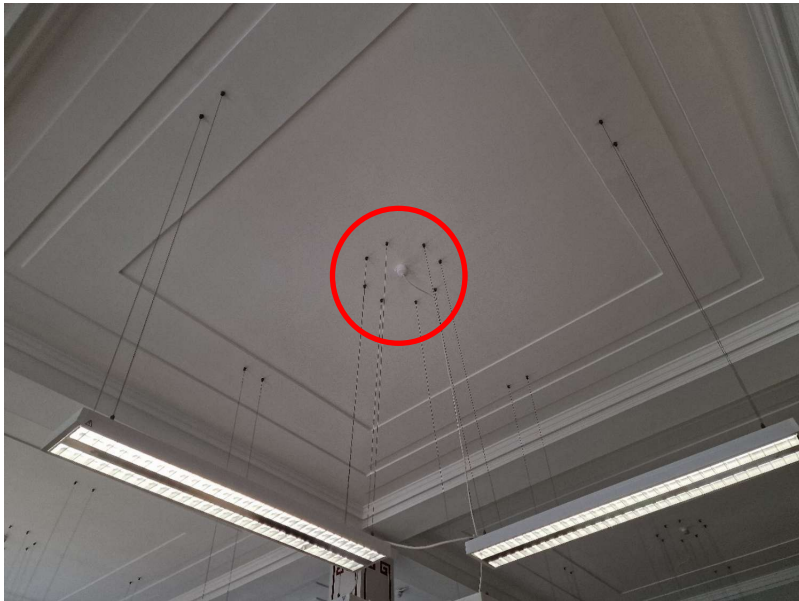
Figure Room Ref. 01-07 - Music Library

1F - Proposed - New Fisheye CCTV Camera To Ceiling Centre

N.B. May Require c. 0.5m Cable Drop to Ensure 360-degree Room Coverage

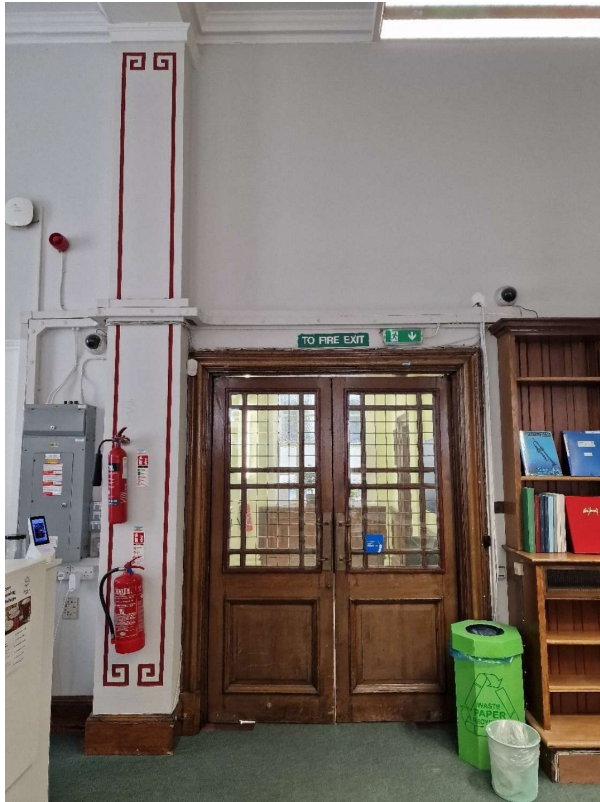
Figure Room Ref. RL01-07 - Music
Library

**1F - Existing - 2 No. CCTV
Cameras Around Entrance Doors
- To be Removed (Not on Plans)**

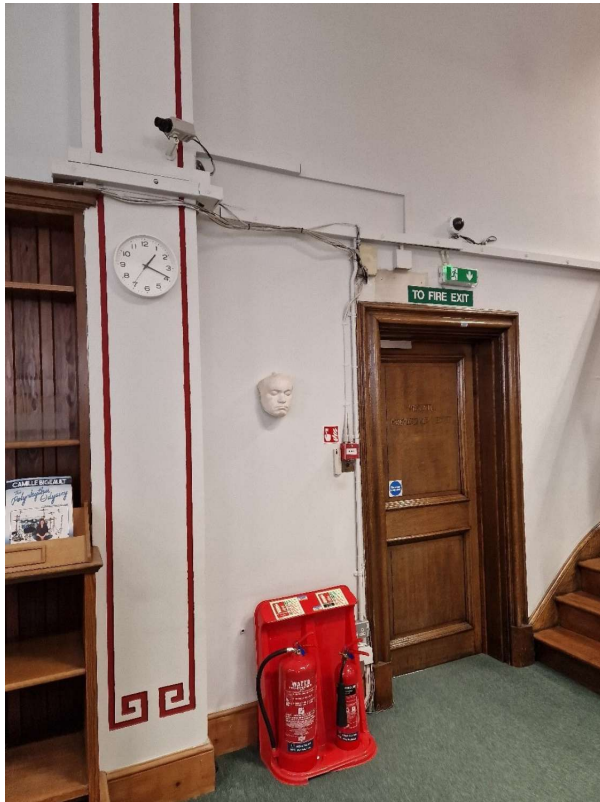
Figure Room Ref. RL01-07 Music
Library

**1F - Existing - 2no. Old CCTV
Cameras On North Wall - To be
Removed (Not on Plans)**

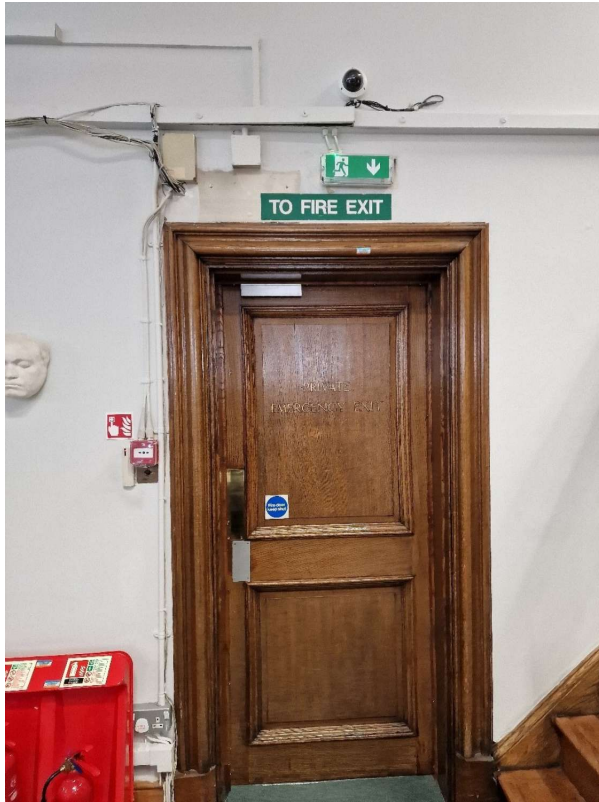
Figure Room Ref. RL01-07 - Music
Library

**1F - Existing - Camera Over Door
To RL01-03 Storage - To be
Removed (Not on Plans)**

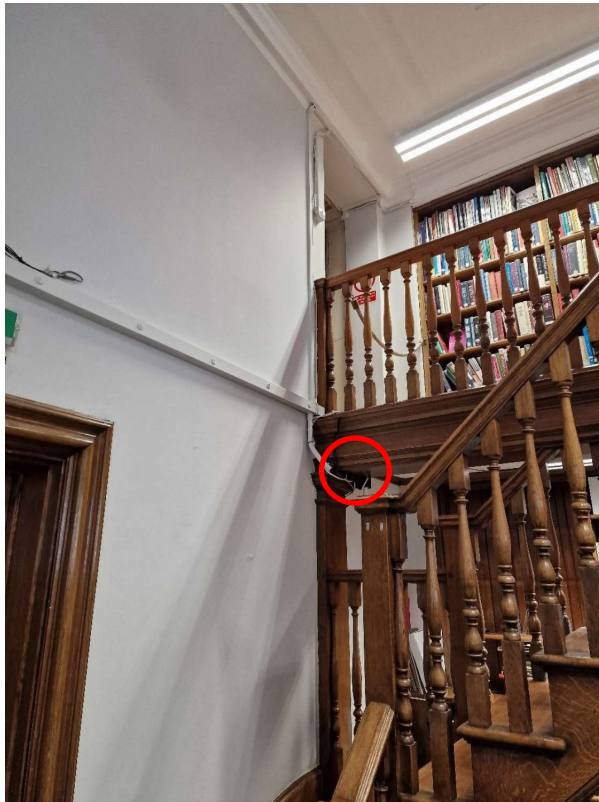
Figure Room Ref. 01-07 - Music
Library

**1F - Proposed - Corner Location
For 1 No. Additional CCTV
Camera**

N.B. Corner Location Based on
Existing Cable Routes

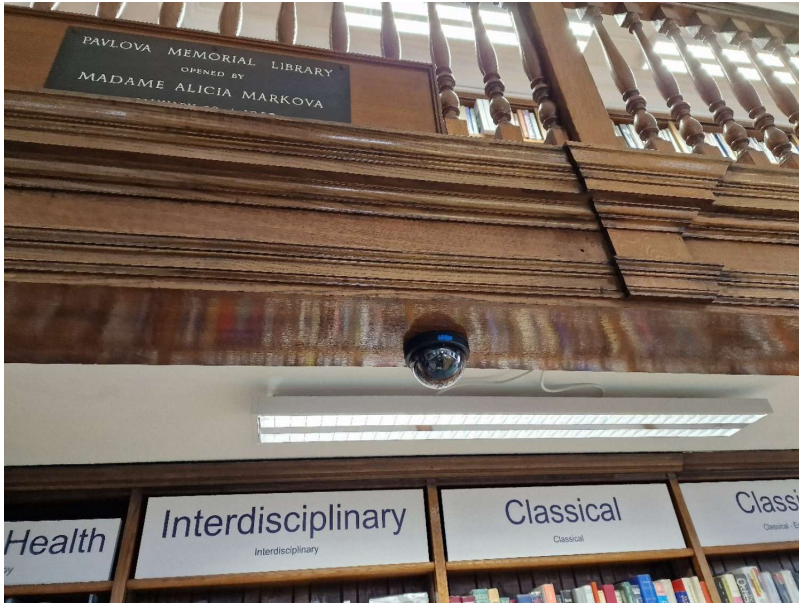
Figure Room Ref. RL01-07 - Music Room

1F - Existing - CCTV Camera On Balcony Edge - To be Removed (Not on Plans)

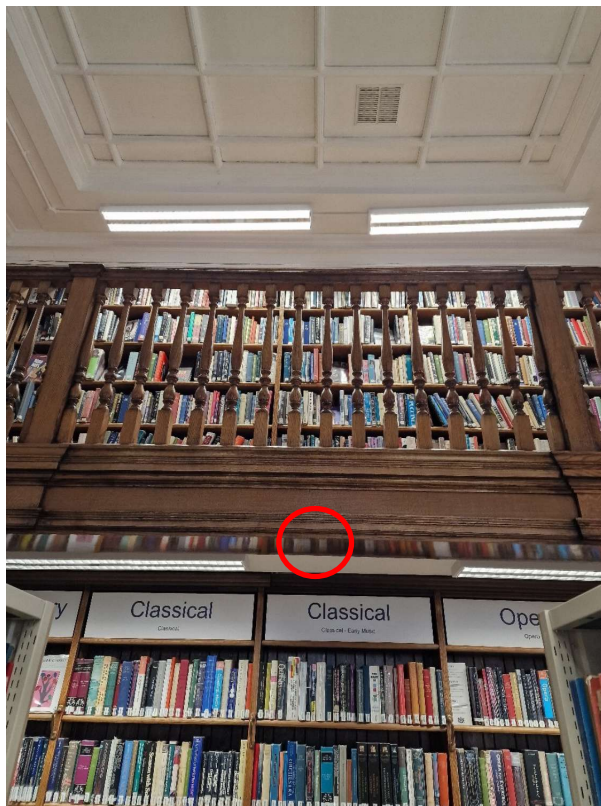
Figure Room Ref. RL01-07 - Music Room

1F - Proposed - New Location For 1no. CCTV Camera

New centralised location for camera to ensure coverage

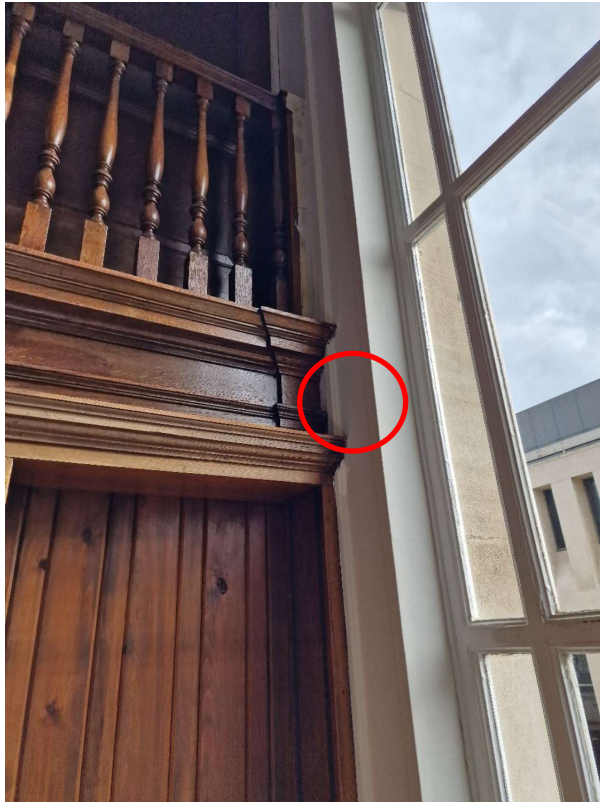
Figure Room Ref. RL01-07 - Music Library

1F - Proposed - 1 No. New CCTV Camera To SE Corner

Note - Alternative location for corner camera if ceiling corner not considered feasible by contractor. Along existing cable trunking route.

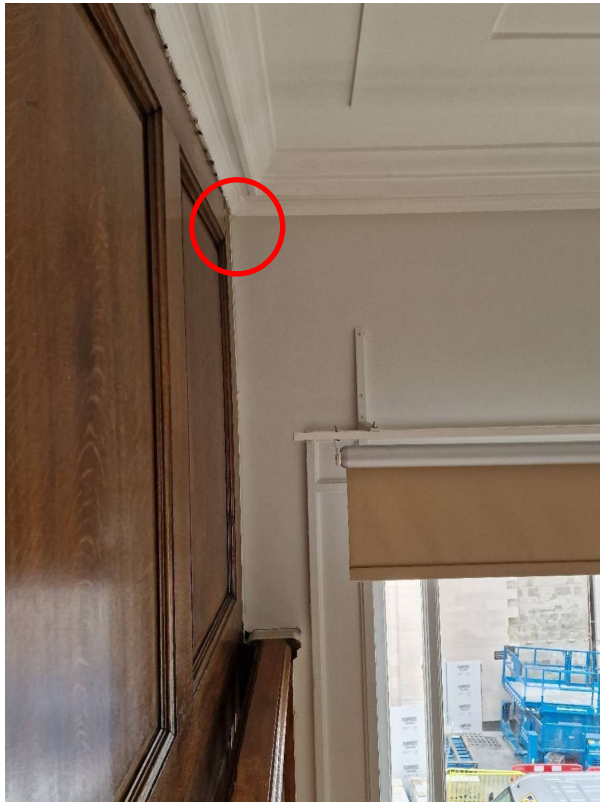
Figure Room Ref. RL01-07 - Music Library

1F - Proposed - New CCTV Camera Location Full Height SE Corner

Full height camera proposed to ensure room coverage.

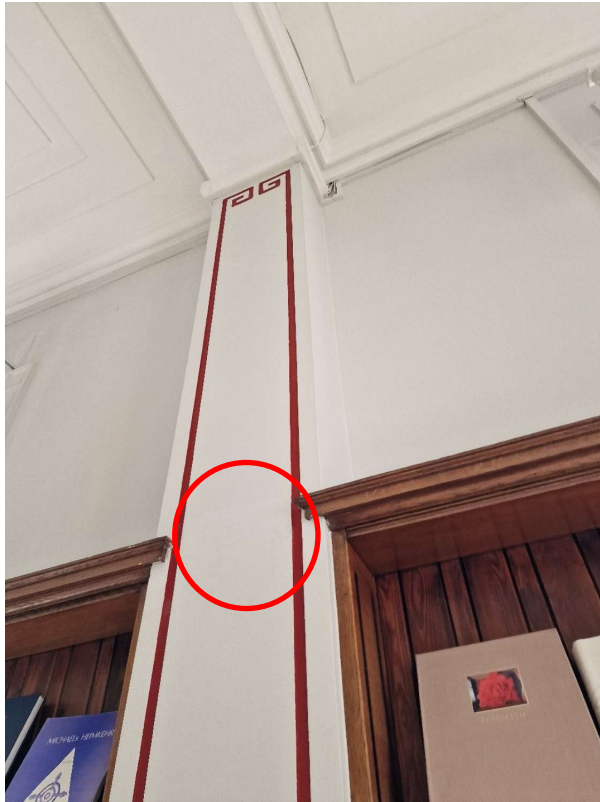
Figure Room Ref. RL01-07 - Music Library

1F - Proposed - New CCTV To South Central Pilaster

Camera height confirmed by FHP as shelf-top-level. Note painted cable trunking in-situ nearby.

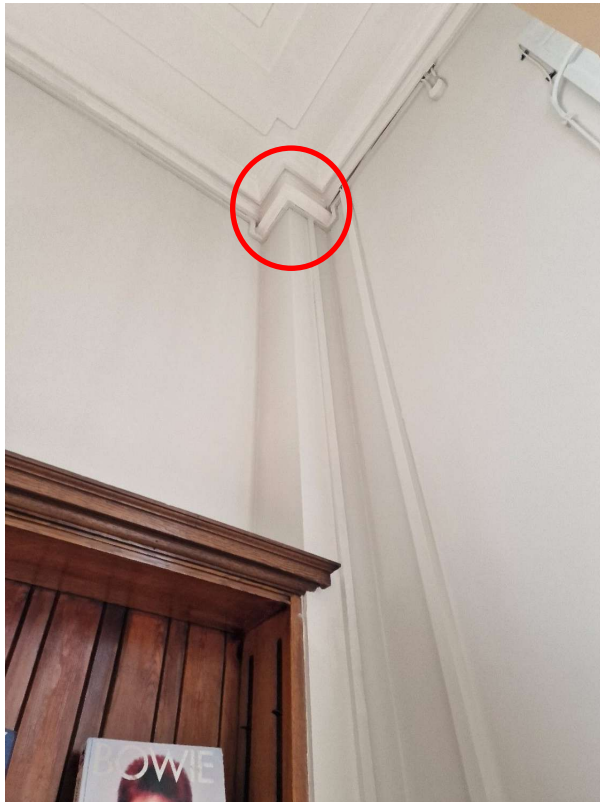
Figure Room Ref. RL01-07 - Music Library

1F - Proposed - New CCTV Camera To SW Corner Pilaster

Camera height confirmed as full height by FHP. Note existing cable trunking nearby.

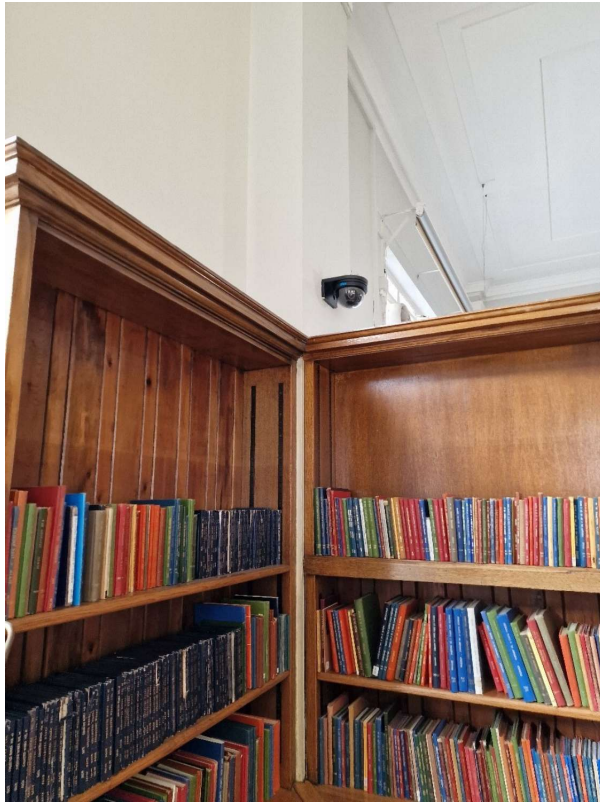
Figure Room Ref. RL01-07 - Music
Library

**1F - Existing - Old CCTV Camera
To West Elevation Pilaster - To
be Removed**

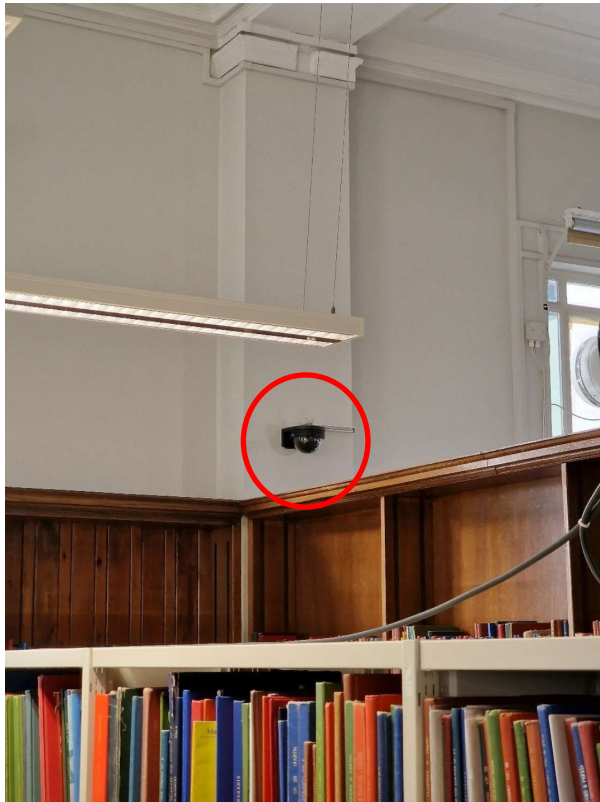
Figure Room Ref. RL01-07 - Music
Library

**1F - Proposed - New CCTV
Camera To Middle Of West
Pilaster**

Camera Location on pilaster to
replicate that of existing camera.

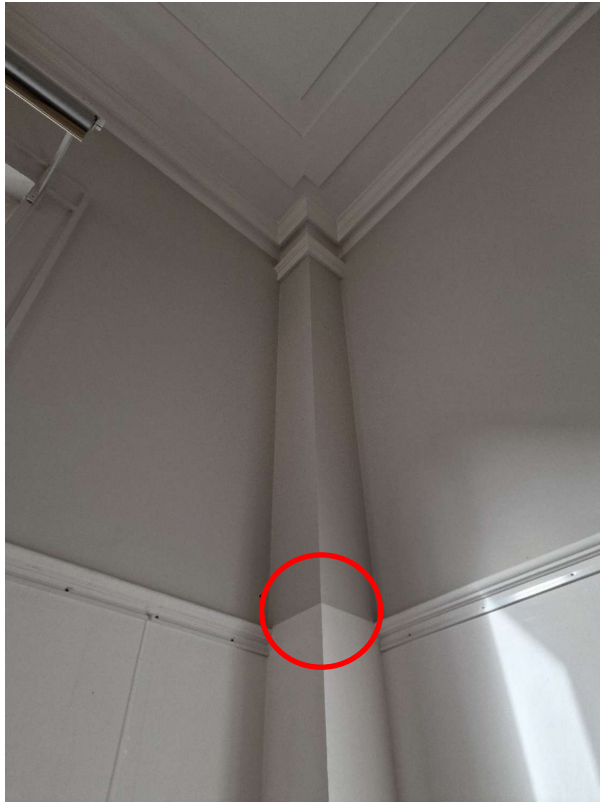
Figure Room Ref. RL01-07 - Music
Library

**1F - Proposed - New CCTV
Camera To NW Corner Pilaster**

Camera height confirmed by FHP
as mid-height to monitor library
desk users. Existing wiring runs
along mid-rail in close proximity.

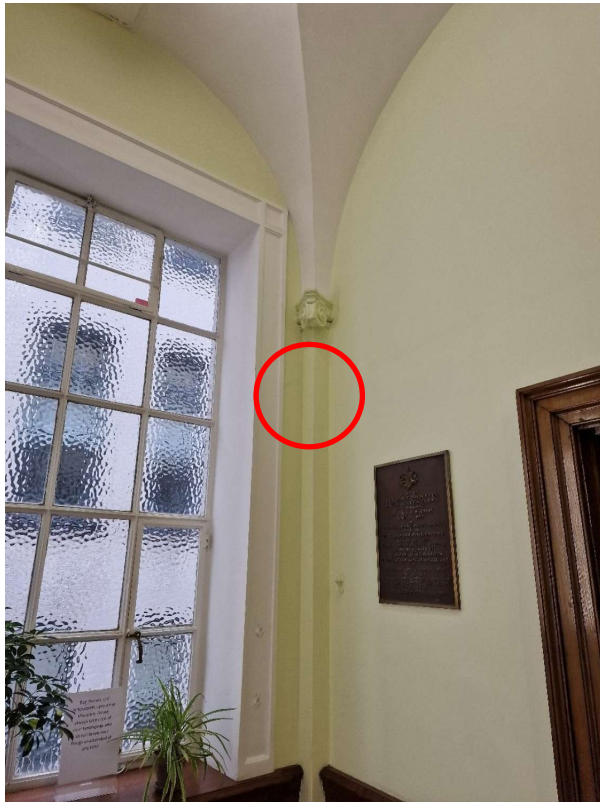
Figure Room Ref. RL01-06 - Stairs

**1F - Proposed - New CCTV
Camera To Main Stairwell NE
Corner**

Camera height & location per red
circle on photo.

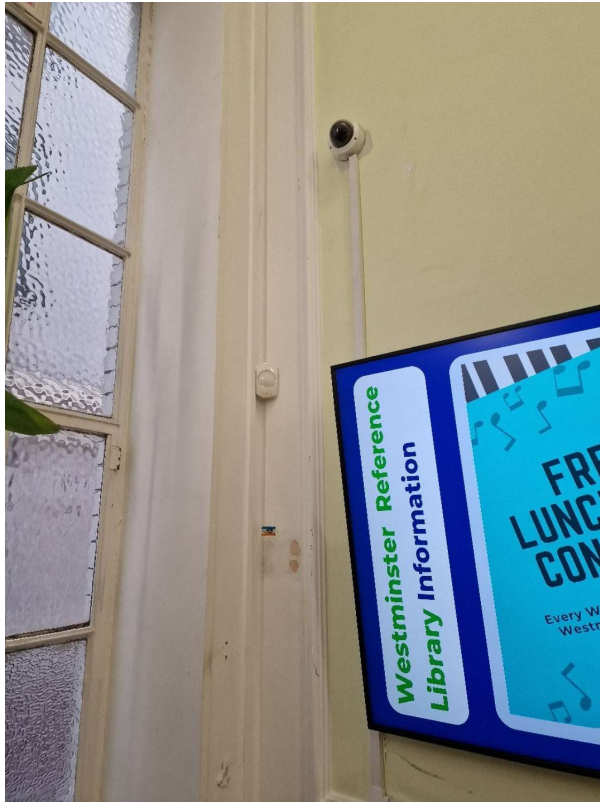
Figure Room Ref. RLG-07 - Stairs

GF - Existing - Old Camera To NE Lobby Corner - To be Removed (Not on Plans)

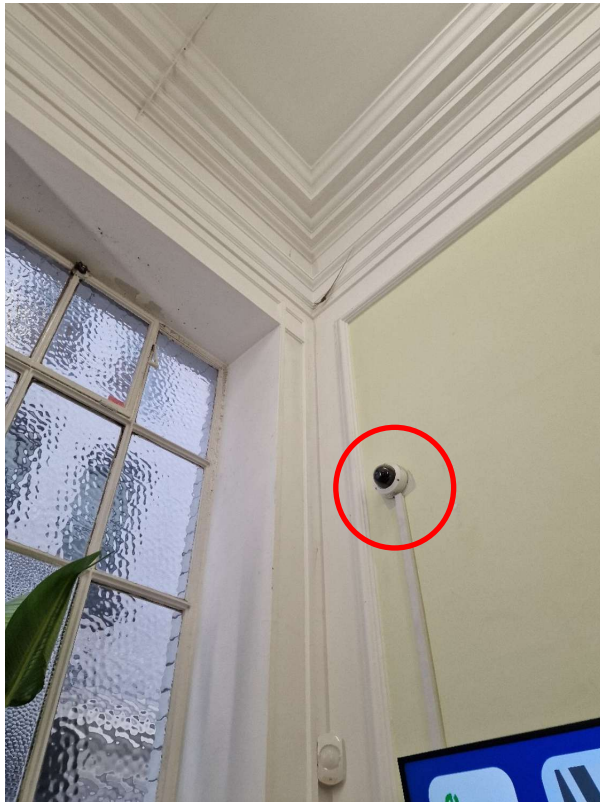
Figure Room Ref. RLG-07 - Stairs

GF - Proposed - New Camera To Lobby NE Corner

Camera location to match existing.

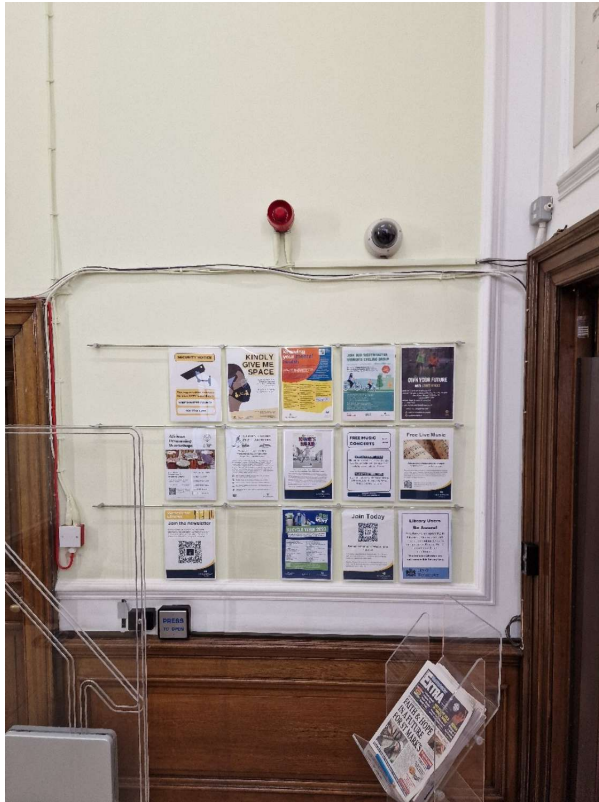
Figure Room Ref. RLG-07 - Stairs

GF - Existing - Old CCTV Camera Location In Lobby SE Corner - To be Removed (Not on Plans)

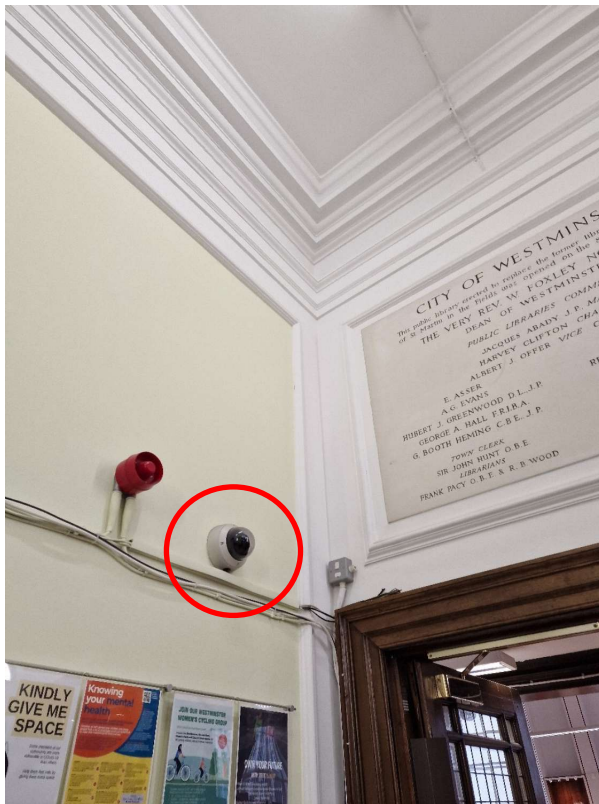
Figure Room Ref. RLG-07 - Stairs

GF - Proposed - New CCTV Camera To Lobby SE Corner

Camera location to match that of existing camera. To eliminate blind spots in conjunction with other new lobby camera.

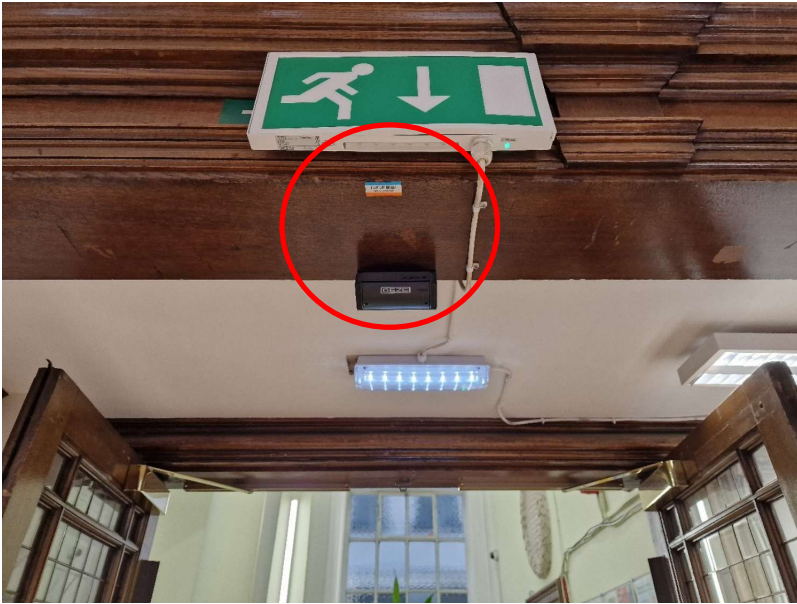
Figure Room Ref. RLG-12 Main
Library

**GF - Proposed - New CCTV
Camera Location Looking Into
Main Library**

Camera location confirmed by
FHP as affixed to base of
balcony.

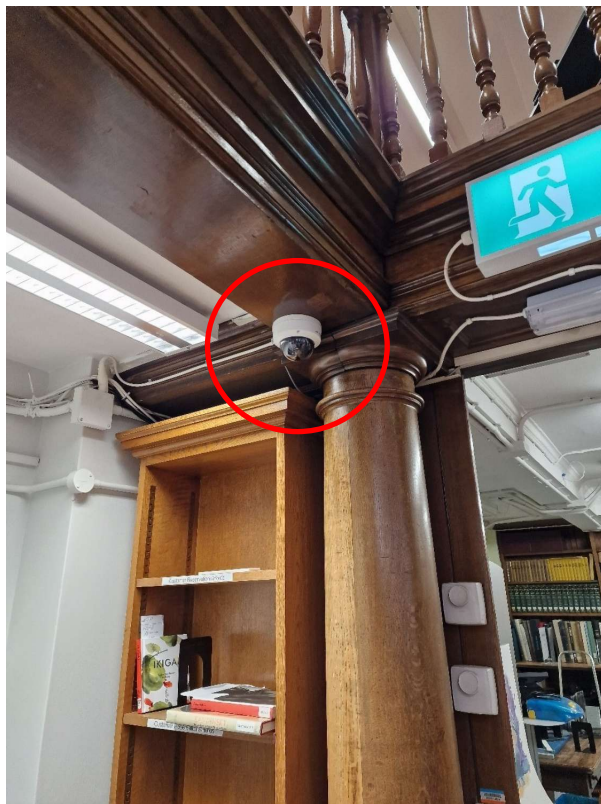
Figure Room Ref. RLG-12 - Main
Library

**GF - Proposed - New CCTV
Camera To Monitor Desk**

Camera position to match that of
existing camera.

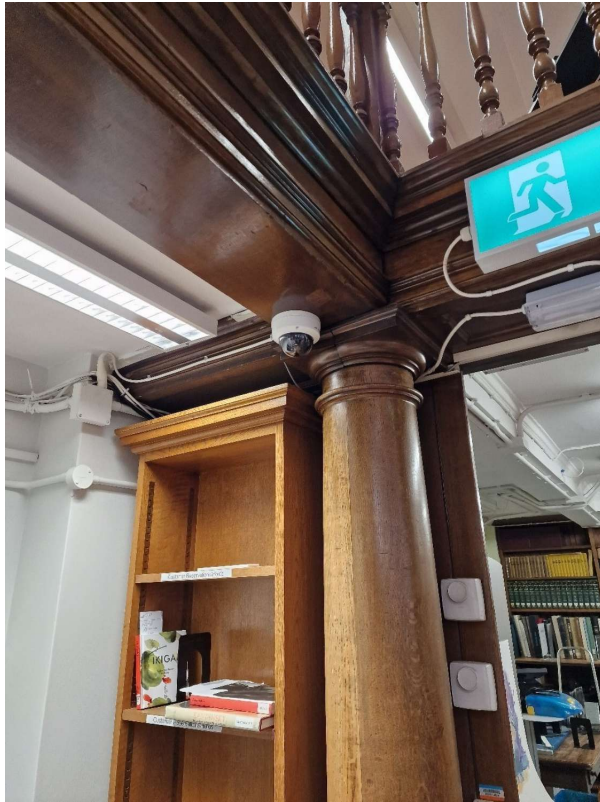
Figure Room Ref. RLG-12 - Main Library

GF - Existing - Old CCTV Camera Over Desk - To be Removed (Not on Plans)

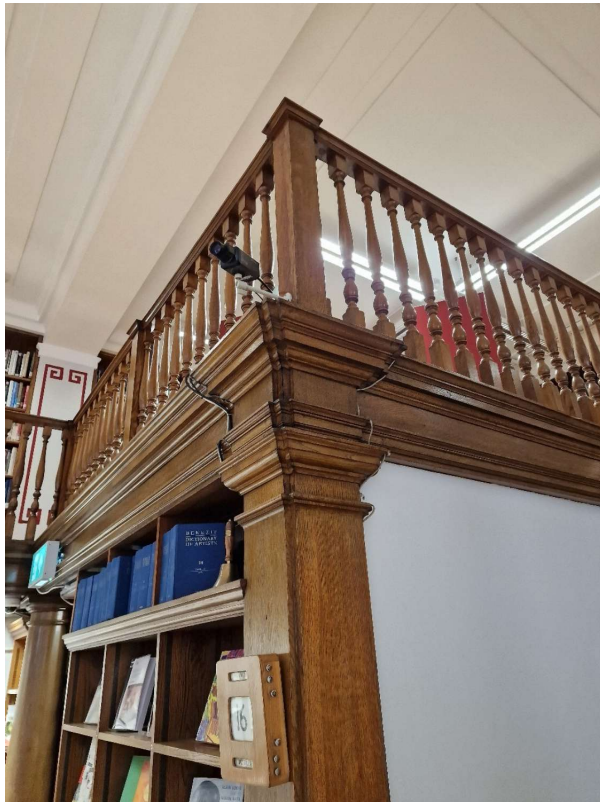
Figure Room Ref. RLG-12 - Main Library

GF - Existing - Old CCTV Camera On NE Balcony Corner - To be Removed (Not on Plans)

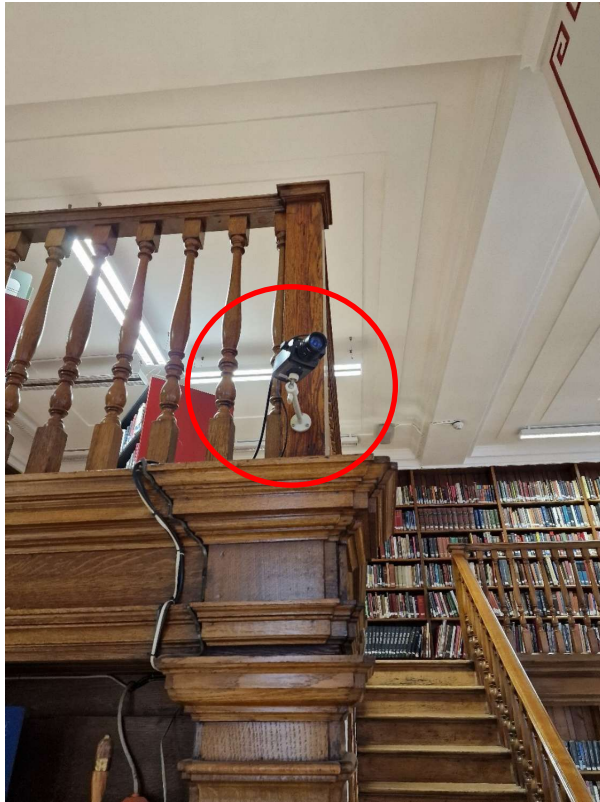
Figure Room Ref. RLG-12 - Main Library

GF - Proposed - New CCTV Camera To NE Balcony Corner

New camera to be installed in same location as existing, subject to fixing bracket detail confirmation.

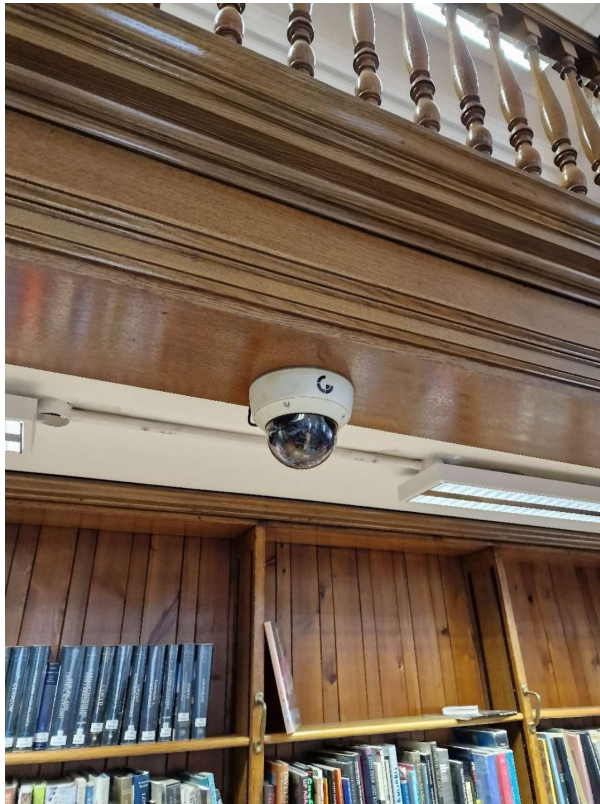
Figure Room Ref. RLG-12 - Main Library

GF - Existing - Old CCTV Camera To East Balcony Underside - To be Removed (Not on Plans)

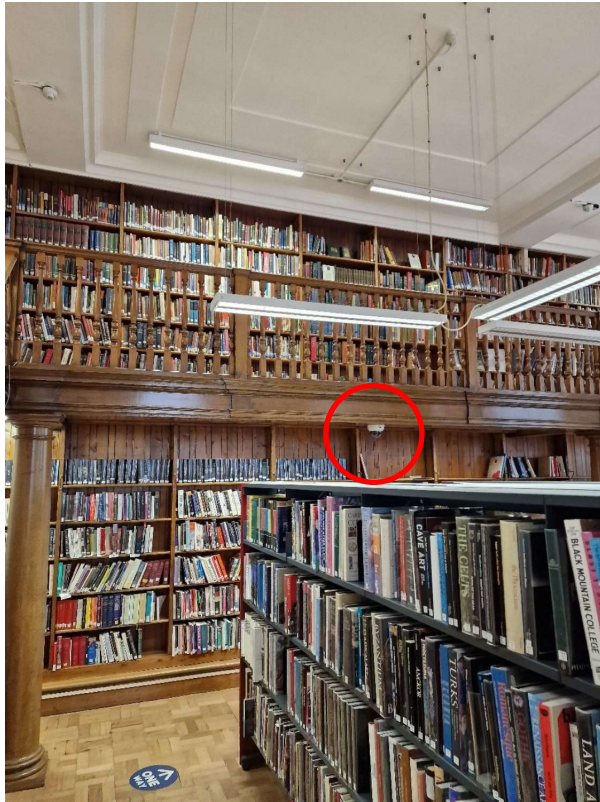
Figure Room Ref. RLG-12 - Main Library

GF - Proposed - New CCTV Camera To East Balcony Underside

Note - location to match existing CCTV camera.

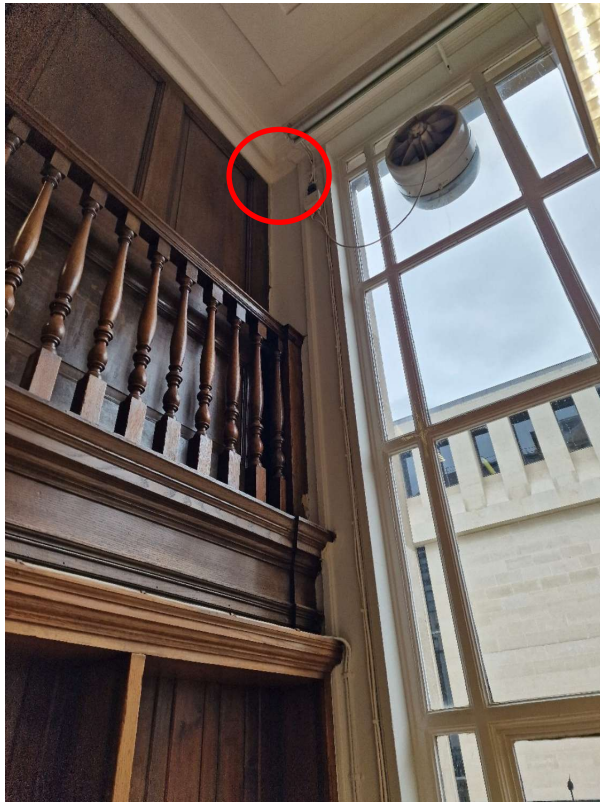
Figure Room Ref. RLG-12 - Main Library

GF - Proposed - New CCTV Camera To SE Room Corner

Note nearby existing cable trunking to fan which could run CAT6 data cables to feed camera.

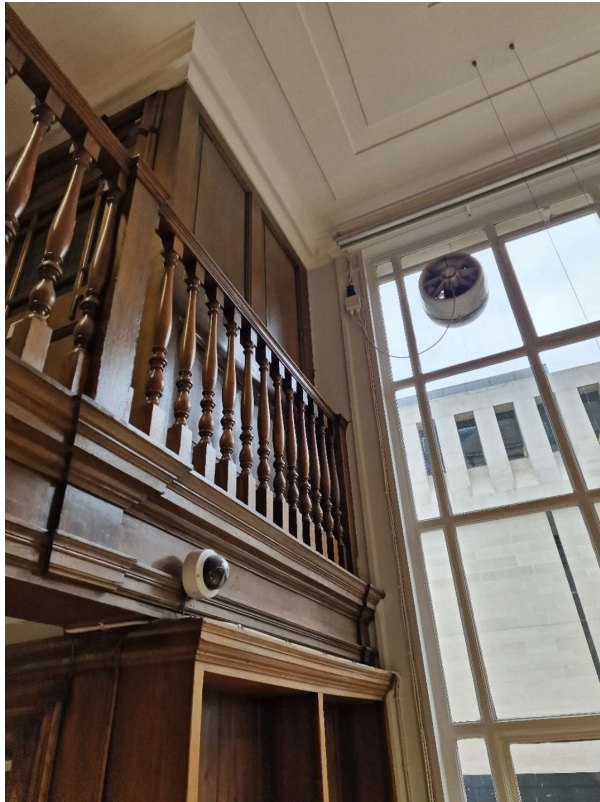
Figure Room Ref. RLG-12 - Main Library

GF - Existing - Old CCTV Camera To SE Balcony Side - To be Removed (Not on Plans)

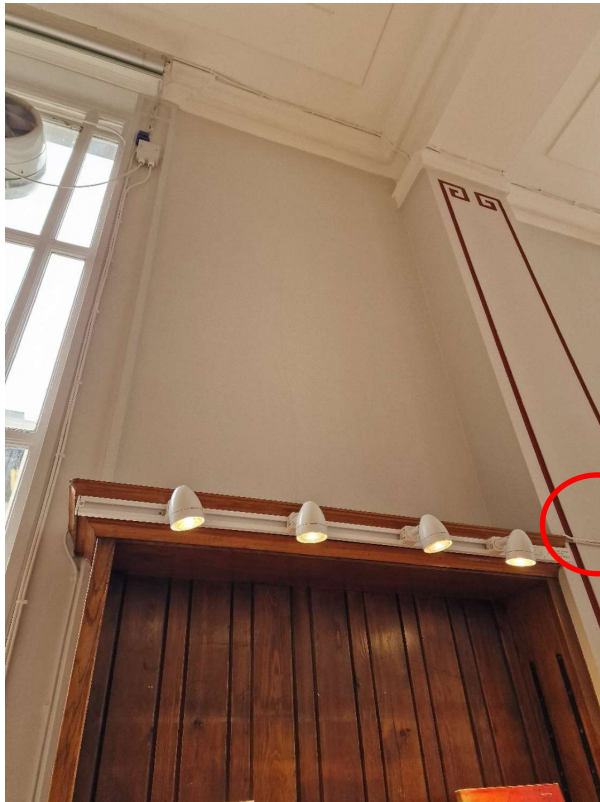
Figure Room Ref. RLG-12 - Main Library

GF - Proposed - New CCTV Camera To South Wall

Note - new camera to sit on central pilaster at top-of-shelf height. Existing lighting cable runs nearby.

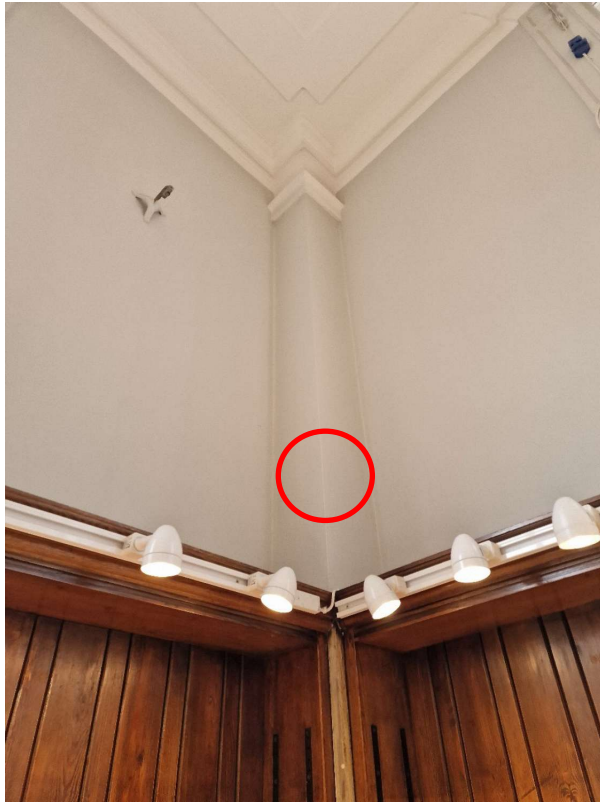
Figure Room Ref. RLG-12 - Main
Library

**GF - Proposed - New CCTV
Camera To SW Room Corner**

Note - existing shelf lighting
cable runs in close proximity.

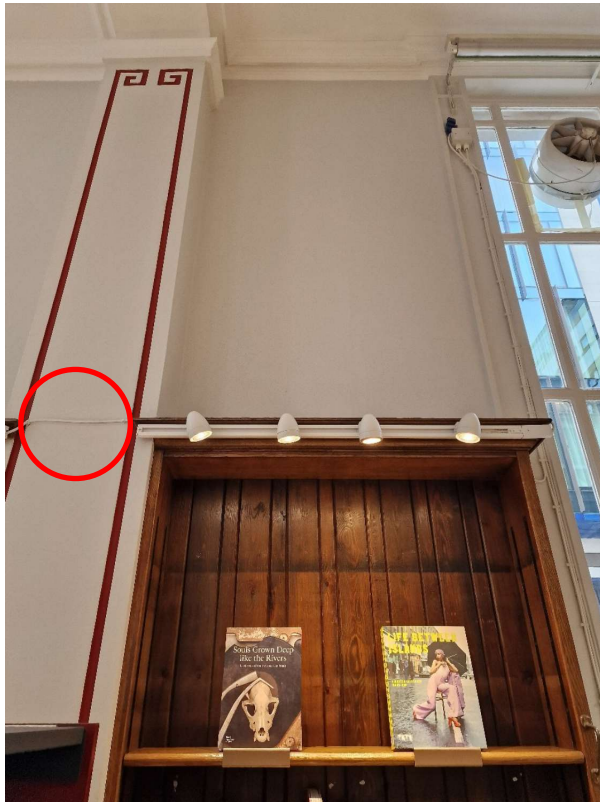
Figure Room Ref. RLG-12 - Main
Library

**GF - Proposed - New CCTV
Camera To NW Main Library Wall**

Note - existing lighting cable runs
in close proximity.

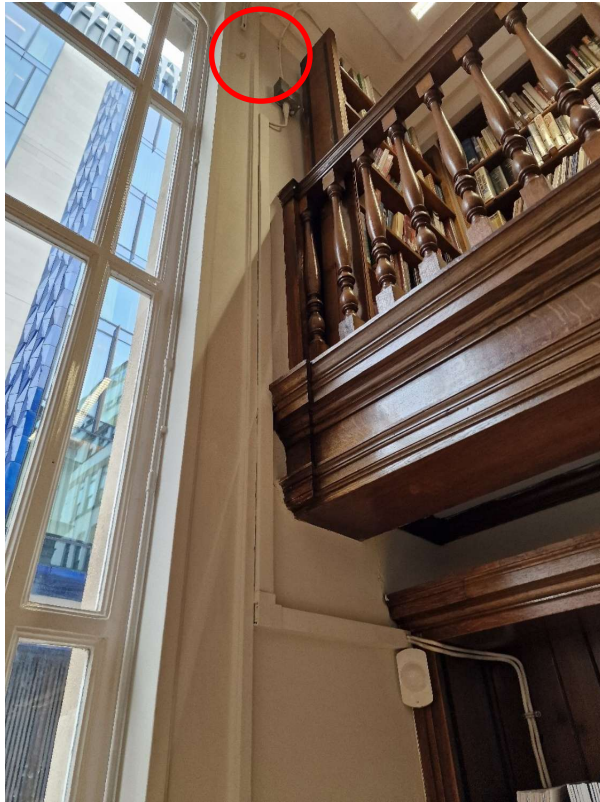
Figure Room Ref. RLG-12 - Main
Library

**GF - Proposed - New CCTV
Camera To NW Balcony Corner**

Camera location proposed as full
-height corner on route of
existing cable trunking - to
ensure room coverage.

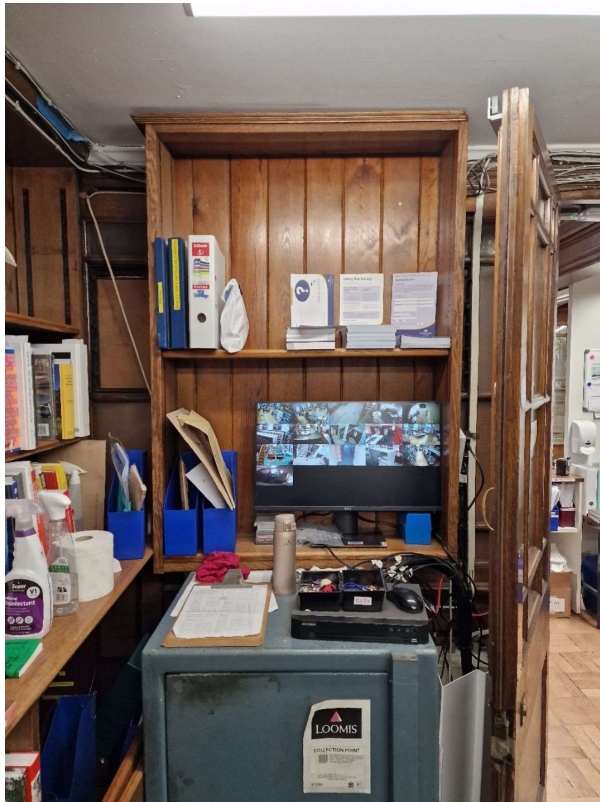
Figure Room Ref. RLG-12 - Main
Library

**GF - Existing Network Video
Recorder - To be Replaced**
