Central Reference Library - CCTV Works

LISTED BUILDING CONSENT

Prepared For Westminster City Council

50 Issues Identified

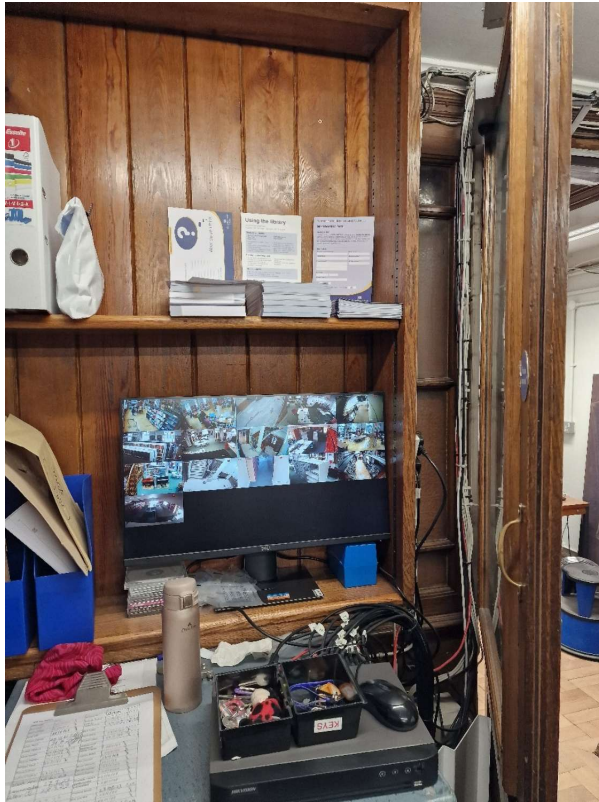
Figure Room Ref. RLG-12 - Main Library

GF - Proposed - New Network Video Recorder In Same Location

Lockable security enclosure to be added to prevent theft - c. 0.5m³ metallic mesh.

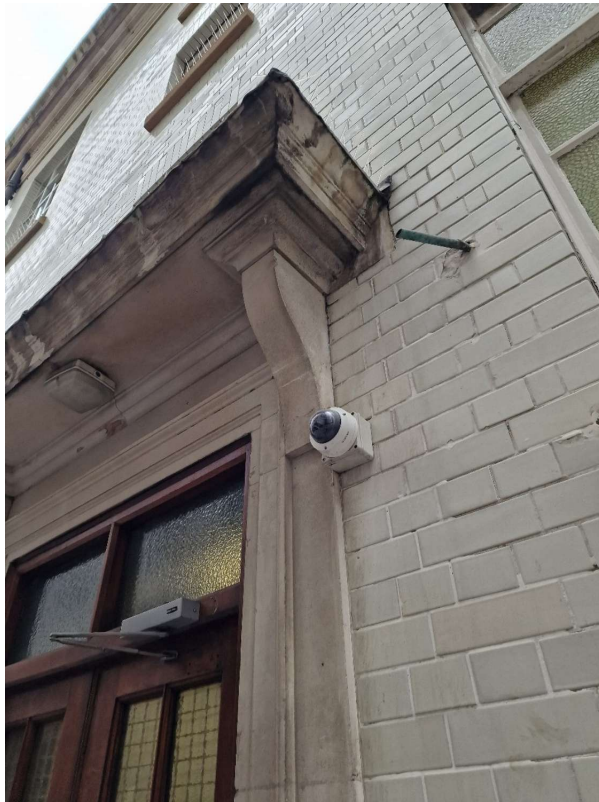
Figure Ref. North Side Entrance

External (GF) - Existing CCTV Camera To Side Entrance - To be Removed (Not on Plans)

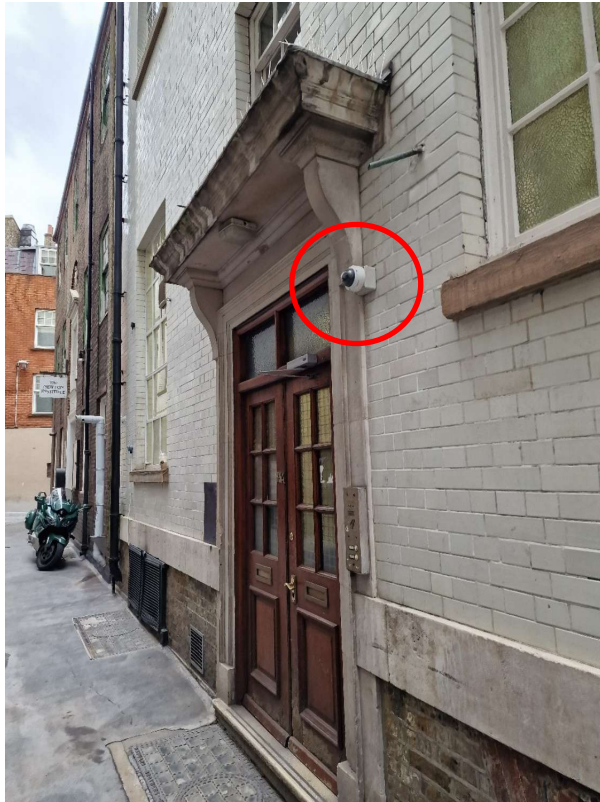
Figure External Side Entrance (North)

External (GF) - Proposed New CCTV Camera In Same Location as Existing

Camera to be fitted with flash capabilities linked to PIR sensor to avoid need for separate security light.

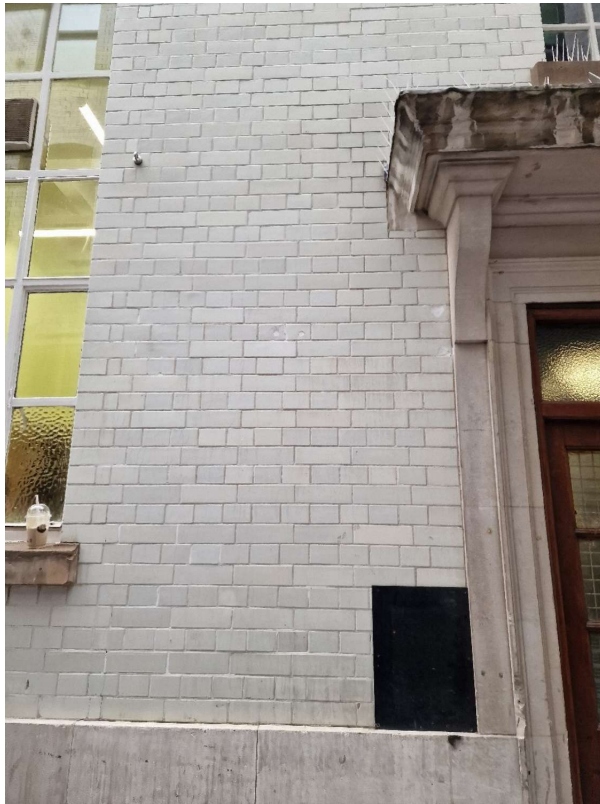
Figure External Side Entrance To North

External (GF) - Existing Glazed Wall Tiles Adj. Side Entrance

Note - no changes proposed here.
