2023 Bat Survey Report for North Rye House, Donnington, Moreton-in-Marsh, GL56 0XU

Cotswold Wildlife Surveys

December 2023

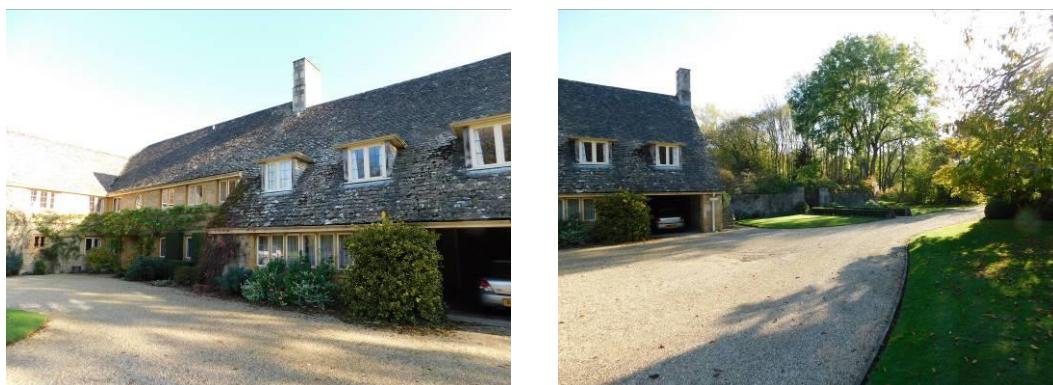
Figs. 1 & 2 North Rye House

The survey site comprised a large, detached stone house with a pitched tile roof. It was built in a 'T-shape' and had gable ends facing northwest, southwest and southeast (Figs. 1 and 2).

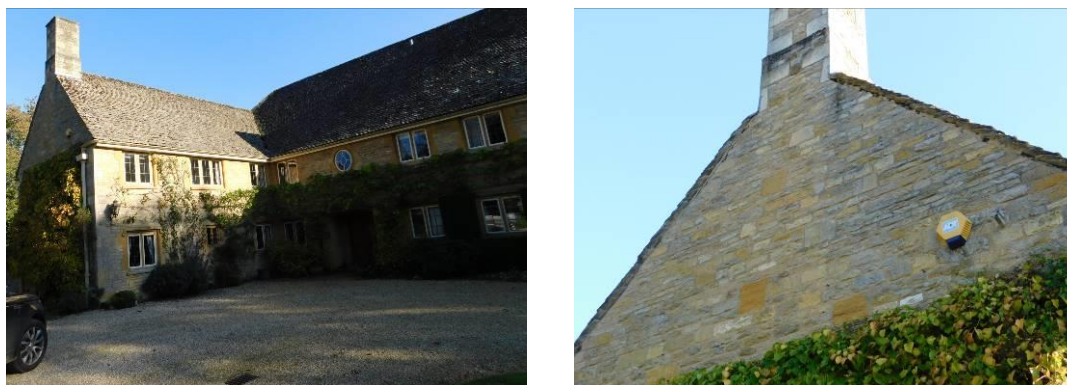
Figs. 3 & 4 Roof and northwest facing gable end

The ridges and roof tiles of the pitched roofs were all present (Fig. 3), although some small gaps were noted under a few tiles where they were slightly raised or dislodged.

The verges originally had a few gaps which appeared to provide access to the attic rooms in the roof void (Fig. 4), but these were all re-pointed under licence in February 2020.

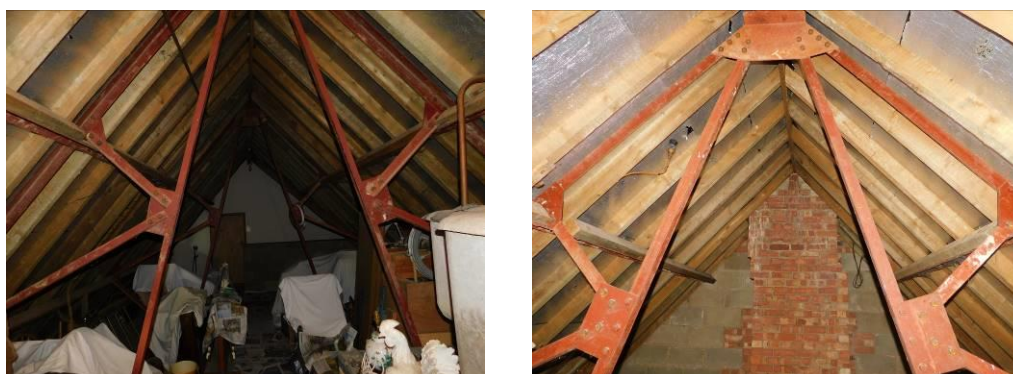
Figs. 5 & 6 Attic rooms

Internally there were several attic rooms, with the two main voids lying above the higher part of the house (Figs. 5 and 6).

The roof was lined with foil-backed insulation, and until the verges had been re-pointed in February 2020, light penetrated from narrow gaps at the gable ends.

A maternity roost of Brown Long-eared Bats was present in 2018, but these were excluded from the house under licence from Natural England in February 2020.

In July 2021 there were no signs of recent bat activity in the attic rooms, including the void above the integral garage, and it was assumed that the interior of the house was no longer accessible to bats.

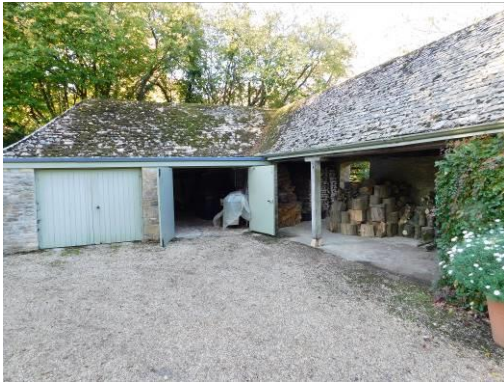
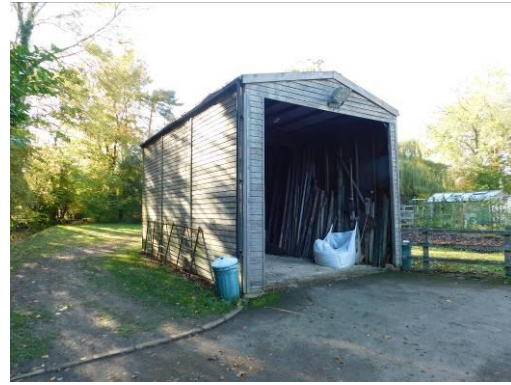
Figs. 7 & 8 Garage building (L) and barn (R)

Approximately 50 m to the west-northwest of the house lay a single storey log store/garage building (Fig. 7), this partially open-fronted, with a large, open-ended timber barn another 50 m beyond that (Fig. 8).

A replacement roost site in the form of a bat house was created in the barn for the Brown Long-eared Bats.

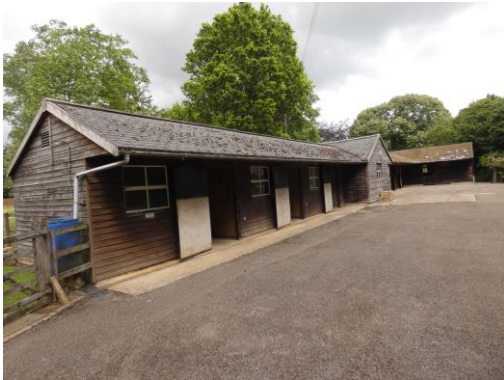
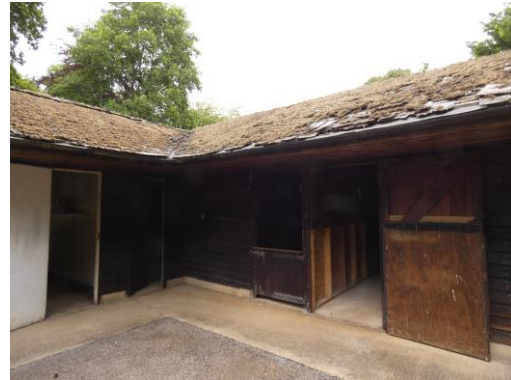
Figs. 9 & 10 Timber stables

Between the log store and barn, there is a set of single storey timber stables with a pitched roof covered by felt tiles and timber shingles, the latter covered in moss and decayed (Figs. 9 and 10).

The only sign of bat activity in the stables was a dead Brown long-eared Bat in the southeastern-most stall. This had perched up and died, but the cause of death was unknown.

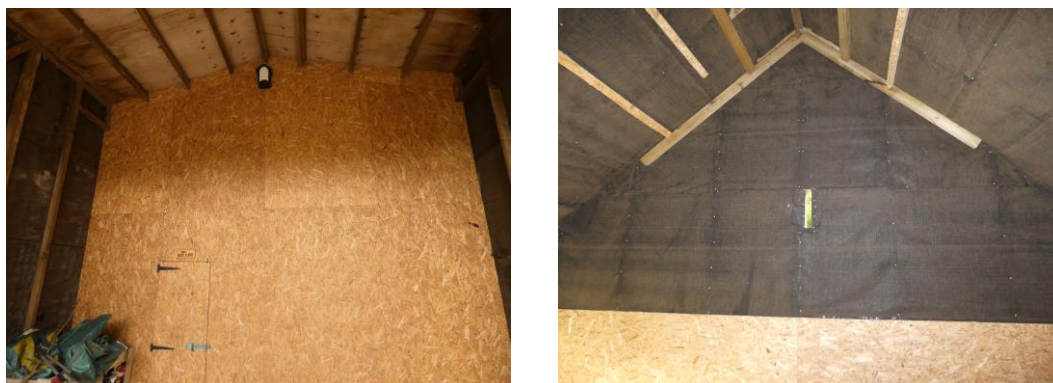
Figs. 11 & 12 Exterior (L) and interior (R) of bat house

The bat house was inspected in July 2021 to see if it was being used by bats. No signs of bat activity or occupation were found, and it was evident that animals had not yet started using the structure (Figs. 11 and 12 - overleaf).

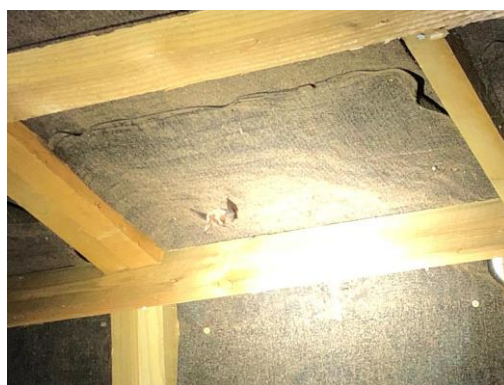
Fig. 13 Brown Long-eared Bat in bat house – 29th June 2023

The building was re-inspected in June 2023, and on 29th June, a roosting Brown Long-eared was present (Fig. 13 – overleaf).

The house, log store and stables were again re-inspected. No bats were present in any of the buildings, but a roosting Brown Long-eared Bat was found in the bat barn (Ref. Fig. 13).

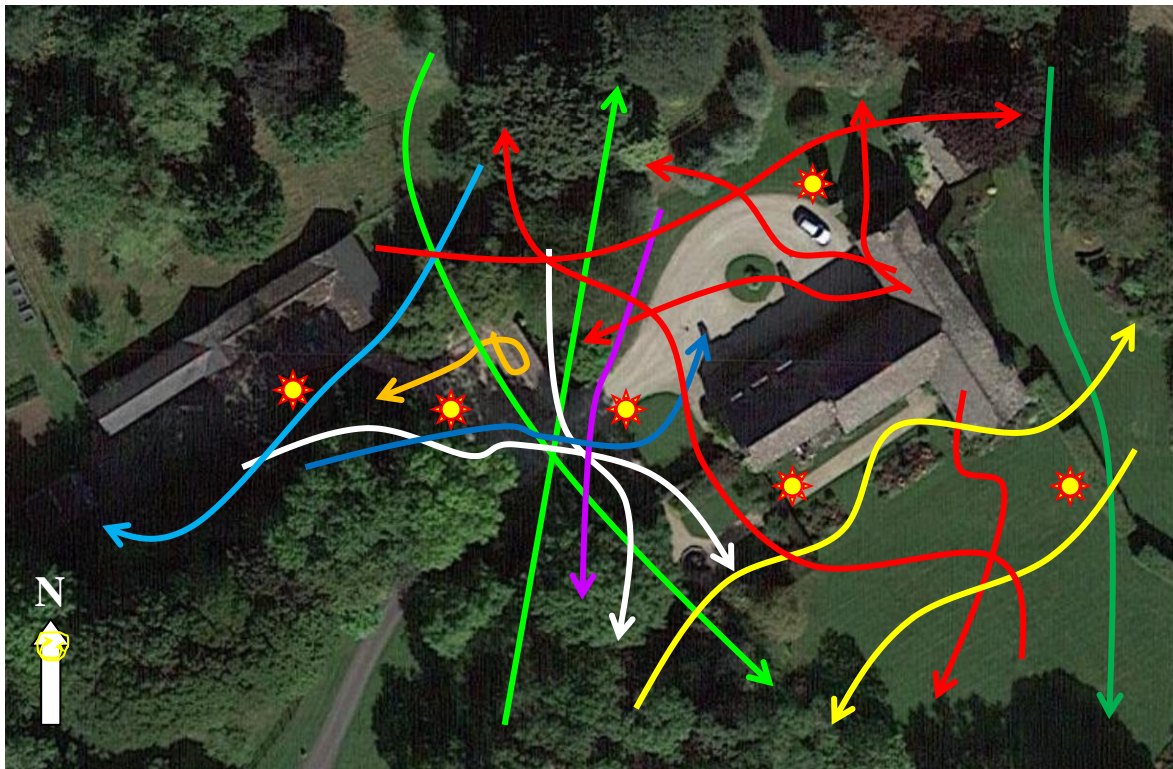
Appendix 3: Bat flight paths at emergence on 4th August 2021

A total of four Common Pipistrelles emerged from tile gaps in the west facing roof slope, three from the front of the house and one from the rear.

Also recorded were overflying Noctule and Leisler's Bats, along with at least two Soprano Pipistrelles, a Whiskered/Brandt's Bat, a Natterer's Bat, one or two Daubenton's Bats, at least one or two Brown Long-eared Bats and a Lesser Horseshoe Bat, the latter roosting in the nearby log store building.

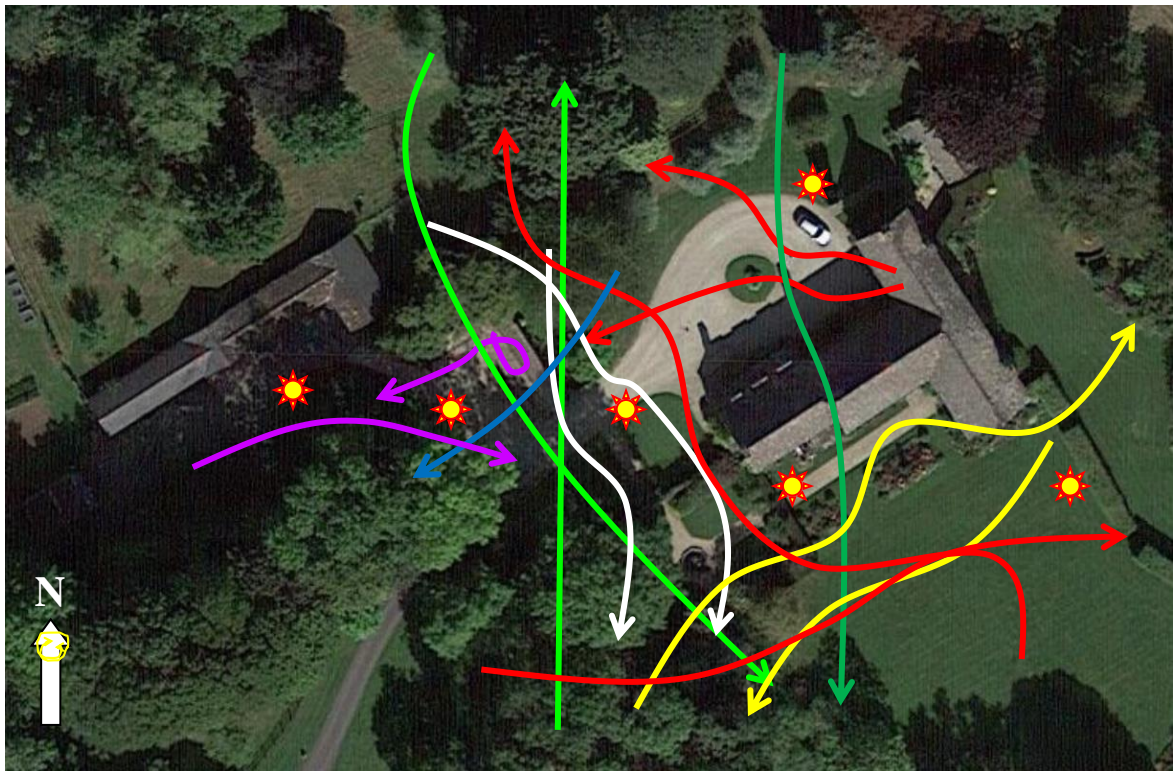
Appendix 4: Bat flight paths at emergence on 20th August 2021

Just two Common Pipistrelles were observed emerging from the roof of the house, with again several species noted flying round or overhead, including Noctule and Leisler's Bats, a Soprano Pipistrelle, single Natterer's and Daubenton's Bats, and a Brown Long-eared Bat, the latter roosting in the log store.

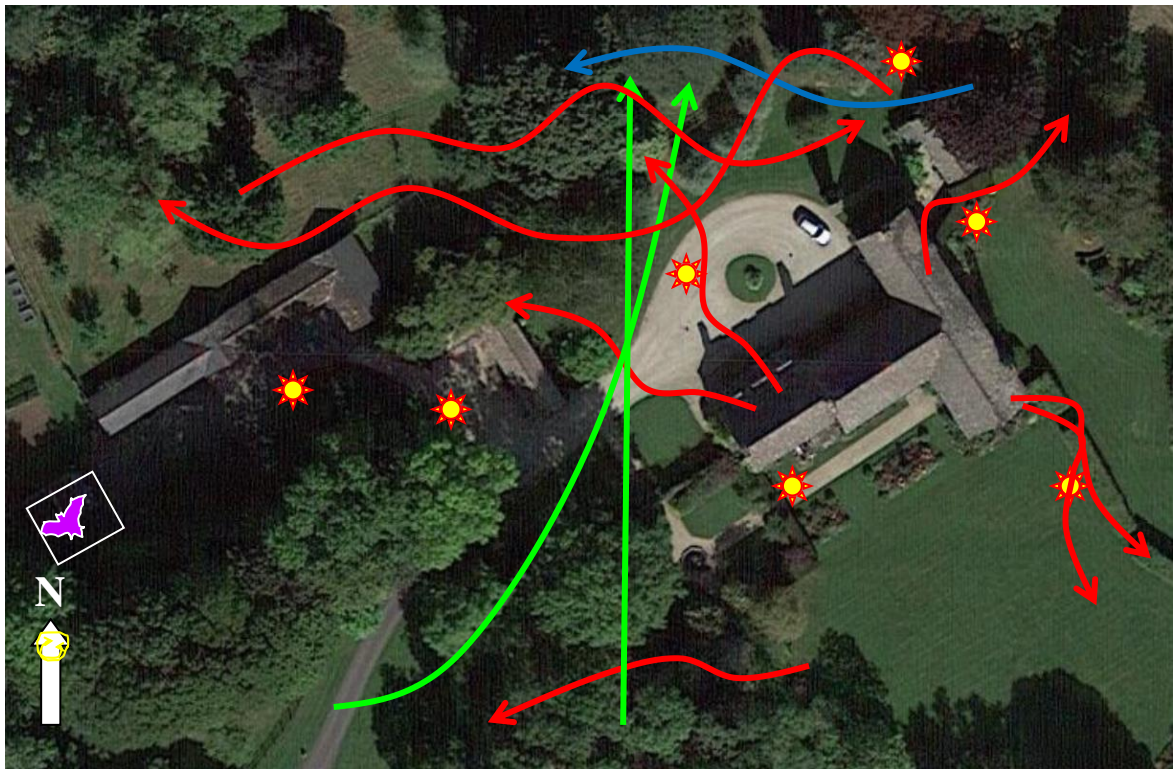
Appendix 6: Bat flight paths at emergence on 29th June 2023

During the nocturnal survey five Common Pipistrelles emerged from the roof of the house, but no Soprano Pipistrelles. One or two Noctule Bats were noted flying overhead, and again a single Natterer's Bat was detected flying round the garden having emerged elsewhere.
