CONSERVATION ROOFLIGHT DETAILS 1:5
BARN AT MONTROSE, HENTON

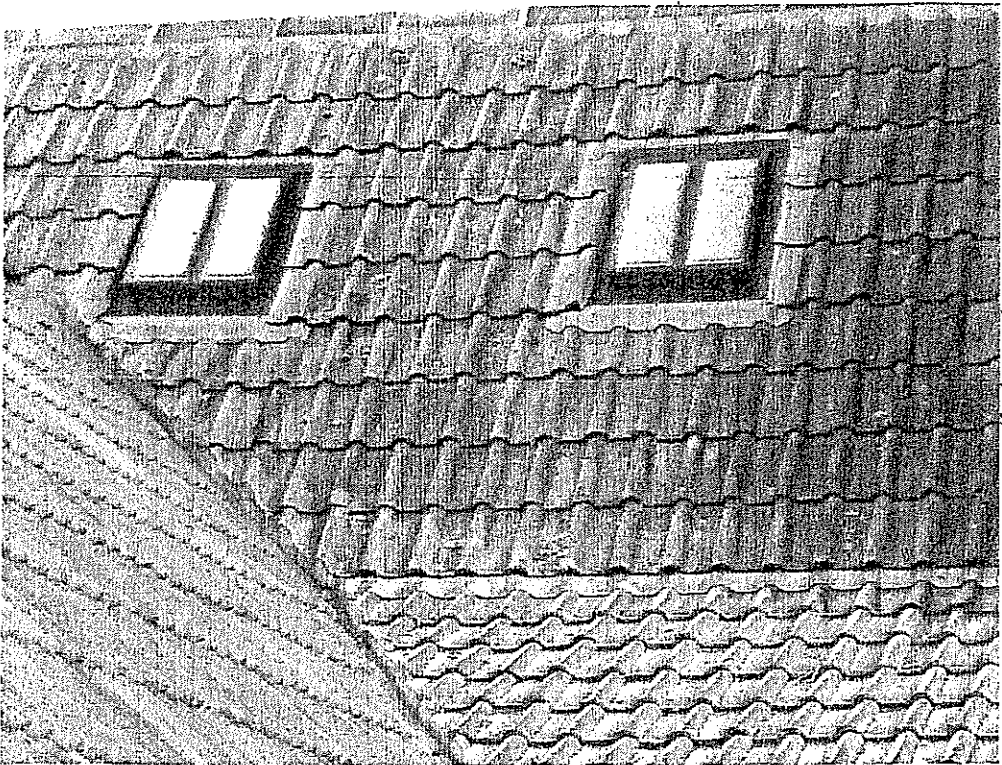
PHOTO OF INSTALLED ROOFLIGHTS

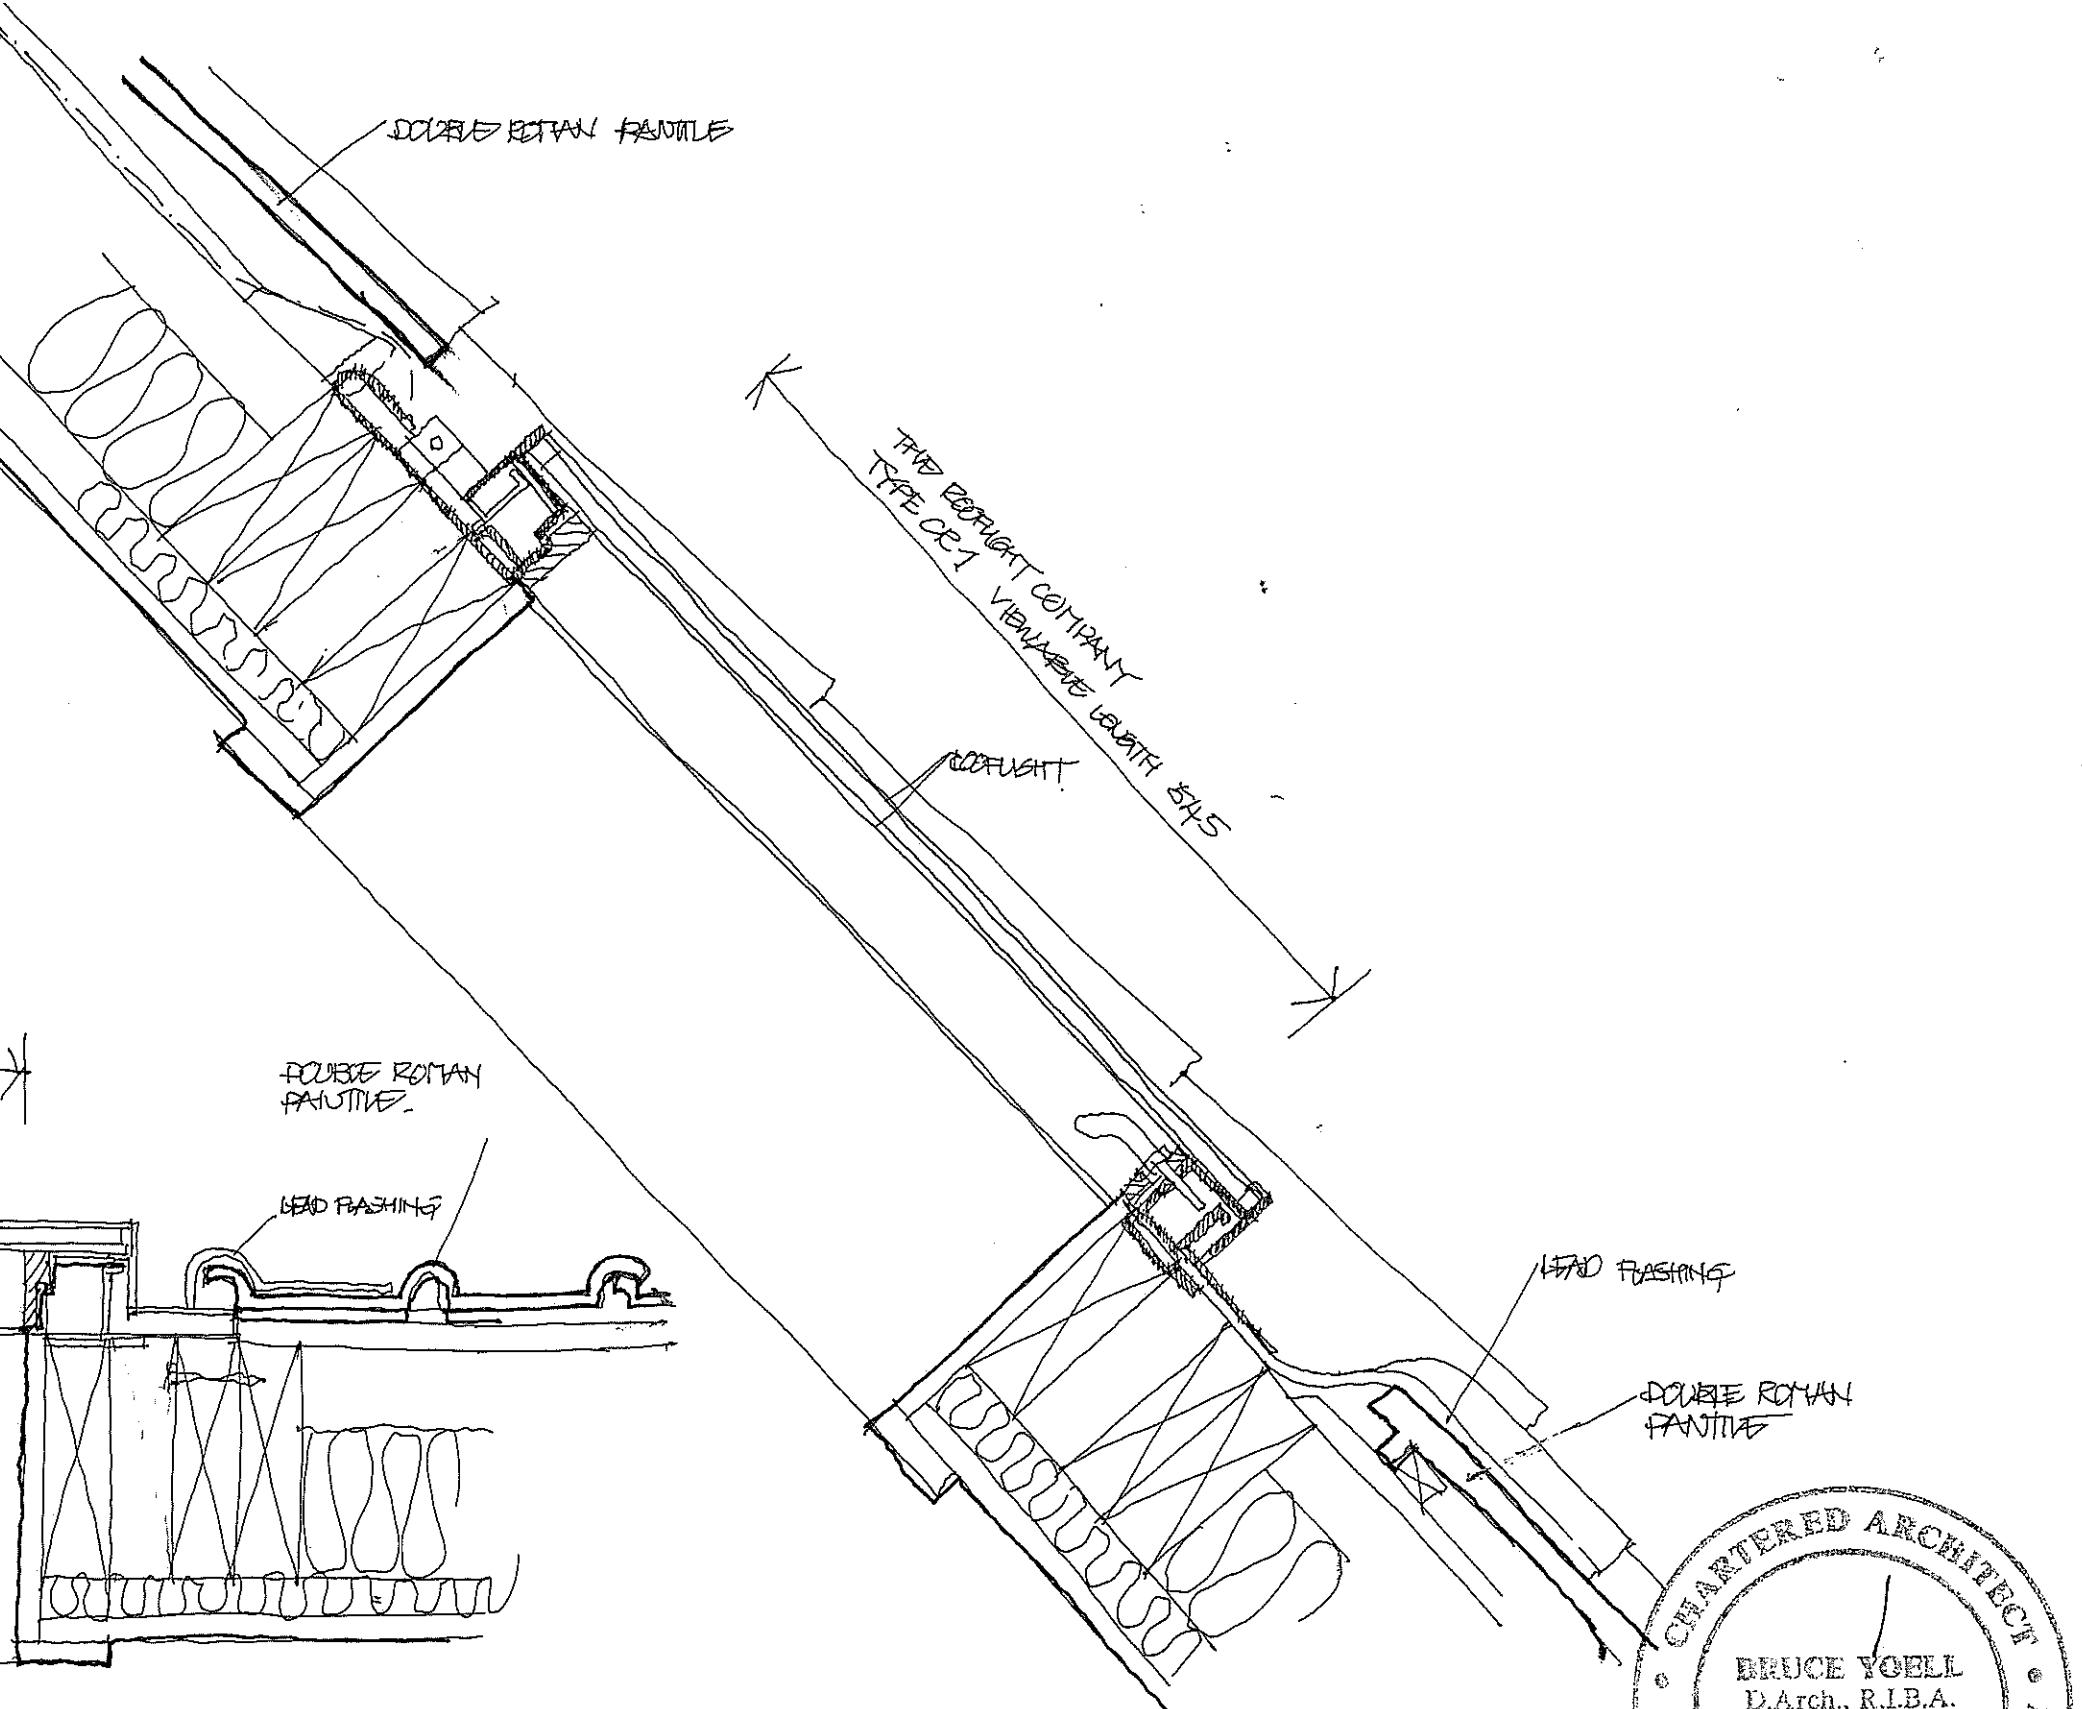
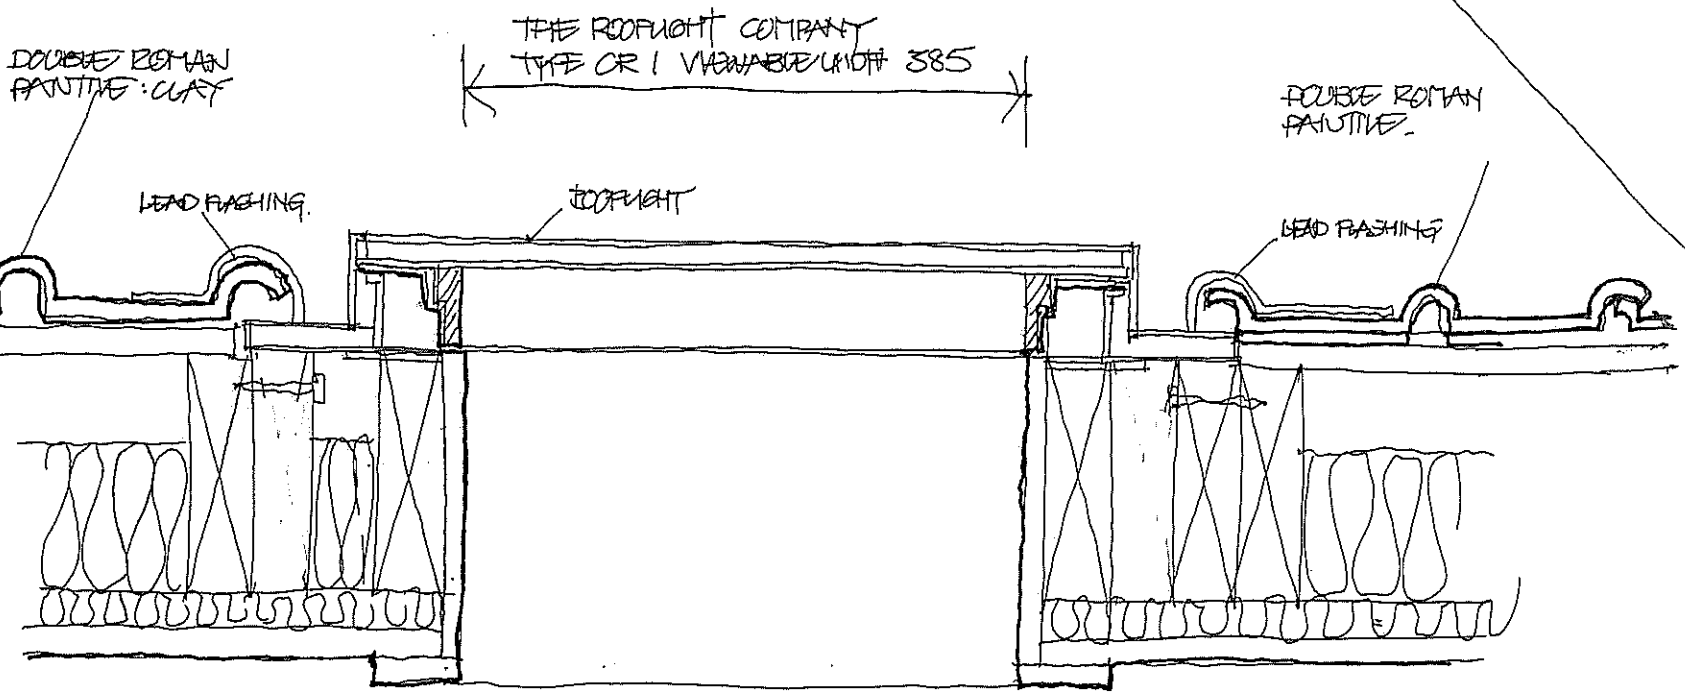
CROSS SECTION 1:5

NOTE CR 1 SHOWN : BUT SECTIONS REMAIN SAME FOR COMPLETE RANGE
OPENING SIZES WILL VARY
