FAIRFIELD ROAD
DROYLSDEN

ADDITIONAL RISK ASSESSMENT
AND UPDATED REMEDIATION STRATEGY
REPORT

Job Number: LKC 20 1761
Date: August 2023
Client: J Greenwood (Builders) Ltd

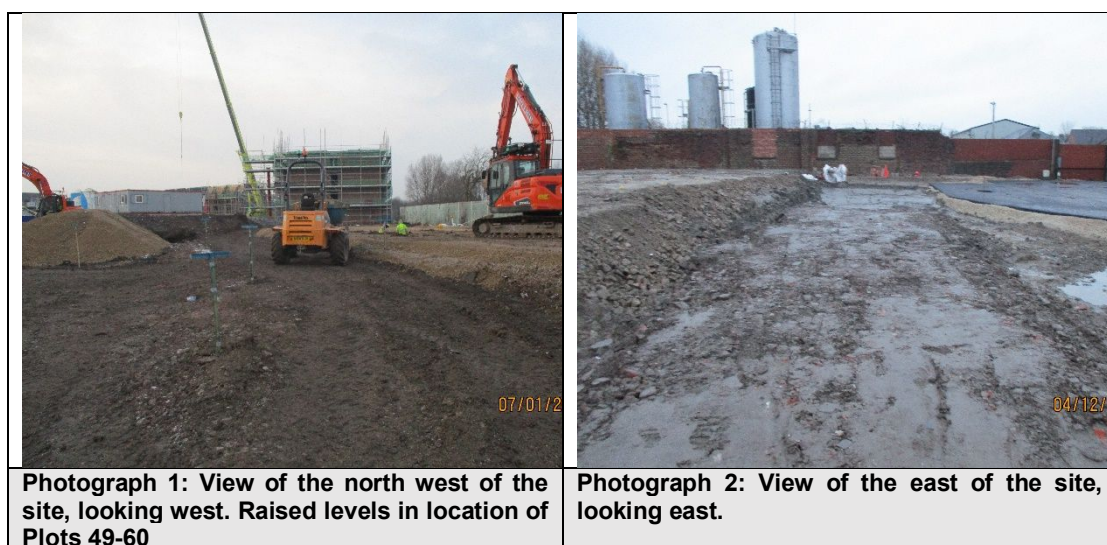
The following photographs were provided by Brierstone Ltd which were taken during earthworks (Plate 1-2).

Plate 1-2: Site photographs taken during earthworks.

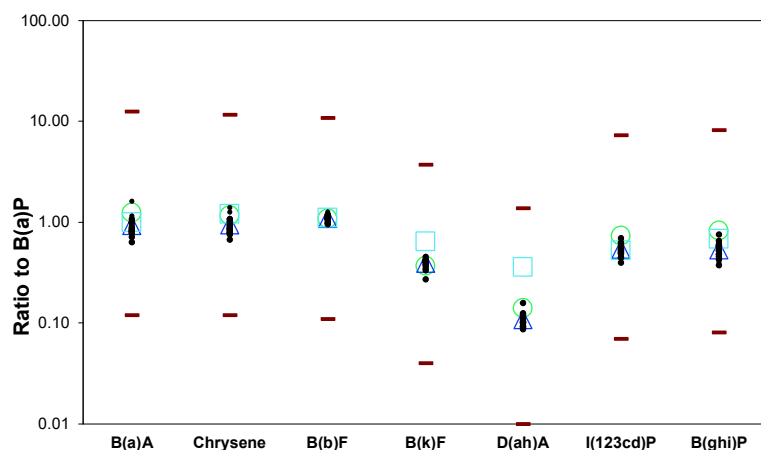
Graph 3-1 summarises the additional soil sample data with respect to how the ratios of carcinogenic PAHs relate to B(a)P, within the confidence limits provided in the HPA document. It should be noted that this relates only to the additional soil sampling outlined in this report. The ratio of PAH to B(a)P graphs for the previous site investigation work are included in the previous Phase 2 and Additional Phase 2 report completed by LKC.

Graph 3-1: The ratio of PAH to B(a)P in soil for all available data at the site based on 19 samples (where values were >LOD to allow the calculation of a ratio).

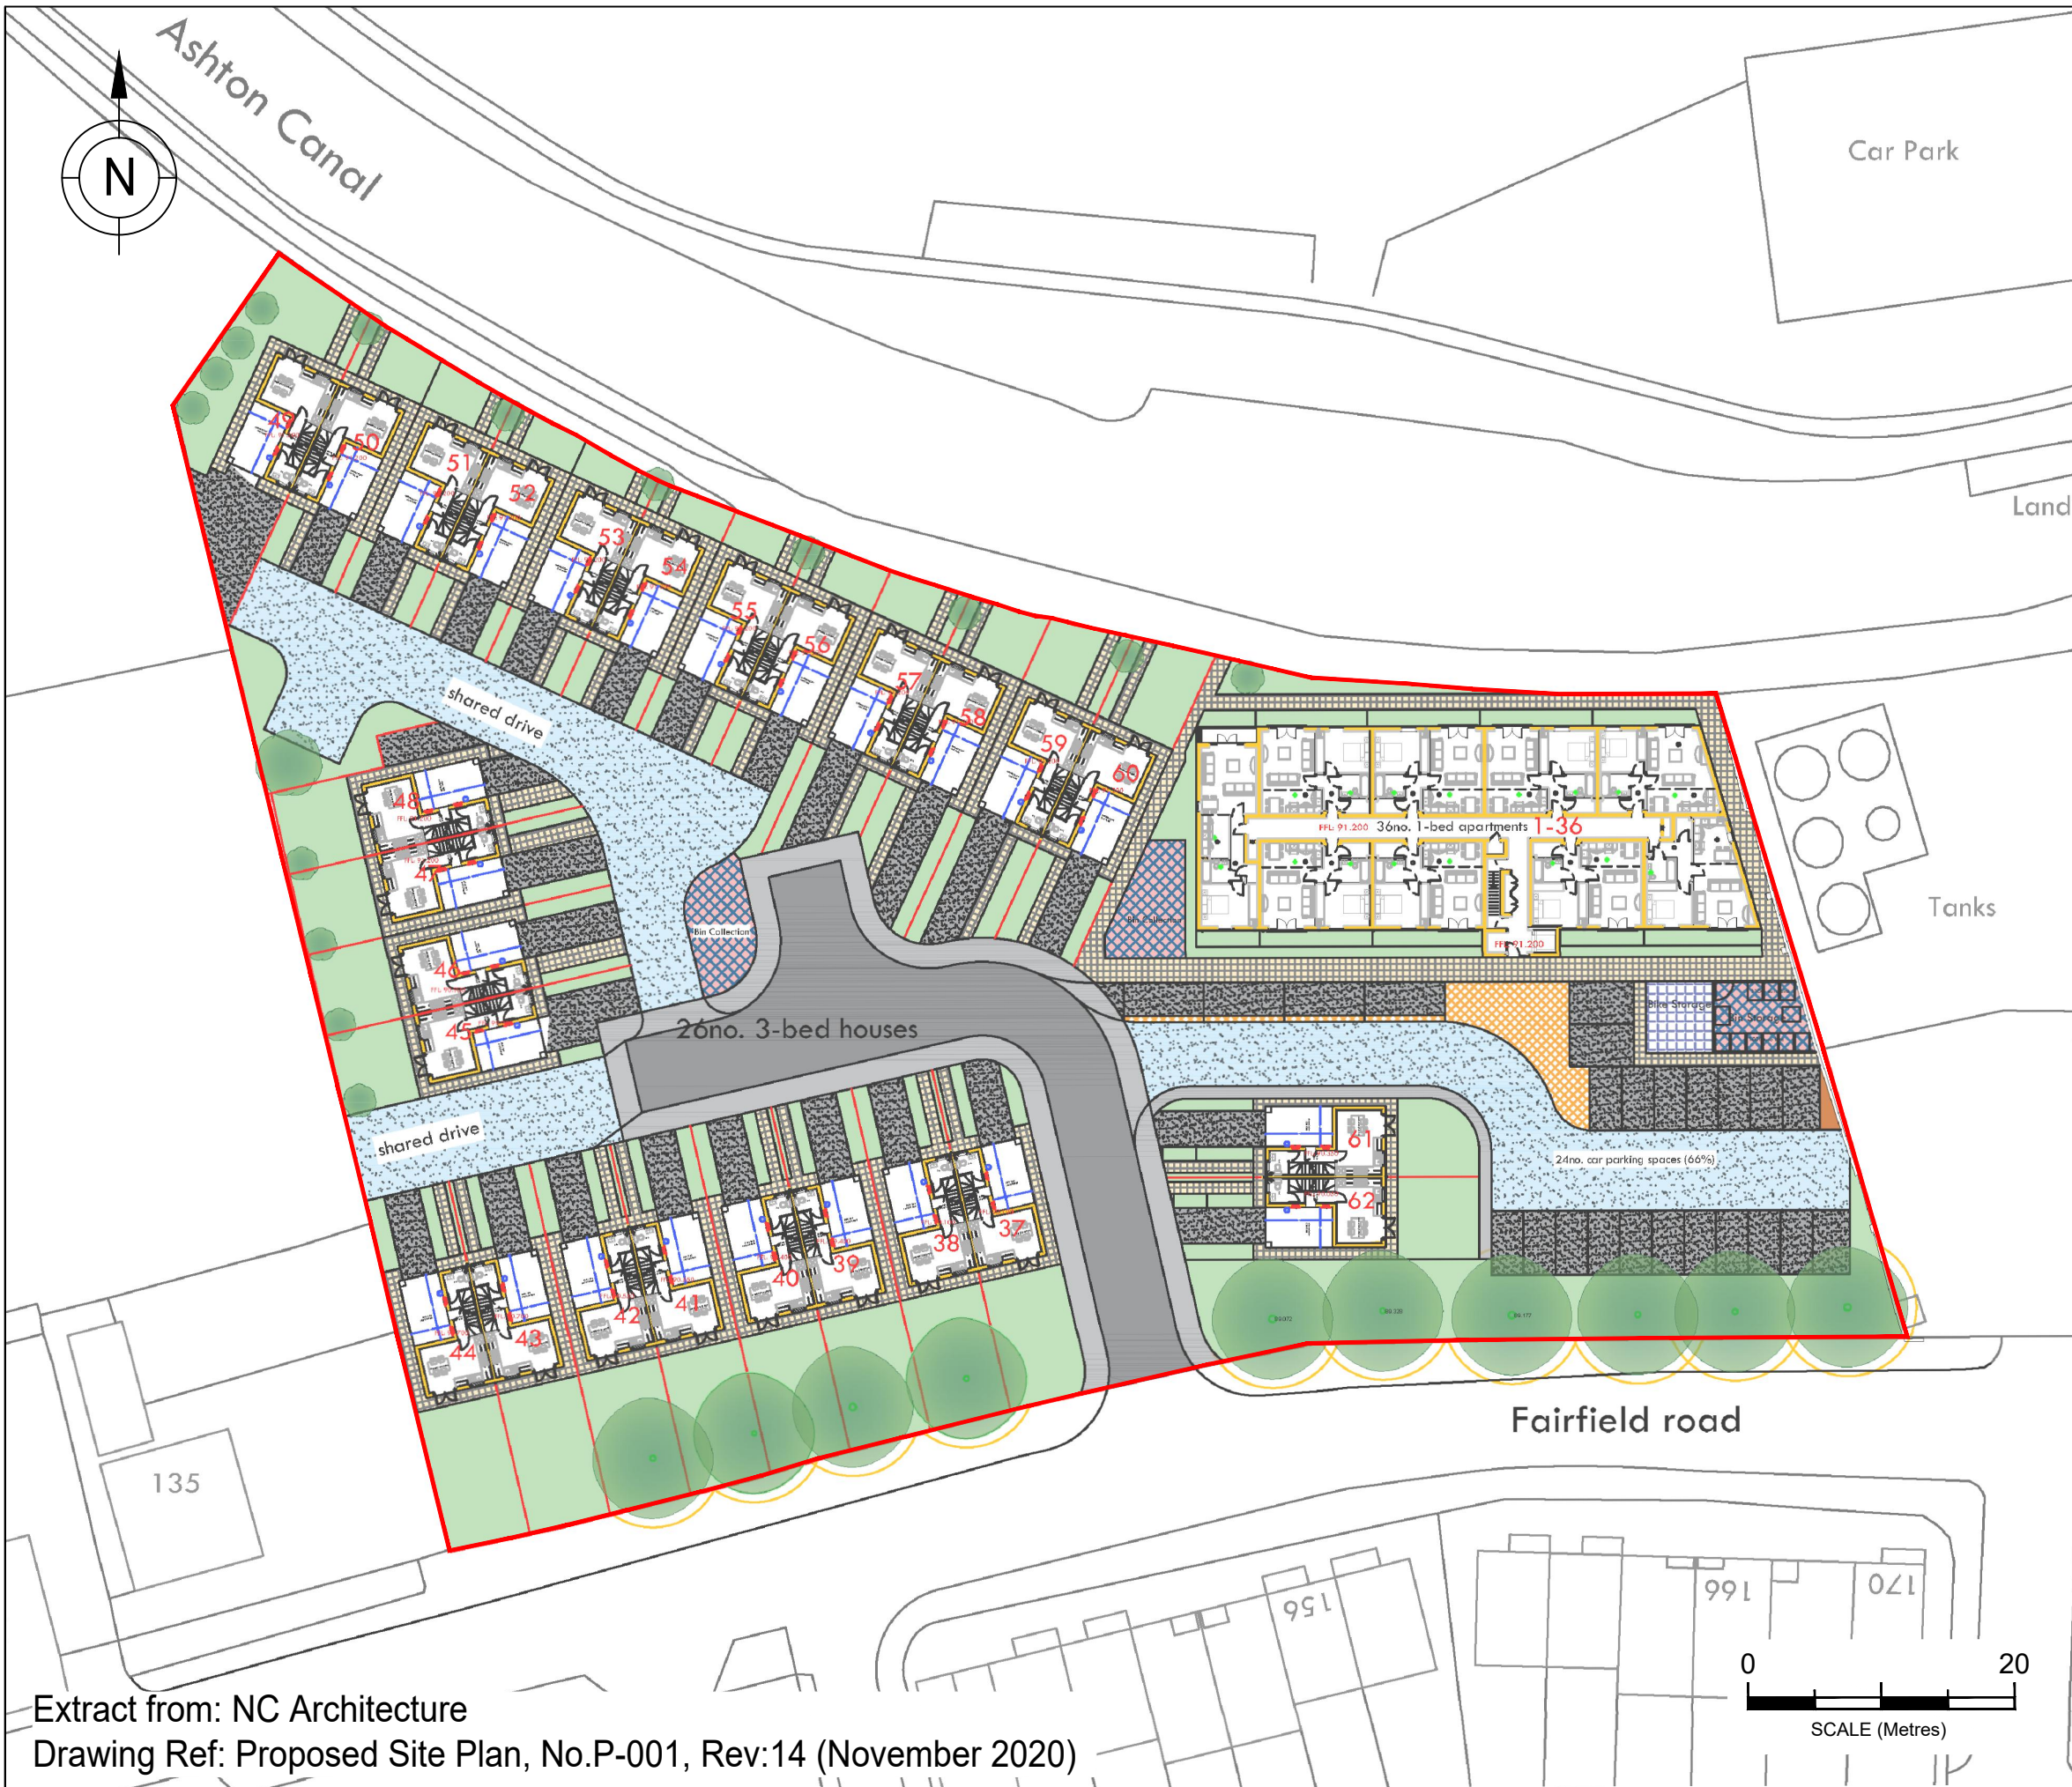
Extract from: NC Architecture
Drawing Ref: Proposed Location Plan, No.P-001 (September 2020)

Total Units: 62no

A summary of the site details is presented in Table 1-1. Figures 1, 2 and 3 indicate the site location, boundary and proposed development.

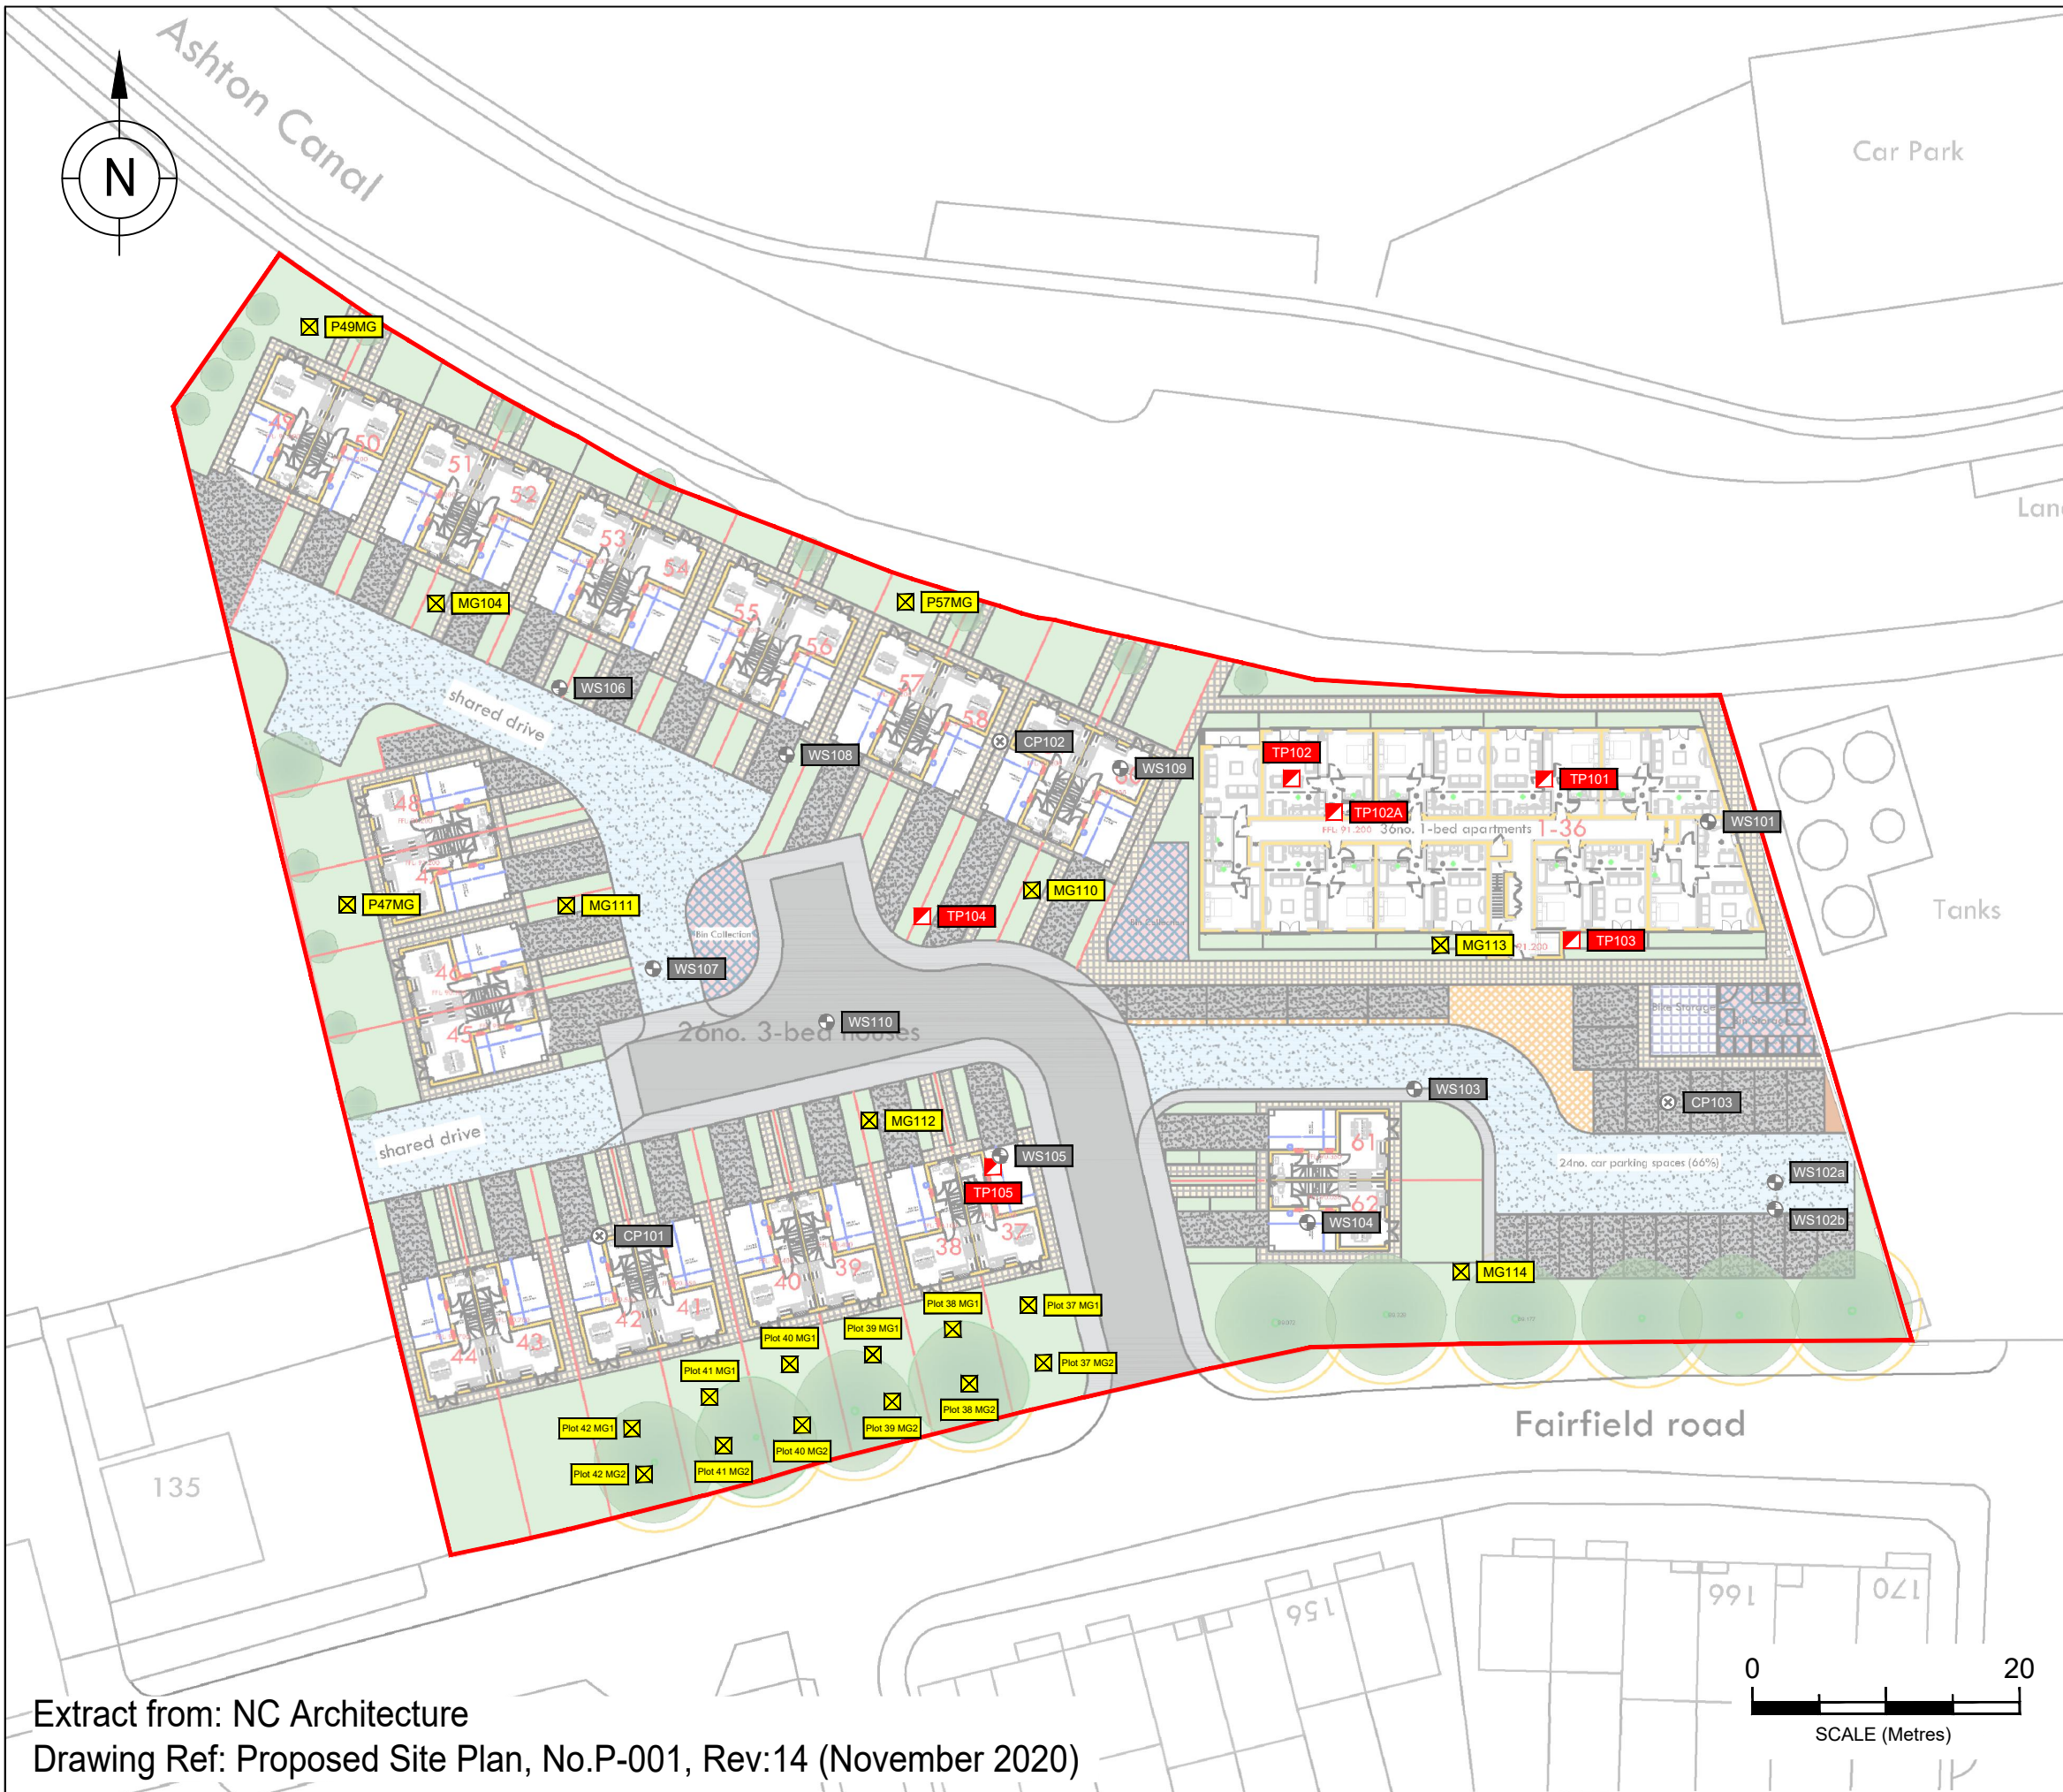
Cable Percussive Borehole (CP)
