Heritage, Design and Access

The Thatched Barn
Eye Road
Hoxne
Suffolk

Proposed PV installation in detached rear garden to the dwelling.

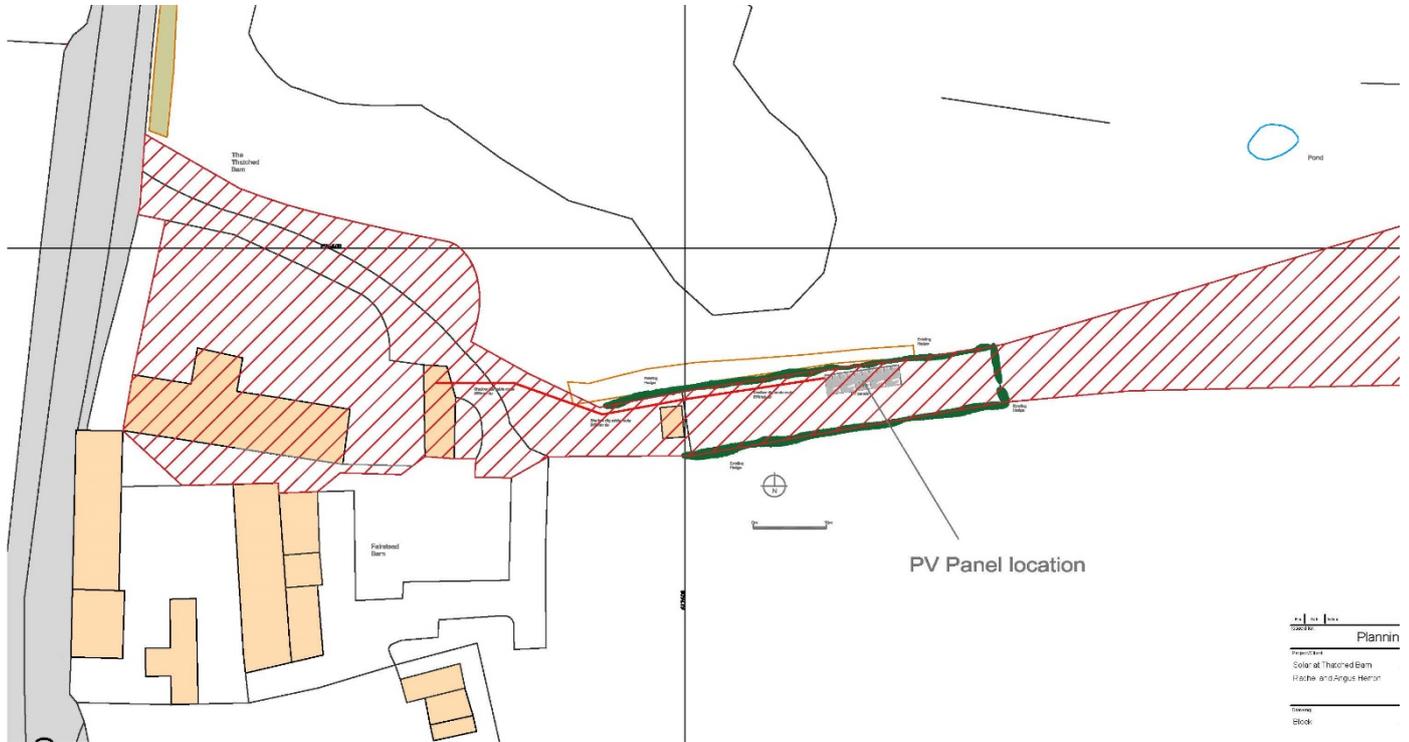
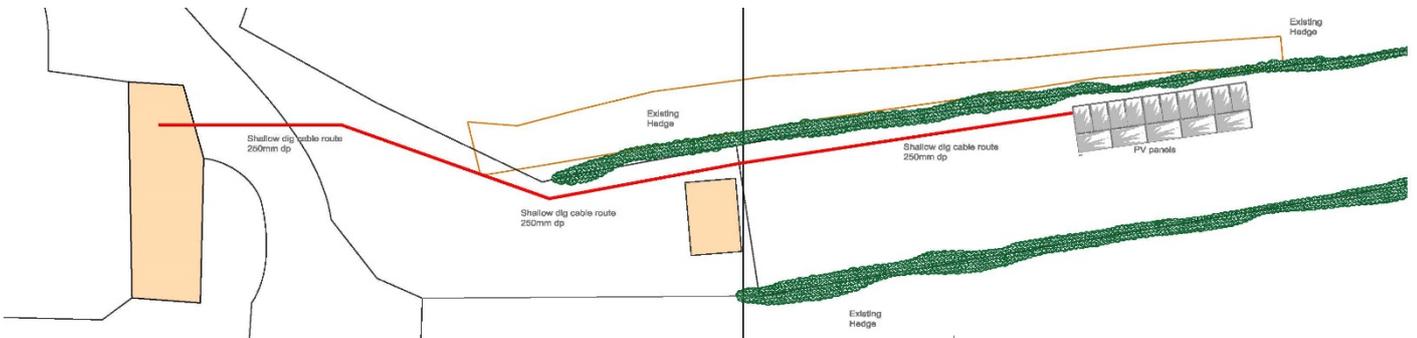
PV Array - Phono Solar Twin plus panels

10 portrait panels on GSE ballast boxes.

5 landscape panels on Renusol Tubs.

Portrait panel mounting GSE integration.

No dig ground sitting box filled with inert ballast (no excavation)

Renusol tub mounting No dig ground sitting box with inert ballast (no excavation)

The no dig solution requires the mounting boxes simply to sit on top of the topsoil before being loaded with ballast.

This proposal seeks to install a 17 kW PV array in the East garden of the barn

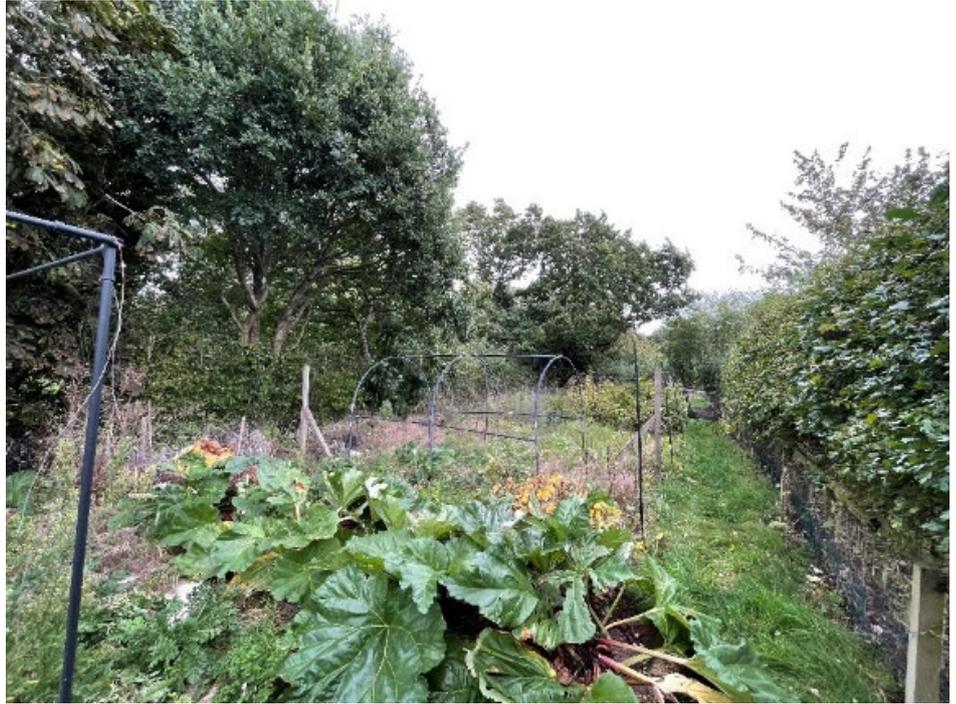
Garden looking East panel
position on the left.

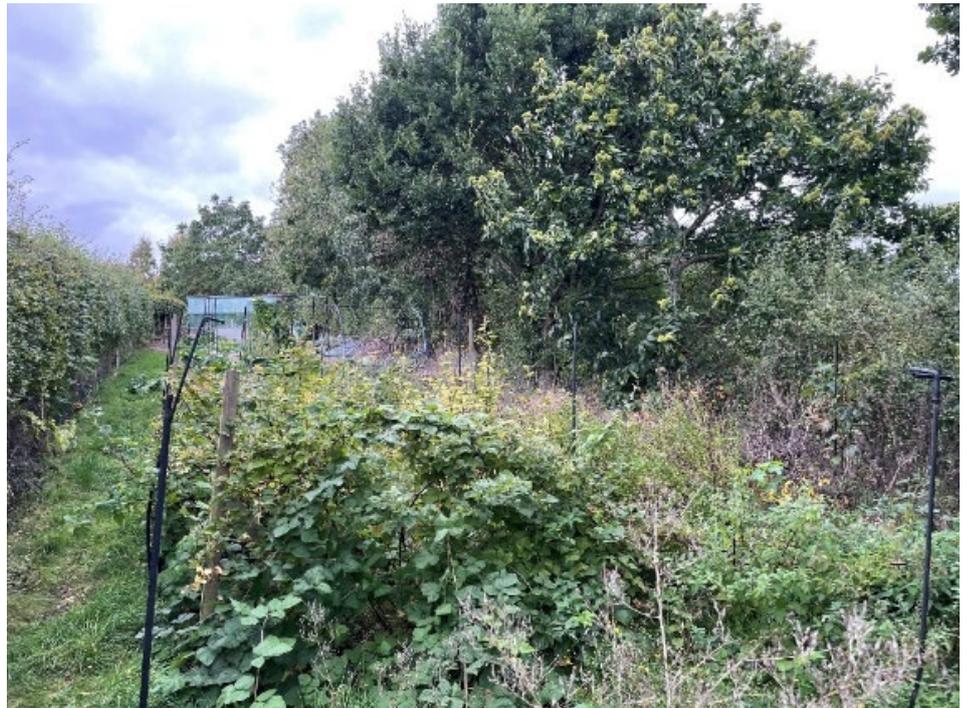
Garden looking West panel
position on right.

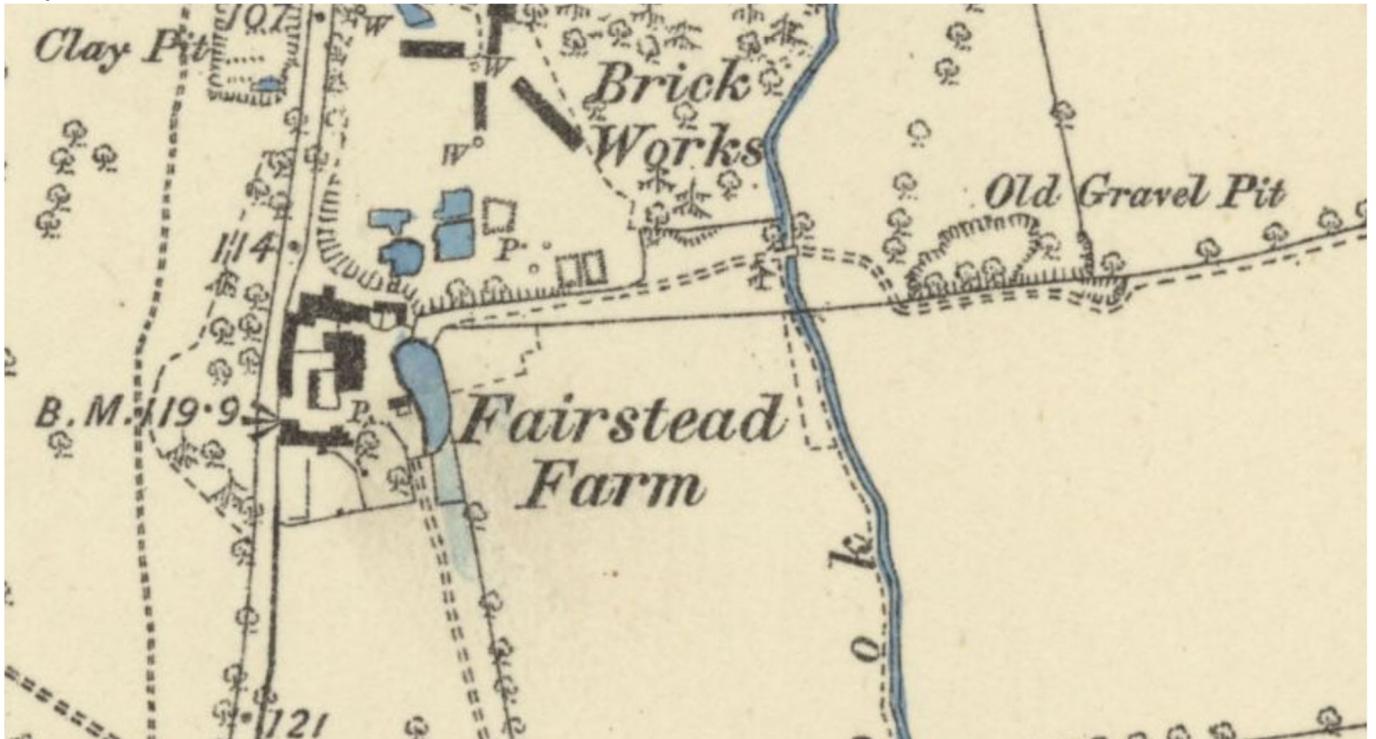
1885 OS – The area which has become the barn garden is divided off from the trackway with an ancient field boundary. The brick pit area of Hoxne Axe find clearly shown to the North where the letter P is located.

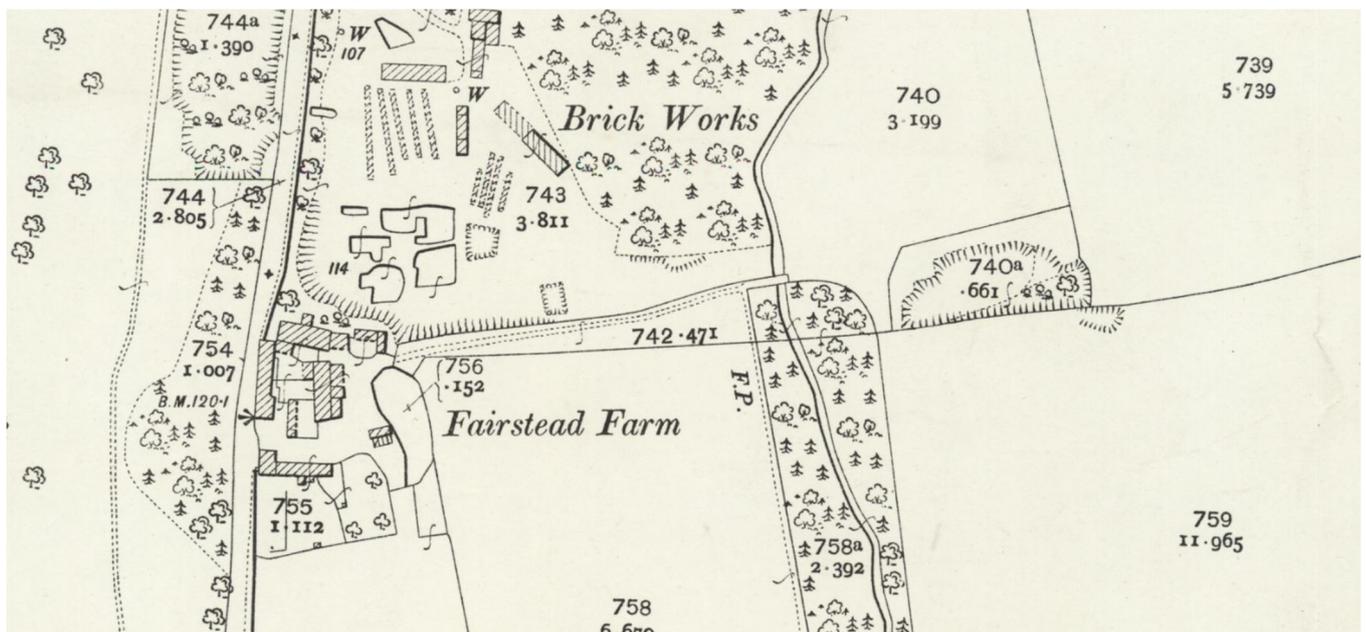
1903 OS – The area which has become the barn garden is divided off from the trackway with an ancient field boundary.

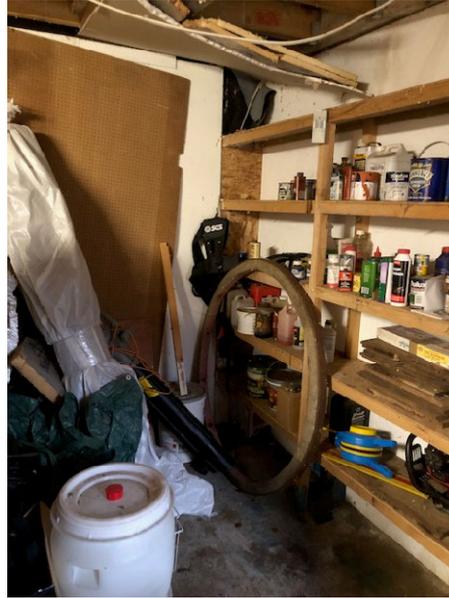
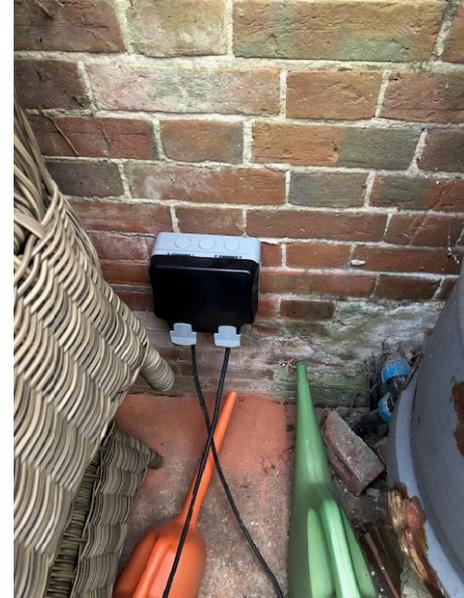
The battery system will be fitted in the Victorian workshop adjacent to the drive – the works will have minimal impact on this structure, The cable from will be brought through an existing duct/hole in the wall. The battery and inverter system will be fixed back the masonry wall.

Photos above show interior and exterior of the workshop / store
