## **Preliminary Bat and Bird Assessment & Bat Survey Report**

Cottages at Trereife House, Newlyn, Penzance, Cornwall, TR20 8TJ

14<sup>th</sup> November 2023

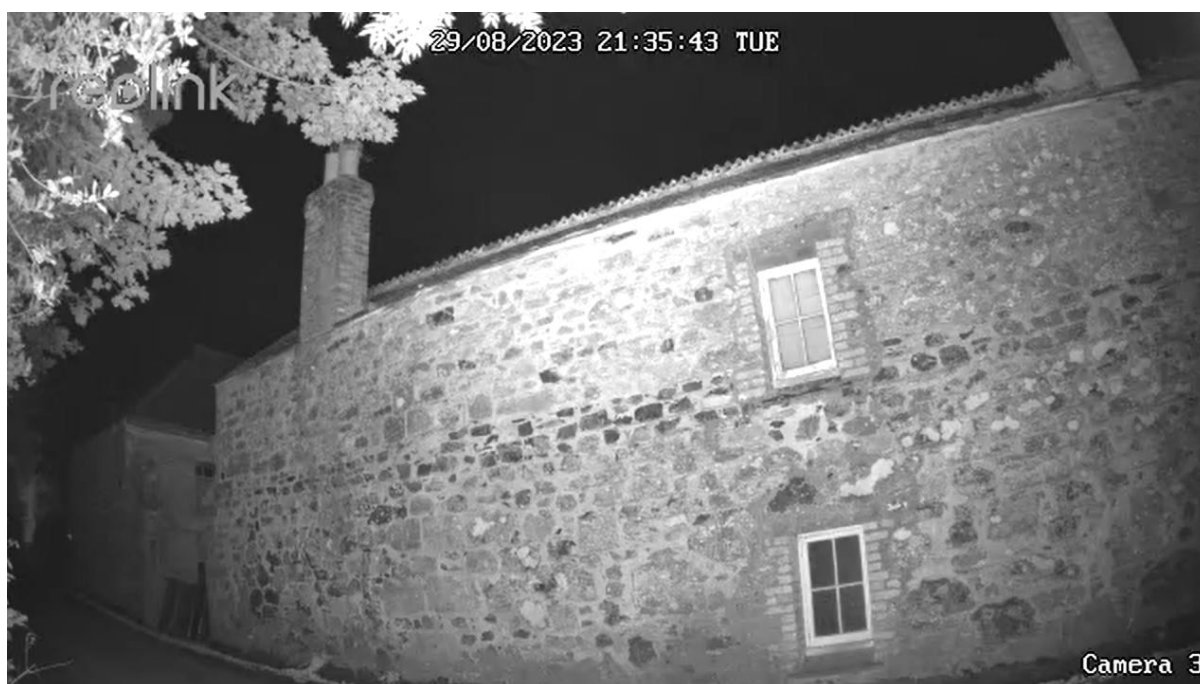
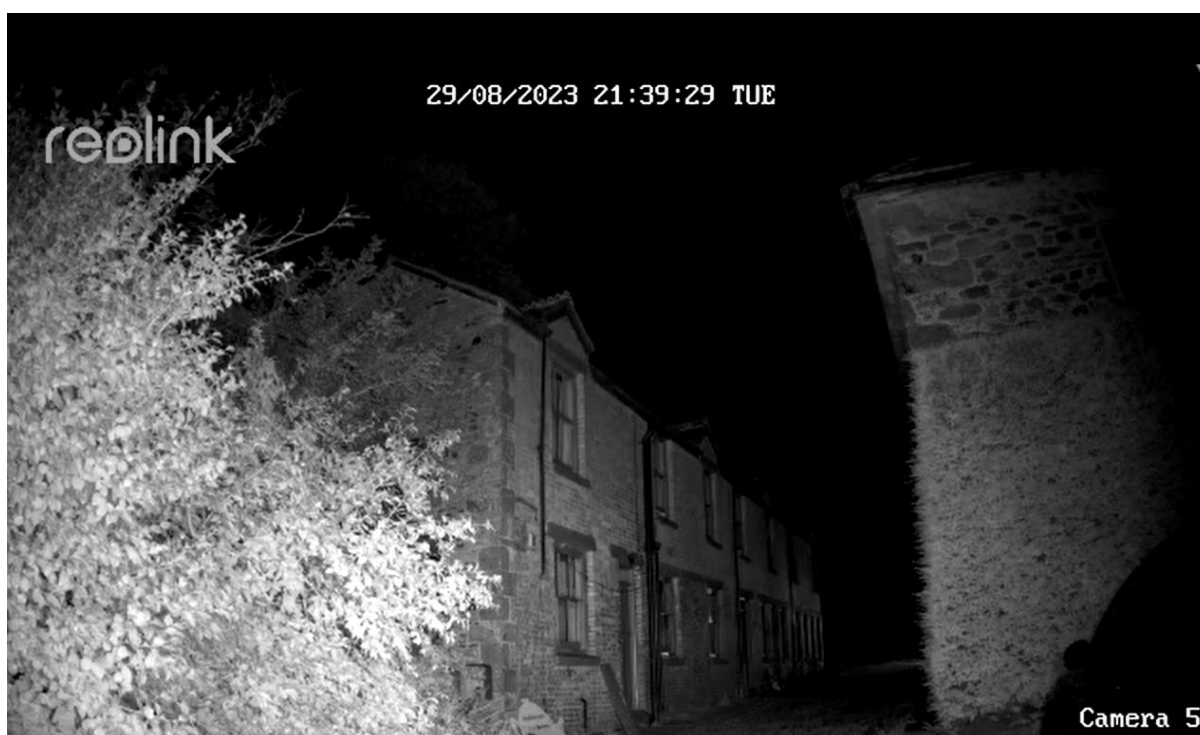
Figure 2: Still images taken from the infra-red video footage from two of the cameras during the emergence survey on 29<sup>th</sup> August 2023, showing the field of view in the latter stages of the survey.

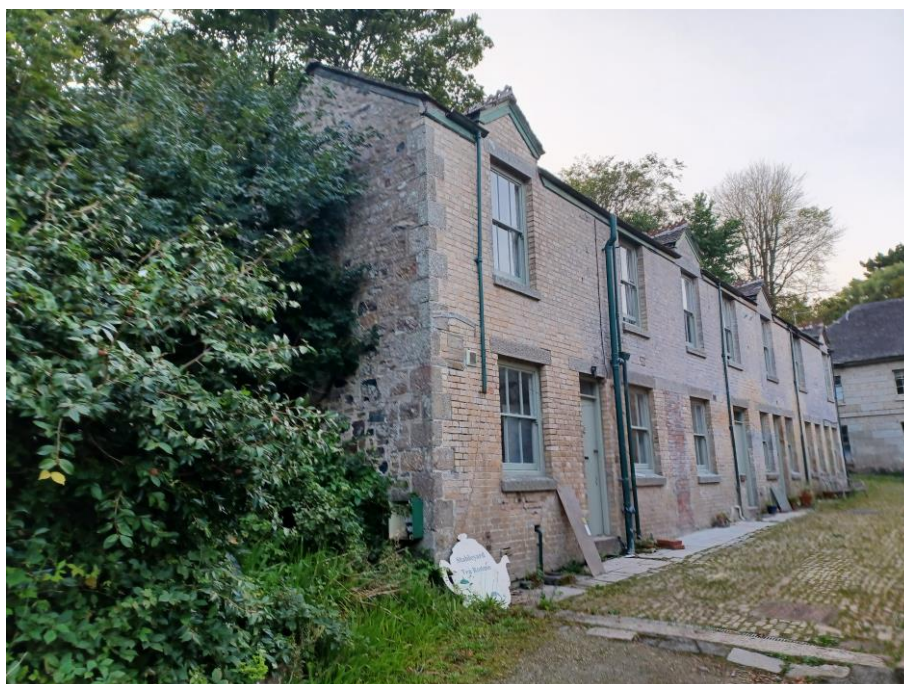
Figure 3: East and south elevations of cottages at Trereife House.

The visual assessment was undertaken on 29<sup>th</sup> August 2023. The Cottages at Trereife House is a two-storey building of stone construction with a pitched slate roof with ornate Victoria ridge tiles (Figs. 3-5). There are three rendered chimneys off the west elevation (Fig. 5) and four dormer windows off the east elevation (Fig. 3). The building supports wooden fascias throughout which have gaps beneath and some of the ridge tiles are loose and/or missing. There are gaps beneath hanging slates located at each gable end (north and south) of the building.

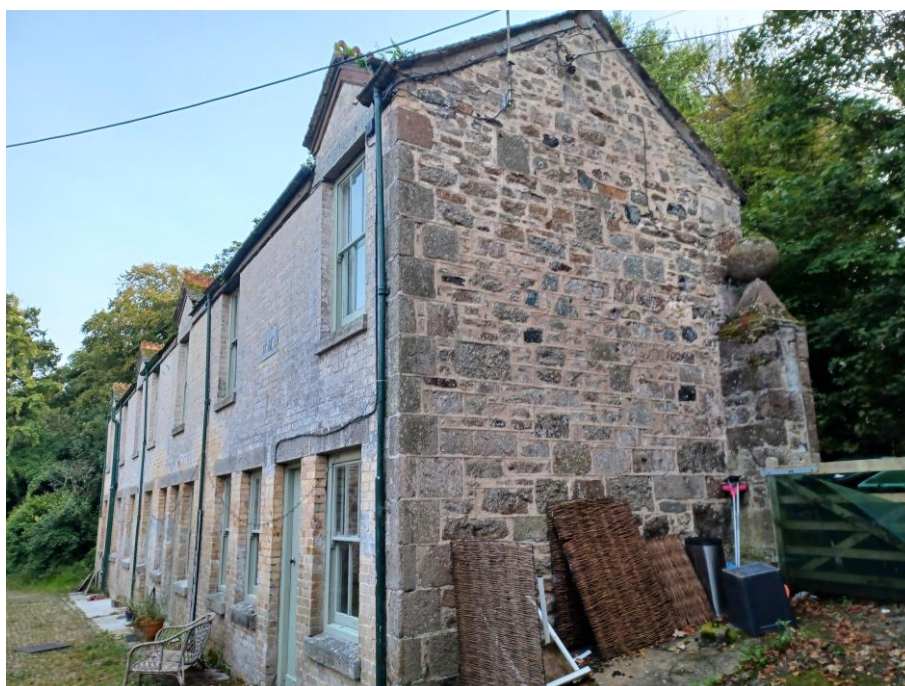
Figure 4: North and east elevations of cottages at Trereife House.

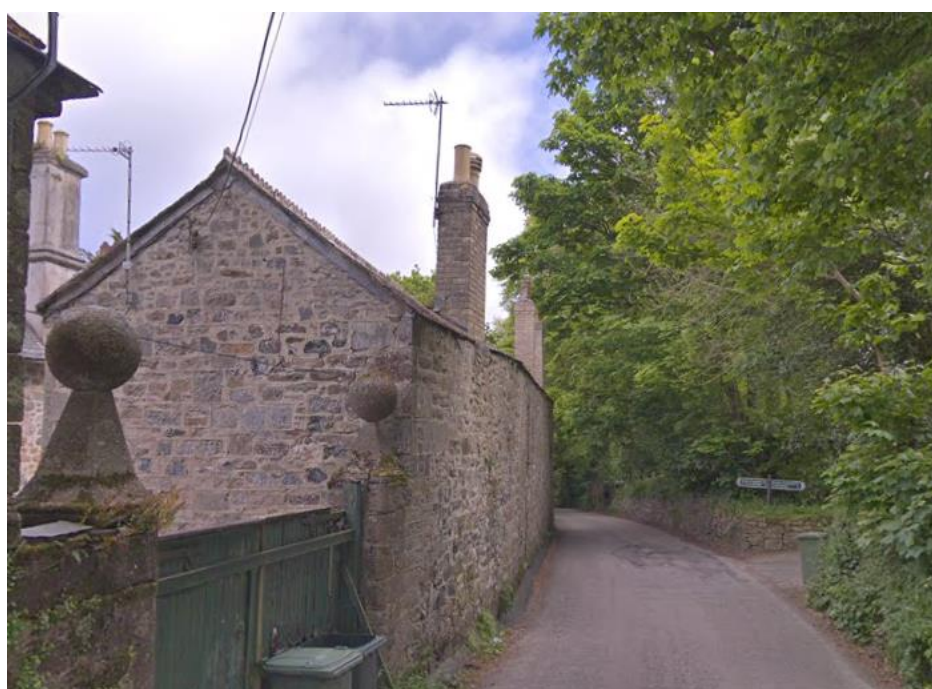
Figure 5: North and west elevations of cottages at Trereife House.

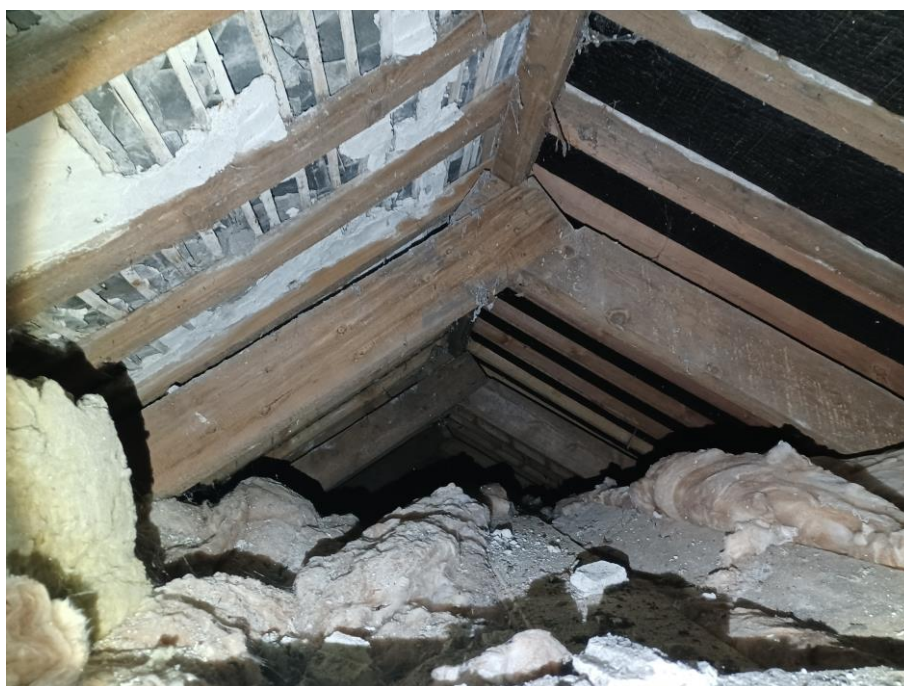
The interior of Cottages at Trereife House supports a long shallow roof void above the first floor. The roof is timber framed and partially lined with bitumen and partially unlined, with rolled insulation between the joists (Fig. 6). Evidence of roosting bats in the form of bat droppings scattered over the loft hatch was observed.

Figure 6: View of roof void within cottages at Trereife House.

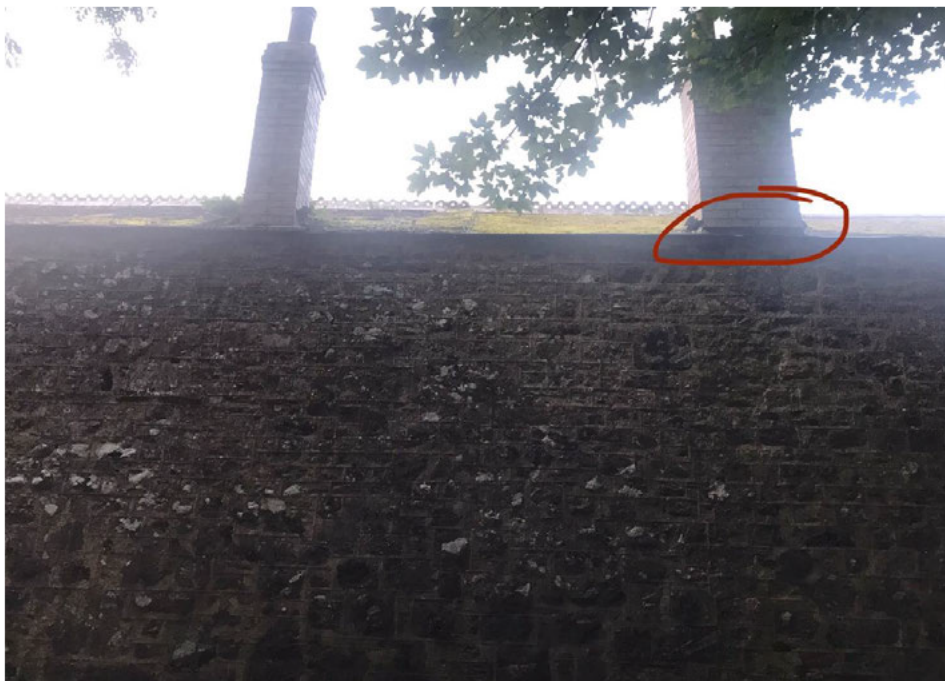
During the first emergence survey on 29<sup>th</sup> August 2023, a common pipistrelle bat was seen to emerge at 20:50 from near a missing ridge tile at the northern section of the roof (Fig. 7; yellow arrow). A second common pipistrelle bat was seen to emerge at 20:51, close to the chimney on the west elevation (Fig. 7; red arrow; Fig 8; red circle).

Figure 8: View of chimney on west elevation of cottages at Trereife House. Red circle shows approximate emergence location of common pipistrelle bat on 29<sup>th</sup> August 2023 and 26<sup>th</sup> September 2023.

- Loss of the common pipistrelle bat day roosts will be compensated preferably by reinstating comparable gaps beneath a ridge tile and roof tile. This can be achieved by leaving a 20mm x 50mm gap beneath a ridge tile through sparing use of mortar and by installing a bat slate within the roof structure. Alternatively, two bat boxes could be installed on the exterior of the renovated building. The location/ aspect of the alternative bat roost features will replicate those lost as closely as possible (north and west elevations).
