Ref: Proposed rear dormer extension, front rooflight and replacement windows at 78 Newmarket Road, Brighton BN2 3QF

The Ecology Co-op undertook a bat scoping assessment at 78 Newmarket Road on the 6th December 2023 at the request of City Lets. This assessment was undertaken further to a proposal to construct a rear dormer extension and insert a roof light into the front of the roof and replace windows. The survey was undertaken in accordance with best practice guidance produced by the Bat Conservation Trust¹.

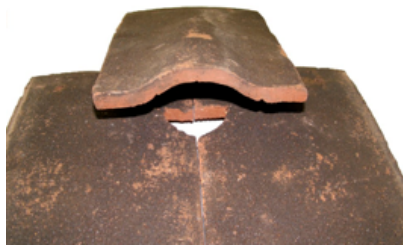
Bat Access Tile Set, 2FR Schwegler Bat Tube, 2FE Schwegler Wall-Mounted bat shelters and Improved Crevice Bat Box.

Additionally, the site can be enhanced for bats by incorporating the features below into the fabric of the building. Where bat access tiles are used, only a Type 1F bitumen lining must be used instead of modern breathable membranes such as Tyvec, which over time fray and entangle bats. Bat boxes and features should be installed under the instruction of a suitably licensed ecologist to ensure that the positioning is optimal, but generally locations above 3.5m in the most southeasterly facing aspect of the building would be best.

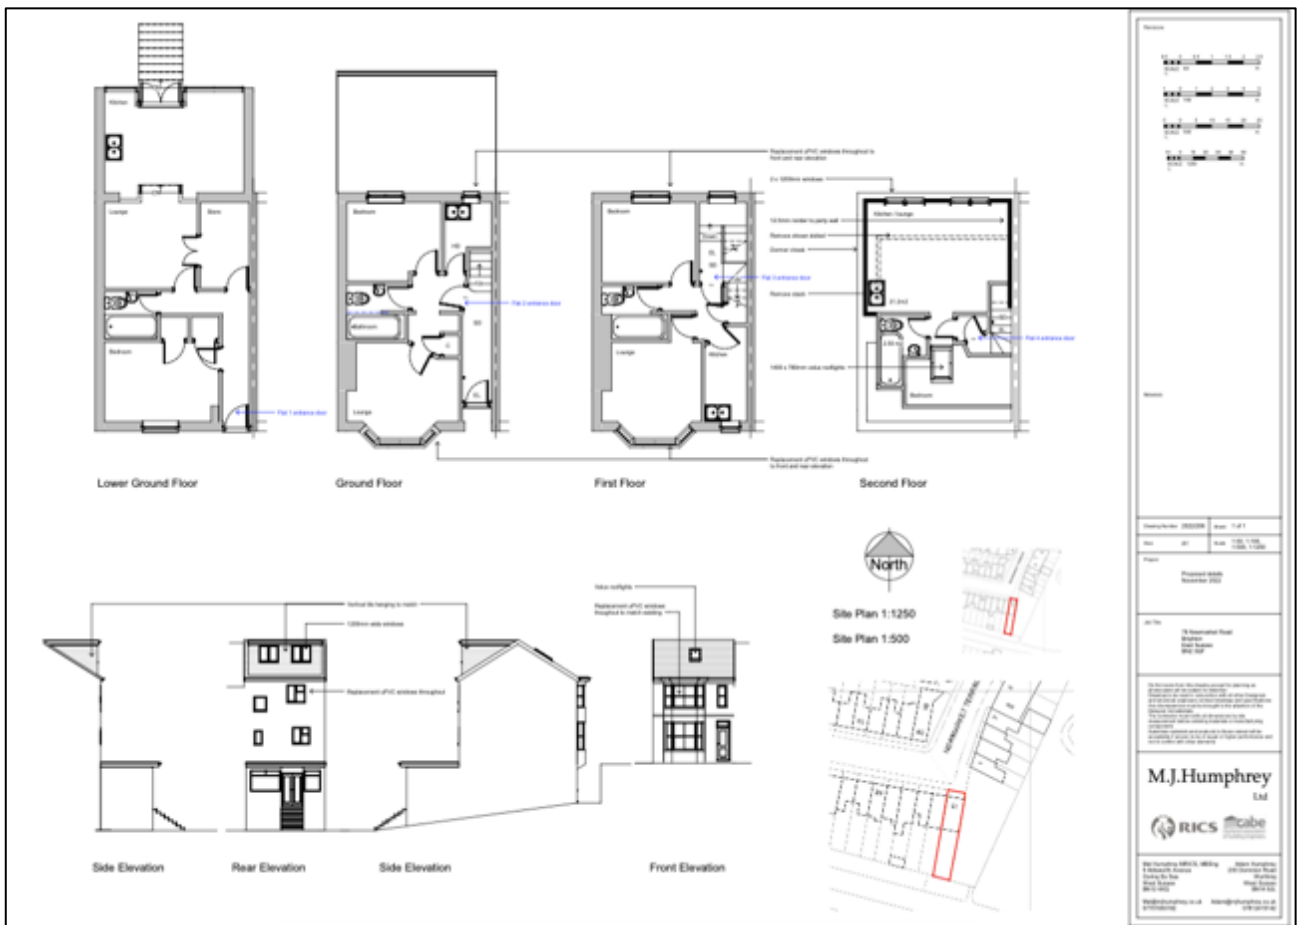
Figure 2. Proposed plans for 78 Newmarket Road. M.J. Humphrey Ltd. November 2022, dwg no. 2022/208.

The planned works will result in the removal of all roof tiles on the southern aspect and a small area of roof tiles on the northern aspect, along with the loss of two chimneys and a small void within the building. The proposals for the site are shown in Figure 2, Appendix 1.

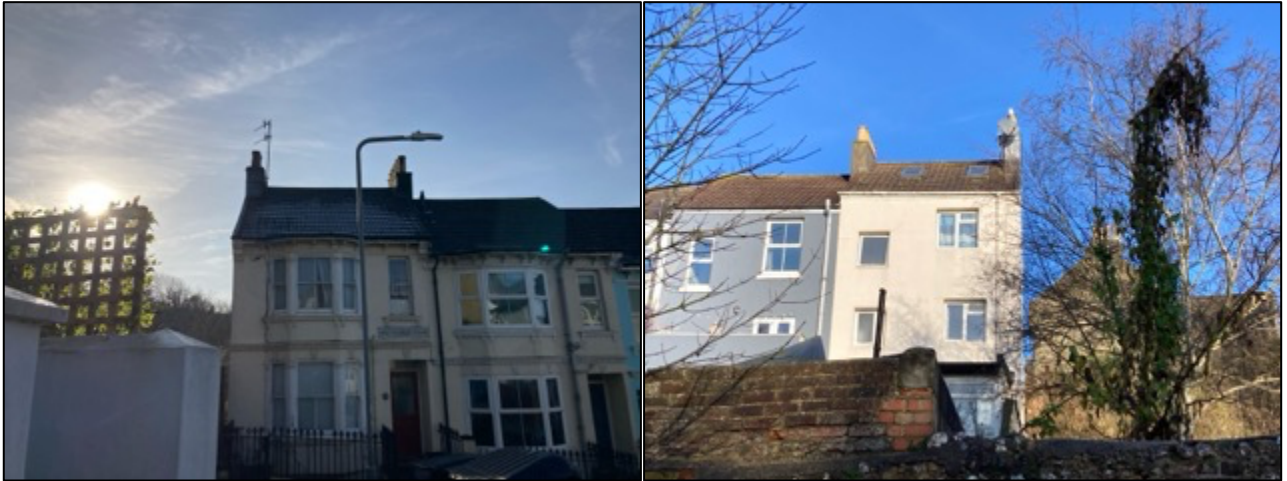
Building section	Description of features	Assessment of suitability ¹
Northern roof aspect	The roof is clad in clay interlocking tiles. The ridge tiles are well mortared. There are no obvious gaps beneath tiles or other features that could be used by roosting bats.	Negligible bat roost suitability
Southern roof aspect	The southern roof aspect is also clad in clay interlocking tiles. Approximately three tiles are missing in the bottom row, however access to these is inhibited by the presence of a drain pipe. There are also a small number of gaps beneath roof tiles, however they appear	Negligible bat roost suitability

Building section	Description of features	Assessment of suitability ¹
	to be superficial. There are no obvious gaps around the chimney or beneath lead flashing around the windows.	
Void 1	Void 1 is located just above the eaves in the roof. It is approximately 0.5m in width and 0.5m in height. The roof is lined and small amounts of insulation are present. The void is currently used as storage.	Negligible bat roost suitability
Void 2	Void 2 is located above the converted loft void. It measures approximately 0.5m in height and 1m in width, and runs the length of the ridge. The roof is lined and supported by timber beams. Heavy cobwebbing is present along the ridge.	Negligible bat roost suitability

Photographs 1a (left) and 1b (right). 1a: the front (northern) aspect of the building. 1b: the rear (southern) aspect.

Overall, the suitability of the building to support roosting bats is rated as 'negligible', considering the condition of the building and its context within suitable foraging habitat for bats. Given this rating but in consideration of the risk of bats using roosts which would typically be considered unsuitable, a precautionary approach to the development is recommended in line with BCT guidelines (section 5.2.9), where it states that 'an ecologist should make a professional judgement on how to proceed based on all of the evidence available'.

- preparatory works – 'soft strip': all roof tiles should be carefully removed from the roof by hand under the supervision of a licensed bat ecologist;
- timing: the hand stripping of roof tiles should be undertaken in the period between May and the end of October to avoid disturbing bats that could be in hibernation;
- in the unlikely event that any bats or evidence of bats is identified during the roof strip, all work should halt and the potential for impacts and need for European Protected Species (EPS) licencing will be reassessed.

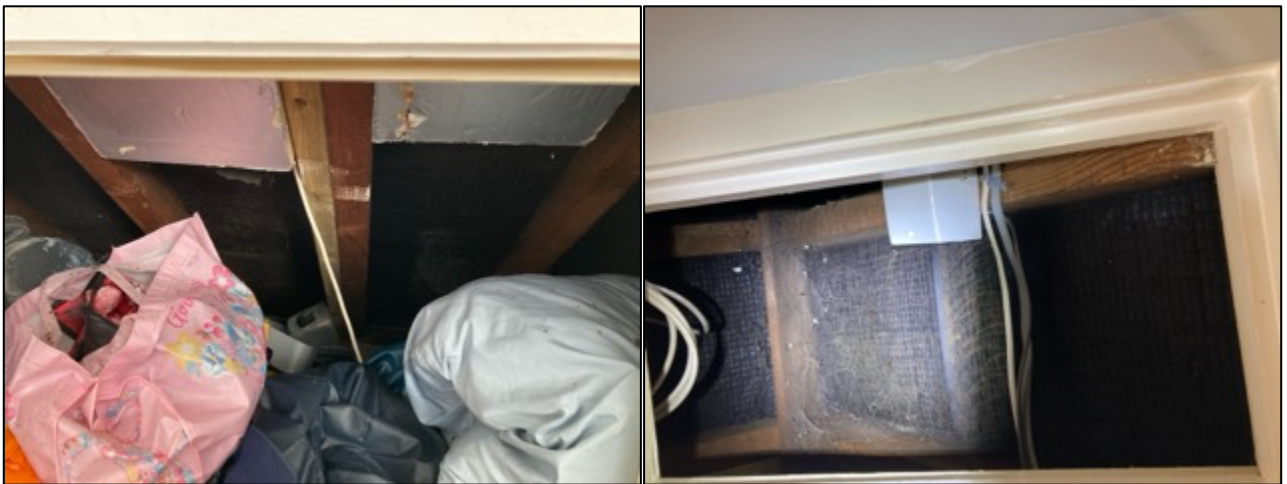
Photographs 2a (left) and 2b (right). 2a: Void 1. 2b: Void 2.
