SUMMARY

Proposed relocated, replacement and/or additional roof lights

Project Title: THE OLD FARMHOUSE, 76 WELHOUSE RD., ALTON

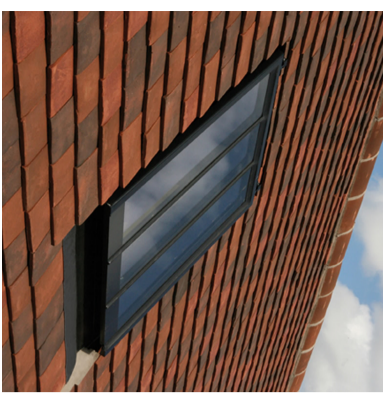
Image of the proposed metal framed double glazed replacement conservation roof lights

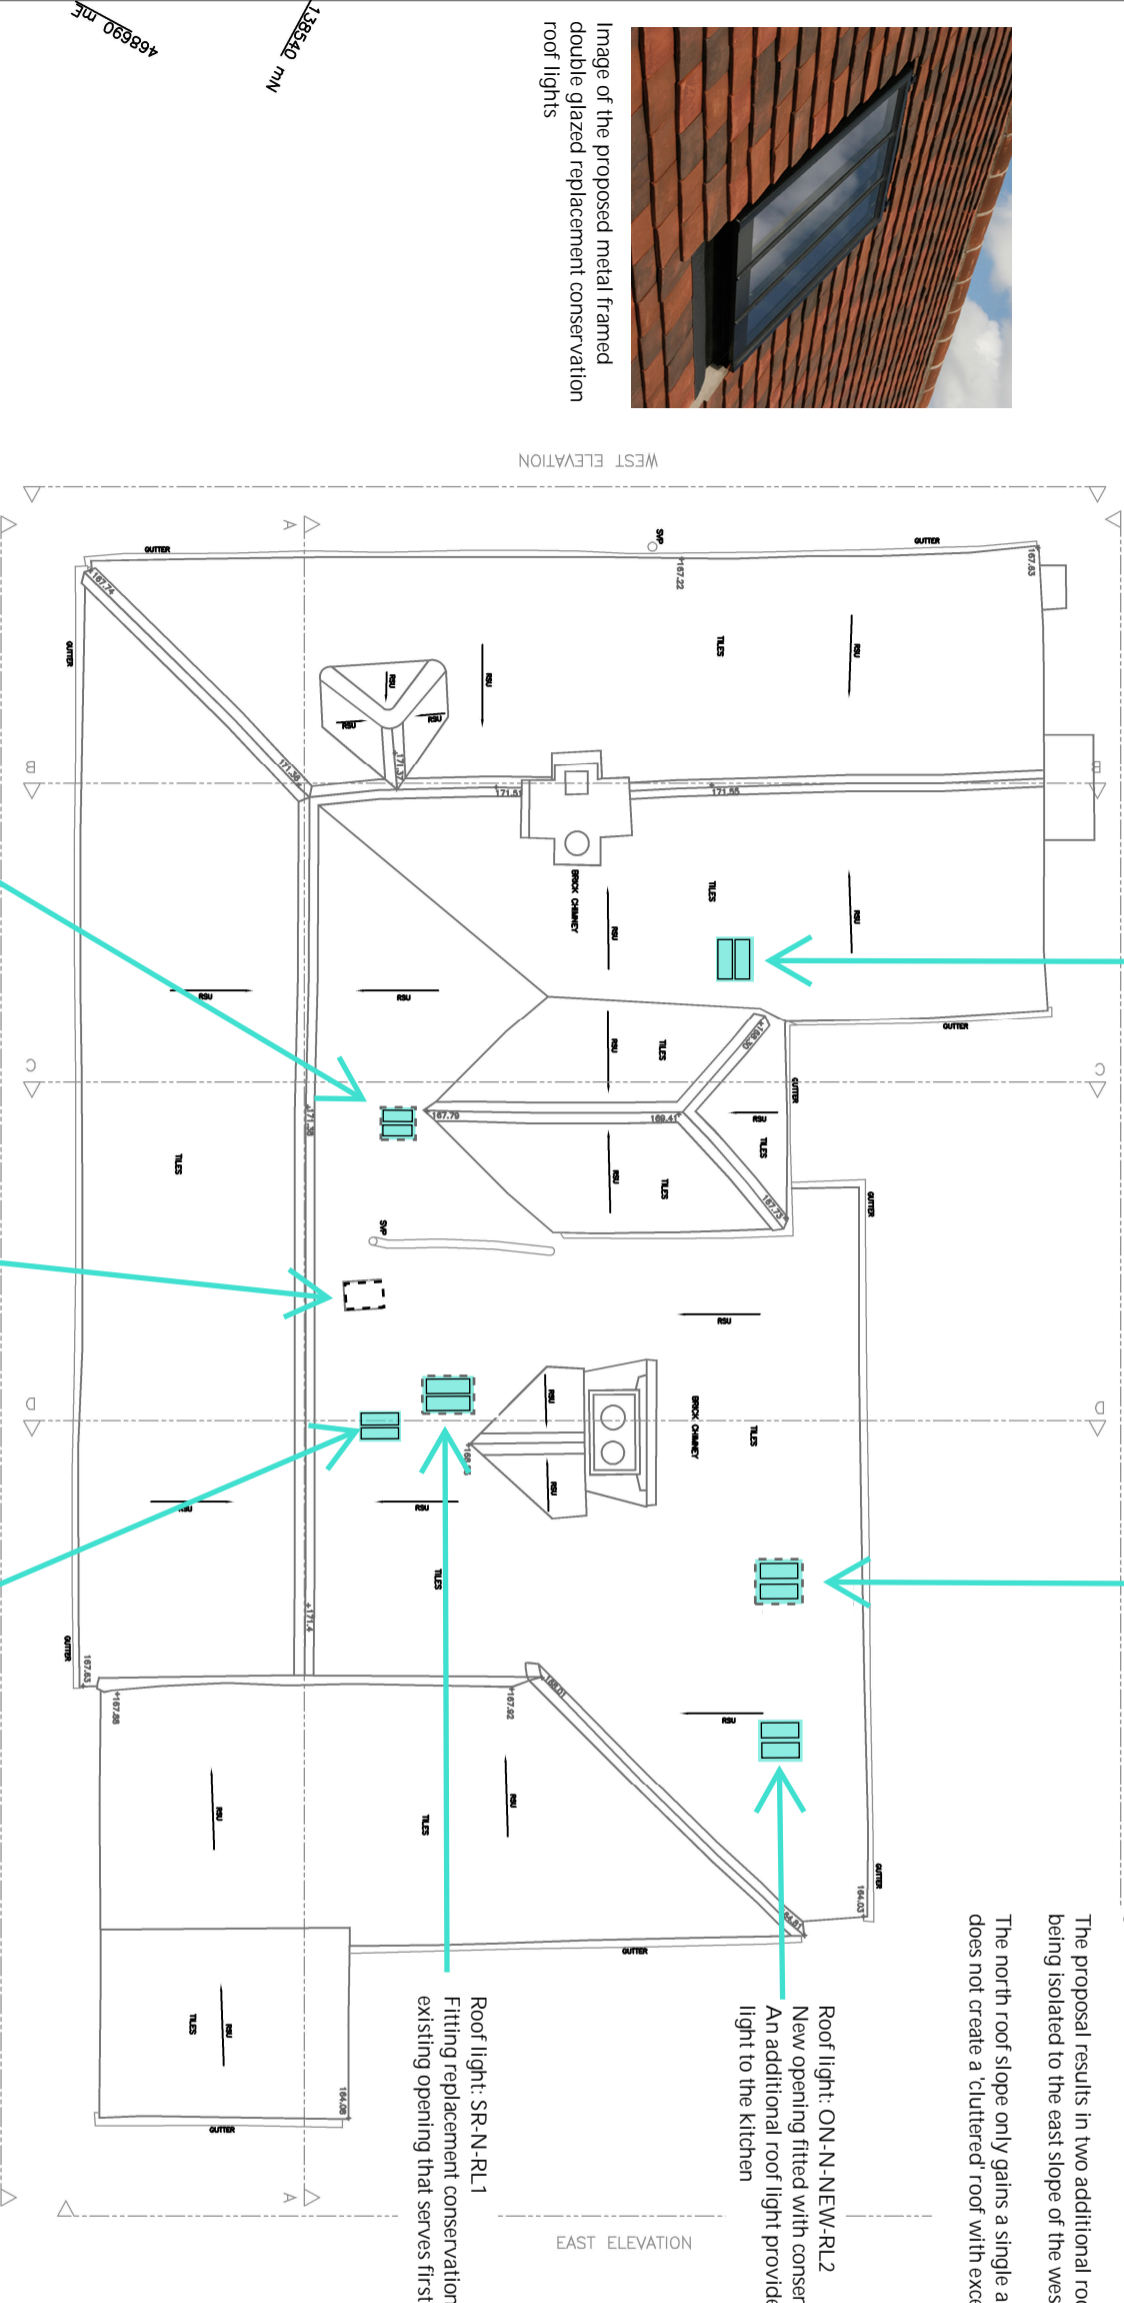
Roof light: WR-E-NEW-RL4  
New opening fitted with egress conservation roof light serving the attic floor accommodation  
The proposed opening is relocated to east slope as this provides the most practicable place to allow safe access to the valley gutter for routine maintenance or in the case of emergency

Roof light: ON-N-RL1  
Fitting replacement conservation roof light into existing opening - the replacement roof light to be smaller than the existing fitting

Roof light: ON-N-NEW-RL2  
New opening fitted with conservation roof light  
An additional roof light provides improved natural light to the kitchen

Roof light: SR-N-RL1  
Fitting replacement conservation roof light into existing opening that serves first floor bathroom

Roof light: SR-N-RL3  
Fitting replacement conservation roof light into existing opening

Existing roof light to be blocked-up and tiled over

Roof light: SR-N-NEW-RL2  
New opening fitted with conservation roof light  
This roof light will serve the attic bedroom  
It is located behind the chimney stack, which will mean that the visual impact of the roof light is minimised

Three existing openings will be reused and fitted with replacement double glazed conservation style roof lights.

One existing roof light will be blocked-up and recovered with tiles.

Two new openings will be created on the north roof slope, one acting as a replacement for the blocked-up opening [SR-N-NEW-RL1] and one added to improve the natural light in the kitchen [ON-N-NEW-RL2].

An additional roof light will be added to the east slope of the west range [WR-E-NEW-RL4] to provide access to maintain the central valley gutter and a means of escape for the attic/second floor accommodation in the event of an emergency. This egress roof light is not readily visible from ground level.

The proposal results in two additional roof lights in total, with one of these being isolated to the east slope of the west range and not readily visible. The north roof slope only gains a single additional roof light and, as such, does not create a 'cluttered' roof with excessive roof lights.
