Bat Survey Report

Heywoods Farm, Stratfield Saye, Reading, RG7 2DG

Surveys conducted in August and September 2021 and June 2023

Report Title: Heywoods Farm, Bat Report

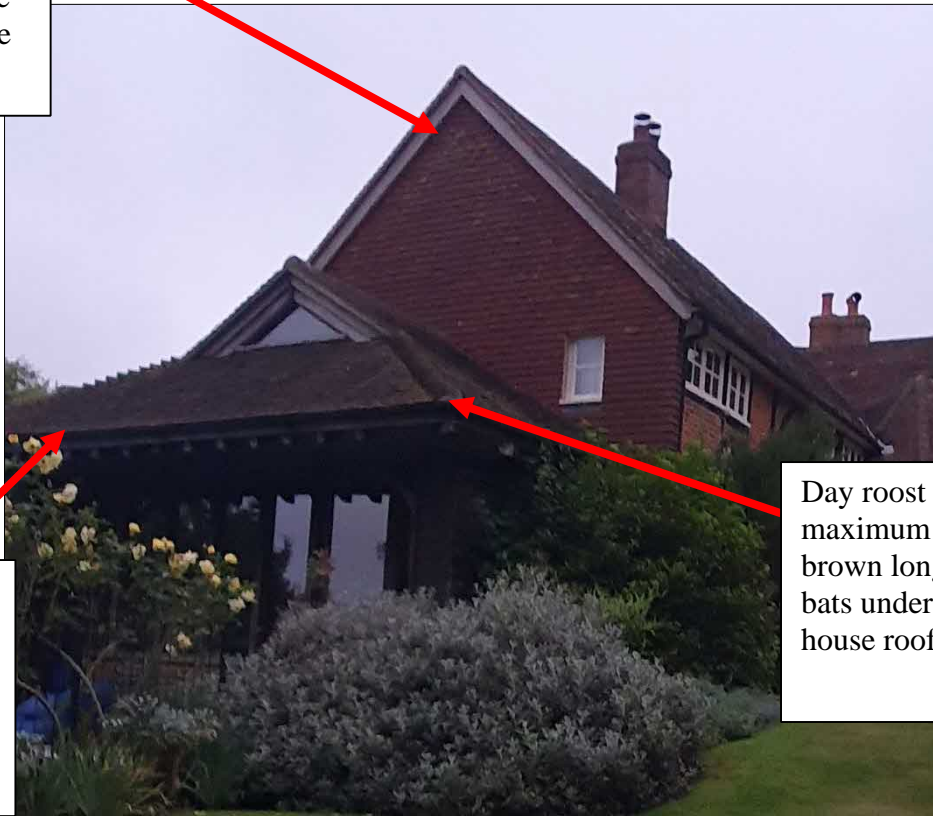
APPENDIX 3: Position of Bat Roosts

Roost C is a maternity roost for a maximum of twenty-one soprano pipistrelle bats under hanging wall tiles on the south gable end of the house.

Maternity Roost for 21 Soprano pipistrelles between hanging wall tiles on the gable end of the house.

Additional bat access points: On the house bat tiles will be added to the areas of roof on the southern elevation to provide crevices for common pipistrelle bats and access into the loft for brown long eared bats.

In addition a squeeze box or maternity box will be added into the retained loft space to mitigate for the soprano pipistrelle maternity roost being lost. This will be accessed by

the bats via a bat access tile which will create a similar access to that of the previous roost.
