Bat Survey Report

Heywoods Farm, Stratfield Saye, Reading, RG7 2DG

Surveys conducted in August and September 2021 and June 2023

Report Title: Heywoods Farm, Bat Report

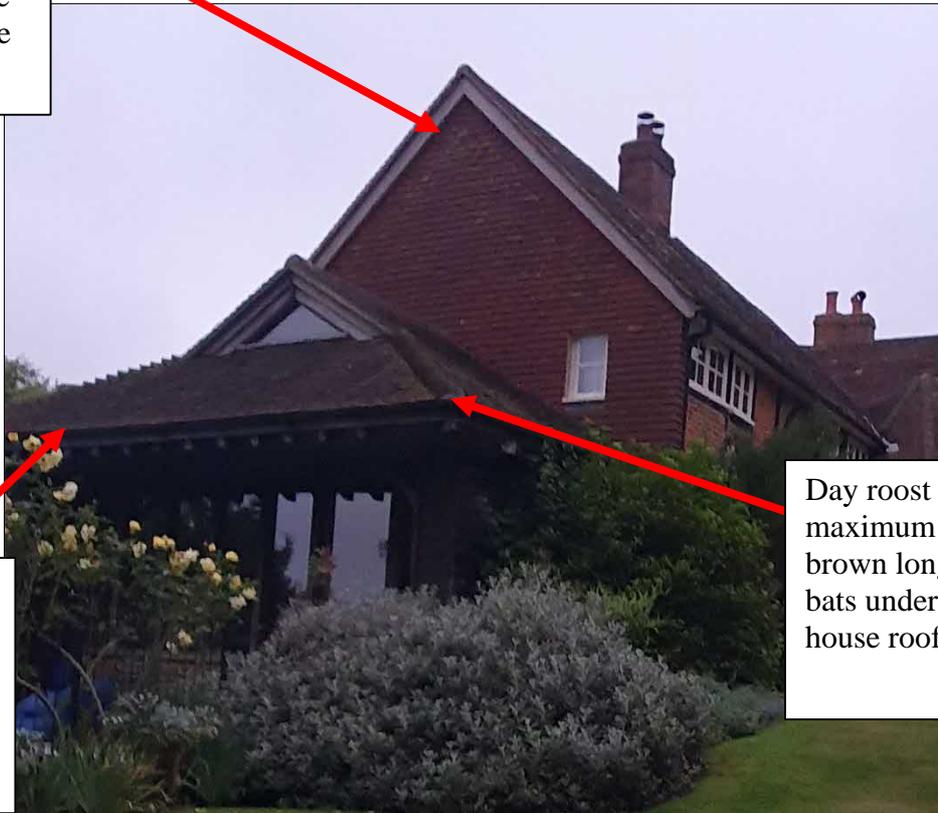
Maternity Roost for 21 Soprano pipistrelles between hanging wall tiles on the gable end of the house.

Roost C is a maternity roost for a maximum of twenty-one soprano pipistrelle bats under hanging wall tiles on the south gable end of the house.

Roosts A, B and C will be destroyed by the planned demolition of the pool house and removal of the hanging wall tiles on the south elevation.

The mitigation plan will provide temporary bat roosting. Any tiles or roof materials and hanging tiles will be removed under a soft strip in September/October or March/ April. On the house bat tiles will be added to the areas of roof on the southern elevation providing crevices for common pipistrelle bats as well as a squeeze box for the maternity roost to provide a similar roost space and access to that currently under the wall tiles.

In addition a squeeze box or maternity box will be added into the retained loft space to mitigate for the soprano pipistrelle maternity roost being lost. This will be accessed by

the bats via a bat access tile which will create a similar access to that of the previous roost.

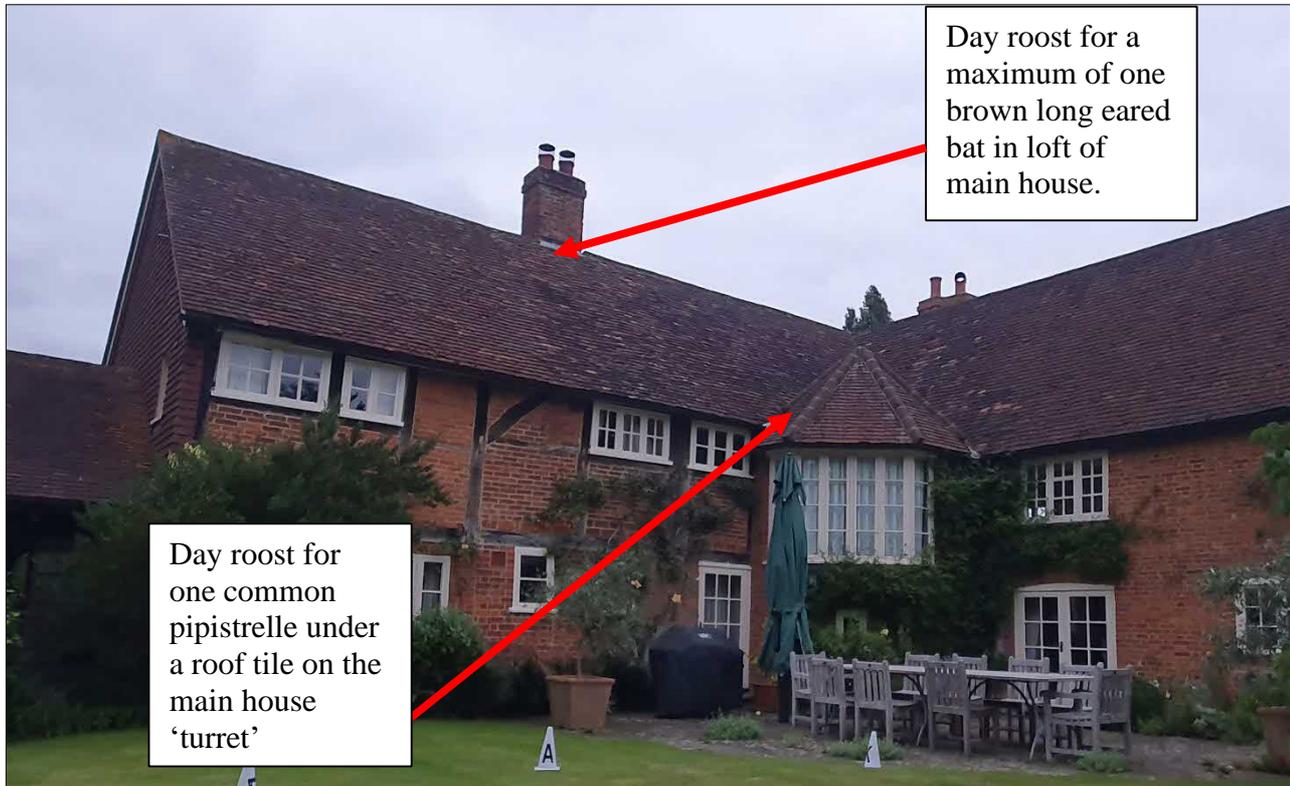
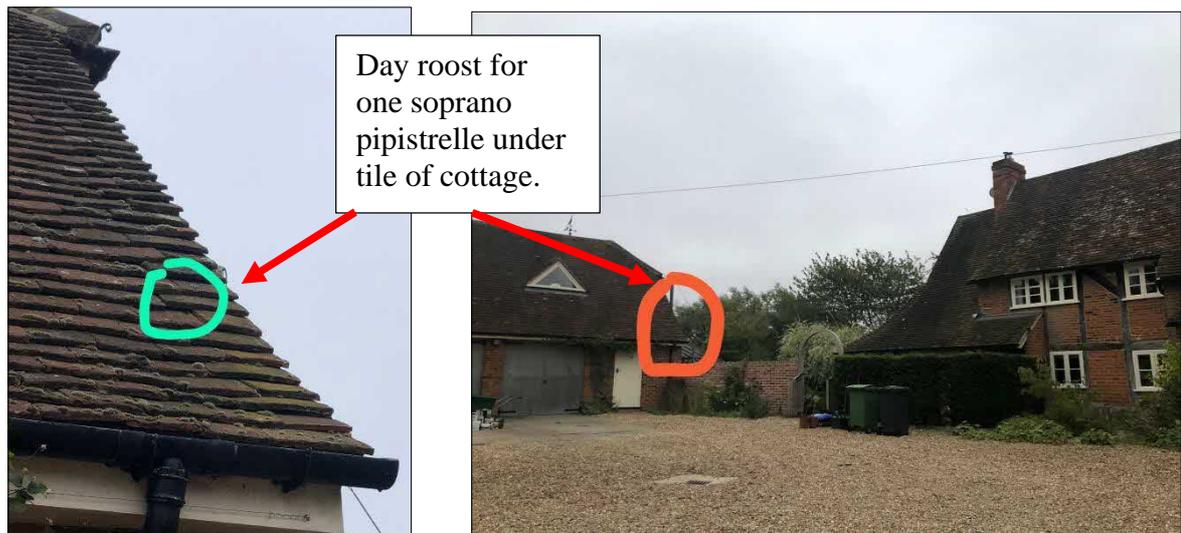
Day roost for one Common pipistrelle under left hand side of guttering of pool house.

Day roost for a maximum of two brown long eared bats under pool house roof tile

Roost A is a day roost for 1 common pipistrelle bats under a roof tile on the end of the pool house near the gutter line on the left-hand side.

Roost B is a day roost in the pool house loft space for a maximum of two brown long eared bats, accessed via gaps in roof tiles.

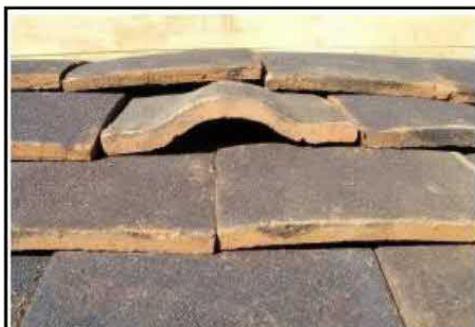
Tudor Tile bat access points ★

Colours available:

- Red antique
- Dark antique
- Medium antique
- Sussex red
- Sussex brown
