18 Lamintone Drive,
Leamington Spa,
Warwickshire, CV32 6SJ

PRELIMINARY BAT ROOST APPRAISAL

November 2023

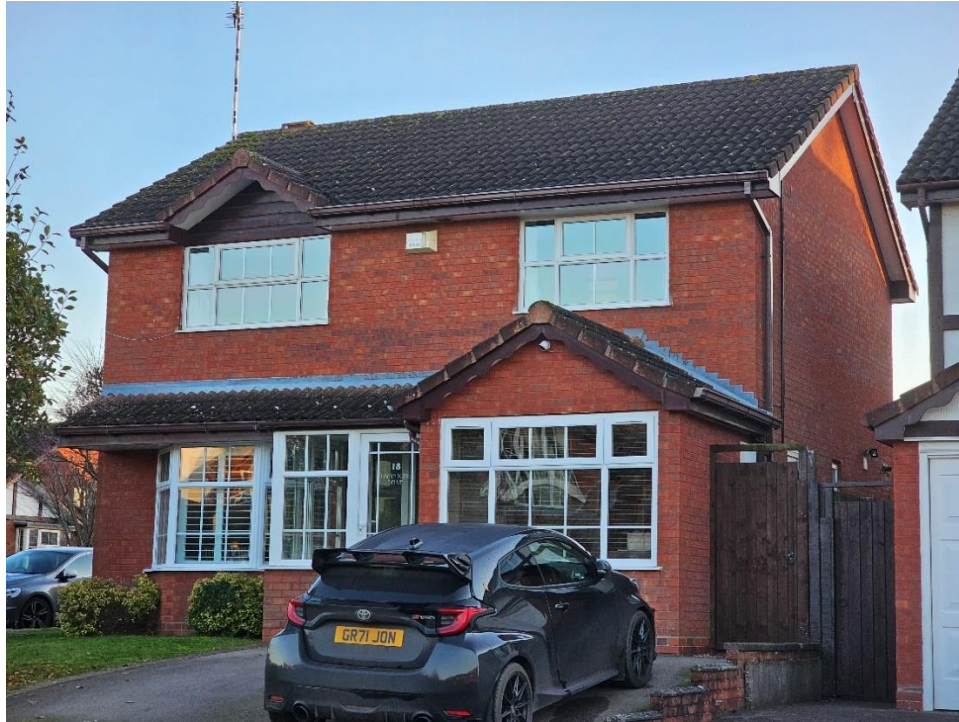
Plate 1. Northern aspect.

Walls are of red brick in a stretcher-bond, with an internal cavity. Brickwork and pointing are in good condition. Doors and windows on northern and southern aspects are of PVCu, in good condition and tight to apertures. On the northern aspect, an attached single garage has previously been converted into living space with brick walls and a PVCu window to match the rest of the property. To the east of this is a flat-roofed brick and PVCu porch, joining onto a pent-roof covering a ground floor bay window. Soffits and fascias are of PVCu, in good condition and tightly fitted.

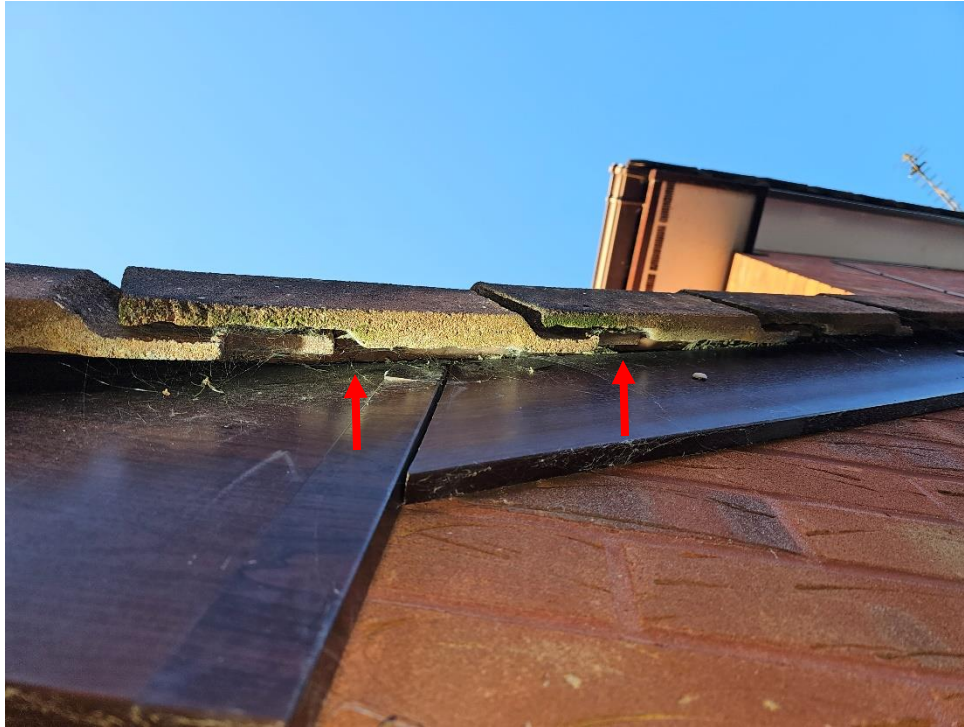
- Raised tiles on lower edge of the southern pent-roofed section, providing access beneath tiles.
- Gaps beneath overhanging verge tiles on ends of the southern pent-roofed section, providing access beneath tiles.

Plate 3. Gaps beneath verge tiles on eastern gable end of pent-roof section, allowing potential access beneath tiles.

- Works to the roof should ideally be timed to begin between November and mid-April to avoid the peak roosting season.
- Pre-works endoscopic inspection of gaps beneath tiles on the pent-roofed extension.
- Toolbox talk to contractors.
- Soft strip of sensitive areas of the roof under direct supervision of a bat-licensed ecologist.
- In the unlikely event that bats or evidence of bat activity are found during works, roofing materials shall be reinstated until such time that further surveys can be conducted during the appropriate season.

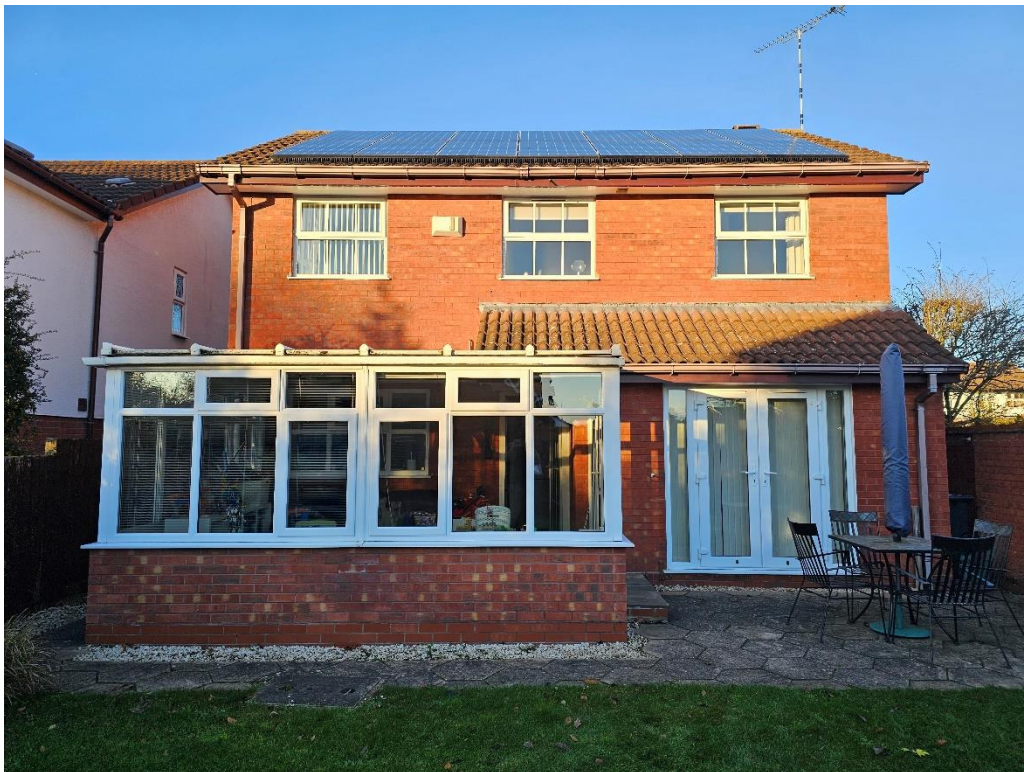
Plate 4. Southern aspect, showing the conservatory and pent-roofed section to be removed.

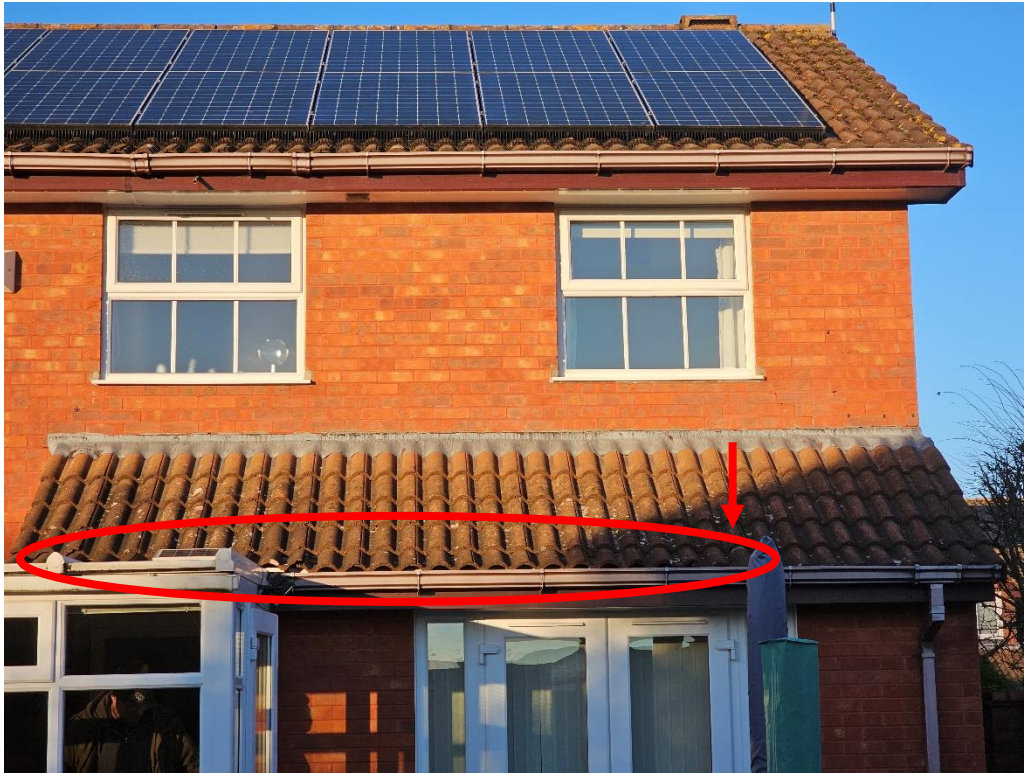
On the southern aspect, there is a pent-roofed section and attached conservatory. The pent roof is of Double Roman interlocking concrete tiles to match the main roof, lined with a breathable roofing membrane. Tiles at the eastern end are well-seated and sealed with plastic weather seals, however tiles along the lower edge of the remaining length are lifted preventing water seals from sealing and allowing potential bat access beneath the tiles. Endoscopic inspection along this feature found no bat droppings or other signs of bat usage in any of the areas that droppings would usually accumulate. On the eastern end of the pent-roofed section, there are gaps beneath the overhanging verge tiles providing further potential bat access. However, these gaps were cobwebbed with no signs of entry on the PVCu fascias. The western end is covered with PVCu cladding in good condition. There may be similar gaps under verge tiles at this end, although the smooth plastic surface provides little grip for bats attempting to gain access. The conservatory is of PVCu-framed glass on a brick footing, flat-roofed with twin-wall polycarbonate sheets providing no potential points of bat access.

Plate 5. Pent-roofed section, showing location of raised tiles (ellipse) and broken tile (arrow).

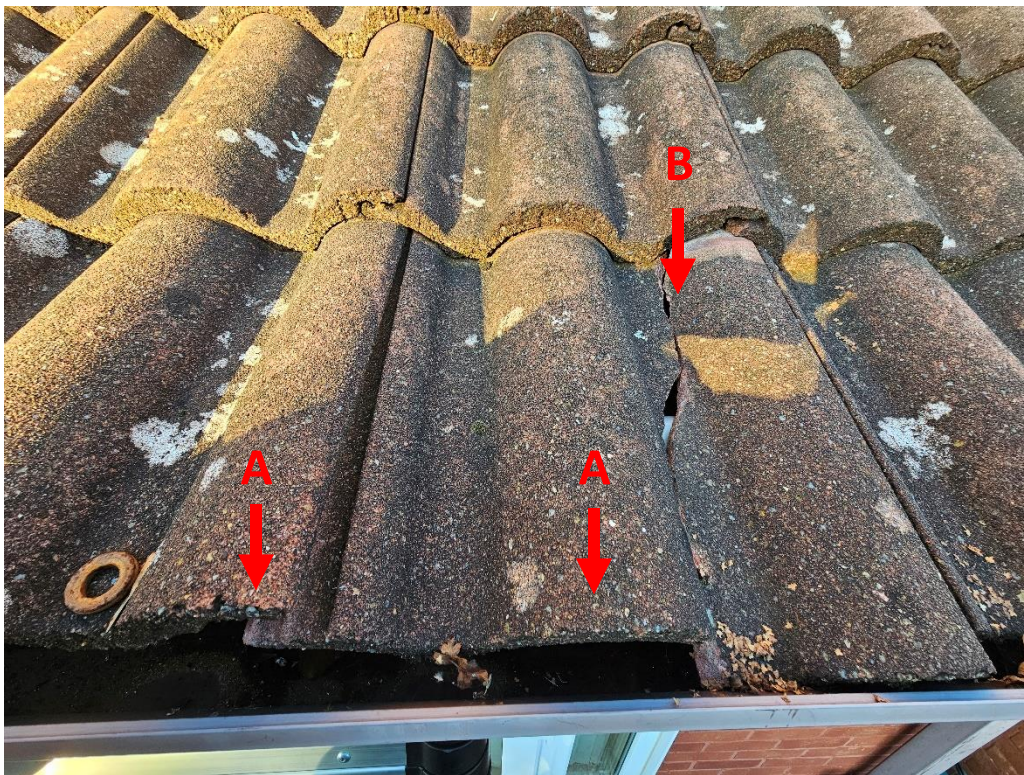
Endoscopic inspection of the raised tiles on the pent-roofed section found no evidence of bat activity in the places bat droppings would usually be expected to accumulate.

Plate 6. Raised tiles (A) and broken tile (B) on the pent-roof section.

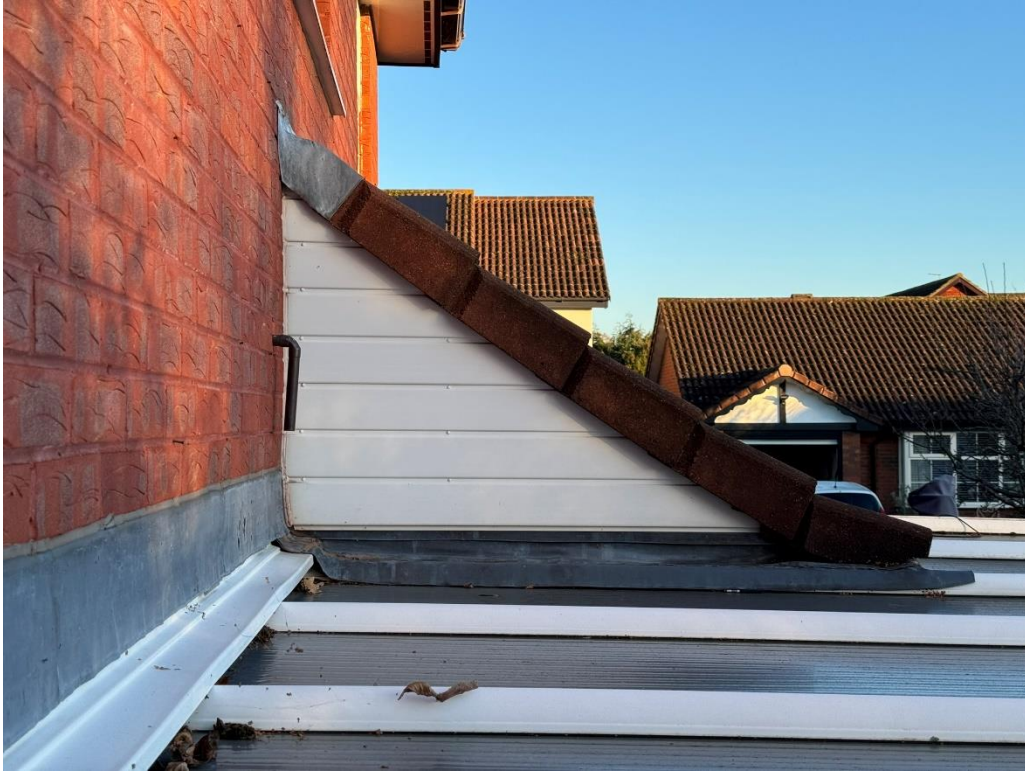
Plate 7. PVC cladding at western end of pent-roof section.

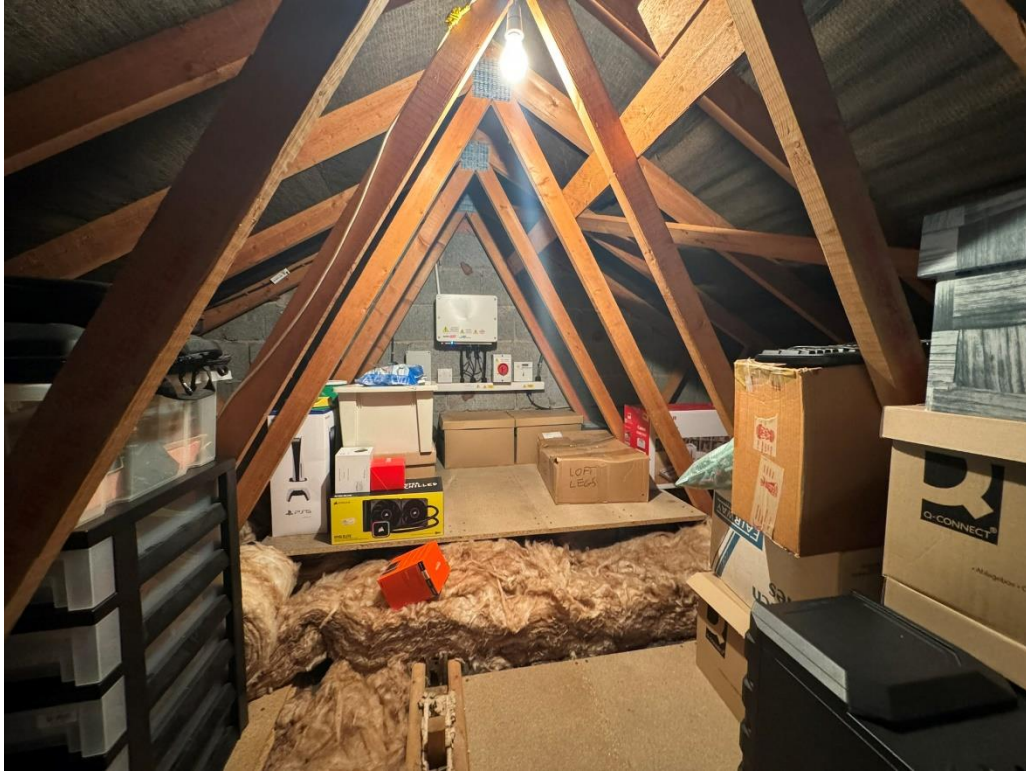
Internally, there is a single large roof void. Timbers are modern, machine-cut, butted and joined by nail plates in fink arrangement. Tiles are lined with hessian-reinforced bituminous roofing felt, which was mostly in good condition but there were some tears and one section was sagging. The base of the void was lined with glass fibre roll insulation, with partial boarding. There was minor daylight ingress and a light coating of wind-blown debris around the flue at the eastern end. This was coming through the raised vent tile, which external inspection showed to be blocked with mesh, preventing bat access. Cobwebbing was very light and no rodent droppings were visible. A thorough inspection found no bat droppings or other signs of bat usage.

Plate 9. Roof void, looking towards western gable.

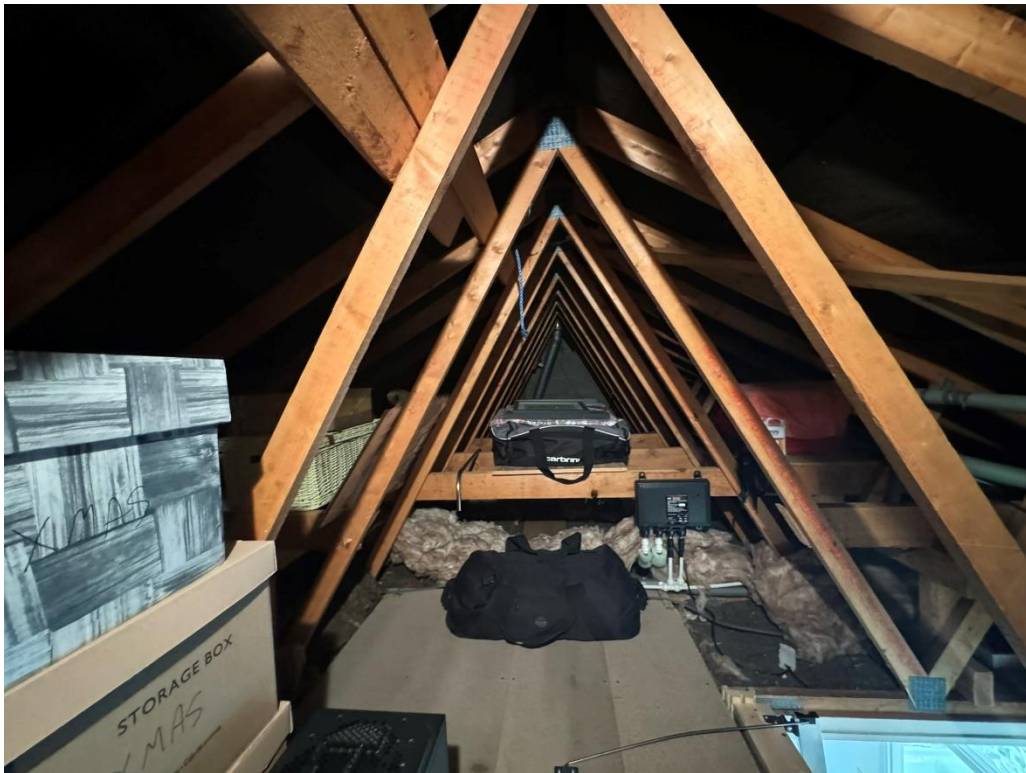
Plate 10. Roof void, looking towards eastern gable.
