PHASE 1 BAT & NESTING BIRD SURVEY

**24 Kenilworth Road, Leamington Spa,
Warwickshire, CV32 6JB**

2nd October 2023

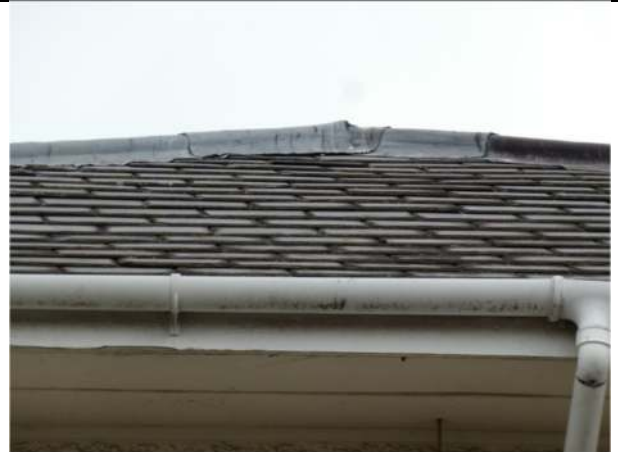
Generally, the roof on the main part of the building appears to be quite well-sealed (e.g. Photographs 8 and 9). The slates on the gable and hipped roof in the centre of the building are also well-sealed (e.g. Photograph 10) except for an opening under a ridge tile (Photograph 11) and under slates at the eastern end (Photographs 12 and 13). These could be visually inspected and did not contain any signs of being used by bats.

Photograph 8. Example of the slates on the west-facing roof pitch of the house

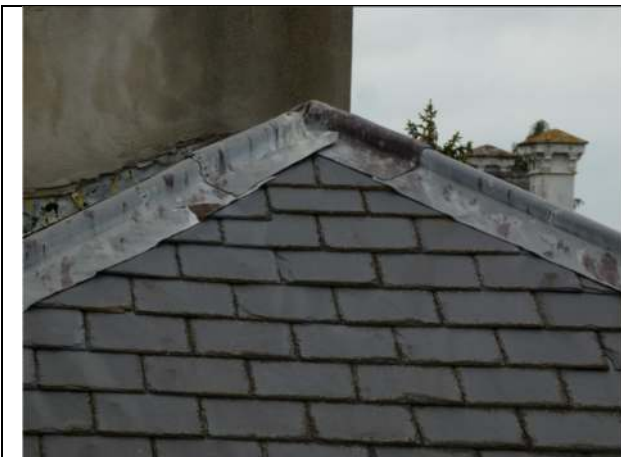
Photograph 9. Example of the slates on an east-facing roof pitch of the house

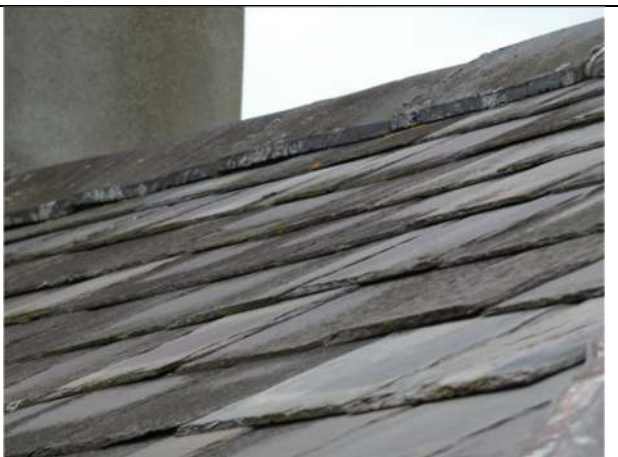
Photograph 10. Example of the slates on the central part of the house

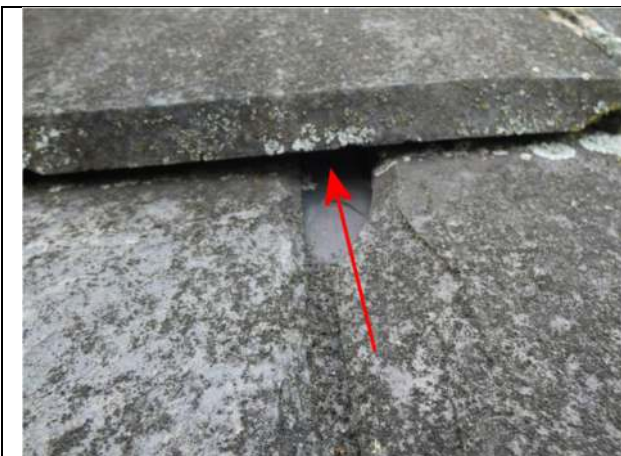
Photograph 11. Opening under a ridge tile on the central part of the house

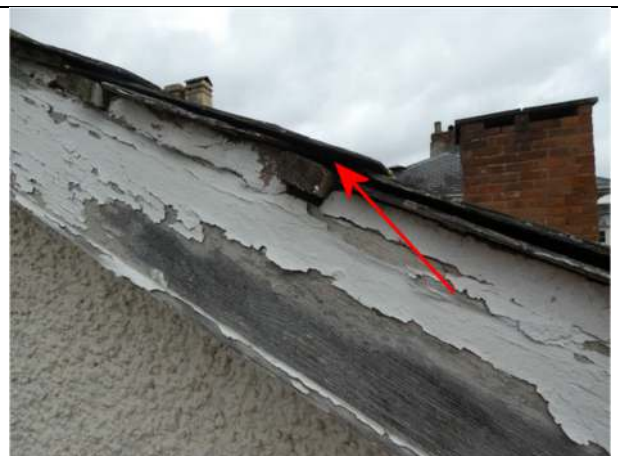
Photograph 12. Opening under a slate above the west gable on the central part of the house

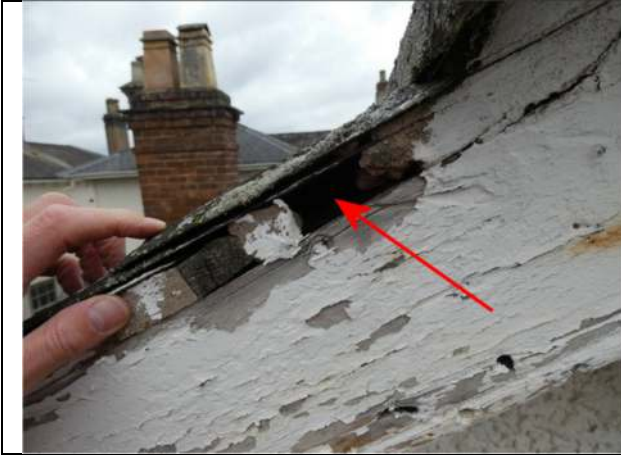
Photograph 13. Opening under a slate above the half gable on the central part of the house

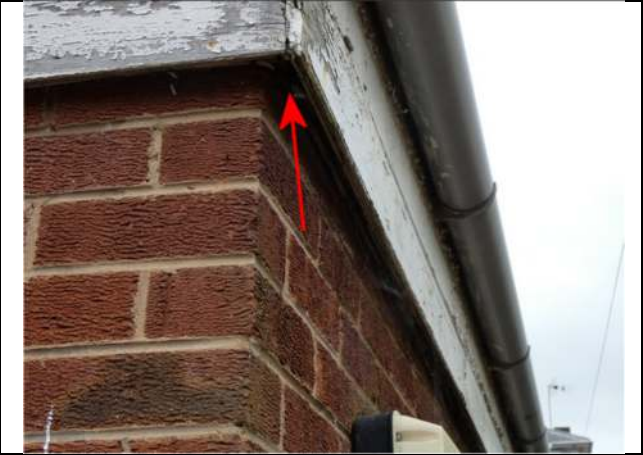
There is a gap between the wall at the fascia at the north-east corner of the central part of the house (Photograph 14). There were no signs of bats in the cavity behind the fascia.

Photograph 14. Gap under the soffit at the north-east corner of the main part of the house

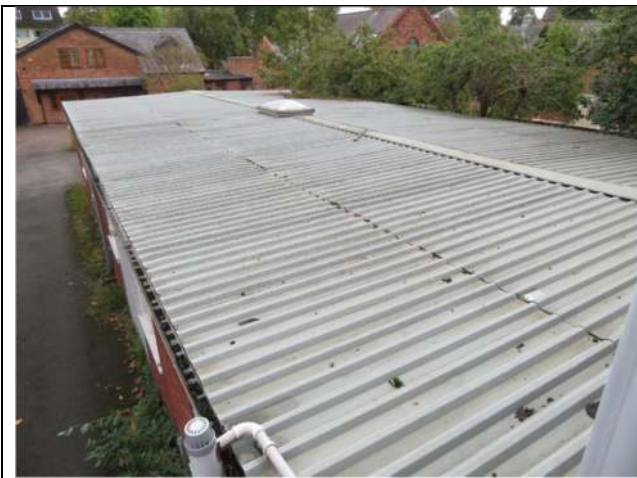
The flat roof of the single-storey extension is completely sealed (Photograph 15) and although there are gaps underneath the edge of the roof (Photograph 16) these are unlikely to be used by bats.

The cavities between the slates, battens and lining are suitable for crevice-dwelling species such as those of the genus *Pipistrellus* and the small *Myotis* (e.g. Photograph 15). However, access is limited to the openings mentioned above.

Photograph 15. The roof of the single-storey section at the eastern end of the house

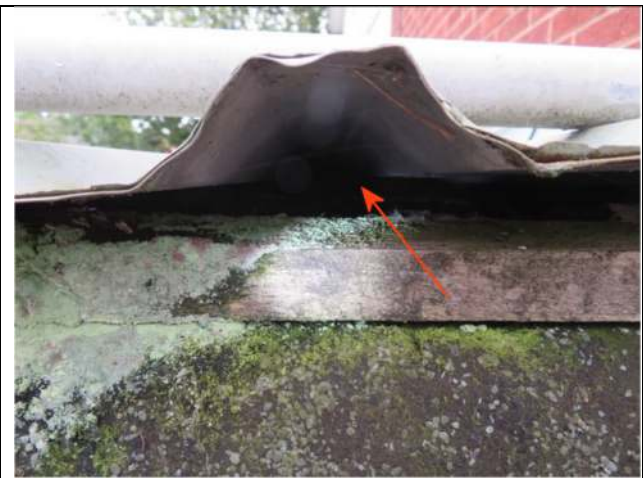
Photograph 16. Example of a gap under the roof of the single-storey section at the eastern end of the house

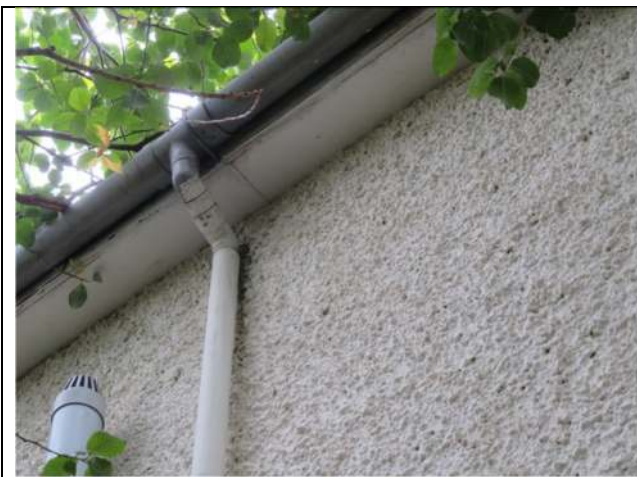
Other than the above, the soffits and fascias are completely sealed (e.g. Photograph 17).

Photograph 17. Example of the soffit on the main part of the house

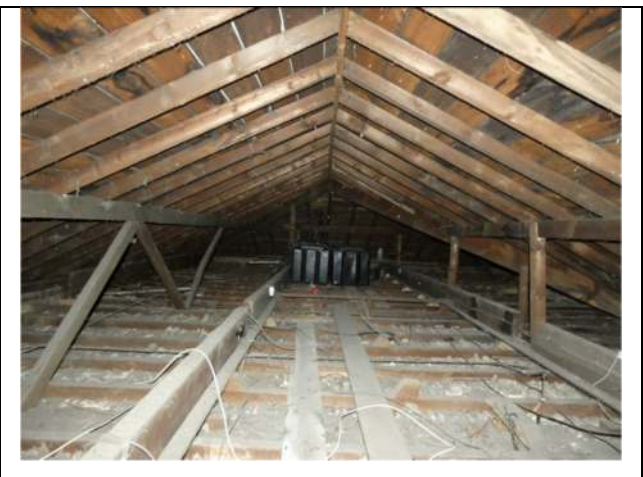
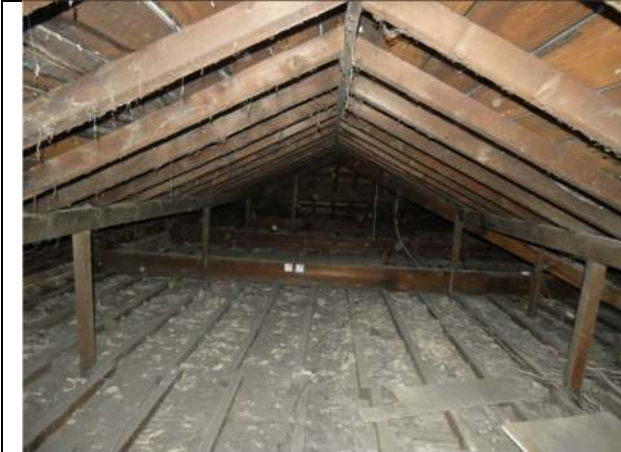
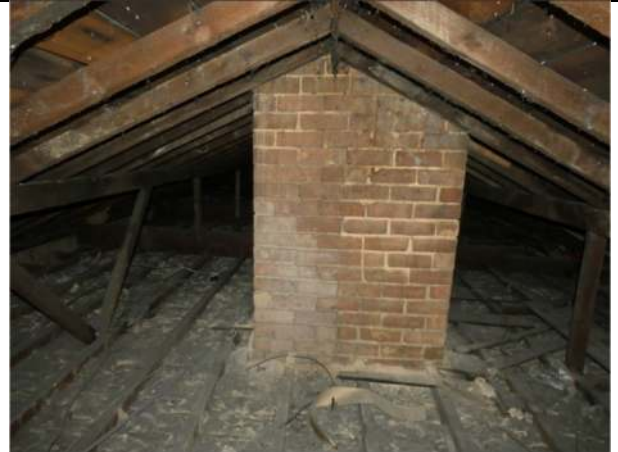
There is a large enclosed roof void within the main part of the building (Figure 2; Photographs 18-20) which contains exposed roof timbers and timber sarking suitable for perching (e.g. Photograph 21). There is also an enclosed roof void within the central part of the building (Photographs 22 and 23) within which the timbers are less exposed as they have been covered with a lower membrane, although this has degraded in many places. Such roof voids are suitable for those species of bats that require a large flying area within the roosting space, such as brown long-eared bats. However, the prevalence of cobwebs and dust indicates that bats have not been present for some time, if at all. In addition, there does not appear to be any suitable access.

Photograph 18. The enclosed roof void within the main part of the house (west section)

Photograph 19. The enclosed roof void within the main part of the house (south section)

Photograph 20. The enclosed roof void within the main part of the house (north section)

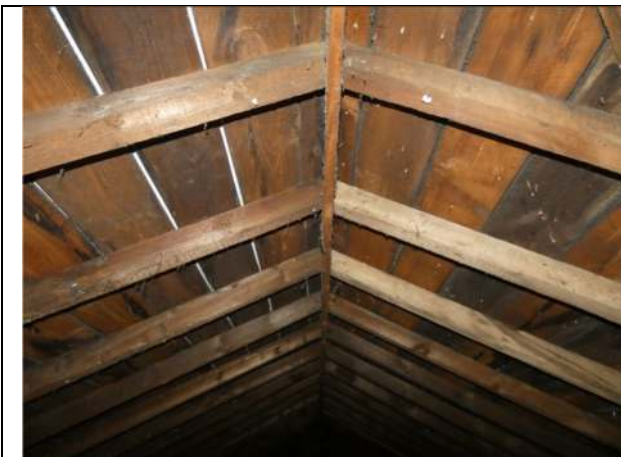
Photograph 21. Sarking and roof timbers within the main part of the house

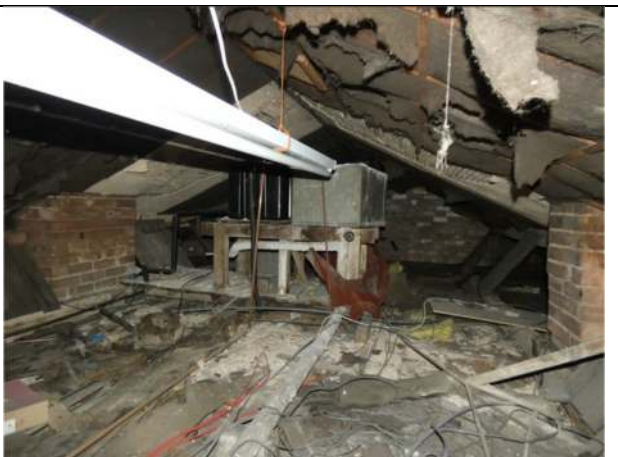
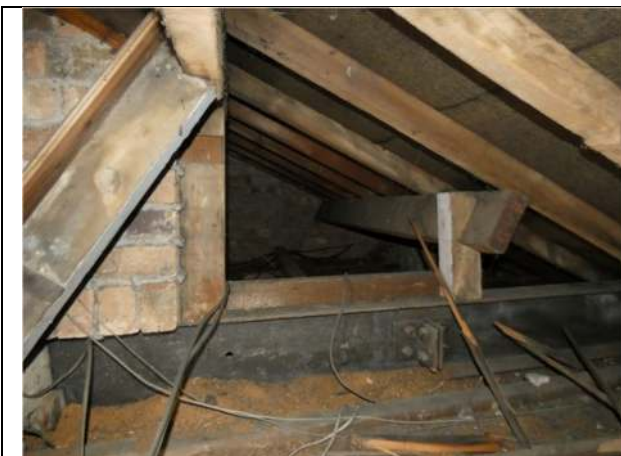
Photograph 22. The enclosed roof void in the central part of the house (to east gable)

Photograph 23. The enclosed roof void in the central part of the house (to half gable)

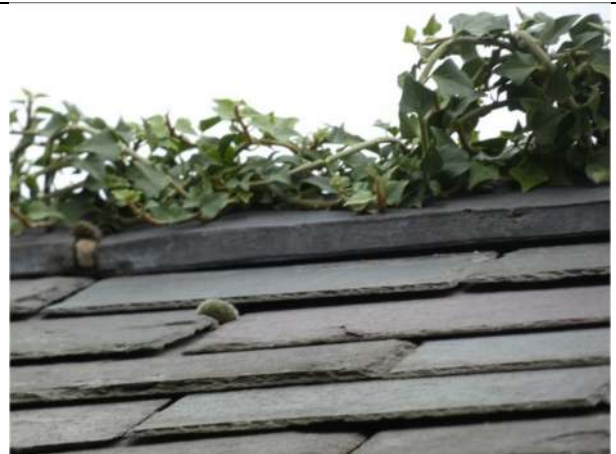
The roof is completely sealed (e.g. Photograph 26) except for a few small openings under the ridge tiles (e.g. Photograph 27).

Photograph 26. Example of the slates on the roof of the cottage

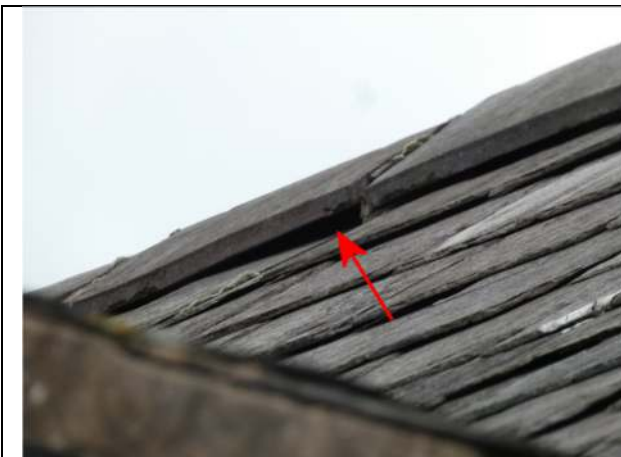
There was no evidence of bats within the house or the cottage. It was possible to visually inspect all of the potential roosting sites with suitable access for bats except for the cavities under ridge tiles on the cottage (see 3.2.2).

Photograph 27. Opening under a ridge tile on the cottage

- As a precaution, a licensed ecologist is present to oversee the removal of the ridge tiles on the cottage, prior to demolition (see 3.2.4). If there is any evidence of bats during the removal of the tiles work must stop and if it is not possible to reinstate the roost sites it may be necessary to obtain an appropriate derogation licence from Natural England.
- All work must be carried out carefully with the expectation that bats may be found. If bats are observed within the buildings at any time Natural England or the ecologist for this project must be contacted. Work must cease immediately and it may be necessary to obtain a European Protected Species licence from Natural England before work can proceed.

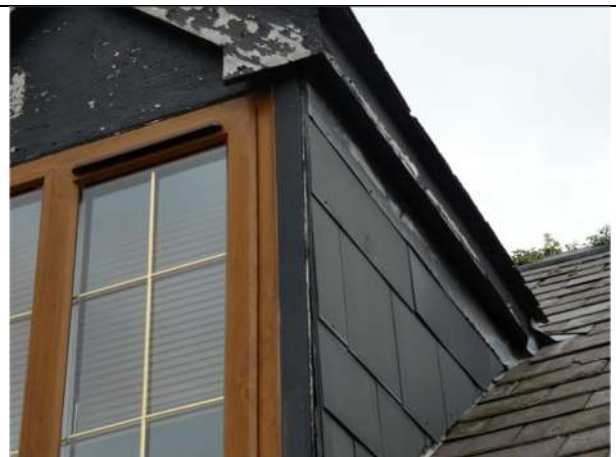
The west dormer window is sealed (Photograph 28). Although there are a few gaps they are too small to afford bats access.

Photograph 28. Example of sealed hanging slates on the dormer window on the western side of the cottage

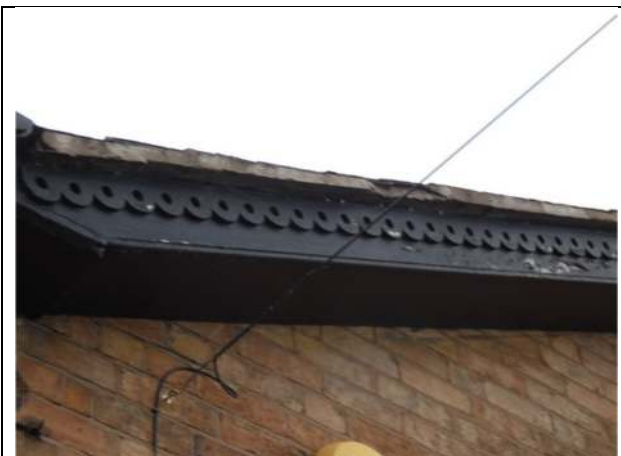
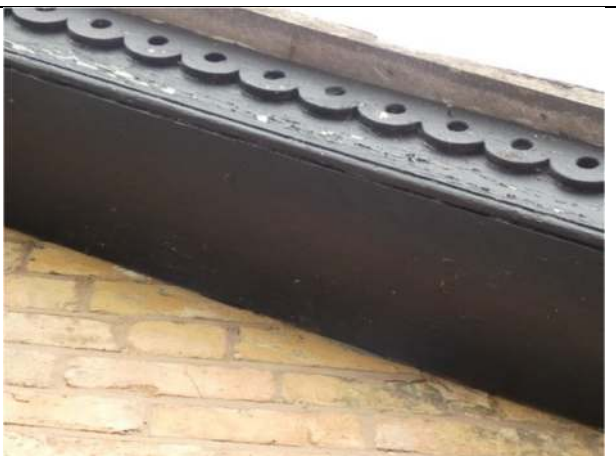
The soffits and fascias are sealed (e.g. Photographs 29 and 30).

Photograph 29. Example of sealed soffits on the cottage

Photograph 30. Further example of sealed soffits on the cottage

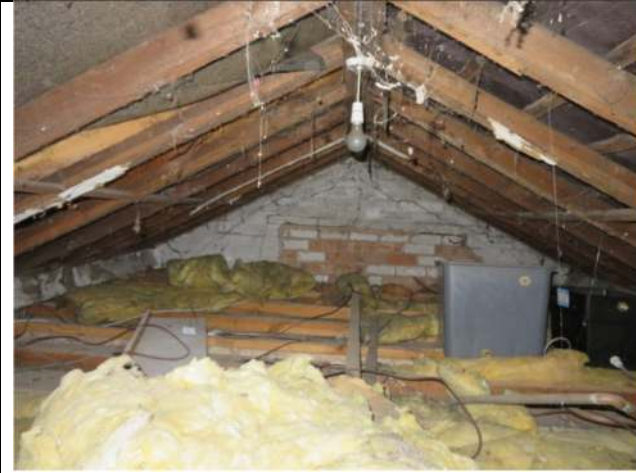
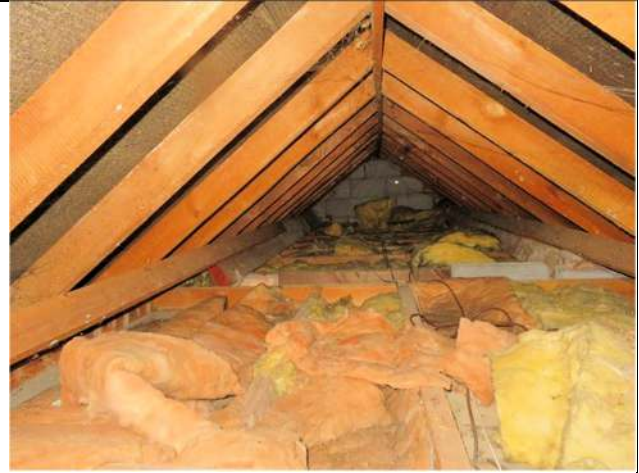
There is an enclosed roof void within the building (Figure 2; Photographs 31 and 32) which contains exposed roof timbers suitable for perching. Such roof voids are suitable for those species of bat that require a large flying area within the roosting space, such as brown long-eared bats. However, the cobwebs hanging from ridge to floor within the main part and to a lesser extent in the gabled projection to the south indicate that bats have not been present for some time, if at all.

Photograph 31. The section of enclosed roof void within the main part of the cottage

Photograph 32. The section of enclosed roof void within the gabled projection to the south on the cottage

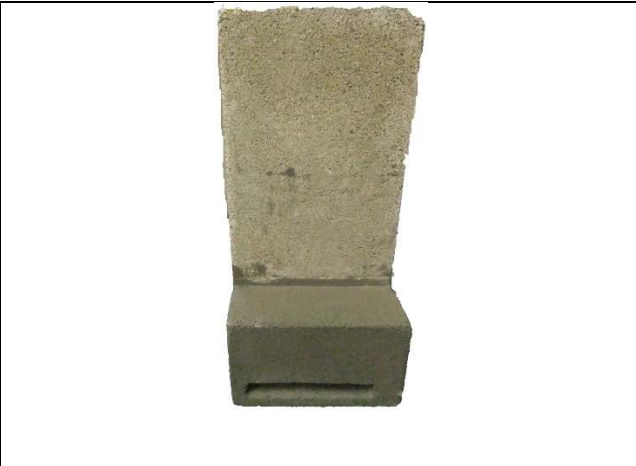
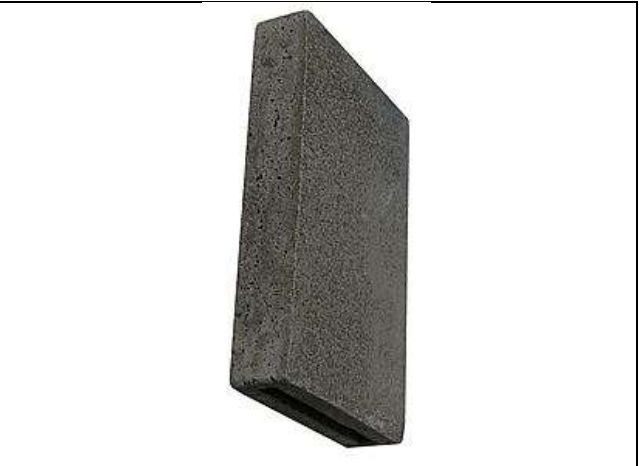
Photograph 31. Woodstone Bat Box

Photograph 32. Greenwood's EcoHabitats single cavity bat box

- Incorporating bat boxes into the top of the east, south or west-facing walls (e.g. Photographs 31 and 32).
