BENLIN FARM.

Suitability of Conversion of a Barn to a Habitable Building.

Structural Statement.

May 2022

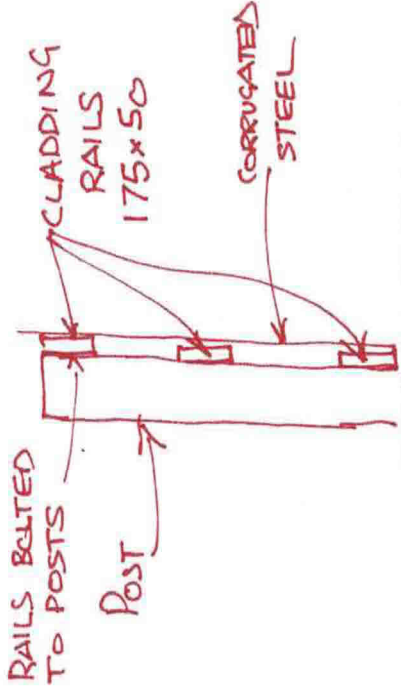
BENJIN FARM BARN
EXISTING FLOOR PLAN
1:100 REV -
27 MARCH 2022

The pitched roof has a corrugated sheet covering supported by timber rafters, purling, struts and a ridge member as shown on the enclosed existing floor plan. The external walls have horizontal timber side rails supported by timber studs at 400mm centres. The external timber walls are built off shallow brick plinths.
