[REDACTED]  
**Re: Proposed development at Agricultural barn building at Bank Top Farm, Mill Lane WN2 1QG**

We understand that the proposal is for the refurbishment of an existing agricultural barn and stables.

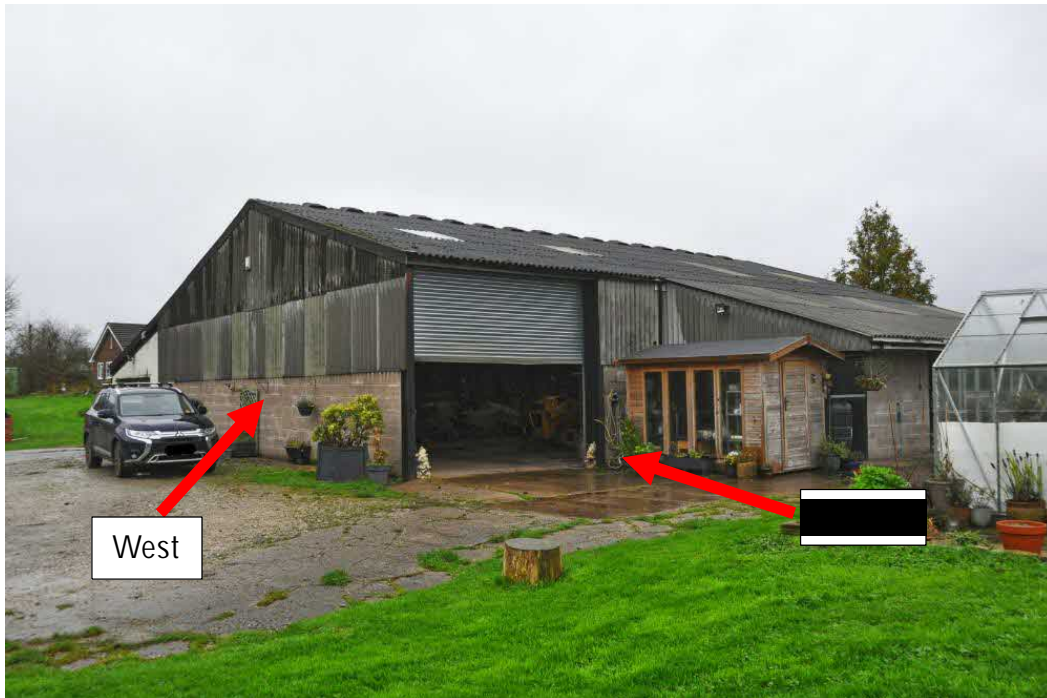
The building comprises a steel and timber framed agricultural barn with adjoining stables on the north and south elevations. The roof is corrugated asbestos sheeting with plastic sheet roof lights. The lower walls are block and the upper walls are a mix of plastic and asbestos sheets. There are no roof voids, the roof is unlined and there are no suitable dark sheltered spaces for use by roosting bats. The only potential roost feature found is a cavity feature associated with the overlapping sheet coverings on the upper walls, located on the west elevation. This cavity was fully inspected during the survey.

View of the barn building showing west and south elevation

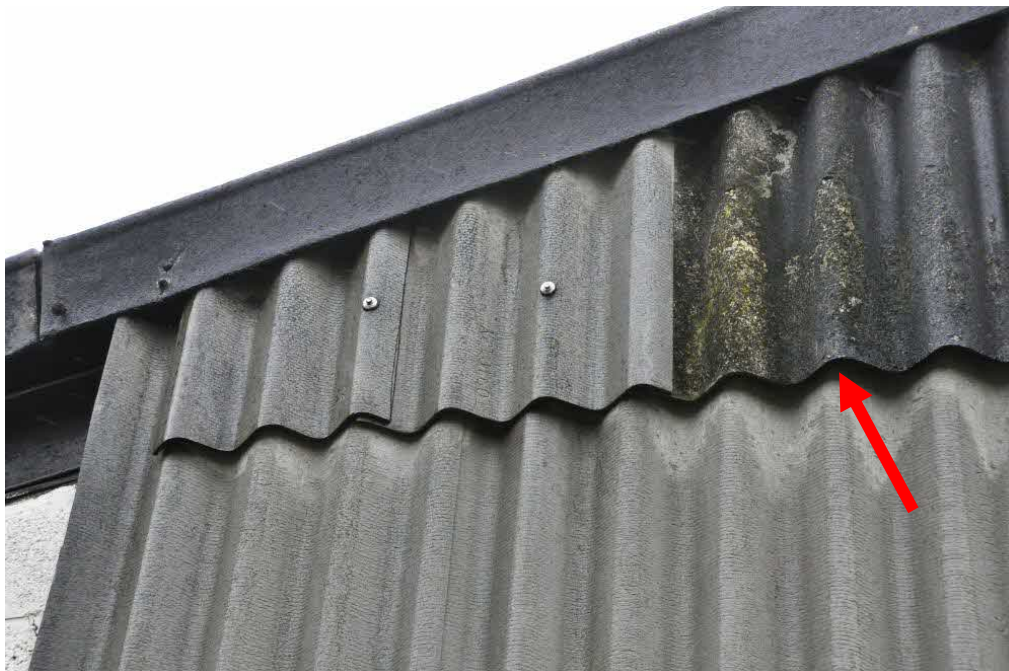
Low potential – cavity feature associated with overlapping sheet walls

View of overlapping external sheet walls. The overlap creates a small dark cavity with low potential for use by bats

Protected Species	Impacts, Issues & Rationale	Action Required
Bats	<p>There are no known impacts to bat roosts as a result of the proposed works.</p> <p>It is advised that there are potential roost features suitable for bats associated with external gaps between overlapping sheet walls. In this location and landscape setting, these features have low potential for bats to use throughout the bat active season (April to October).</p> <p>All bat species and bat roosts are afforded full protection under the Wildlife and Countryside Act 1981 (as amended) and the Conservation of Habitats and Species (Amendment) (EU Exit) Regulations 2019</p>	<p>Advice (mitigation): All personnel involved in proposed works should be carefully by an advised about bats, by a suitably experienced Ecologist, so that all works are undertaken with a clear understanding about legal aspects, precautions to be adopted and what to do if a bat is found. Prior to development.</p> <p>Advice (mitigation): As a precaution, a pre-commencement inspection by a suitably qualified Ecologist should be carried out immediately prior any work affecting the sheet wall coverings. Any removal of wall covering with overlapping features should be done carefully by hand. Prior to and During work.</p> <p>Advice (mitigation): If bats are found at any time during the development, work must stop until advice has been sought from an appropriately experienced Ecologist. If the work affects bats, a licence may be required and suitable mitigation put in place. At all times.</p>

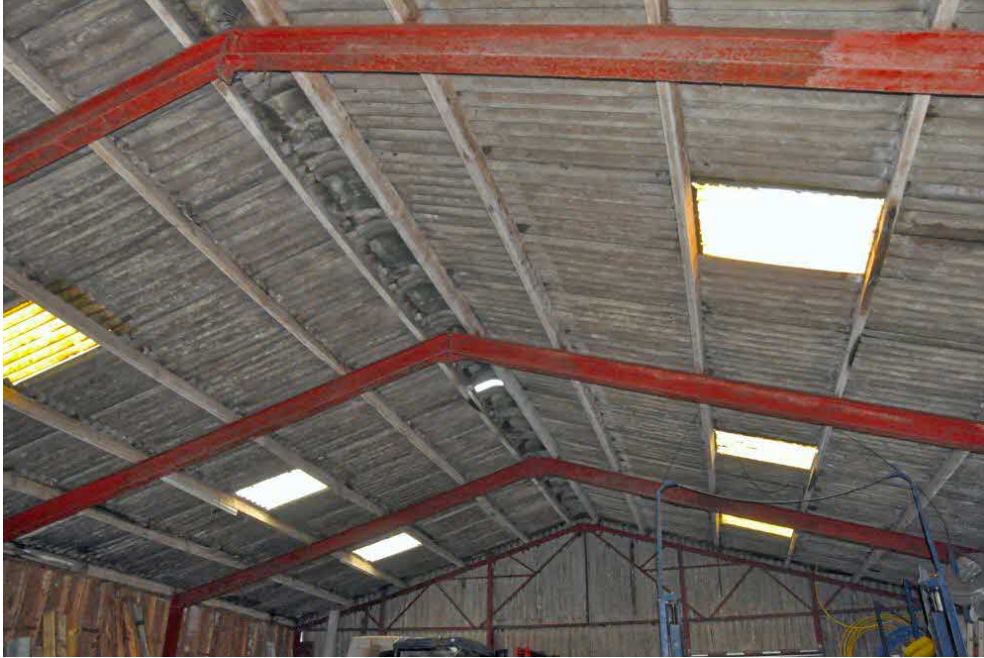
Internal view of main barn showing steel frame, open light conditions and lack of dark sheltered spaces suitable for use by roosting bats

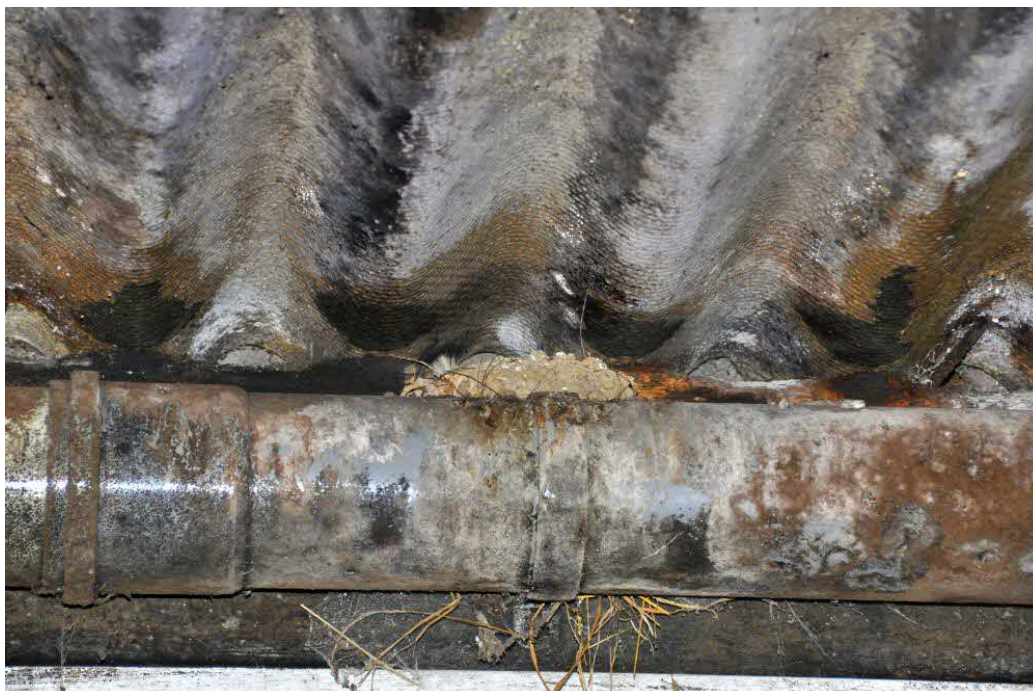
Two unoccupied pigeon nests and 1 unoccupied swallow nest were found inside the main barn, Numerous swallow droppings and an old bird nest were found inside the stable block to the north.

Unoccupied swallow nest

Protected species	Impacts, Issues & Rationale	Action Required
Nesting birds continued		<b>Protection and Enhancement:</b> Swallow nest cups will be installed within an adjacent farm building. This will help to maintain and offset nesting provision for swallows following barn refurbishment. A minimum of 4 nesting cups are recommended. <b>At all times</b>

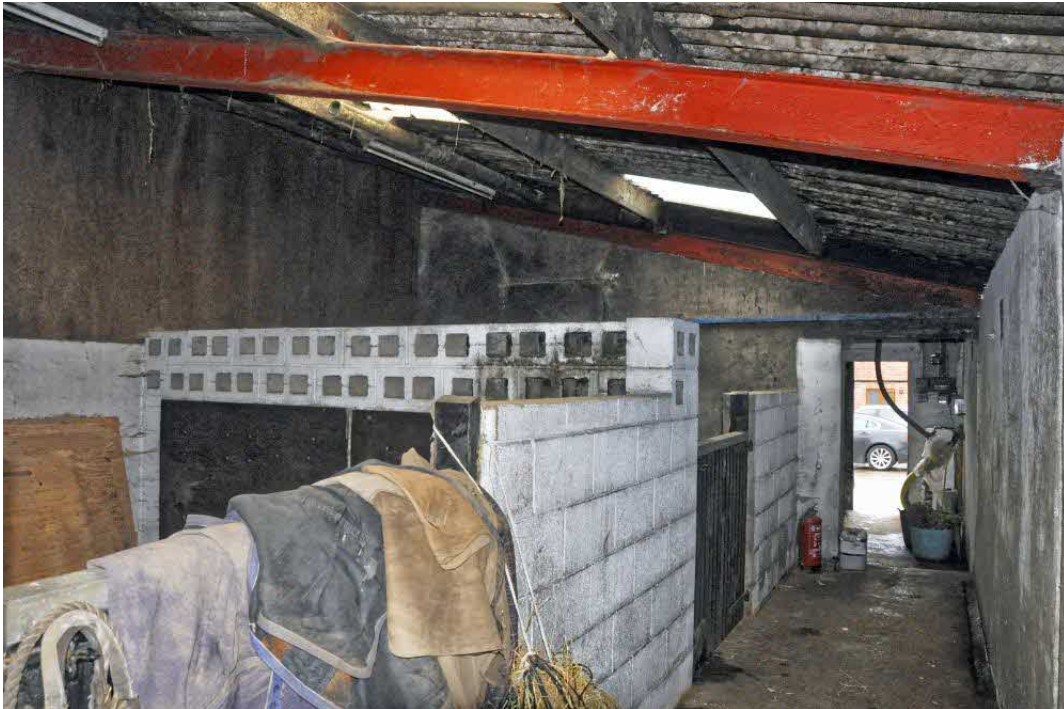
Swallow droppings were frequent throughout, particularly within the stables on the north elevation

View of stable units to the north showing extensive natural light spillage and lack of potential bat roost features

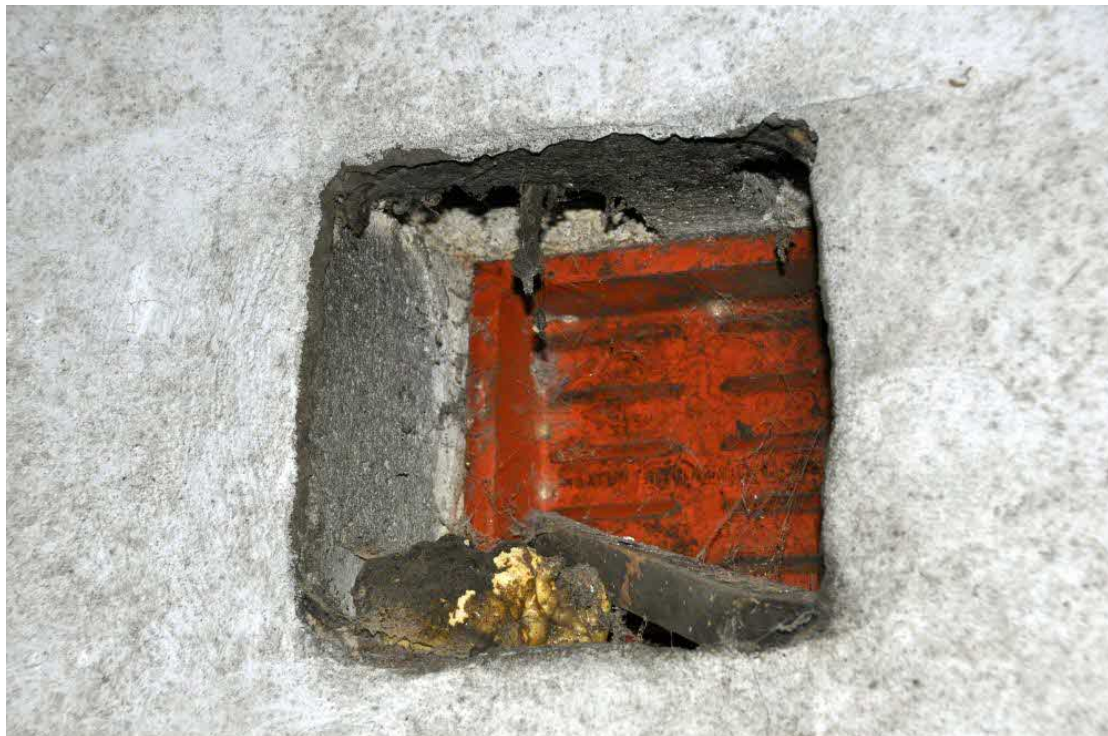
Old bird nest inside wall vent ledge inside stable block

Protected species	Impacts, Issues & Rationale	Action Required
<p>Nesting birds</p>	<p>There are predicted impacts (disturbance, damage and destruction) to nesting birds, nests and eggs as a result of the proposed works.</p> <p>It is advised that there is high potential for birds to be nesting within the barn during the bird nesting season (February to September).</p> <p>Under the Wildlife and Countryside Act 1981 (as amended), wild birds are protected from being killed, injured or captured, while their nests and eggs are protected from being damaged, destroyed or taken.</p> <p>There is no provision under the Wildlife and Countryside Act 1981 (as amended) for licensing the disturbance of nesting birds or the destruction of nests which are in use for the purpose of development.</p> <p>If enforcement action were taken the developer would need to rely on the 'incidental result of an otherwise lawful operation' defence if it were not possible to avoid an offence being committed. This defence can only be tested in court and it is therefore important to ensure all possible mechanisms for avoiding an offence are considered.</p>	<p>Advice (mitigation): It is advised that the most appropriate way to address the risk to nesting birds is:</p> <p>Avoid disturbance to the building during the nesting season.</p> <p>Or</p> <p>If works cannot be delayed, the proposed work area should be carefully checked, immediately prior to works commencing. Checks should be carried out by a suitably experienced ecologist. If the risk of nesting birds remains, then monitoring for nesting bird activity should continue for the duration of works. Prior to any work commencing (checks) and throughout works in nesting season (monitoring).</p> <p>Advice (mitigation):</p> <p>If works are to be undertaken during the nesting season, all people working at the proposed development site should attend a toolbox talk delivered by an appropriately experienced person, to be made aware of the likelihood of encountering nesting birds and how to identify them, the legal protection of nesting birds and their own responsibilities as regards implementation of precautionary measures. Prior to any work commencing.</p> <p>Advice (mitigation):</p> <p>If birds are found to be nesting within or in close proximity to the work area during proposed works, it will be necessary to stop and establish an exclusion area. The extent of the exclusion area, which should be determined by a suitably experienced ecologist, will depend on the bird species and the nature of the proposed works.</p> <p>At all times.</p>

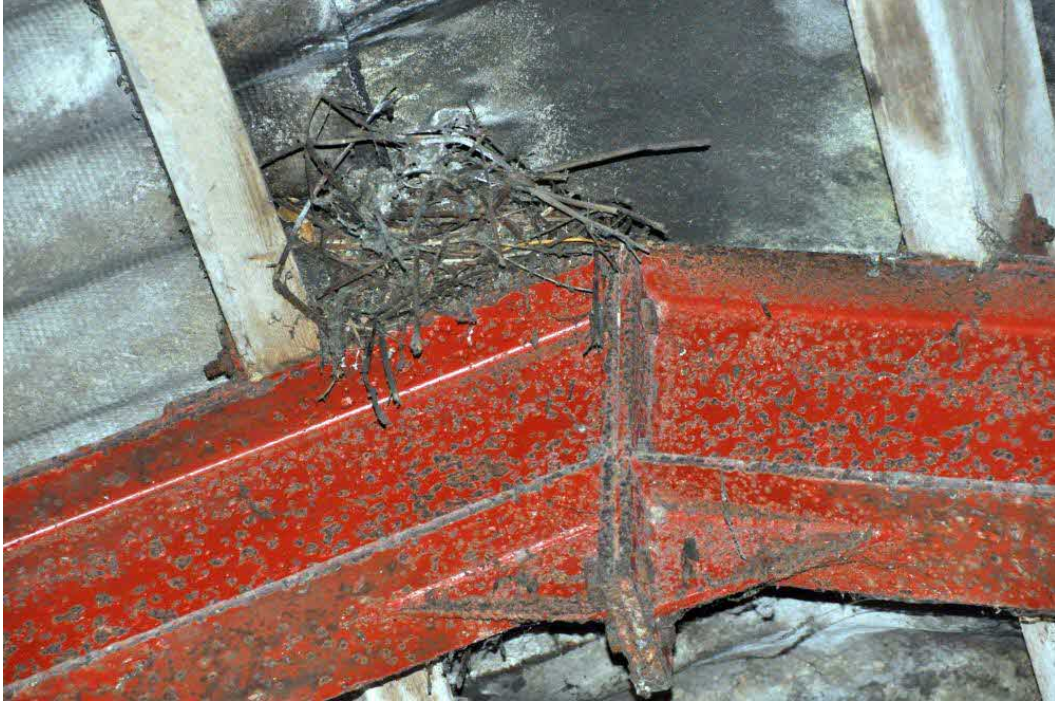
Pigeon nest found in main barn
