HEATHER COTTAGE, AMPNEY ST PETER

HISTORIC BUILDING ASSESSMENT

Natalie Fenner, MSc (Historic Building Conservation), PGDip, BA (hons) Independent Heritage Consultant

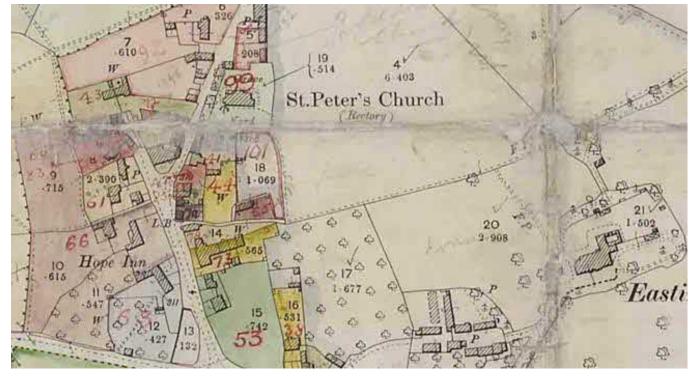
Fig 2 (above) Extract from the 1914 Land Survey mapping showing Heather cottage as hereditament 44 (Gloucestershire Archives/D2428/2/8), *Occupied by:* Smith, William (M), *People holding property:* Daubeney, M C Mrs, Eastington House, Ampney St Peter (F) (owner). Fig 3 (below) D1388/box 2499/3 Gloucestershire Archives, dated 27th January 1854, an indenture between members of the Daubeney family

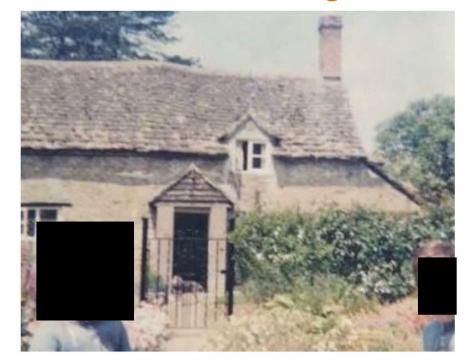
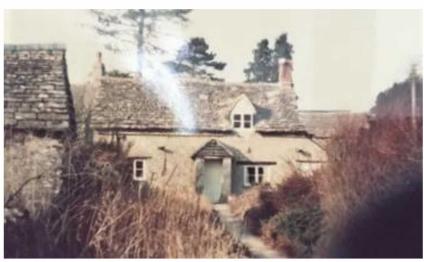
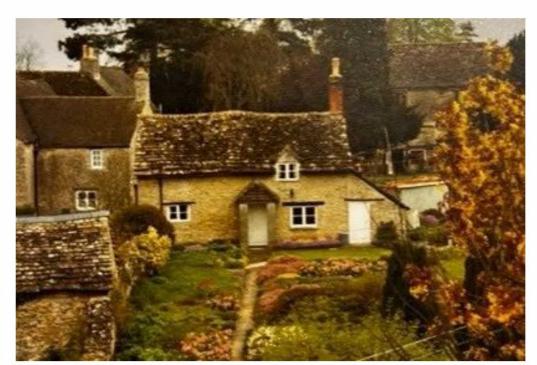
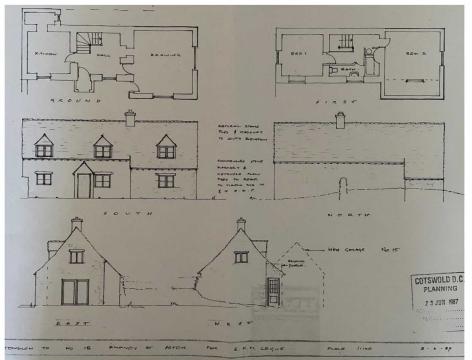
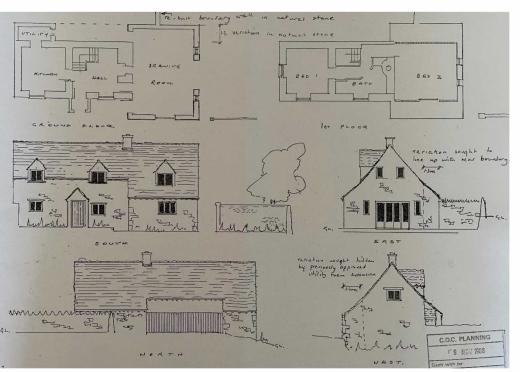
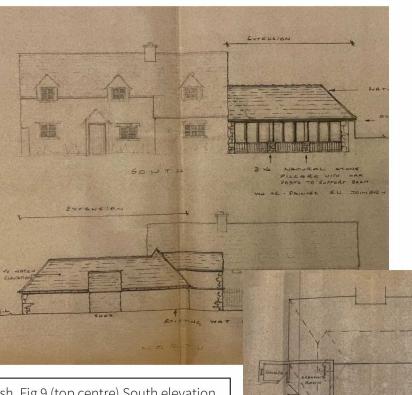
Fig 8 (top left) partial image of south elevation of Heather Cottage, circa 1975, note the slight colour variation beneath the eaves suggesting potential remnants of limewash, Fig 9 (top centre) South elevation of Heather Cottage from garden gate circa 1980, Fig 10 (top right) South front elevation of Heather cottage circa 1985 with hedge removed, just prior to listing, Fig 11 (bottom left) Planning application 1987 - CT6140/B, removing the lean-to, increasing the height of the ridge, and adding dormers. Fig 12 (bottom centre) planning application 1988 (CT6140/C) revised application for larger footprint extension (the footings had already gone in), Fig 13 (bottom right) excerpt drawings from planning application 1990 (CT6140/E) for single storey study and drawing room.

- Fig 5 OS 1903,
- Fig 6 OS 1921
- Fig 7 OS 1960
- Fig 8 Partial image of south elevation of Heather Cottage, circa 1975, note the slight colour variation beneath the eaves suggesting potential remnants of limewash,

- Fig 9 South elevation of Heather Cottage from garden gate circa 1980,
- Fig 10 South front elevation of Heather cottage circa 1985 with hedge removed, just prior to listing,

- Fig 11 Planning application 1987 CT6140/B, removing the lean-to, increasing the height of the ridge, and adding dormers.
- Fig 12 Planning application 1988 (CT6140/C) revised application for larger footprint extension (the footings had already gone in),

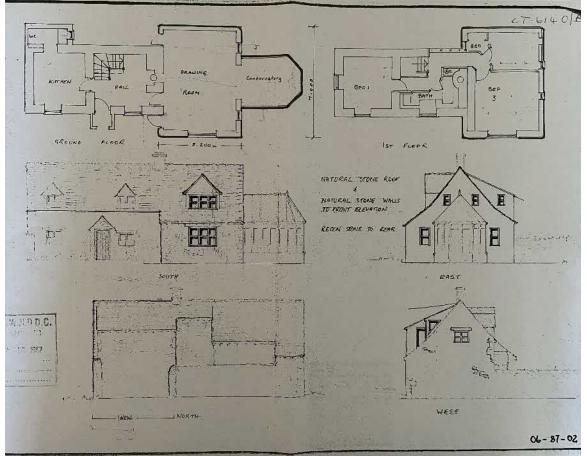
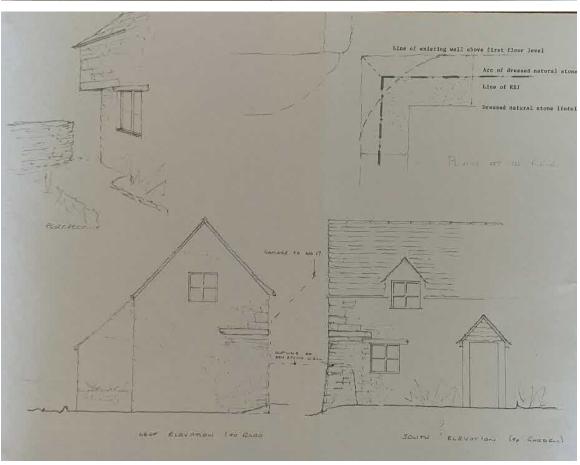
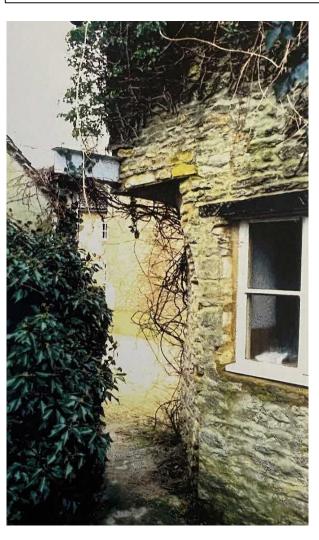
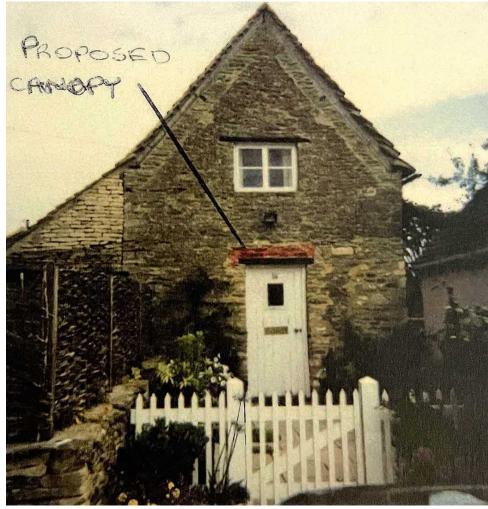
Fig 14 (top left) Details from a withdrawn applications circa 1992 for a conservatory to the E gable, Fig 15 (bottom left) and Fig 16 (bottom centre) both from application CT6140/G and H, whereby stonework was removed to create a first floor over-hang. This work was unauthorized and subsequent applications to authorise it were refused and the appeal dismissed. Fig 17 (bottom right) Photograph illustrating the W gable end circa 1998 from application CT6140/L for the canopy. Note the clearly evident modified stonework surrounding the door, the rebuilt SW corner and the raised stonework level.

- Fig 13 Excerpt drawings from planning application 1990 (CT6140/E) for single storey study and drawing room.
- Fig 14 Details from a withdrawn applications circa 1992 for a conservatory to the E gable, Fig 15 (bottom left) and

- Fig 16 Both from application CT6140/G and H, whereby stonework was removed to create a first floor over-hang. This work was unauthorized and subsequent applications to authorise it were refused and the appeal dismissed.

- Fig 17 Photograph illustrating the W gable end circa 1998 from application CT6140/L for the canopy. Note the clearly evident modified stonework surrounding the door, the rebuilt SW corner and the raised stonework level.

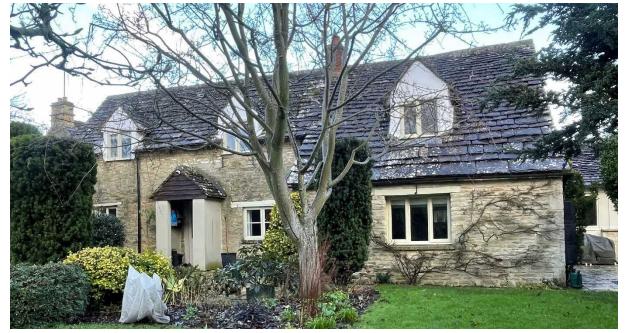
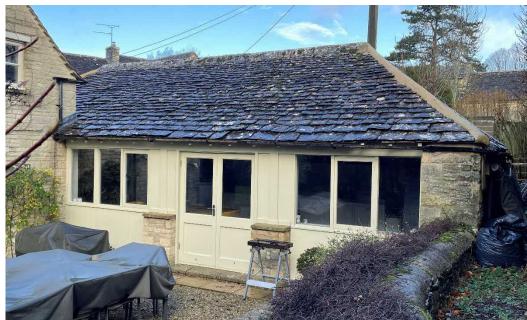
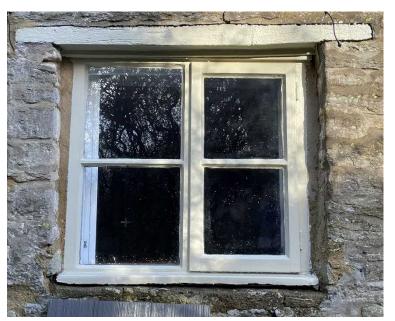
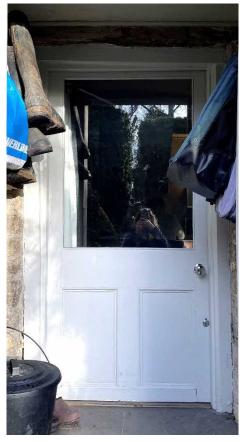
Fig 18 (top left) South elevation, original cottage to the left, large 1987 extension to the right, Fig 19 (top right) 1990s extension now housing the kitchen, Fig 20 (bottom left) window detail of the ground floor west side cottage room with modern casement, Fig 21 (bottom centre) evidence for left-hand dormer being relocated upwwards, Fig 22 (bottom right) central door, replaced during the 1980s/90s works.

- Fig 18 South elevation, original cottage to the left, large 1987 extension to the right,
- Fig 19 1990s extension now housing the kitchen,
- Fig 20 Window detail of the ground floor west side cottage room with modern casement,

- Fig 21 Evidence for left-hand dormer being relocated upwwards,
- Fig 22 Central door, replaced during the 1980s/90s works.
- Fig 23 West gable with former location of purlin ends indicated,

can see that this is the structure which warranted listing in 1986, with its modest proportions and relatively sparse fenestration. There is evidence that the cottage has had its eaves level raised by several inches of new stonework in the late 1980s, in order to accommodate a larger first floor, which has resulted in the dormer to the right also being raised in height. The dormer to the left is an entirely modern addition. Comparing old and new photographs also shows clearly that the ridge has been raised and straightened, whilst the porch has been replaced. The two ground floor windows, set at different heights from one another, with different dimensions and different lintels, both appear to be historic openings, though potentially representing different phases of construction. The window to the right features a concrete replacement sill and with larger proportions and more substantial lintel, may be the more recent addition of the two. Both now feature modern softwood casements which in themselves are not of historic interest. Though the porch enclosure is a modern replacement, now rendered in cement with softwood cladding to

its gable, the central doorway appears to be an historic opening, and retains what appears to be a late C19th/ early C20th beaded and part glazed door within an historic door surround. Given the listing description mentions a plank door here, this suggests the door at least is reclaimed, with clear visual evidence for it having been cut down to size (see Fig X)This A section

of masonry to the left ground floor corner has been entirely rebuilt, and this is understood to date to the 1990s when the then owner attempted to cut the corner of the building in order to create a new side access and archway, which resulted in enforcement action. The re-built stonework was a compromise to 'make good' the building.

In the centre, and in place of the lean-to described in the listing (which is visible in Fig X), is a sizeable single bay extension which projects forwards of the original cottage, as well as being over two thirds its width. Dating from the late 1980s, it was clearly intended to be somewhat sympathetic to the character of the adjacent cottage, using a similar pallet of materials and shares a continuous simple pitched roof, tiled in diminishing courses of Cotswold stone tiles. However, its overly large form with a central dormer with wide cheeks. Stonework visible to the ground floor is all modern and all fenestration modern softwood. The chimney is formed in modern brickwork, and appears from comparison with archive photographs to be a late C20th replacement for an earlier brick stack.

Tucked to the rear, but projecting sideways, is the single storey hipped kitchen extension, also added from the late 1980s onwards, which is formed over modern stonework piers with timber cladding and glazing forming the substantial part of its south elevation. It too has a roof of Cotswold stone laid in diminishing courses, but with steeply hipped gables. The extent and form of glazing, as well as the overall form of the kitchen extension, are at odds with the character of the historic cottage, and as a result does not have any heritage significance.

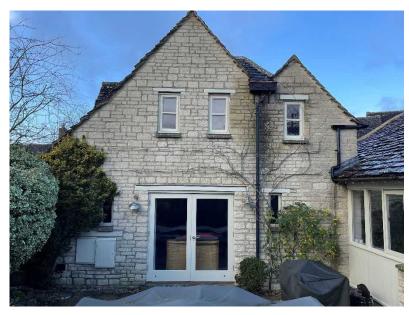
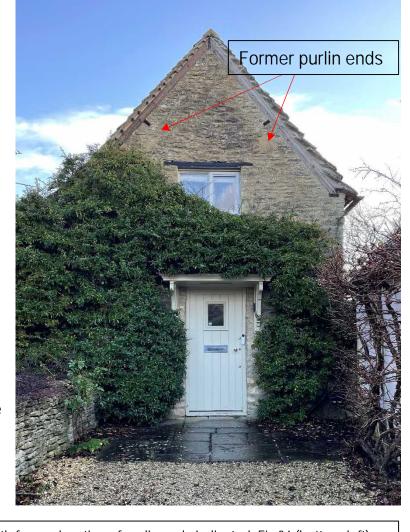
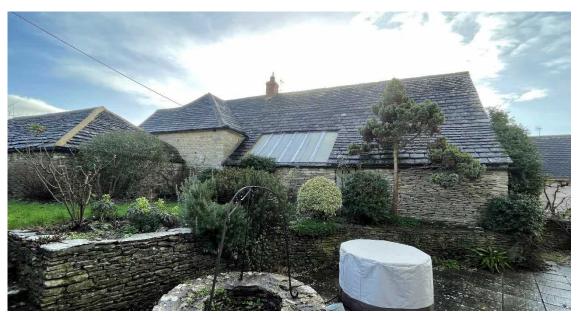
Fig 23 (top) west gable with former location of purlin ends indicated, Fig 24 (bottom left) west gable, Fig 25 (bottom right) the accumulation of modern additions to the rear northern elevation.

The west gable which now forms the principal entrance to the cottage, features a single opening to the first floor which appears to be historic in form with a slim timber lintel above and stone sill. The casement has however been replaced and now features a modern soft-wood glazed casement. The doorway and its canopy to the ground floor date from 1993 and 1998 respectively, and were inserted following the construction of a boundary wall which closed off access to the garden from this elevation. The stonework

surround to the doorway is entirely new, as is the part-glazed door, and there is no evidence of previous openings here. The high-level stonework does show evidence of being raised in height (see Fig X) whilst the eaves boards and slim visible purlin ends(?) are both modern softwood. Two enlarged patches of mortar at first floor level (see Fig X) may indicate the location of formerly exposed purlin ends which appear to

approximately correspond to the locations of the purlins internally (see Fig X). Whether these were removed, cut-back or rotted is unclear, but the patches of mortar retain the evidence of their position.

There is no historic form visible within the north elevation. Whilst the south 'front' retains its diminishing courses of Cotswold stone tiles, the rear is entirely clad in reconstituted stone slates and forms a cat-slide roof form over what appears to be three phases of extension added since the late 1980s. A

section of poor-quality polycarbonate roofing features in the centre, providing a lightwell to the staircase internally. With a drystone-wall external face to the lower sections of wall, including the perimeter of the kitchen extension, all incorporate low level polythene DPCs, and feature distinctly angled stonework of small dimension. The curious gated section to the right of the polycarbonate roof suggests there may at some stage, have been an access here, though no evidence is visible internally, and all surrounding stonework is so heavily reworked that no clear evidence remains externally either. The mortared stonework to the first floor hipped extension dates to 199X and is a rather odd addition since it is of much more varied stone in both colour and size, as well as being conspicuously mortared whilst sat on-top of drystone.

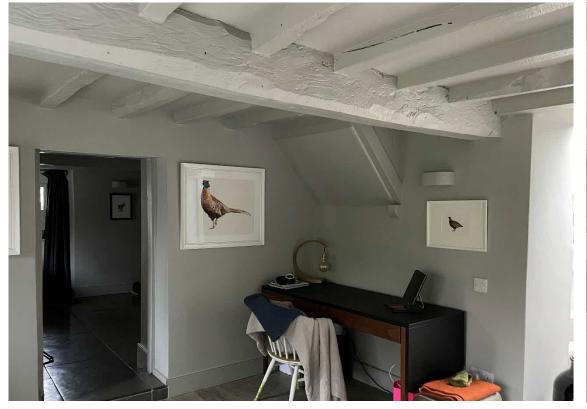
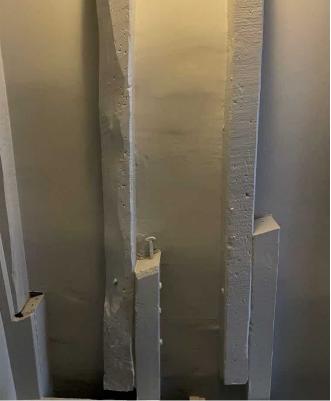
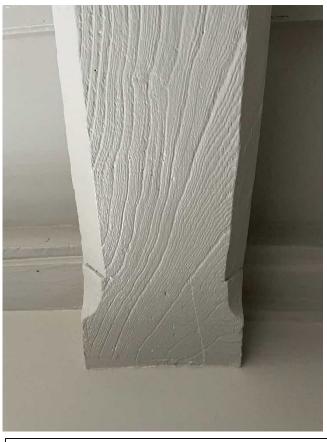
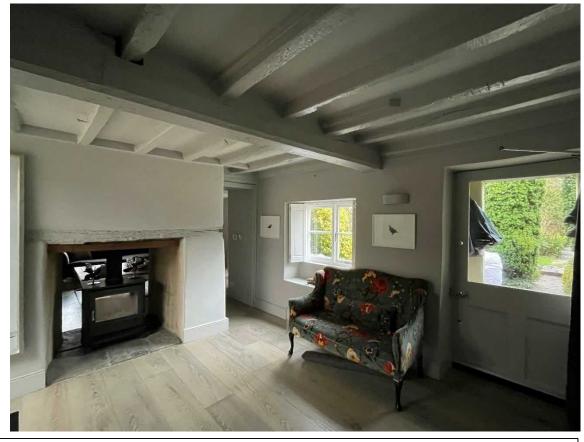
Fig 26 (top left) ground floor parlour from SE corner showing location of staircase pre 1990 (see archive images and note the two newer joists adjoining the stairs bulkhead), Fig 27 (top right) angled cuts to joist ends in NW corner of original cottage, Fig 28 (bottom left) beam detail showing the simple stops, Fig 29 (bottom right) ground floor 'parlour' with historic beam and joists and modernised fireplace.

- Fig 24 West gable,
- Fig 25 The accumulation of modern additions to the rear northern elevation.
- Fig 26 Ground floor parlour from SE corner showing location of staircase pre 1990 (see archive images and note the two newer joists adjoining the stairs bulkhead),

- Fig 27 Angled cuts to joist ends in NW corner of original cottage,
- Fig 28 Beam detail showing the simple stops,
- Fig 29 Ground floor 'parlour' with historic beam and joists and modernised fireplace.

To the ground floor, the modest proportions and beamed ceilings to the two rooms of the original cottage remain clear though heavily altered. To the hallway, the beamed ceiling appears to have undergone significant replacement to the exposed joists, with most of those now visible being machine sawn and of at best late C19th/early C20th date. This ceiling is supported by a later softwood beam sitting below but not junctioning with the joists above. This may have been a C20th structural intervention to address significant deflection which is visible to the first floor structure above. Within the north west corner of the room, three joists have been cut-back at an angle (see Fig 27), which may indicate the former location of an historic winder staircase, though no further evidence for this exists. Consent was granted in 1994 for the rear wall to this room to be substantially removed and for a new beam to be installed overhead in order to create an enlarged kitchen. This work appears not to have been carried out. The utility and WC to the rear are all modern fabric dating from the late 1980s. The doorway between the hall and second cottage room beyond, features some historic fabric with the hinge pins and latch plate retained to the hall side, though the door has long since been lost. It nevertheless retains its proportions as an historic connecting door, and a small step exists at its threshold (just visible at the base of Fig 26).

The second cottage room retains an older chamfered beam with simple stops and what appear to be predominantly

historic joists above. These may be original as there is little evidence for alteration. This room seems likely to have been the historic 'living room' with its integrated fireplace in the end wall and main door to outside. It and may also represent the earliest phase of the building as a single unit³, perhaps extended to the east by a further bay. If there were two phases to the earliest structure, there is no clear evidence for this elsewhere in the building besides the difference in floor level between the two historic ground floor rooms. The south-facing front door and its surround, as mentioned in the south elevation section, appear to be a mixture of reclaimed door installed post listing and a more historic surround, whilst the window seat and window surround to the adjacent opening are now all formed in modern fabric internally. The fireplace to this room is also a modern confection featuring a modern double-sided wood-burning stove with a painted lintel of re-used timber. Whether the lintel is re-used from elsewhere within this building is uncertain, but the 'death-watch beetle' holes are fake and have been drilled at regular intervals to give the impression of age. The pronounced grain of the timber may also be indicative of sandblasting. Within the stack and all surrounding faces of the fireplace are modern rendered/plastered leaving no evidence for what the form of fireplace may have been historically, though given the humble nature of the cottage this is likely to have been a very simple open hearth. The large openings through to the living room and stair hall to the rear are modern, and date from 1987 and 1990 respectively. This room appears to have housed stairs to the first floor until the early 1990s (see Fig 11-12), and it is understood evidence for the former opening in the first floor structure remains concealed beneath floor finishes above. This is also the location of the only two replacement joists in the NW corner of the room (see Fig 26). The current stairs appear to be the result of c

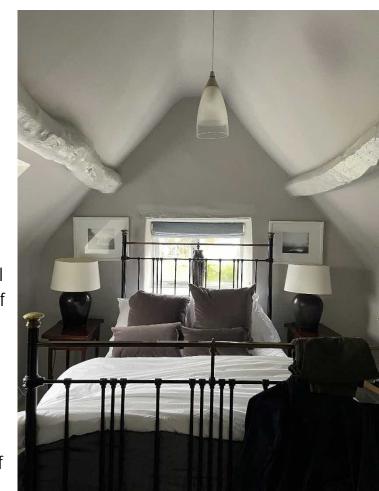
Fig 30 First floor W gable bedroom with historic gable opening now infilled with modern casement and prominent purlins.

Since this floor is predominantly built into the attic space, the purlins remain dominant, and appear to be of some age. To the south side of the building a single continuous rough hewn purlin runs the length of the cottage, whilst to the rear, the same length is formed in two sections, one half of which is chamfered whilst the other half is similarly rough hewn to the front. Whether these are original is very difficult to say but their rough appearance would appear to be appropriate for the humble nature of the cottage. Curiously, the purlins all appear to remain in their historic position, seemingly unaffected by the raised level of the ridge and eaves (compare Fig X with X). As a result, to the landing area the purlin appears to sit proud of the inner roof slope. This seems to suggest that when the cottage and its new extension were re-roofed in the late 1980s, the new roof was sat above the old one, leaving some of it

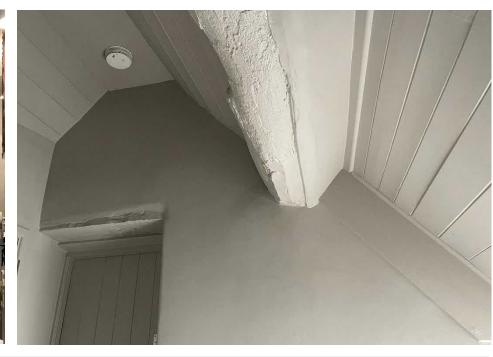
Fig 31 (bottom left) opening in central spine wall appears historic with modern plank door infill, Fig 32 (bottom centre) widened landing area and small opening in N wall, Fig 33 (bottom right) oddly pronounced purlin detail suggesting previous historic rafters removed to increase headroom above staircase.

- Fig 30 First floor W gable bedroom with historic gable opening now infilled with modern casement and prominent purlins,
- Fig 31 Opening in central spine wall appears historic with modern plank door infill,

Fig 32 Widened landing area and small opening in N wall,

Fig 33 Odd pronounced purlin detail suggesting previous historic rafters removed to increase headroom above staircase.

in place. How much, if any, remains beyond the purlins, is unknown, but no rafters are now visible, all concealed behind plasterboard or modern tongue and groove panelling.
