## **Bat Preliminary Roost Assessment**

**6 Pinewood Road, Poole BH13 6JS**

Reference Number: 5658

Visual Survey: 17/10/2023

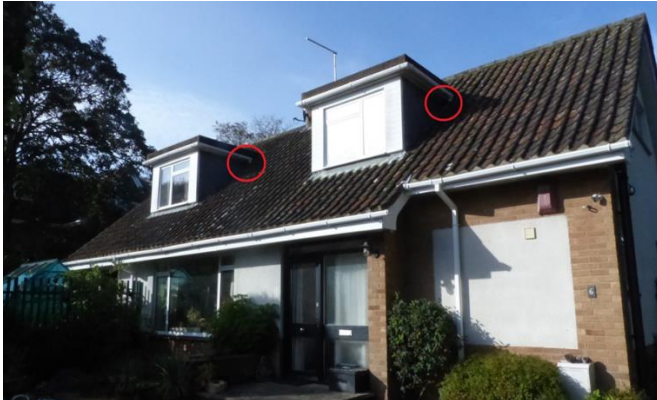
- In the main, all elevations of the bungalow were very well sealed.
- Almost all soffits, flashings, tiles, windows and doors were very tight fitting.
- The dormer windows had flat, felt roofs. Dormer cheeks were fully covered with lead.
- Where the soffits either side of both eastern (front) dormers met the roof, there appeared to be a gap that could potentially allow access to a bat. Location is marked red on photo below (these gaps were both sides of each dormer).

Location of gaps by dormers

- Immediately prior to demolition the small number of potential bat roosts must be investigated by a licensed ecologist using an endoscope or torches to confirm that crevices are not in use as bat roosts. If no bats are found demolition work may proceed.

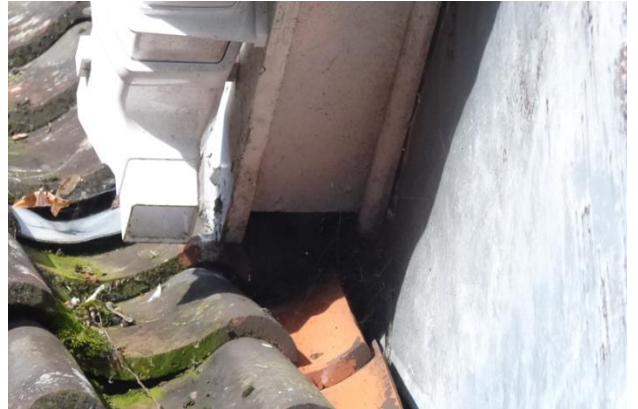
Close up view of gap

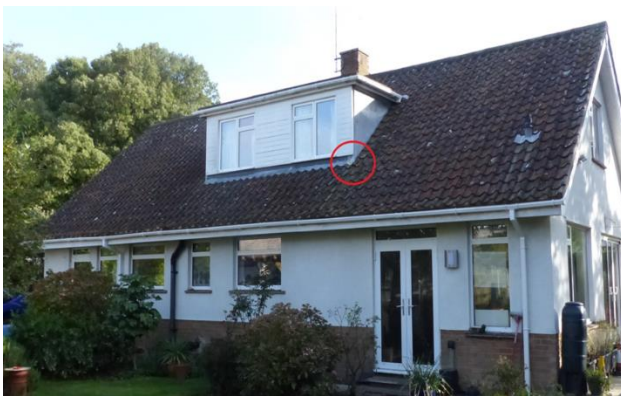
- At the lower right corner of the dormer on the West elevation were 2 slightly raised tiles (location marked red in photo above).

Tile gaps by dormer

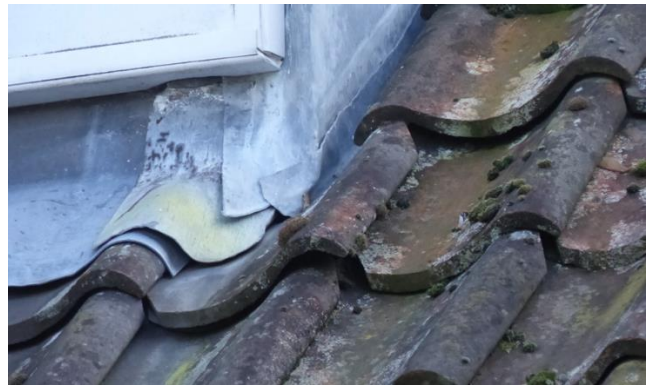
Close up of tile gap
