Phase II Geo-Environmental Assessment

90 High Street
Girton
Cambridge
CB3 0QL

EPS Reference Number: UK23.6692

Date Issued: 21st November 2023

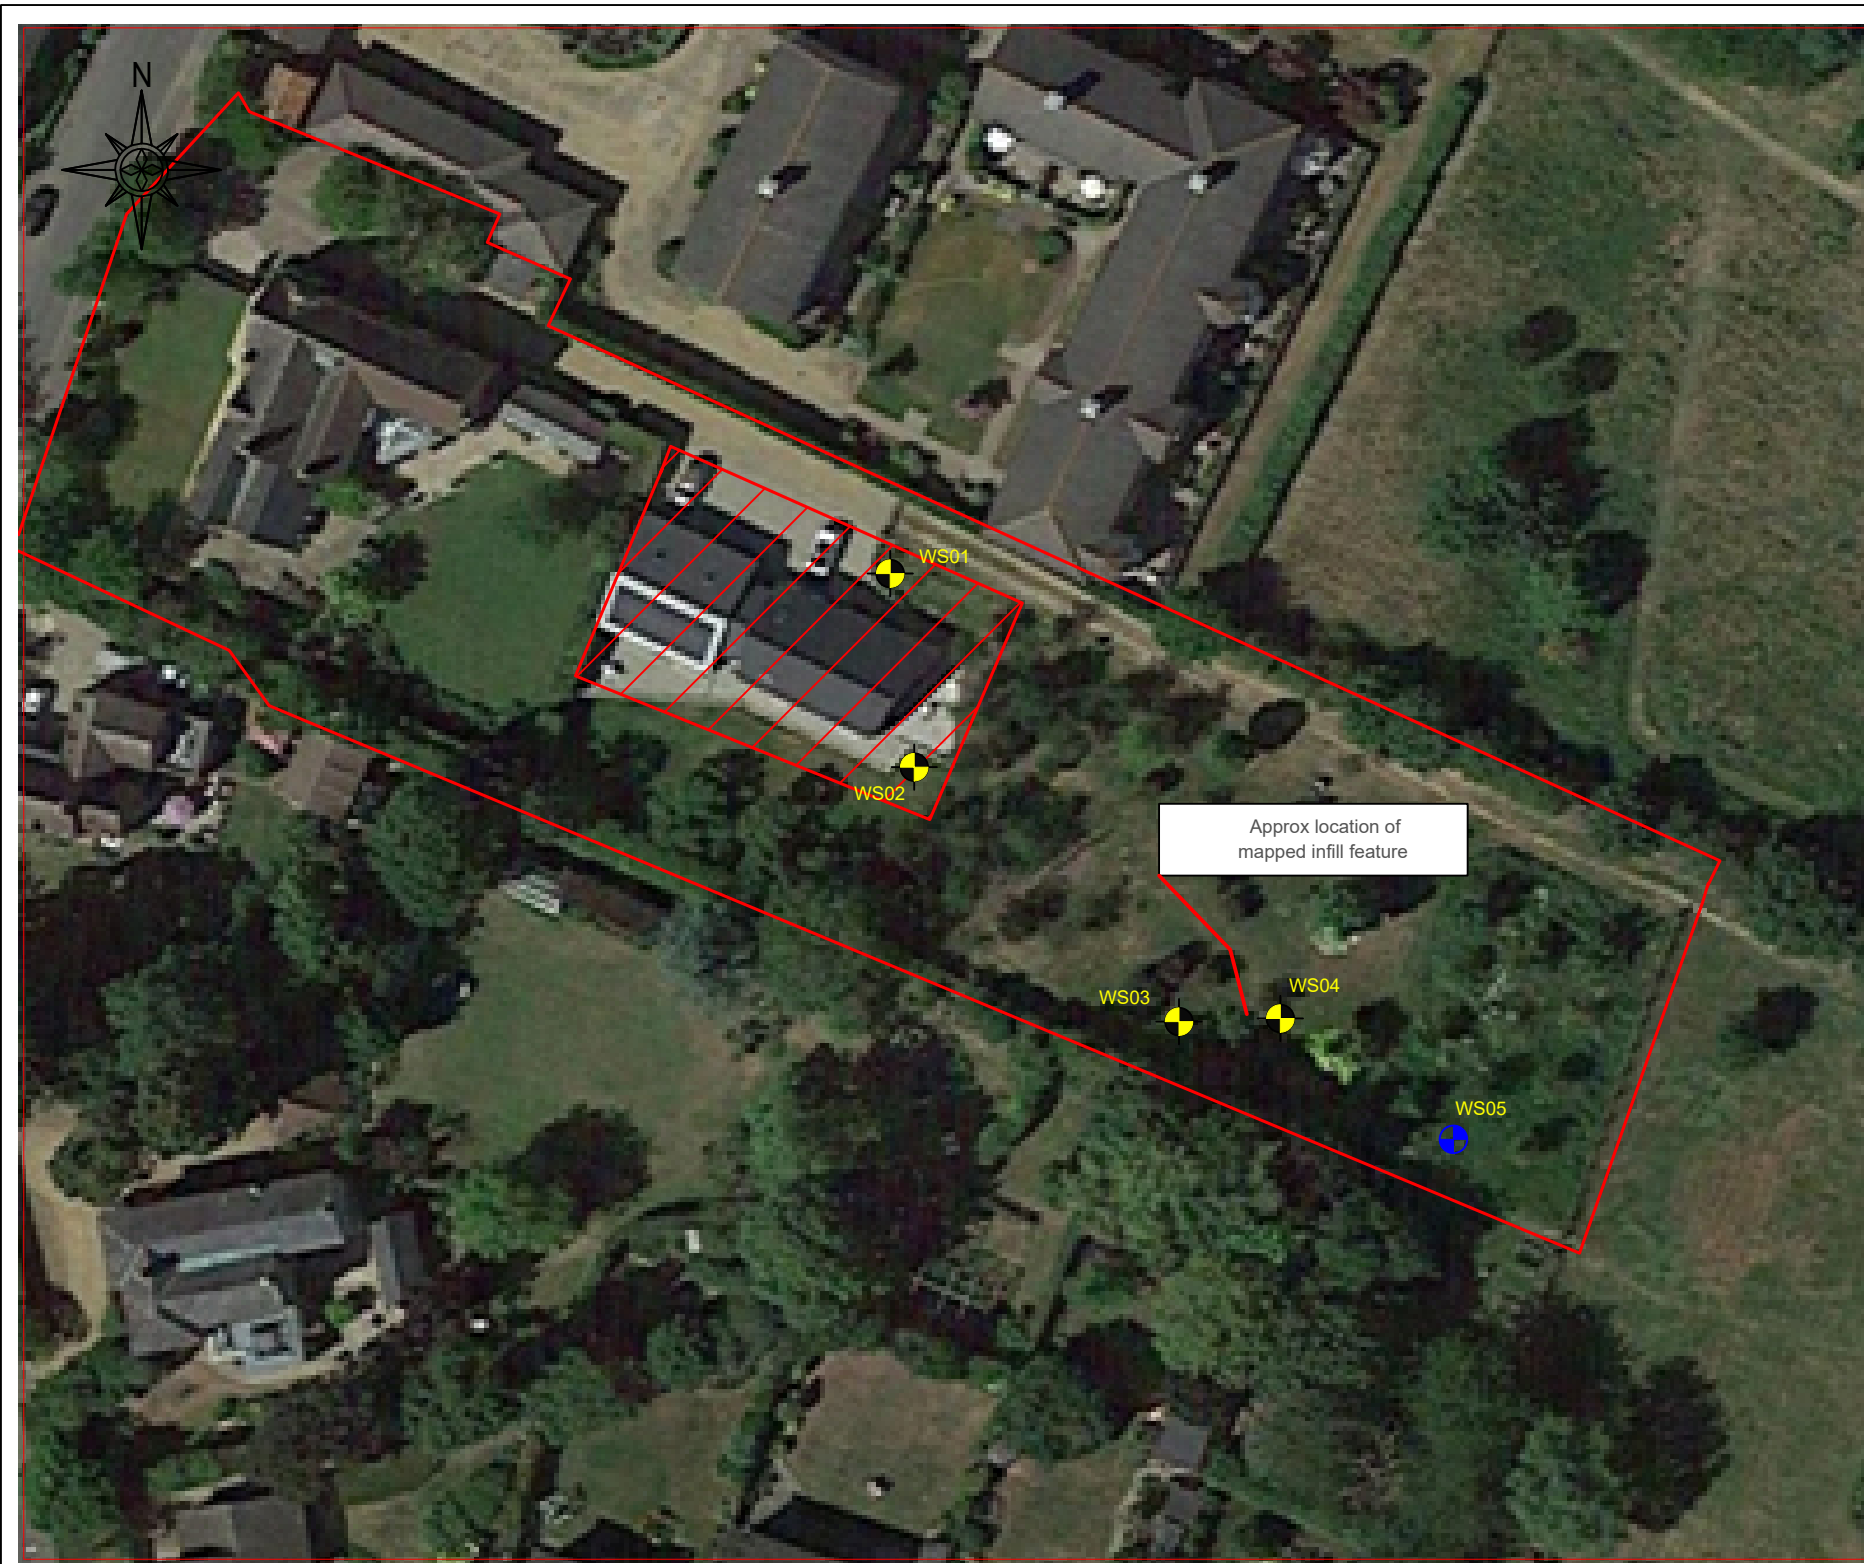
A borehole location plan is presented as Figure 2.

Approx boundary of 90 High St (RED HOUSE)

Five window sample boreholes (WS01 – WS05) were formed at the site to a depth of 4.0m using a track-mounted percussive drilling rig. The rationale for the placement of these boreholes is listed in the table below.

Location	Rationale
WS01	Provide information on the underlying shallow soils and install a standpipe on the far side of Mill House from the infilled pit.
WS02	Provide information on the underlying shallow soils and install a standpipe on the near side of Mill House from the infilled pit.
WS03 & WS04	Provide information on the underlying shallow soils and install standpipes in the location of the infilled pit.
WS05	Provide information on the extent of the former pit.

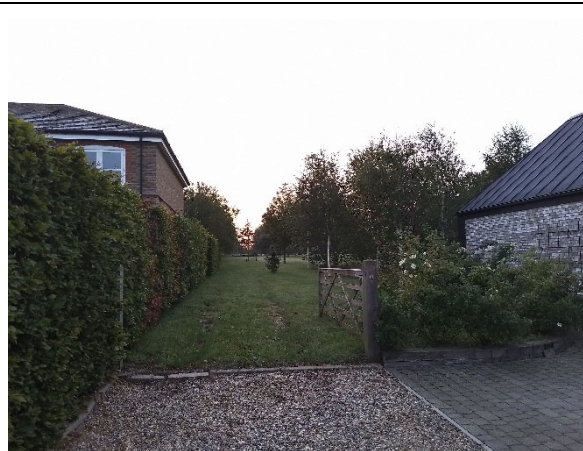
Photo 1: Access to site looking south-east with Mill House in frame

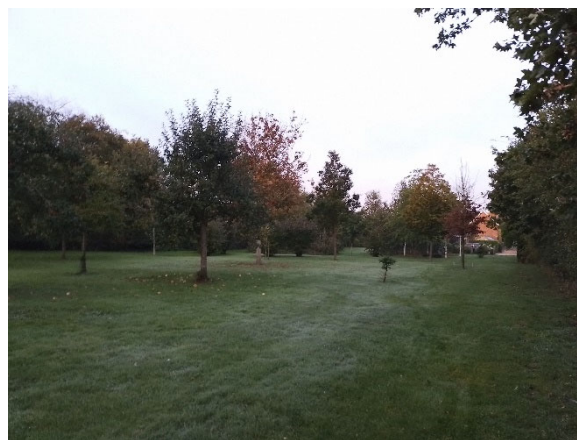
Photo 2: Wooded paddock containing location of infilled pit, looking north-west

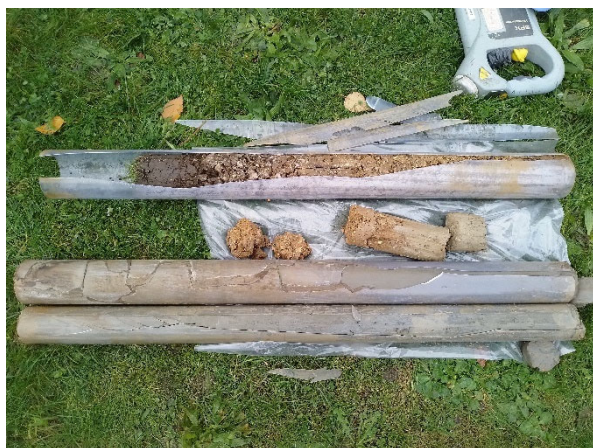
Photo 3: Recovery from WS01, showing Head Deposits and Gault Formation clay

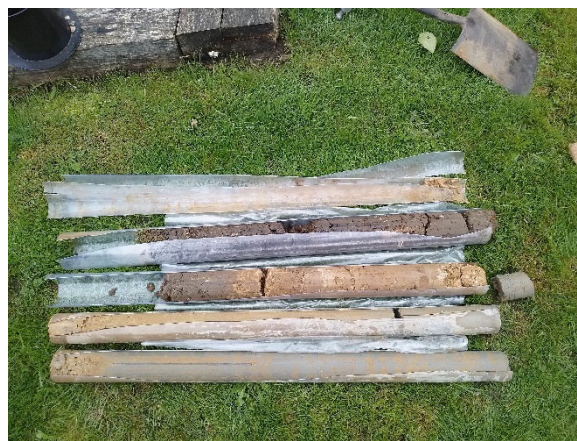
Photo 4: Recovery from WS03, showing made ground onto Head Deposit and Gault Formation clay

In all locations except WS01, material interpreted as made ground was recovered. This varied slightly in character across the site, however generally comprised dark brown, gravelly clay from below the topsoil with occasional brick, sand lenses and dark staining to approximately 1.0mbgl. This was the only made ground recorded in WS02 by Mill House.

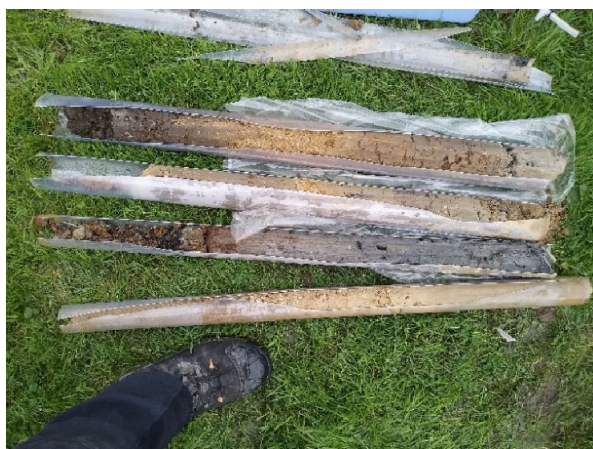
Photo 5: Recovery from WS05, showing deeper made ground onto Head Deposit and Gault Formation clay

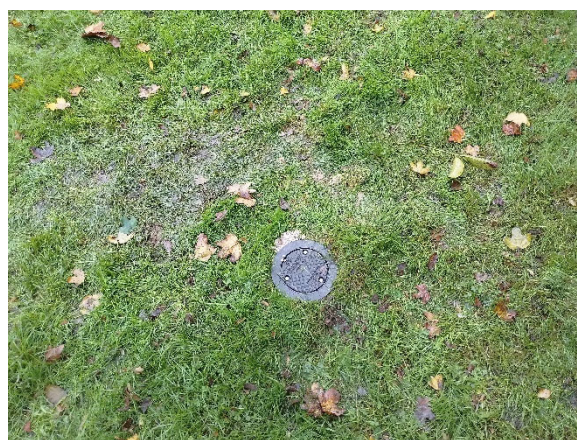
Photo 6: Installed monitoring well set flush with surface

Standpipes were installed in boreholes WS01 - WS04. Groundwater sampling pipes were installed using 50mm diameter uPVC well casing and fitted with a gas tap. Slotted casing (1mm slot) was installed at each location from the base of the borehole to approximately 1.0m below the surface. The installations were completed to ground surface using plain casing. A filter pack of 2-3mm of washed gravel extended from the base of the boreholes to approximately 0.1m above the slotted section with a bentonite seal to surface. All installations were finished with flush-mounted, bolt-down headworks.
