GEOSPHERE ENVIRONMENTAL

REPORT NUMBER: 8005,DS,JD,DESK,06-12-23,V2

SITE: Boundary Farm Barn, Boundary Farm, Framsdan,
Suffolk, IP14 6LH

Report Number: 8005,DS,JD,DESK,06-12-23,V2
Client: Jack Rogers
Project Name: Boundary Farm Barn, Boundary Farm, Framsdon, Suffolk, IP14 6LH
Project Number: 8005,DS
Report Type: Phase 1 – Desk Study and Preliminary Risk Assessment
Status: Final
Date of Issue: 06 December 2023

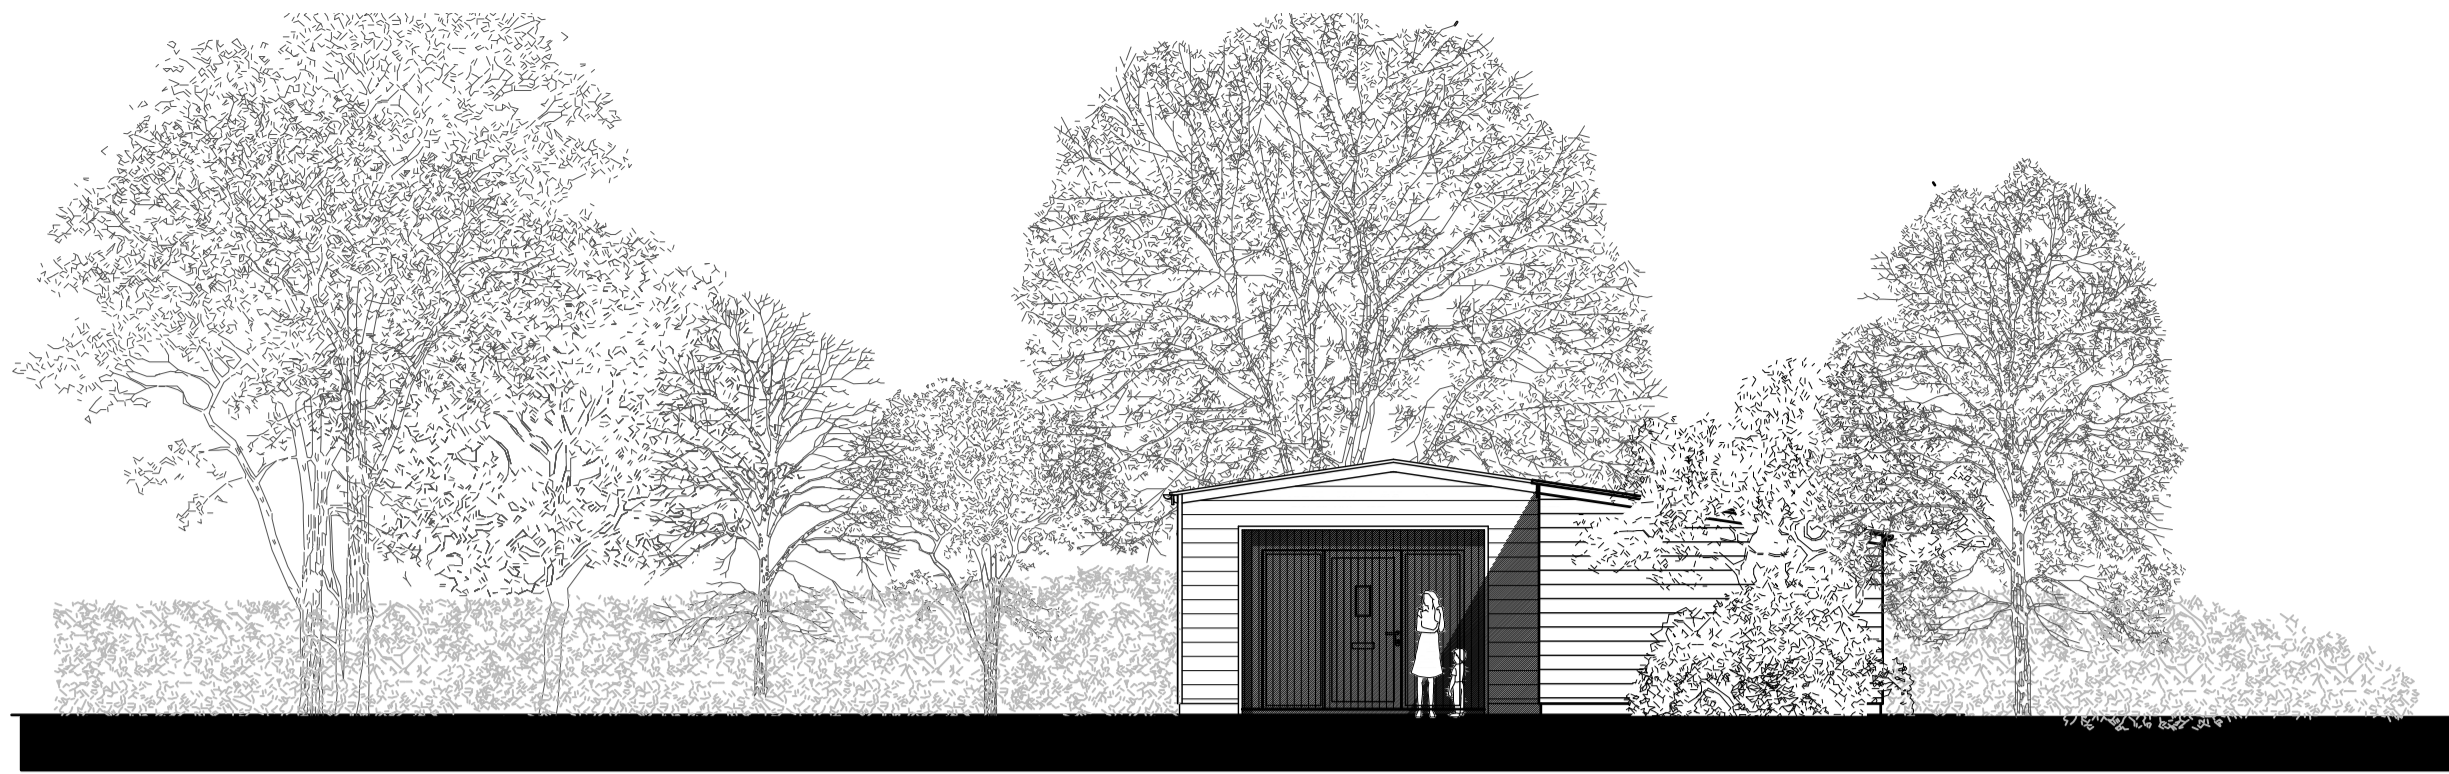
PROPOSED FRONT ELEVATION

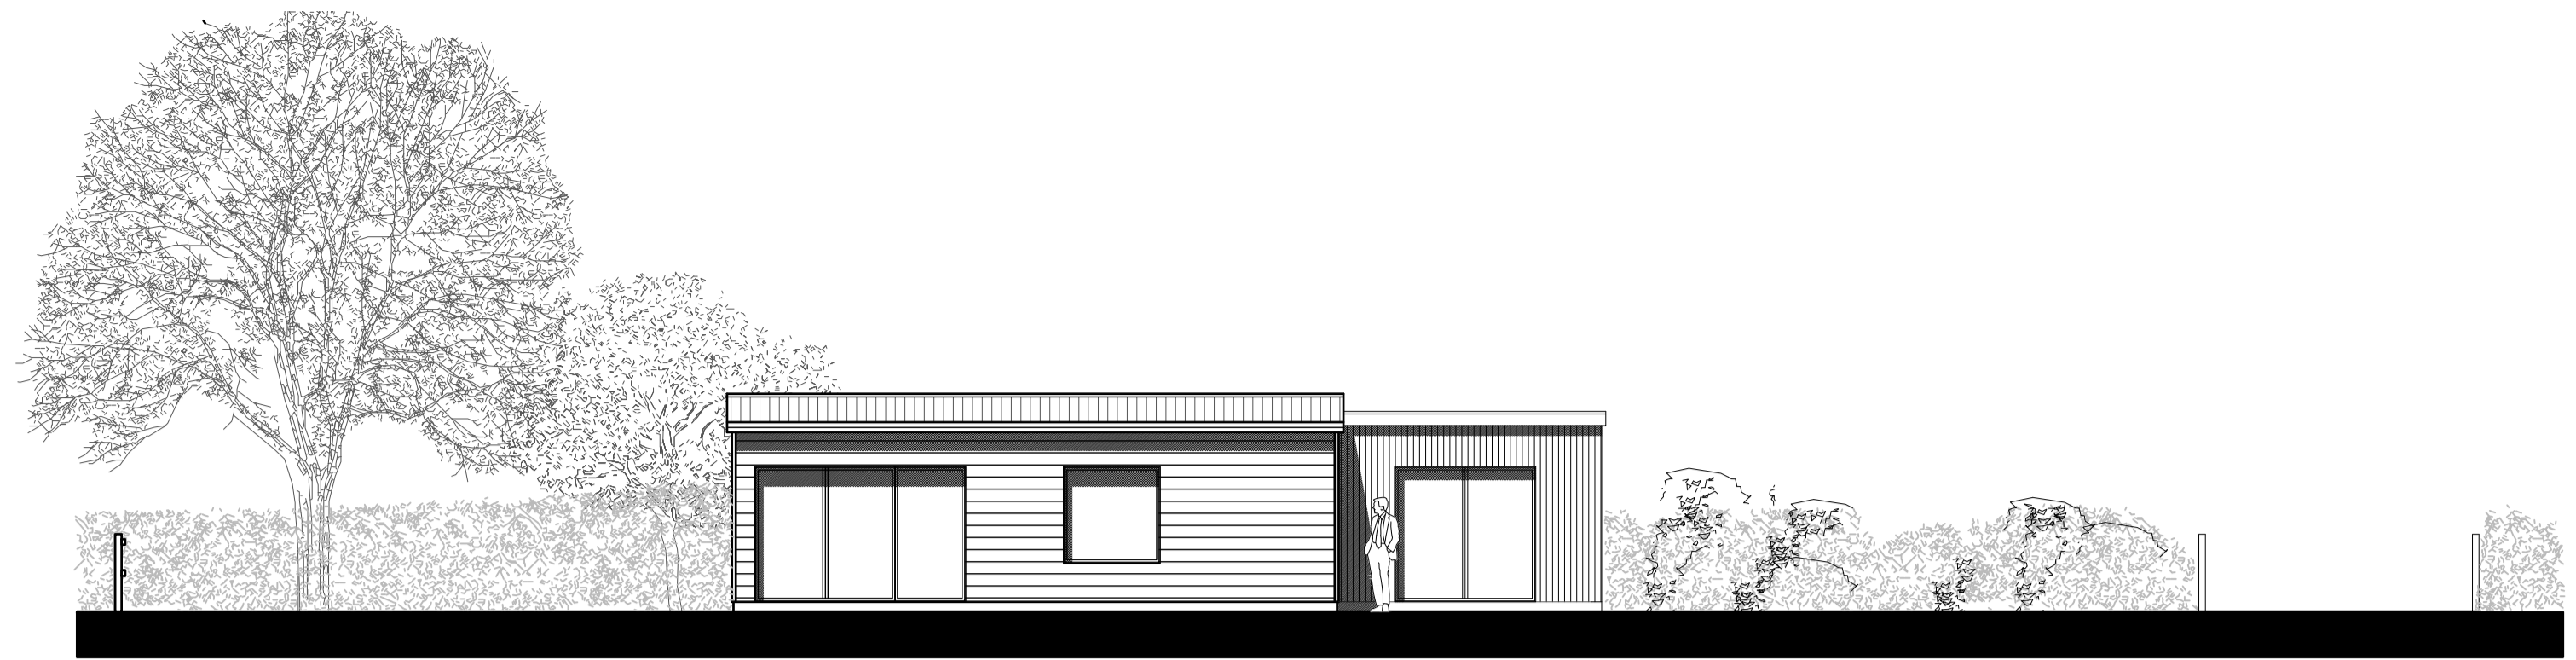
PROPOSED SIDE ELEVATION

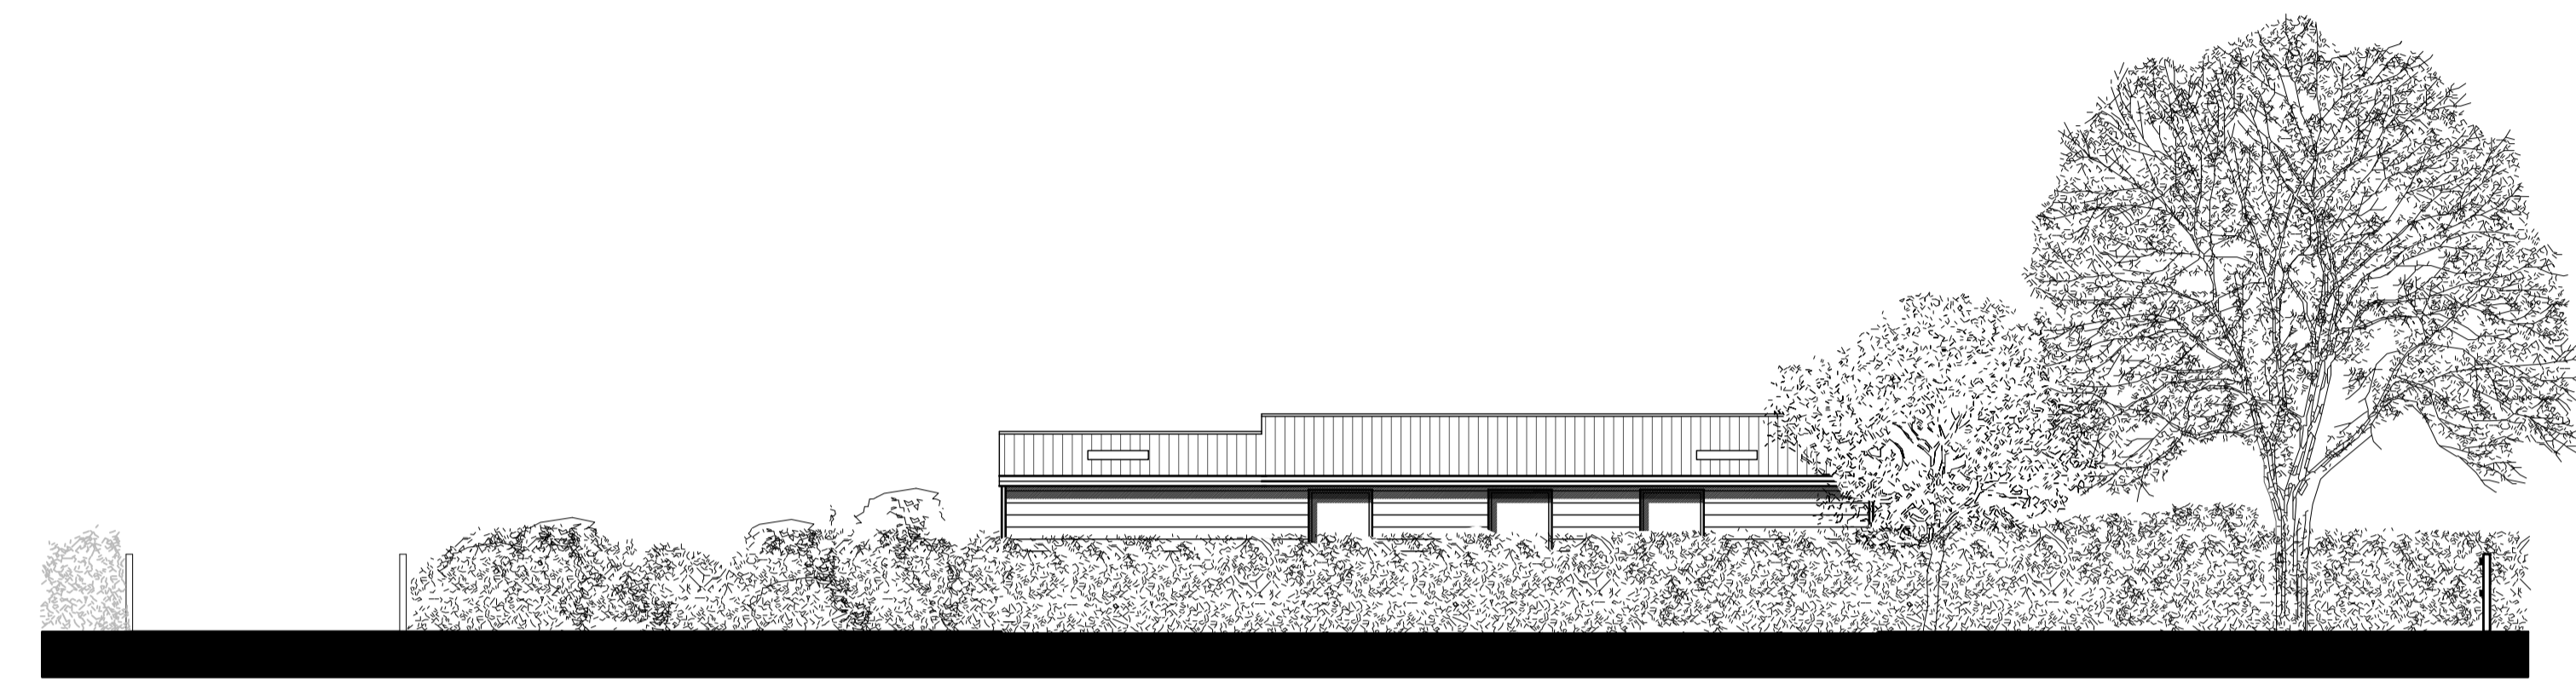
PROPOSED SIDE ELEVATION

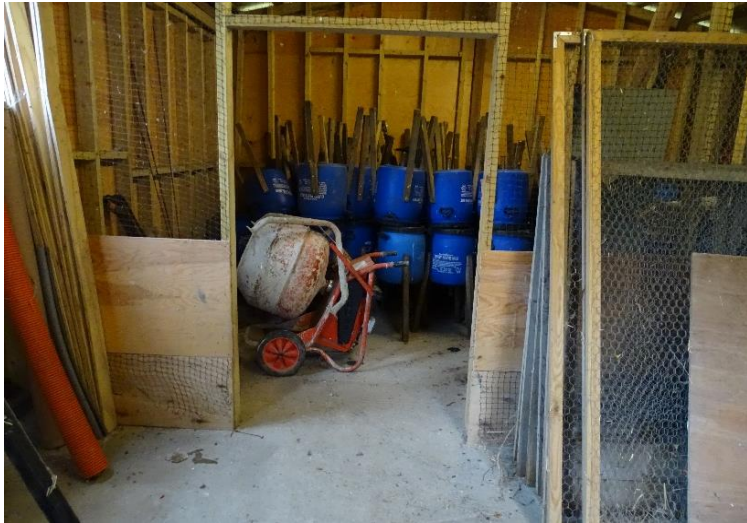
Photograph 1

Chemicals stored in barn

The site walkover that historically the site has been used for various agricultural purposes and there were still a number of chemicals stored on the barn onsite. In addition to a tank of unknown origin or use located in the vegetation along the southern boundary of the site.

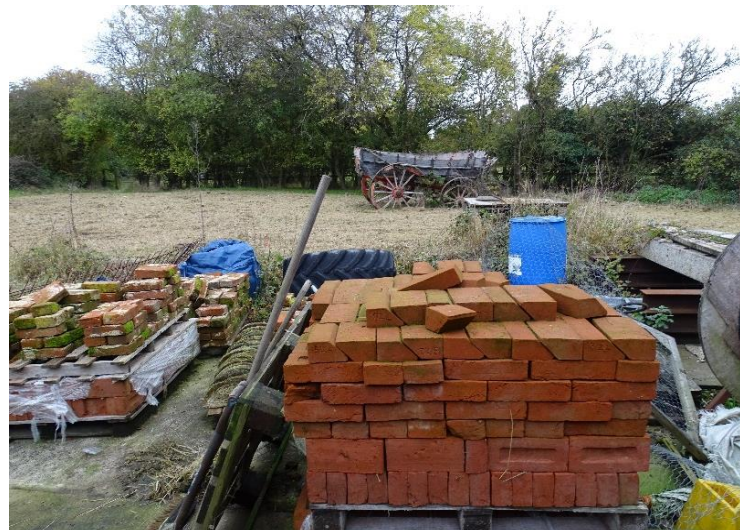
Photograph 4

Building materials stored outside
