DESIGN AND ACCESS STATEMENT

The Old Bakery, Church Street, Upton Grey, RG25 2RA

(1) the erection of a new stud wall and doorway to create enlarged rear entranceway and boot room (2) removal of garden terraces and construction of a new retaining wall to create enlarged sunken patio

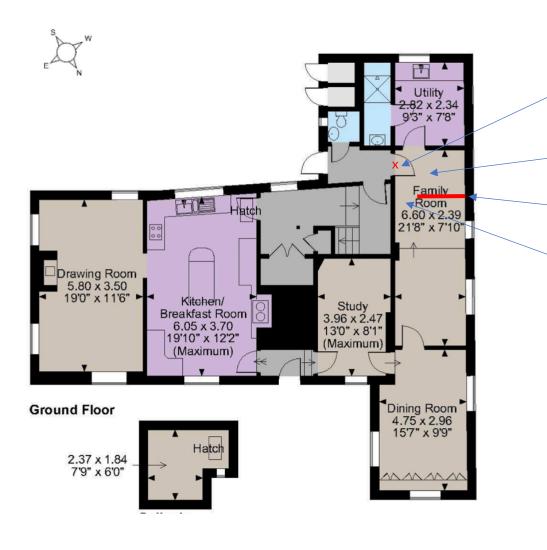
Floor Plan with Reference to New Stud Wall

Existing, modern brace and ledge door to be removed. Opening to remain and made good

Existing carpet to be removed within newly created boot room and replaced with terracotta tiles to match existing tiles within the rear entranceway and utility room

Position of new stud wall. Details on pages $4\,\&\,5$

New doorway to be located in new stud wall

The new dividing wall will be of classic timber frame construction using 2x4 softwood studs, set on 400mm centre. The bottom plate will be fixed to the floor and the top plate will be fixed to the existing rafters. Both sides will be fixed to the wall with 4-inch screws used for the fixing points. The timber frame wall will have horizontal noggins on a height of 1200mm to give extra rigidity. The wall will be closed off with 9.5mm plasterboard. The plasterboard will be fixed with 3.5 x 32mm plasterboard screws.

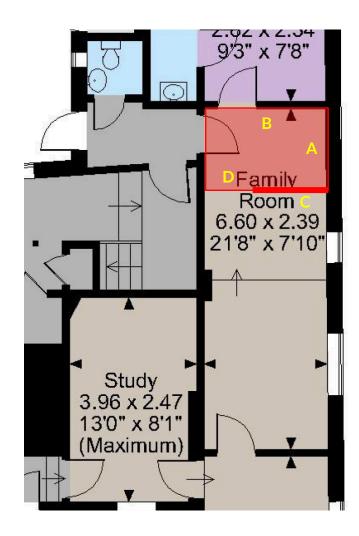
Dimensions of New Boot Room

DIMENSIONS

Existing Family Room:

6.60m x 2.39m

New Boot Room (shaded red):

- (A) 1.77m x (B) 2.39m
- (C) 1.51m (length of new wall)
- (D) 0.88m (width of new door)

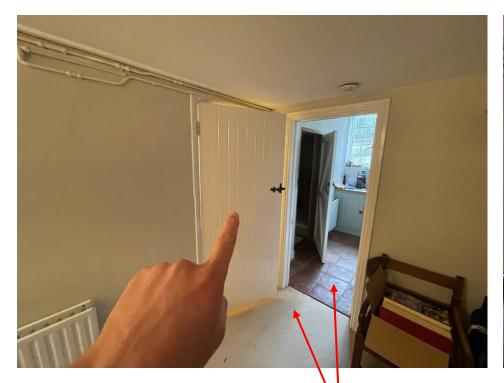
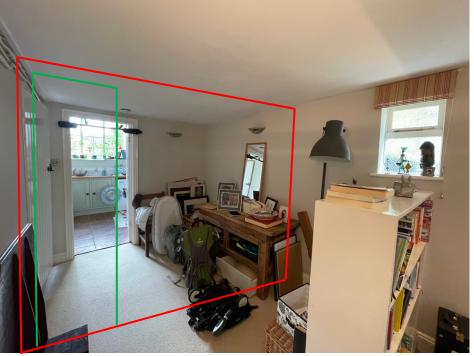
Interior Photos of Family Room

Existing ledge and brace door to be removed. Opening to remain and reveal made good

Carpet in newly created boot room/rear hallway to be removed and replaced with terracotta floor tiles to match the utility room and existing rear entranceway

Location of new stud wall, shown in red, reducing the size of the family room and creating an enlarged rear entrance and boot room. Location of new shaker style door shown in green.

The new door located in the new stud wall will be a wooden shaker style door painted white to match the existing doors throughout the rest of the ground floor of the property. The existing ledge and brace door to be disposed of.

The carpet in the newly formed boot room/rear hallway will be tiled using terracotta floor tiles to match the existing flooring in the utility room and existing rear entranceway.

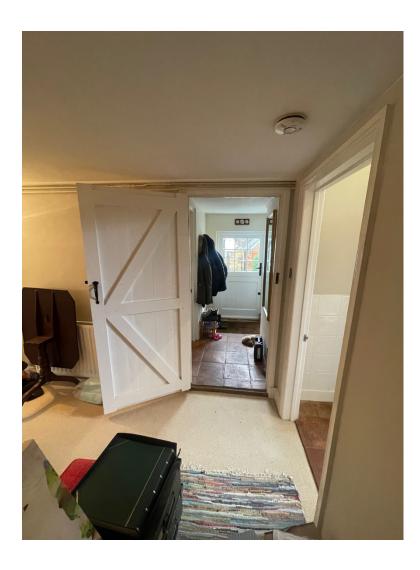
Photo taken from family room looking through to rear entrance way. Existing internal door in photo to be removed but opening to remain

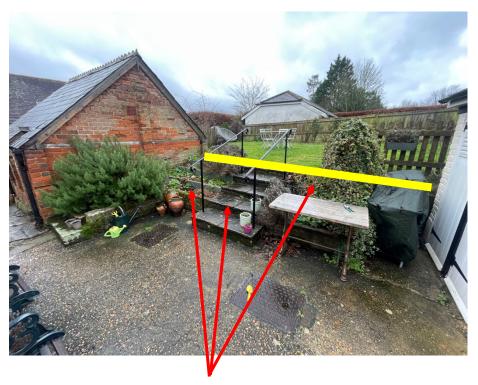
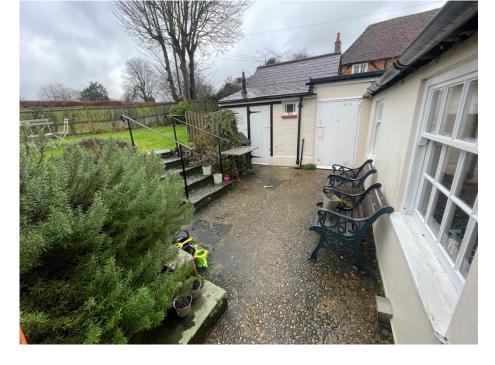
Exterior Photos of Existing Patio and Terraces

Garden terraces to be removed and replaced with new retaining wall in line with the edge of lawn and the top of the existing terrace (yellow line). Garden steps to be relocated against the outbuilding. Newly revealed area of patio beneath existing terraces to be laid with old reclaimed red brick pavers. Construction details on page 9.

- Dismantle & remove existing, modern steps to lawn area by hand and/or mechanical breaker as required and remove waste from site
- Excavate existing, modern raised and tiered brick borders by hand and remove waste from site

- Dig out ground area exposed by removal of steps and borders to a depth of 100-125mm and remove waste
- Backfill excavated areas with scalpings and compress with a plate compactor

- Bed reclaimed red bricks into a mortar bed and point to finish
- Rebuild steps to same dimensions as original but relocated against wall of adjacent outbuilding (as per Dynamic Garden design) and utilising a new, bespoke cast iron handrail

- Excavate a small area of the existing lawn and subsoil to accommodate new retaining wall, approximately 900mm high (as per plans) and remove waste
- Install a concrete foundation for the new wall, incorporating reinforcing bars

- Lay heavy duty hollow, concrete blocks to create retaining section of wall so that reinforcing bars are placed inside the voids
- Backfill voids with wet-flow concrete, allowing for drainage points to remove any build- up of ground water behind wall

- Lay brick facing to wall using older, reclaimed bricks to blend in with age of the property (to be tied into concrete, retaining section of wall)
- Top off with soldier course of bricks to hide concrete blocks

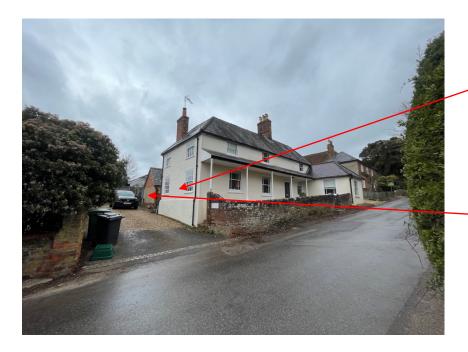
Photos showing the poor condition of the existing pointing to the rear outbuilding.

The southern elevation requiring repointing and decorating

The outbuilding requiring repointing

The application also includes the repointing of the existing outbuilding to the rear and southern external elevation of the main house. The pointing on the outbuilding is in very poor condition and will be repointed using lime mortar and in accordance with Historic England's Repointing Brick and Stone Walls: Guidelines for Best Practice. The outbuilding will remain unpainted. The paint on the southern elevation of the main house is in poor condition and has blown in parts. The proposal is to remove the old paint to reveal the condition of the wall beneath. The wall will then be repointed if required (and as mentioned above) before being repainted using a breathable paint to match the existing colour.
