## **Phase I Geo-Environmental Desk Study**

### **Land North West of Willowdale Farm**

Pound Green  
Guilden Morden  
Royston  
Cambridgeshire  
SG8 0JZ

<b>EPS Project Reference:</b>	UK21.5283
<b>Date Issued:</b>	16 <sup>th</sup> February 2021
<b>Report Status:</b>	Issue 1

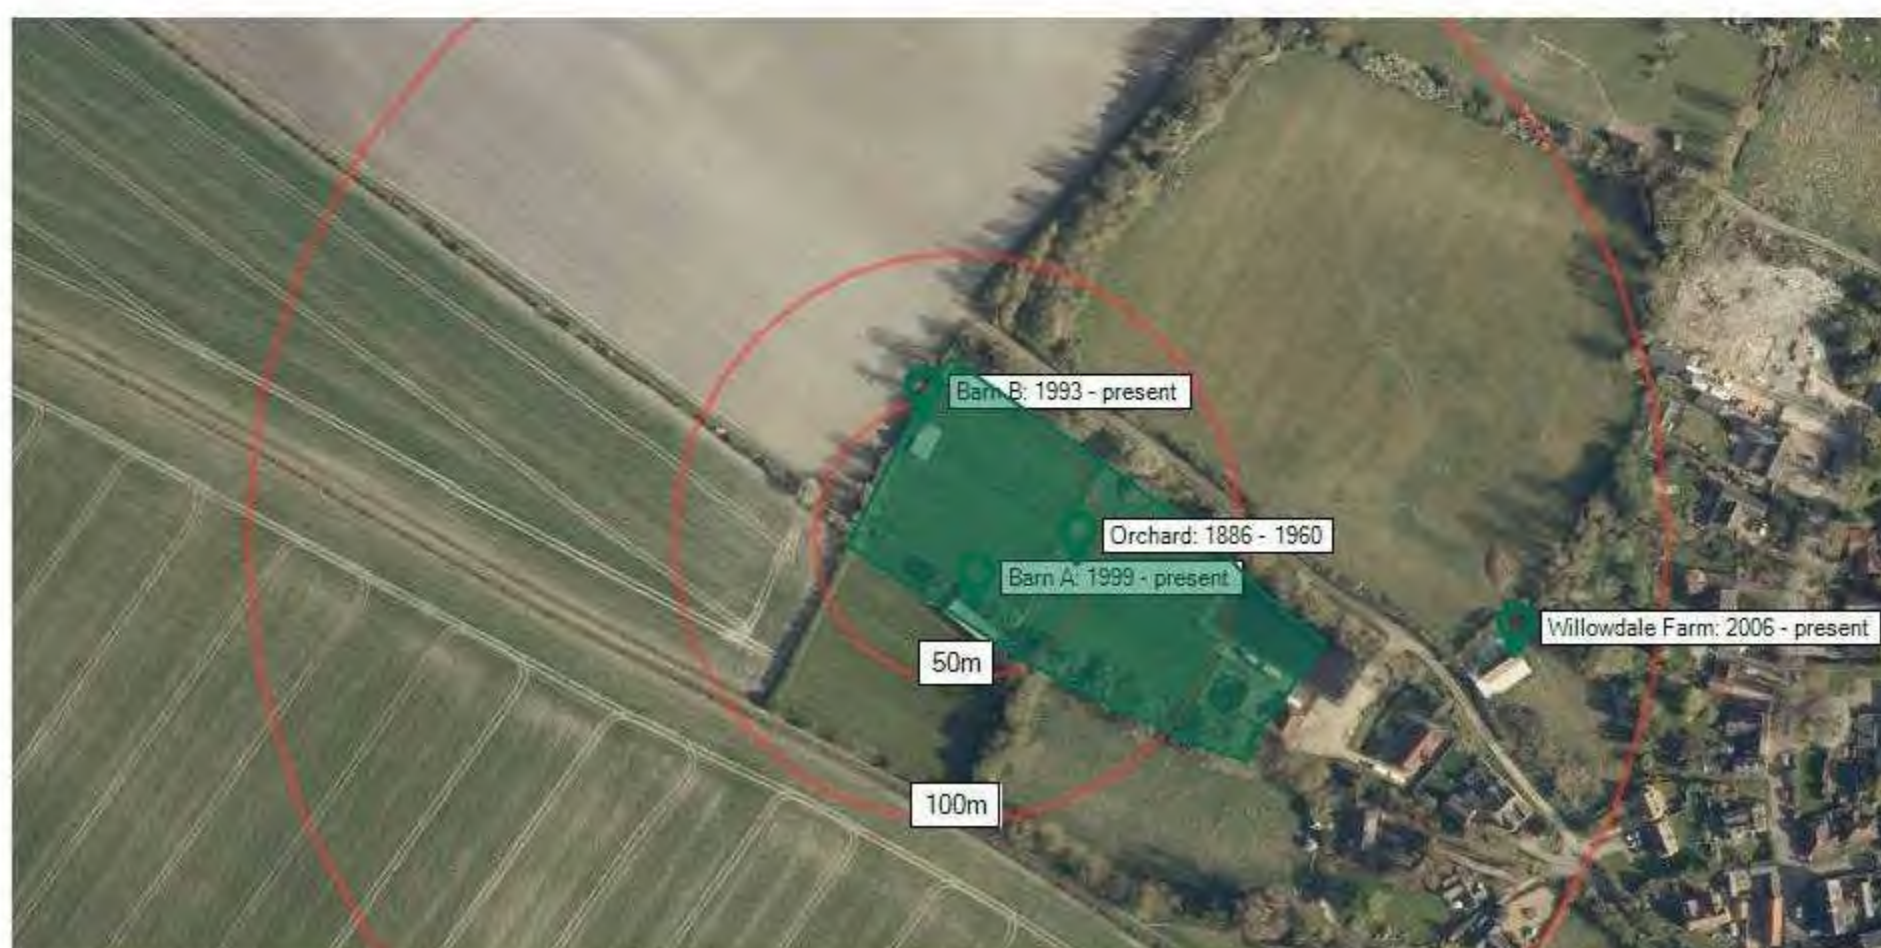
- Earliest mapping from the late 1880's shows the study area to be undeveloped, with sections of the northern field where 'Barn B' is now located, possibly being part of an orchard. This remained consistent until sometime between 1960-1975 when this area was no longer indicated as an orchard and a number of access tracks with similar layout to present day were established. No further significant changes were noted until 'Barn A' was first constructed, according to an aerial photograph from 1999, with 'Barn B' first appearing on maps from 1993.

- At a similar time, a series of small buildings were introduced across the field in which 'Barn B' is currently located, and through discussion with the Client, these were individual/ temporary pig shelters, which have since been removed. No other buildings or land uses have highlighted within the study site.

- The only potentially contaminative land use identified within the surrounding area is Willowdale Farm (180m east), which first appears on maps from 2006.

A summary of notable potential contaminative land uses on site and within the surrounding area taken from historical mapping from 1886 – 2020 is summarised on the recent aerial photograph below. Key points are highlighted and copies of relevant historic maps and any others examined during the investigation are included in this report as Appendix F.

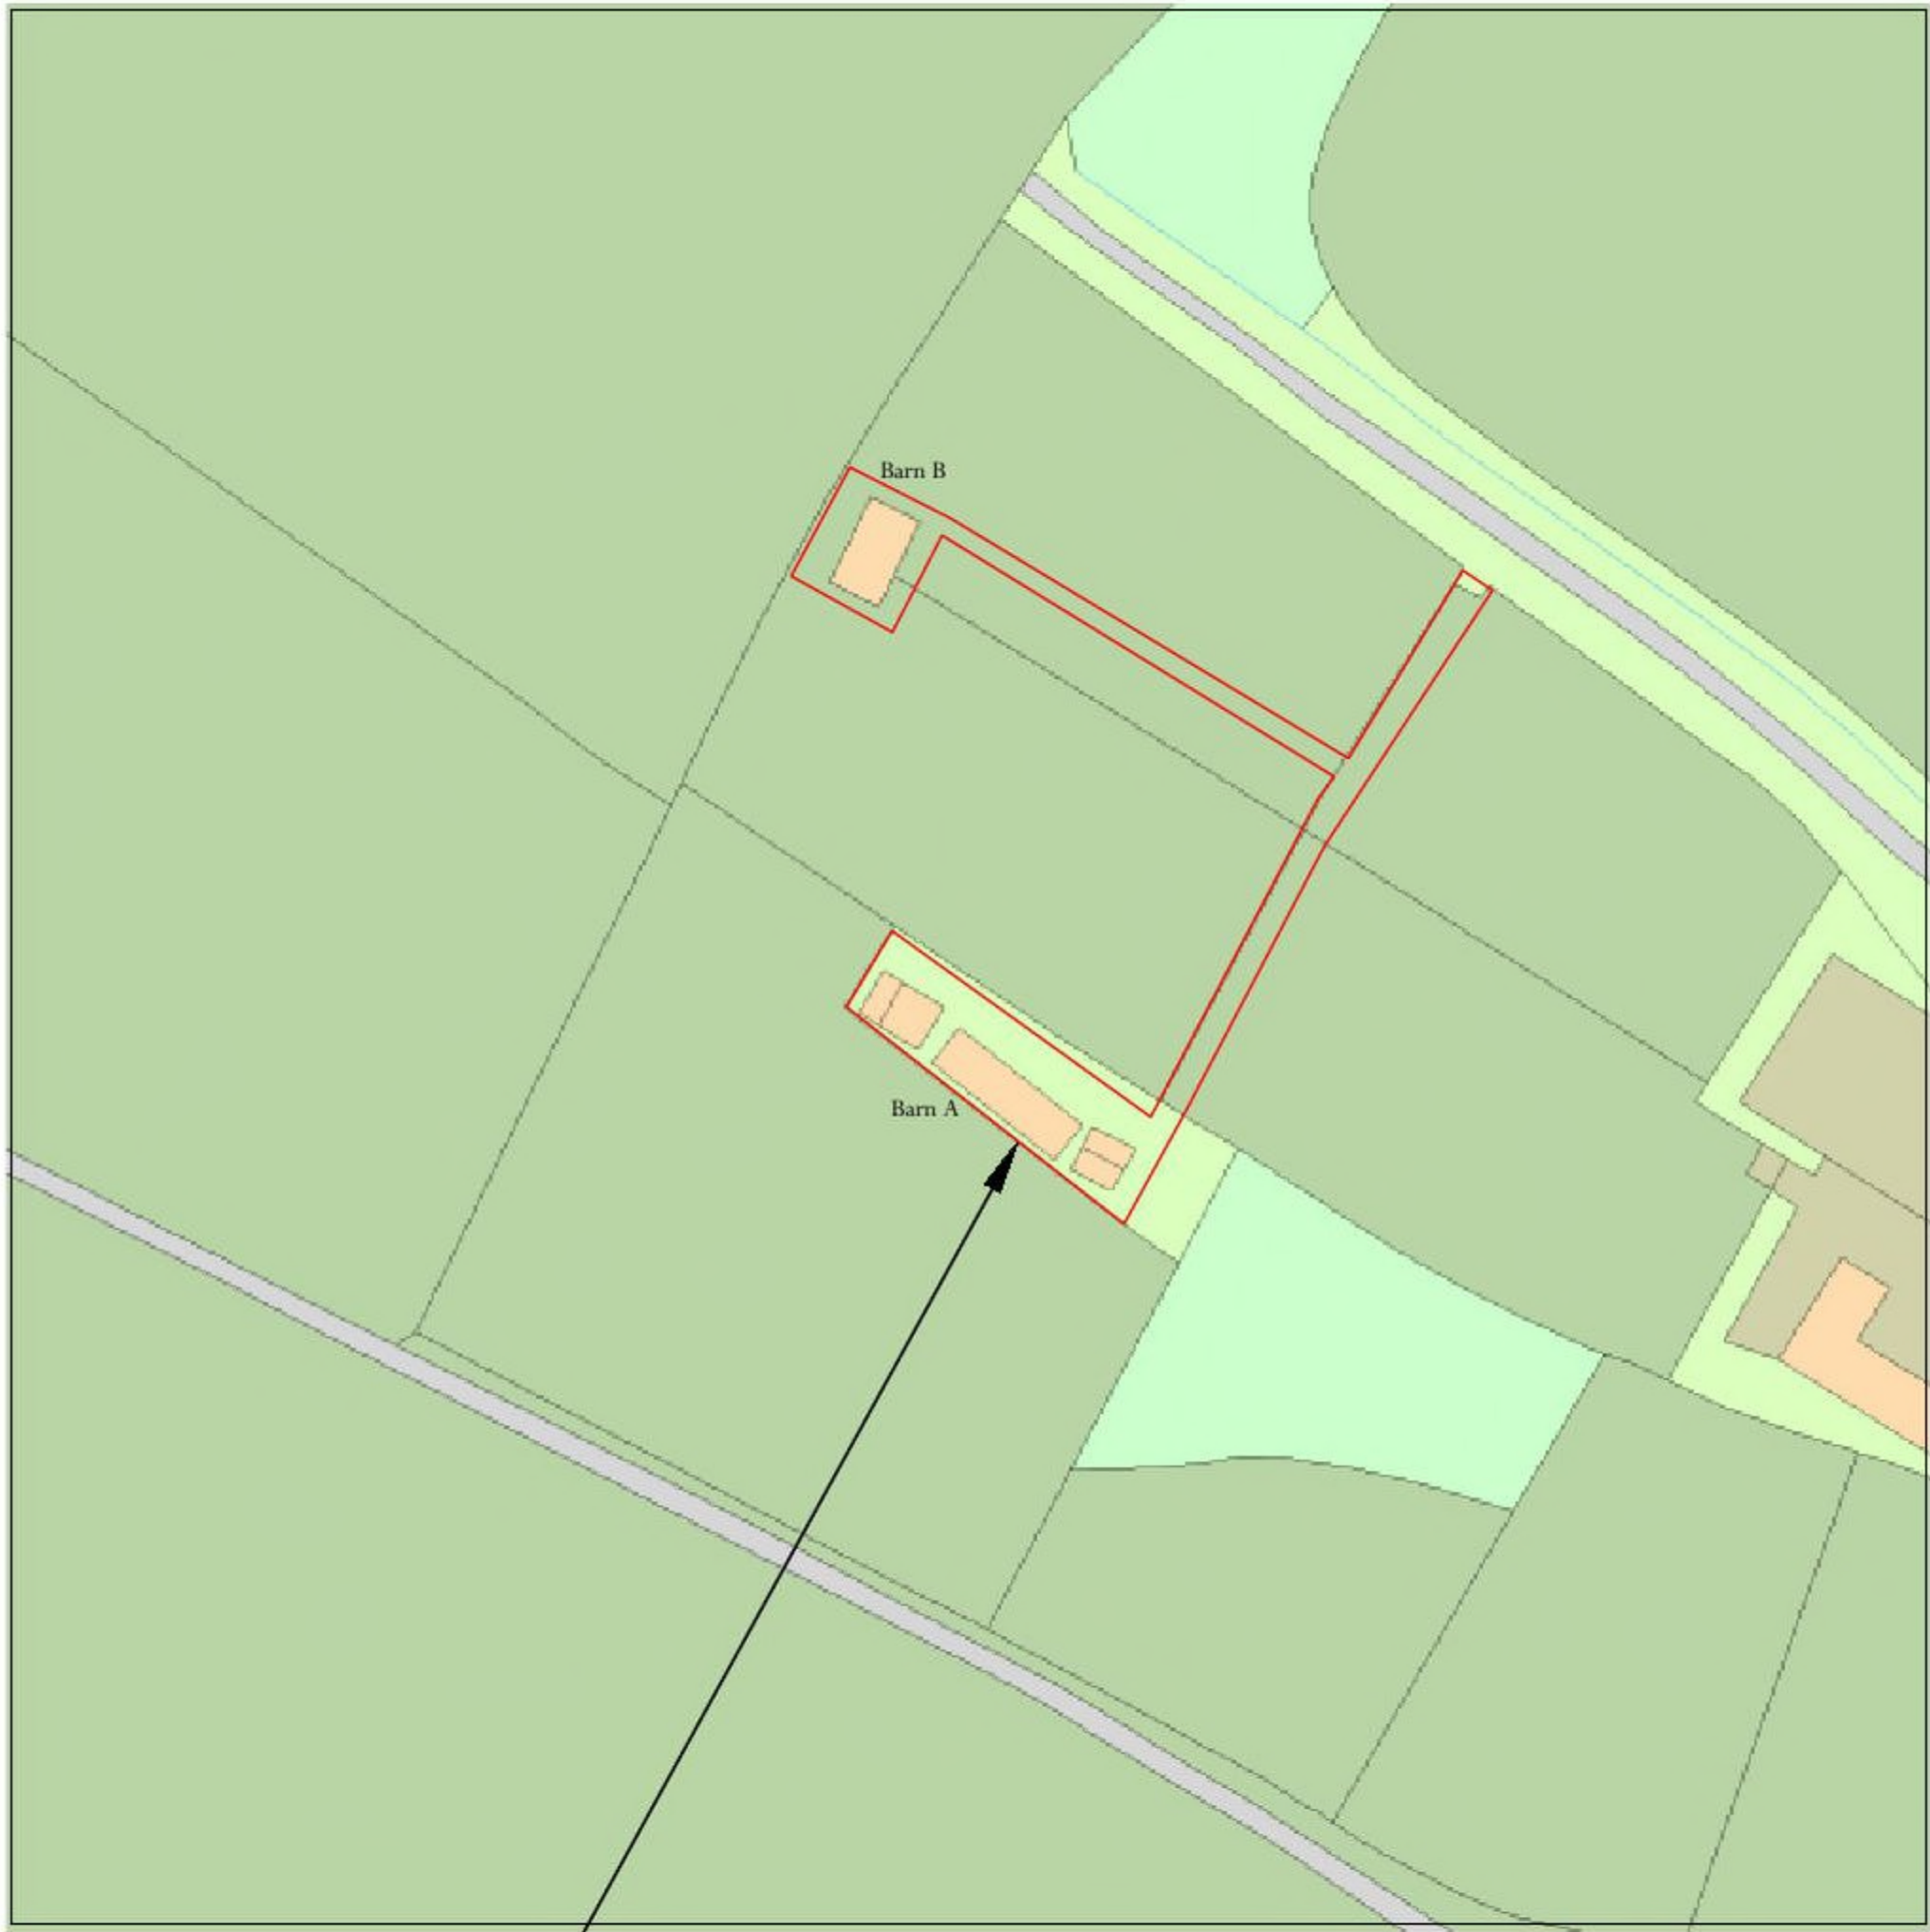
**Fig No:** 2

**Title:** Current Site Layout Plan

A plan showing the site location is provided as Figure 1, the current site layout is detailed on Figure 2 and an aerial photograph is included as Figure 3. Selected Site Photographs are included as Appendix A, an indicative proposed development plan is presented as Appendix B and relevant extracts of a Envirocheck report are included as Appendix C.

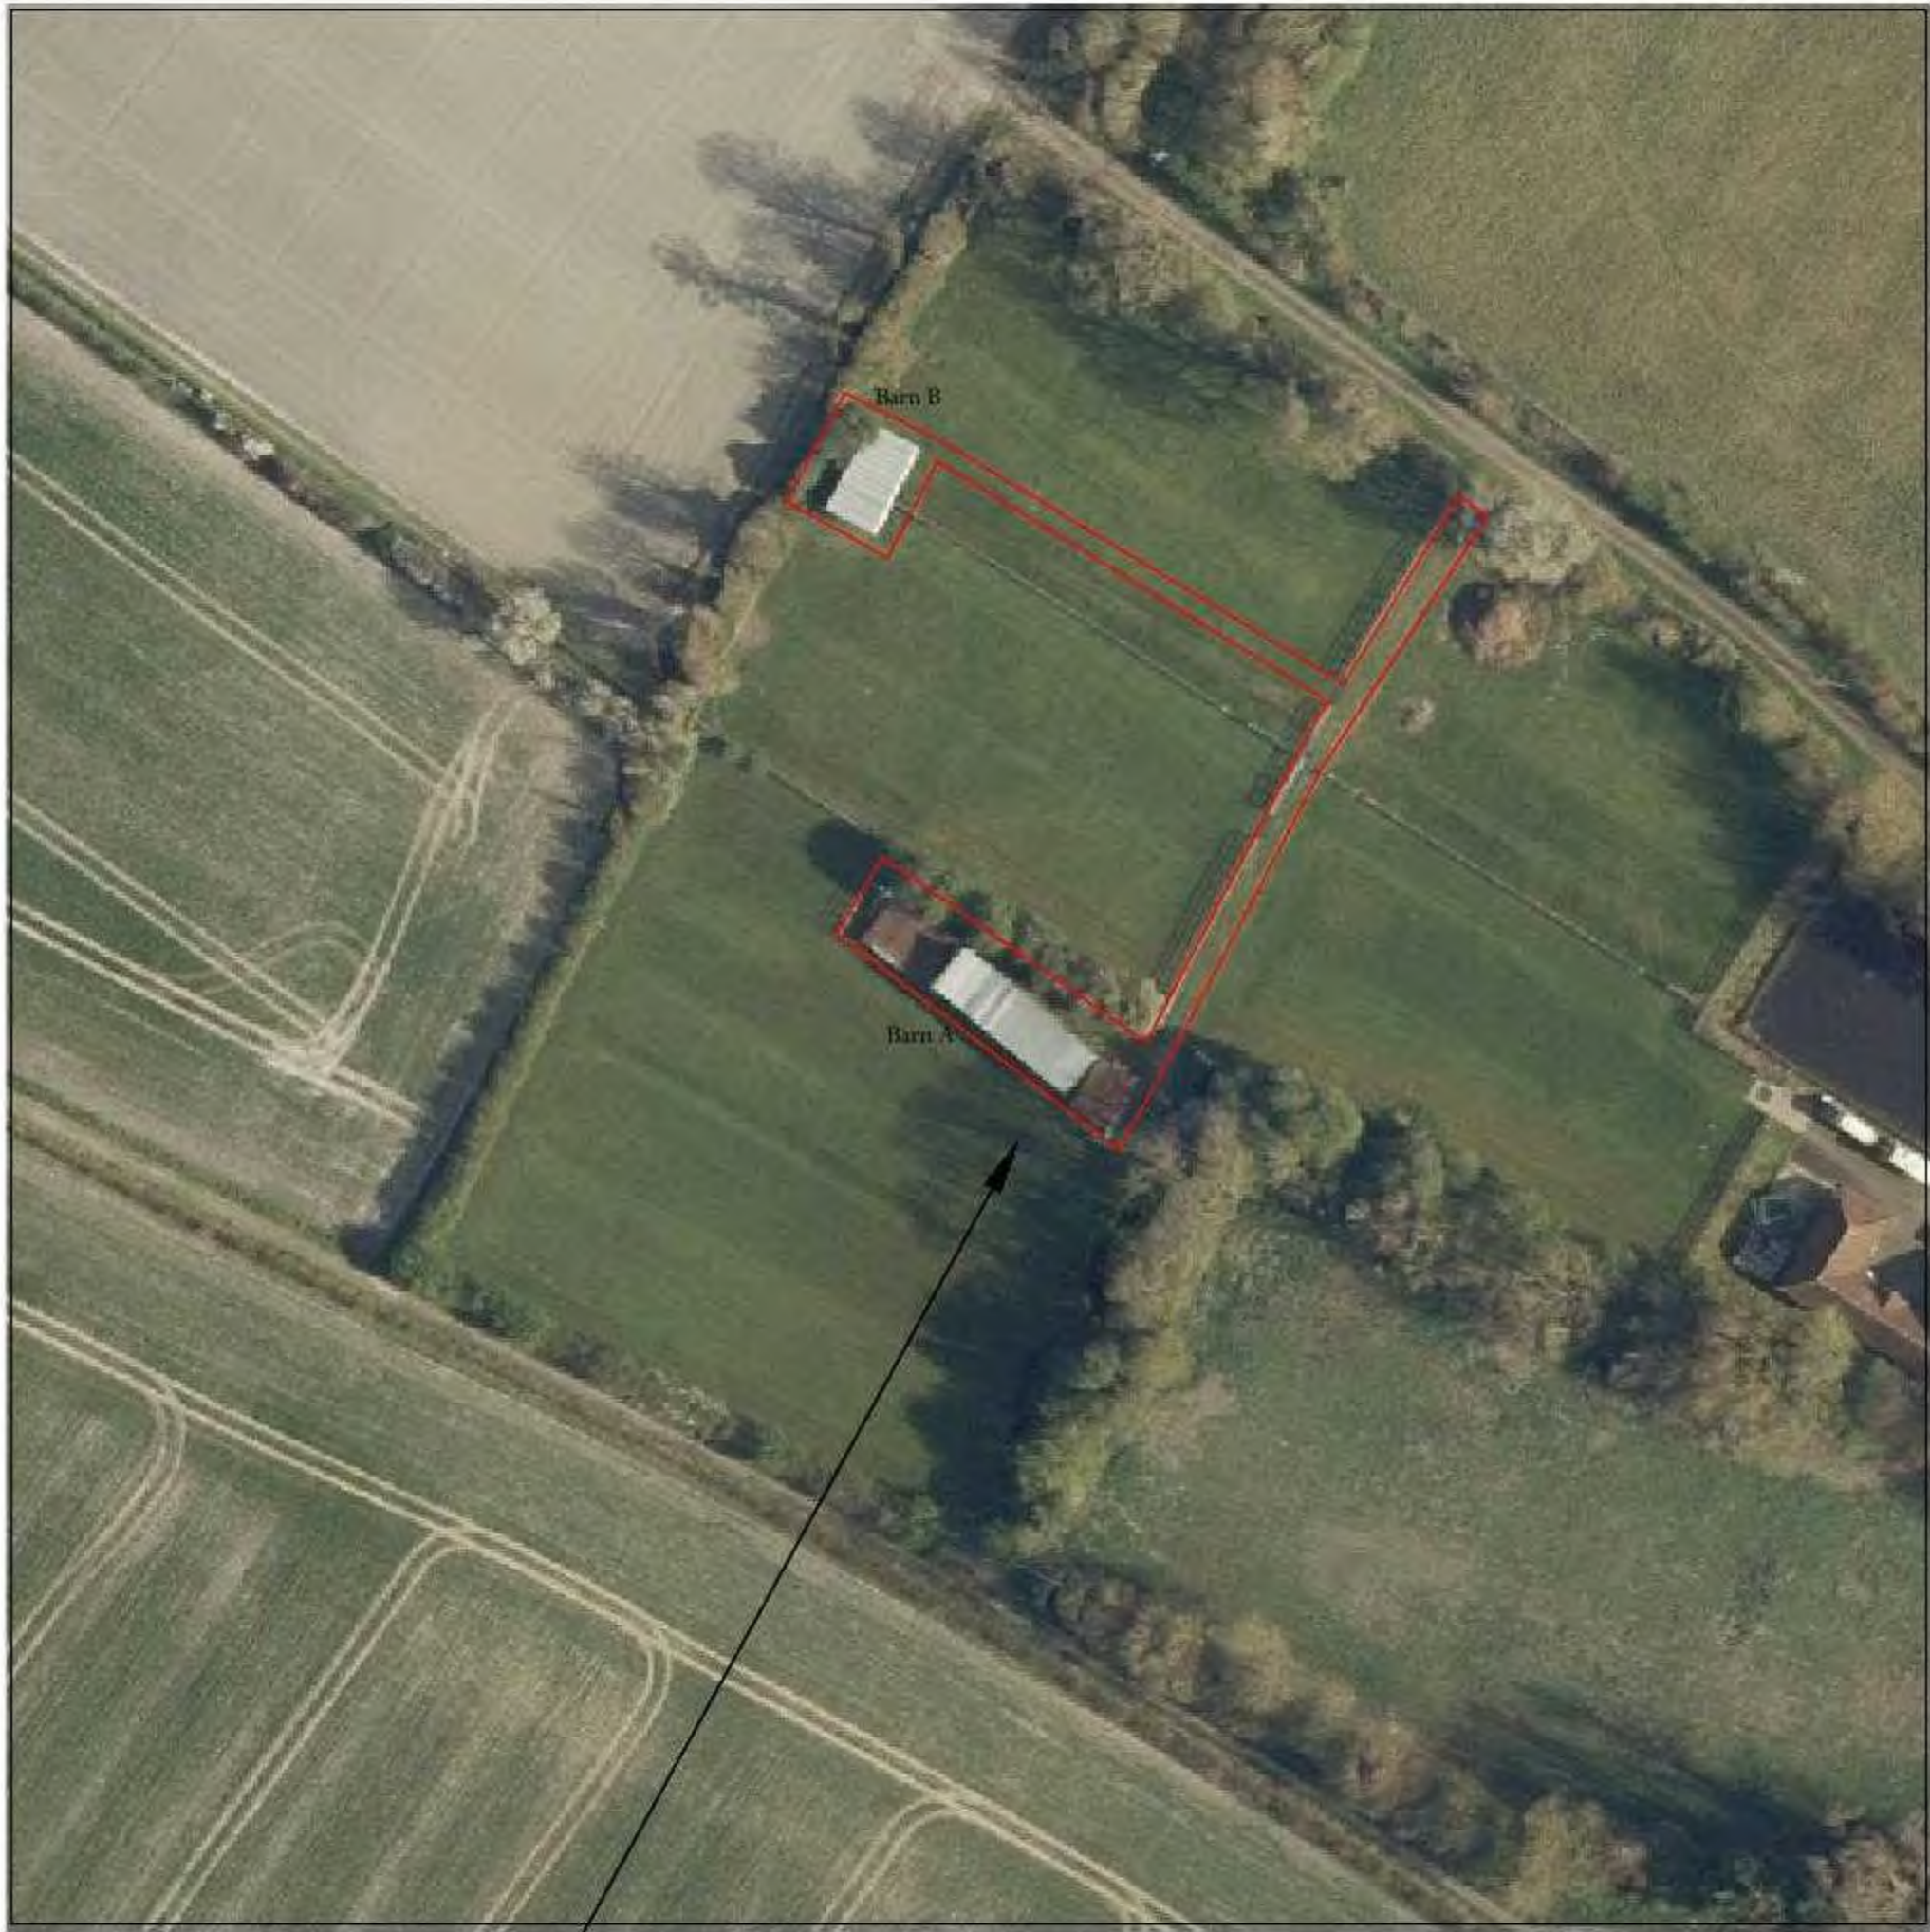
**Project:** Land Northwest of Willowdale  
Farm, Pounds Green, Guilden  
Morden, Royston, Cambs, SG8 0JZ  
**Fig No:** 3

**Title:** Aerial Photograph

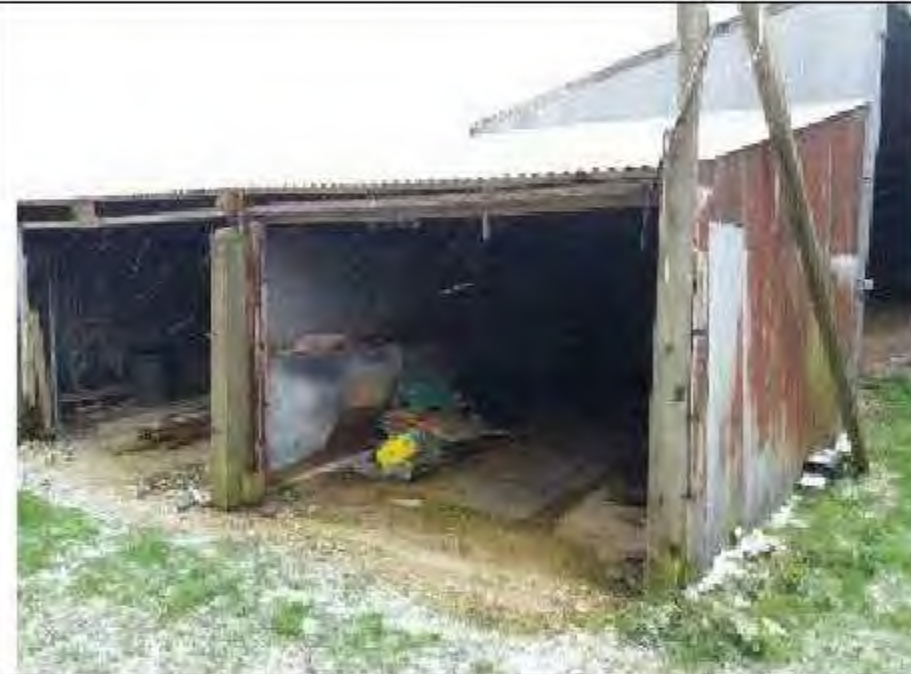
Photo 1: Image looking at the south eastern part of 'Barn A'.

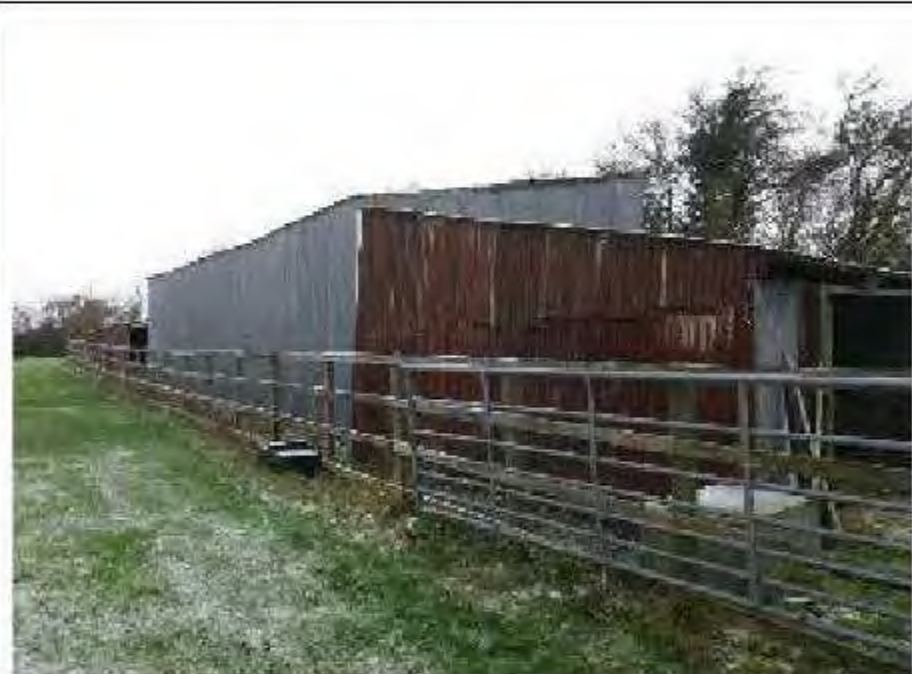
Photo 2: Image showing the south western face of 'Barn A'.

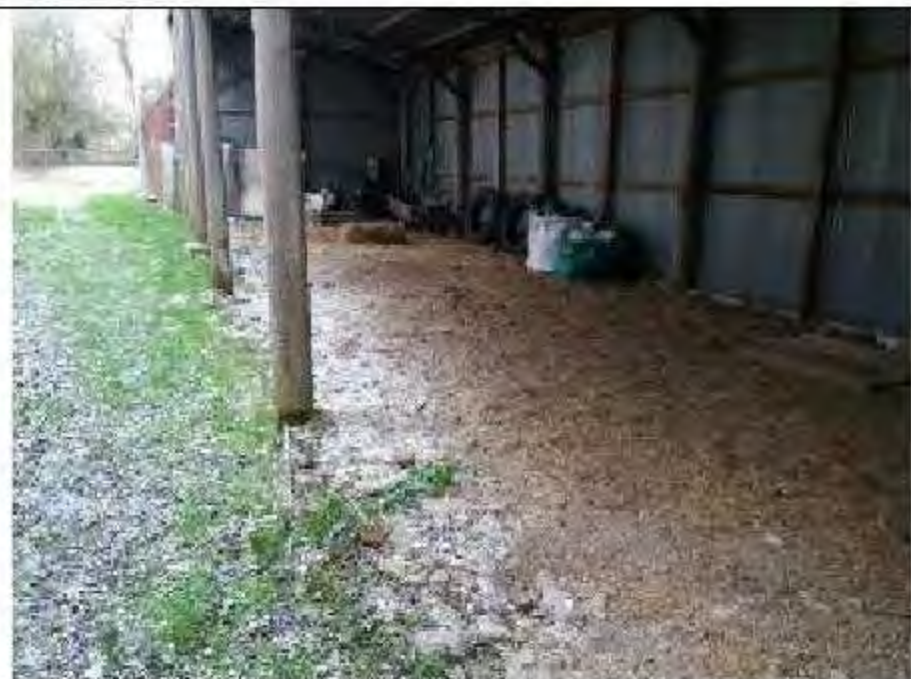
Photo 3: Image showing the north eastern face of 'Barn A'.

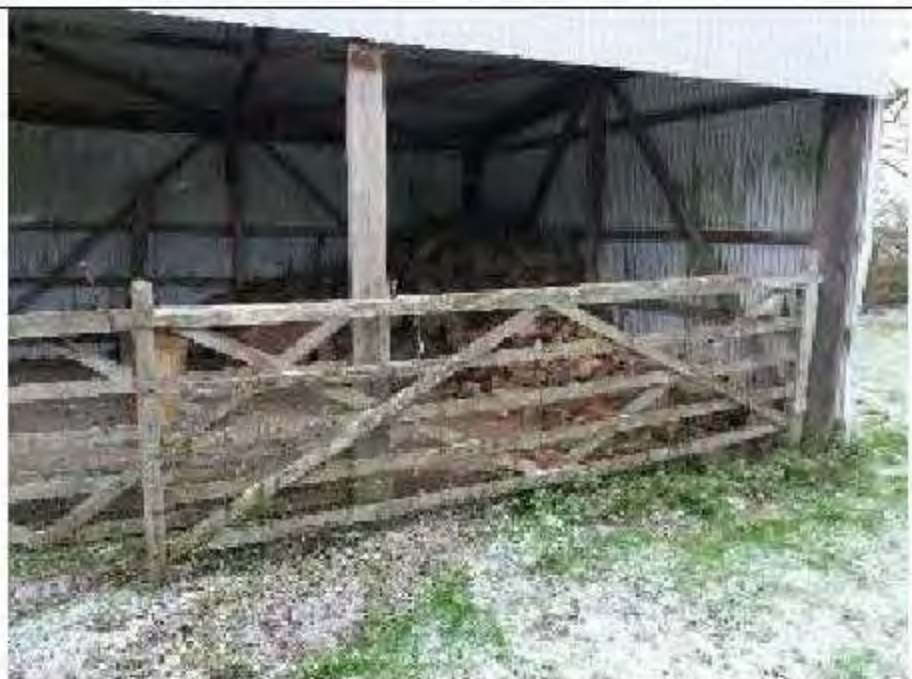
Photo 4: Image showing 'Barn B'.

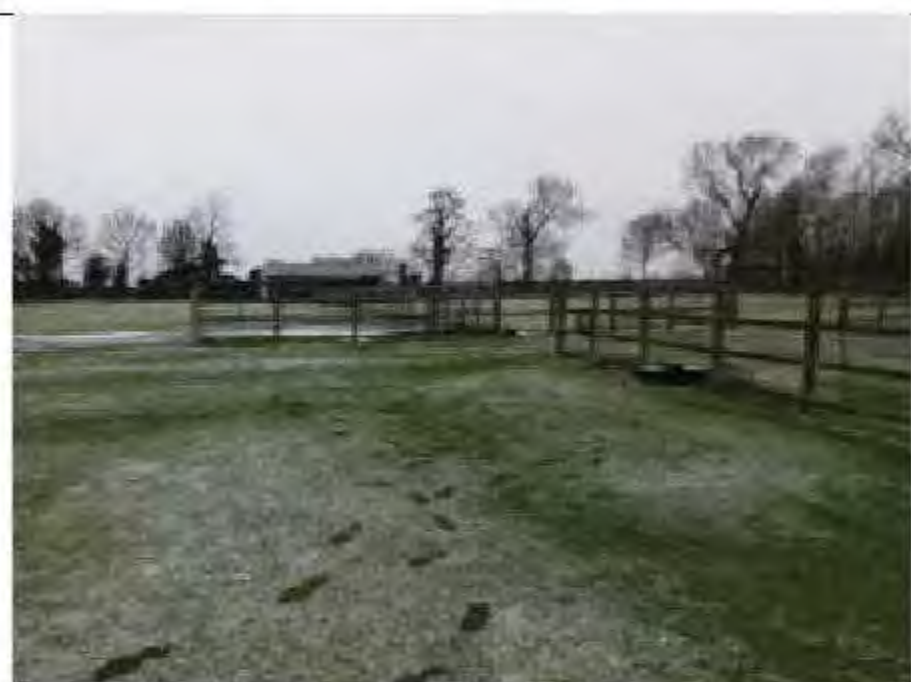
Photo 5: Image looking north west towards 'Barn B'.

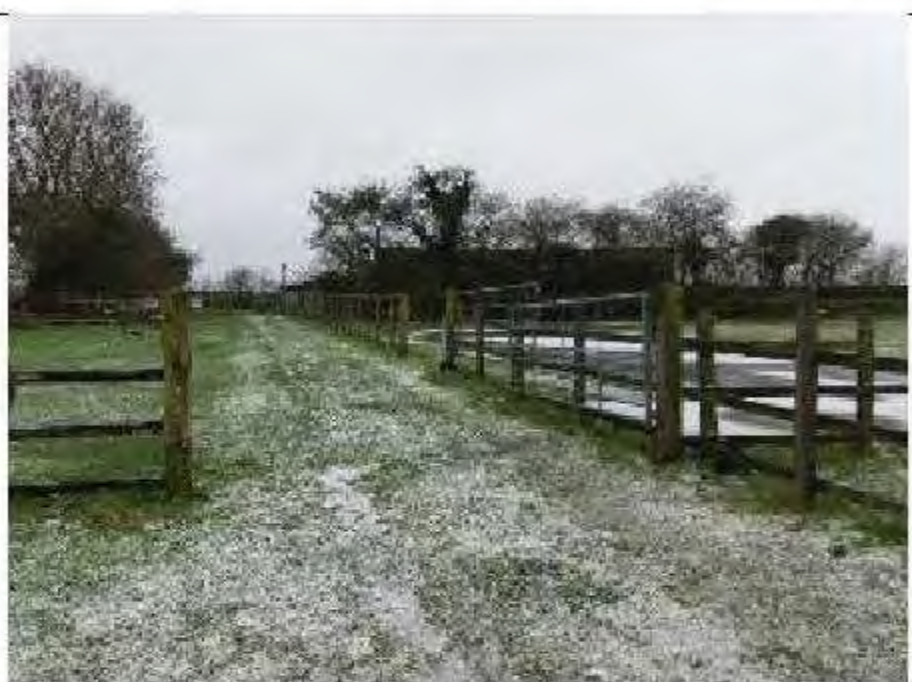
Photo 6: Image looking south west towards 'Barn A'.
