STATEMENT OF SIGNIFICANCE

109 High Street, Eton, SL4 6AN

Lewandowski Architects

March 2017

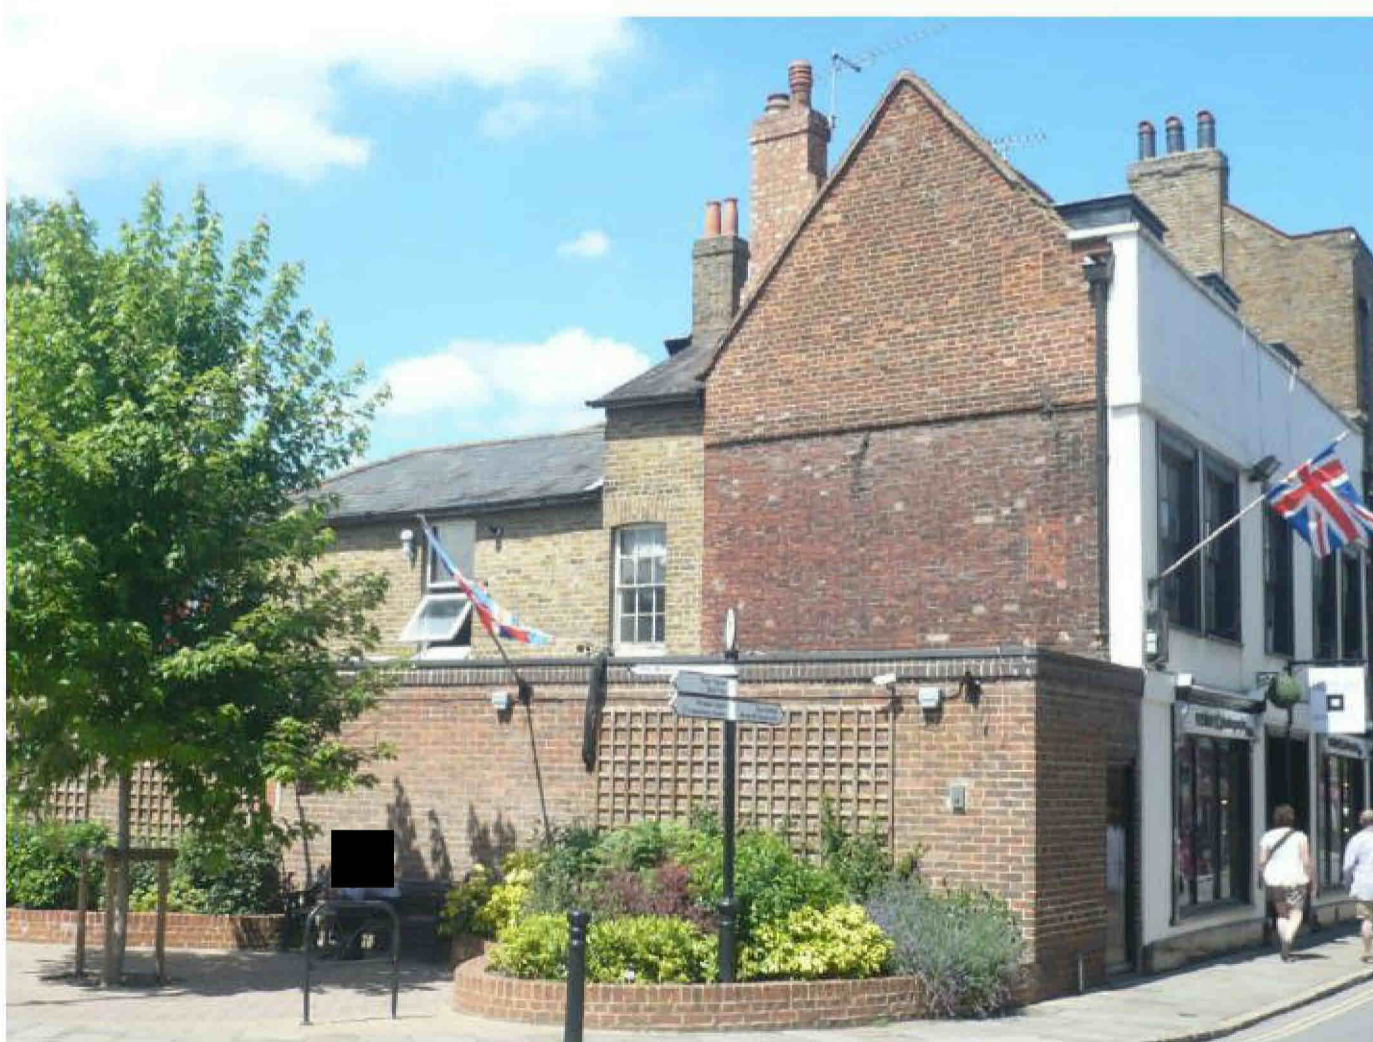
Fig.1 View of 109 High Street from the south at the junction with Eton Court

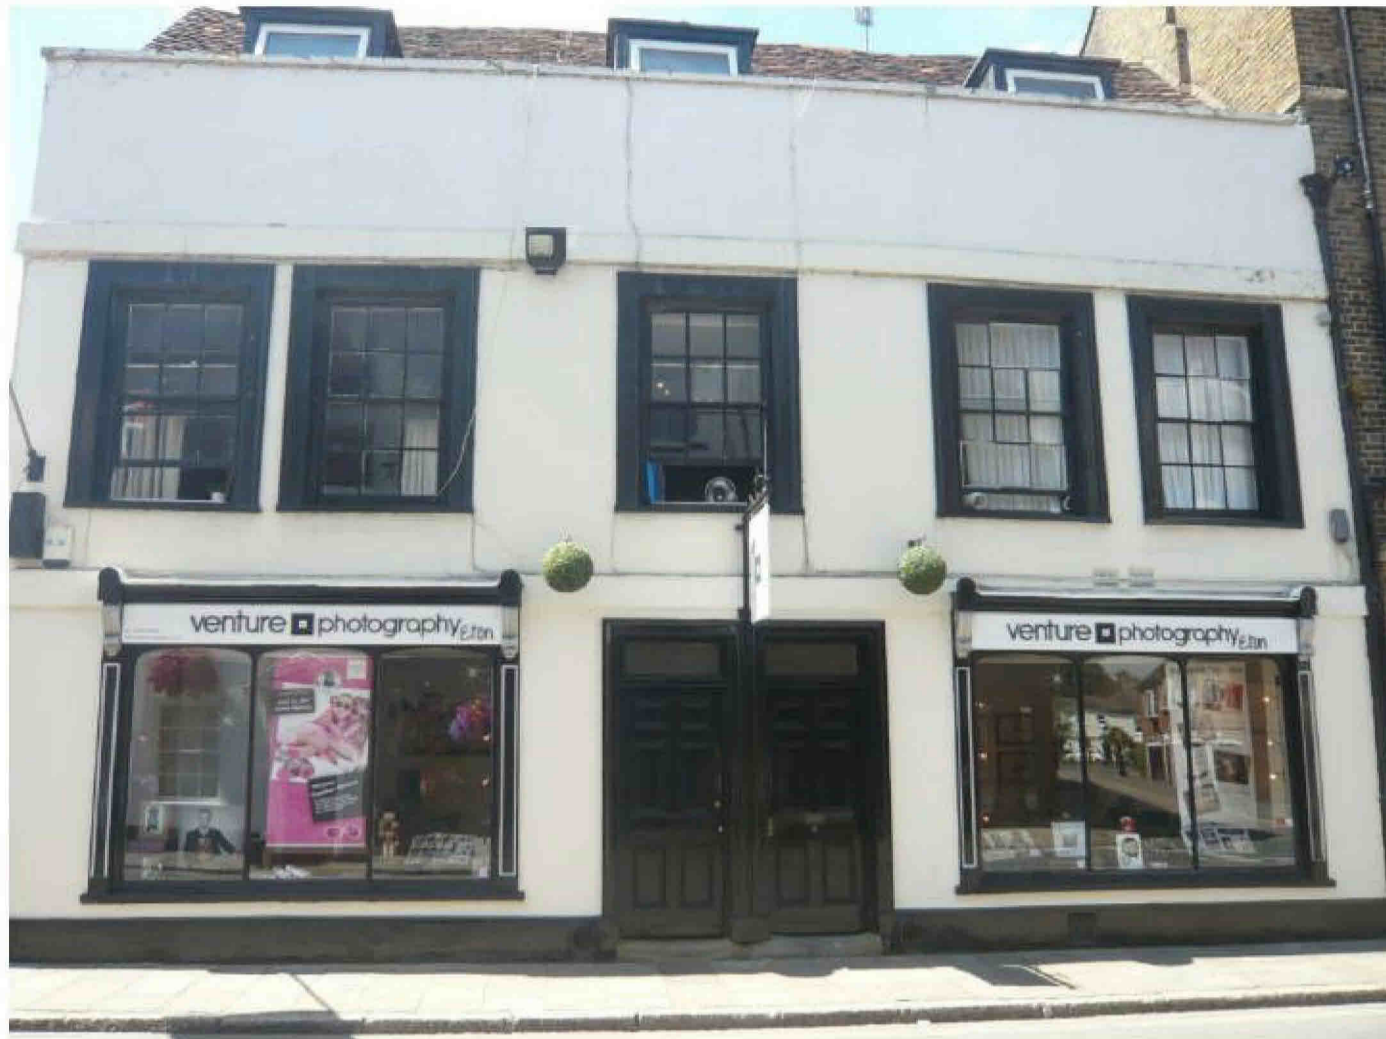
- 3.3 The ground floor front elevation of 109 High Street contains two timber shopfronts and a pair of entrance doors all set to the right-of-centre.

Fig.2 The frontage of 109 High Street

- 3.4 The shopfronts are matching and they have pilasters with scroll corbels supporting a cornice, and tripartite glazing with flat arches and mullions. The entrance doors are centrally positioned between the shopfronts and are six-panelled and beaded with plain fanlights.

- 3.5 There are five six-over-six paned sliding sash windows without horns and with lamb's tongue glazing bars set within architraves on the first floor.

- 3.6 There are projecting plat bands at ground and first floor level, and a parapet at roof level. The roof is steeply pitched and covered with plain clay tiles. There are three lead flat-roofed dormers on the front-facing roof slope. There is a tall brick chimney stack at the southern end of the rear slope.

- 5.4 The sash windows on the building's frontage without horns and with narrow lamb's tongue glazing bars suggest they are early 19th century.
- 5.5 The main staircase, comprising open-string with ramped hardwood handrail, stick balusters and tapered newel, probably dates from the early 19th century. This was perhaps added at the same time as the building's re-fronting.

- 5.6 The shopfronts are of 19th century date, again possibly coinciding with the early 19th century re-fronting. The two central doors with a shopfront to either side suggest the ground floor was at one time divided into two shops, probably with a partition through the middle. The current layout does not reflect the historic arrangement.

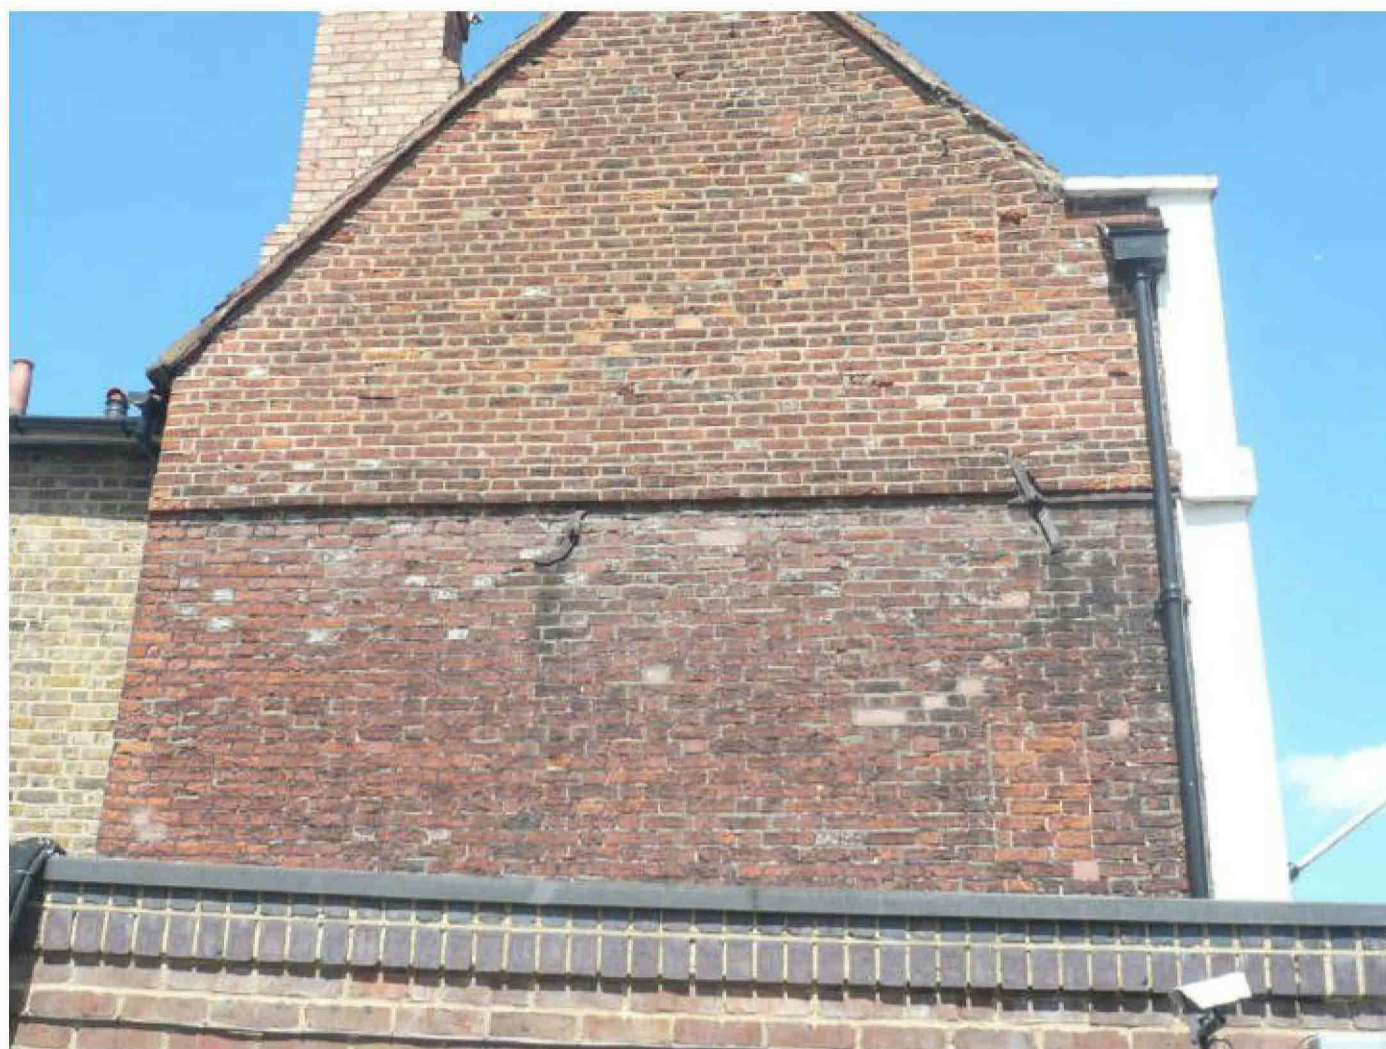
- 3.7 The side gable of the frontage range is constructed of red brick laid in Flemish bond. The brick below the first floor plat band is dark red, while the brick above is more orange-coloured. There is evidence of a blocked window at first floor and attic level. There are two cast-iron ties at first floor level.

Fig.3 The south gable of the frontage range of 109 High Street

- 5.9 The attic floor might have been brought into use in the early 19th century with the insertion of the main staircase, which rises continuously up to this level. There is some evidence to suggest the gable was altered or rebuilt from the changes in the brickwork on the south elevation. The two two-panel doors at attic level probably date from the early 19th century.

- 5.11 The section of gabled roof rising up from the main hipped roof on the southernmost rear projection perhaps suggests this was a later addition. This section houses the secondary stairs, which from their design appear to date from the second half of the 19th century, so it may have been added then. Perhaps prior to this staircase the rooms at attic level were interconnected: this might explain why some of the tie-beams at attic level have been severed. The two historic metal ties in the gable might have been added when the attic was brought into use.

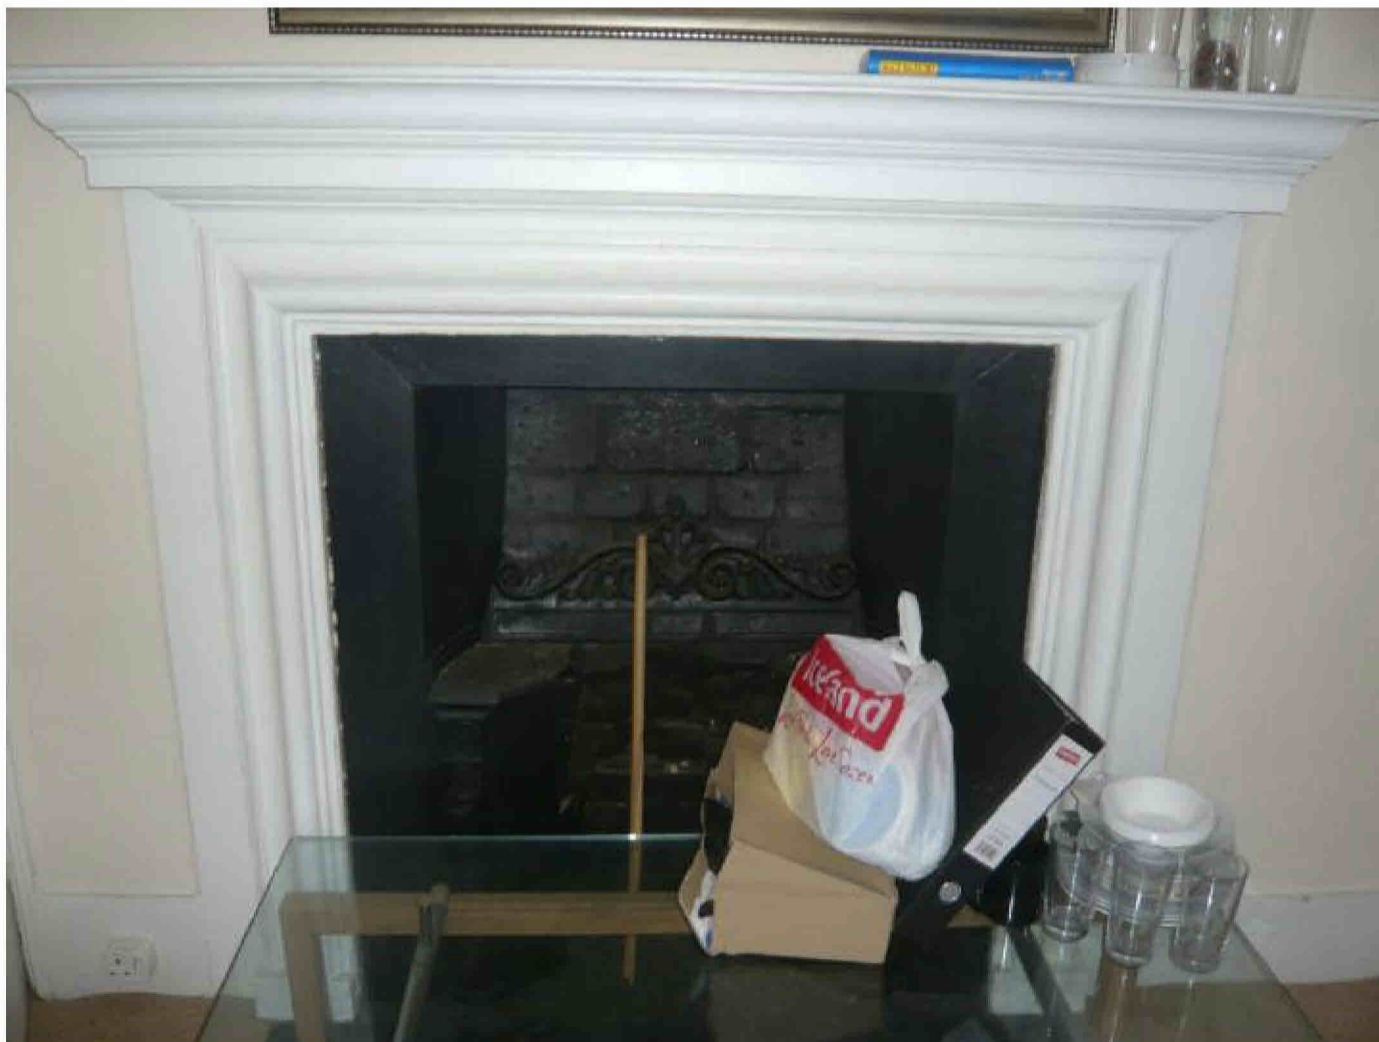
- 3.22 There is a cornice within the northern room with a composite quarter-round convex and concave mouldings. On the west wall there is a painted bolection-moulded fire surround with a cast-iron hob grate.

Fig.7 Bolection-moulded fireplace on the first floor

- 5.2 The surviving physical evidence from the bolection-moulded fireplace with cast iron hob grate on the first floor of the frontage range and the quarter-round cornices suggests this part of the building could date from the late 17th or early 18th century.

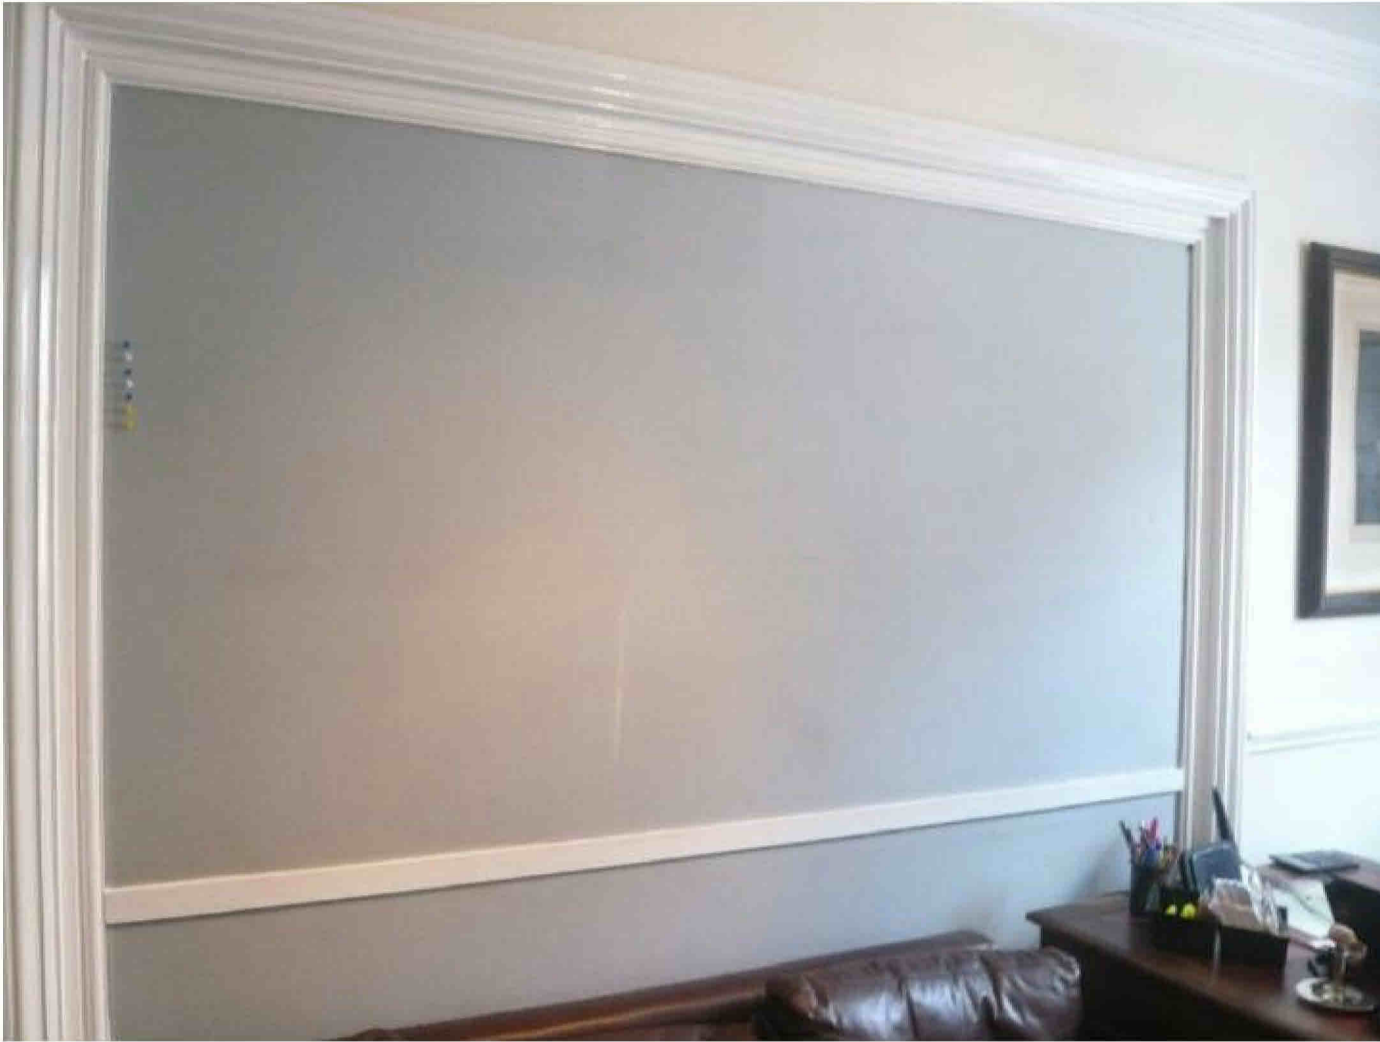
- 3.23 There is evidence of a former wide arched opening between the northern and central of the three rooms, which has been filled in with a stud wall.

Fig.8 Filled in former wide opening between two first floor rooms

- 5.8 At first floor level within the frontage range, the central and northernmost room were at one time connected via a wide opening in the subdividing wall. Historically, the rooms on the first floor frontage would have been the most important rooms in the house, and were used for receiving guests and entertaining. The level of decoration usually reflects this.

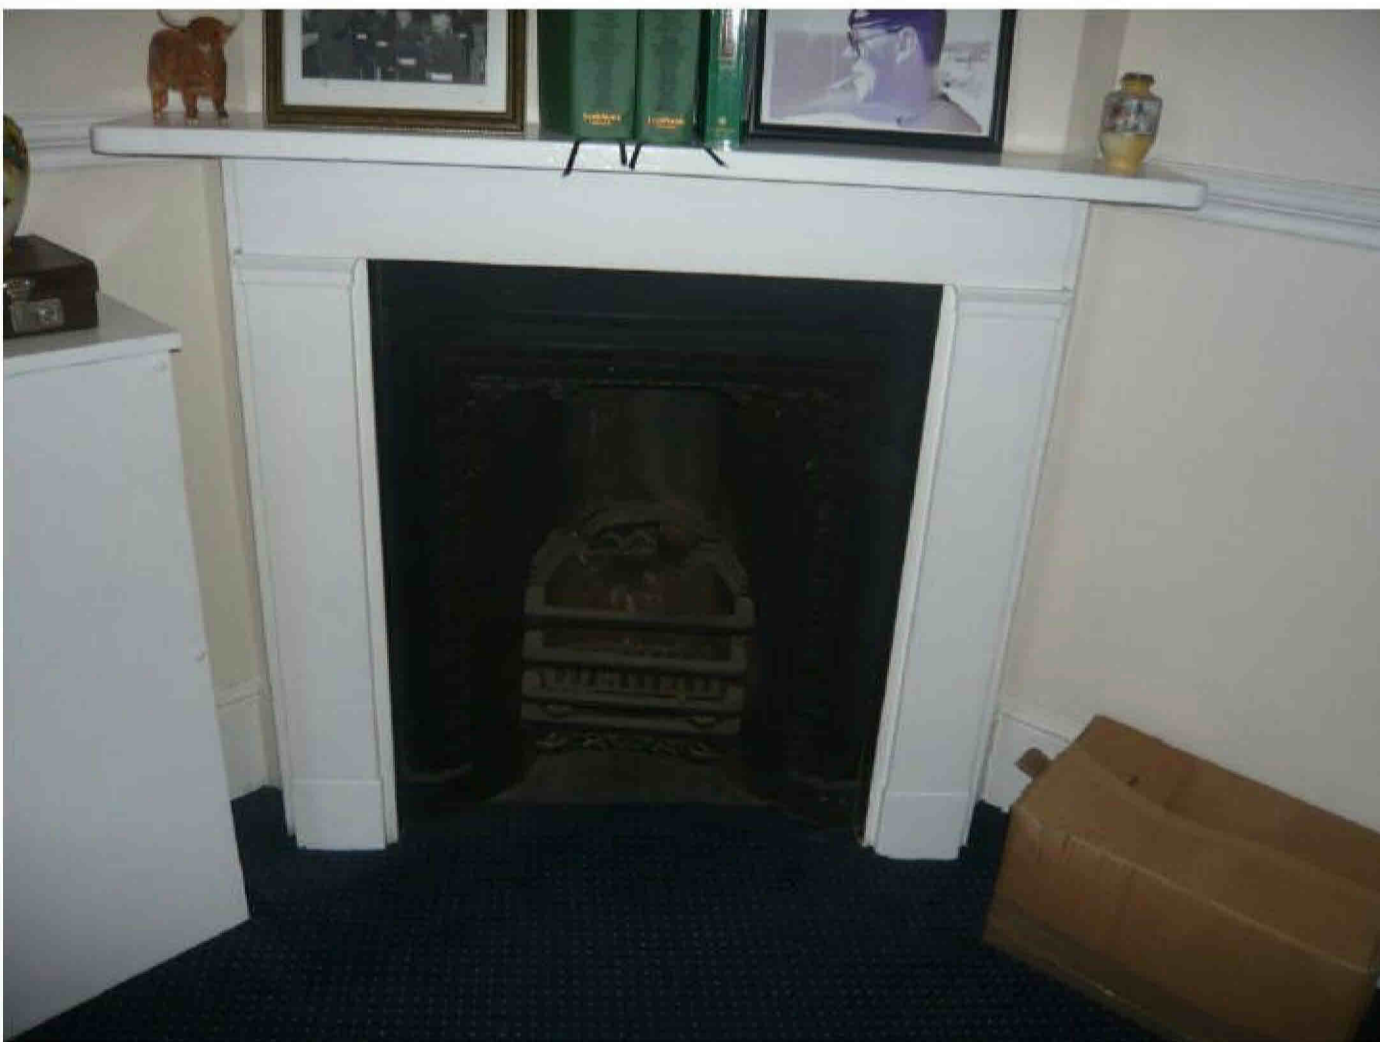
- 3.24 The central room on the first floor has a simple timber corner fire surround with an ornate cast iron register grate.

Fig.9 Corner fireplace in the central room on the first floor at the front

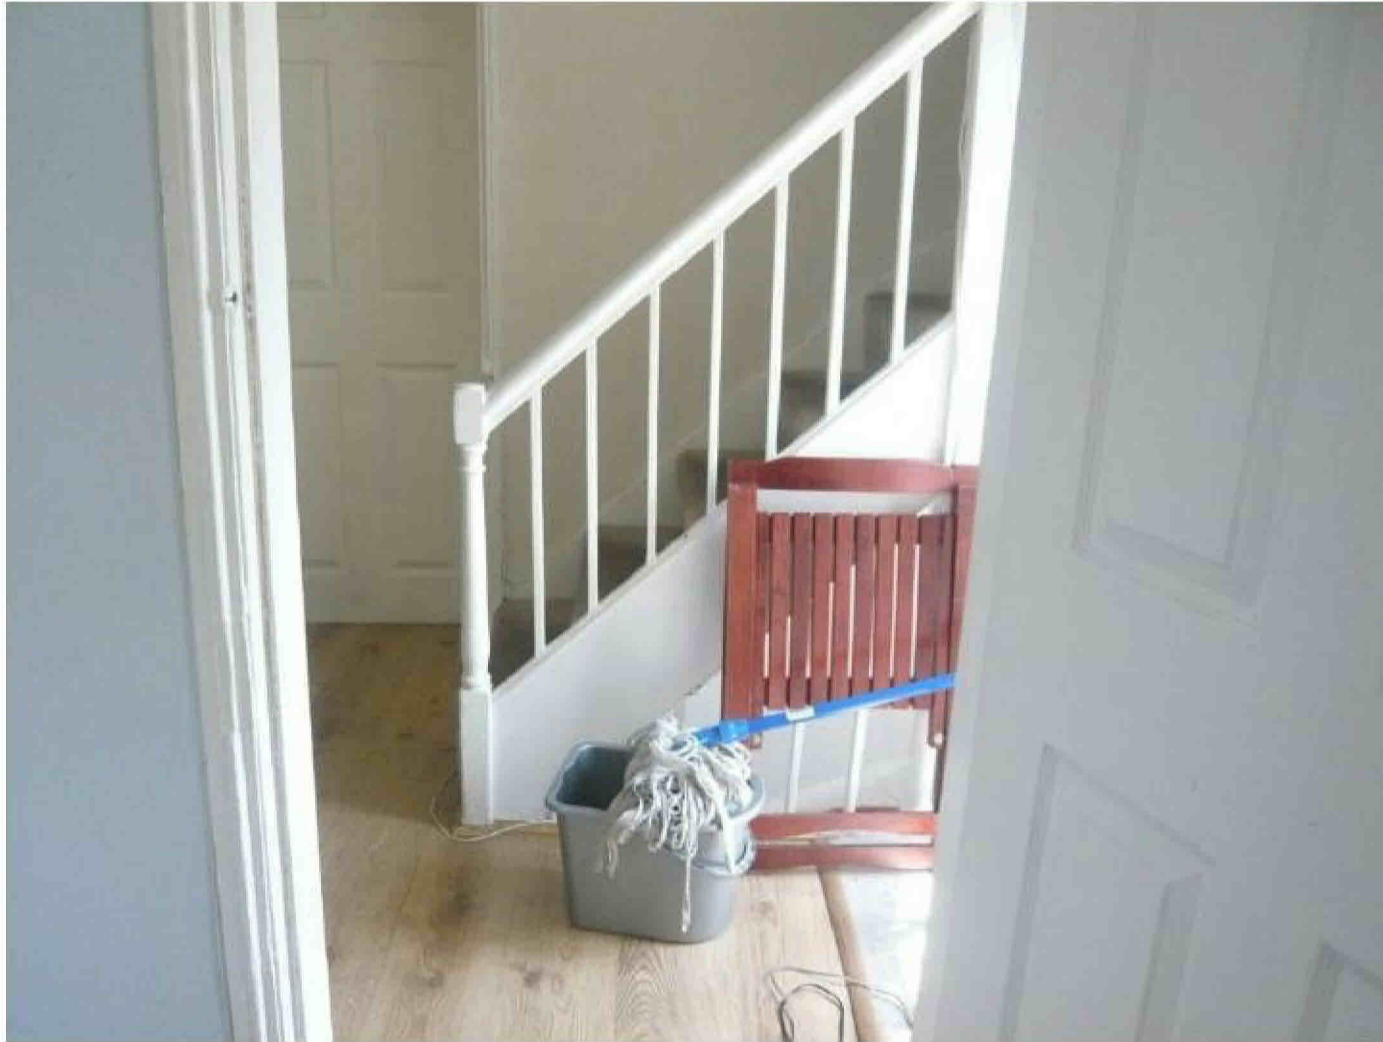
- 3.26 The lobby contains a painted closed-string straight-flight staircase with stick balusters and heavily-turned newel posts (NB the staircase continues below to the ground floor but access is blocked off – see section 3.14 above).

Fig.10 The staircase at the southern end of the first floor

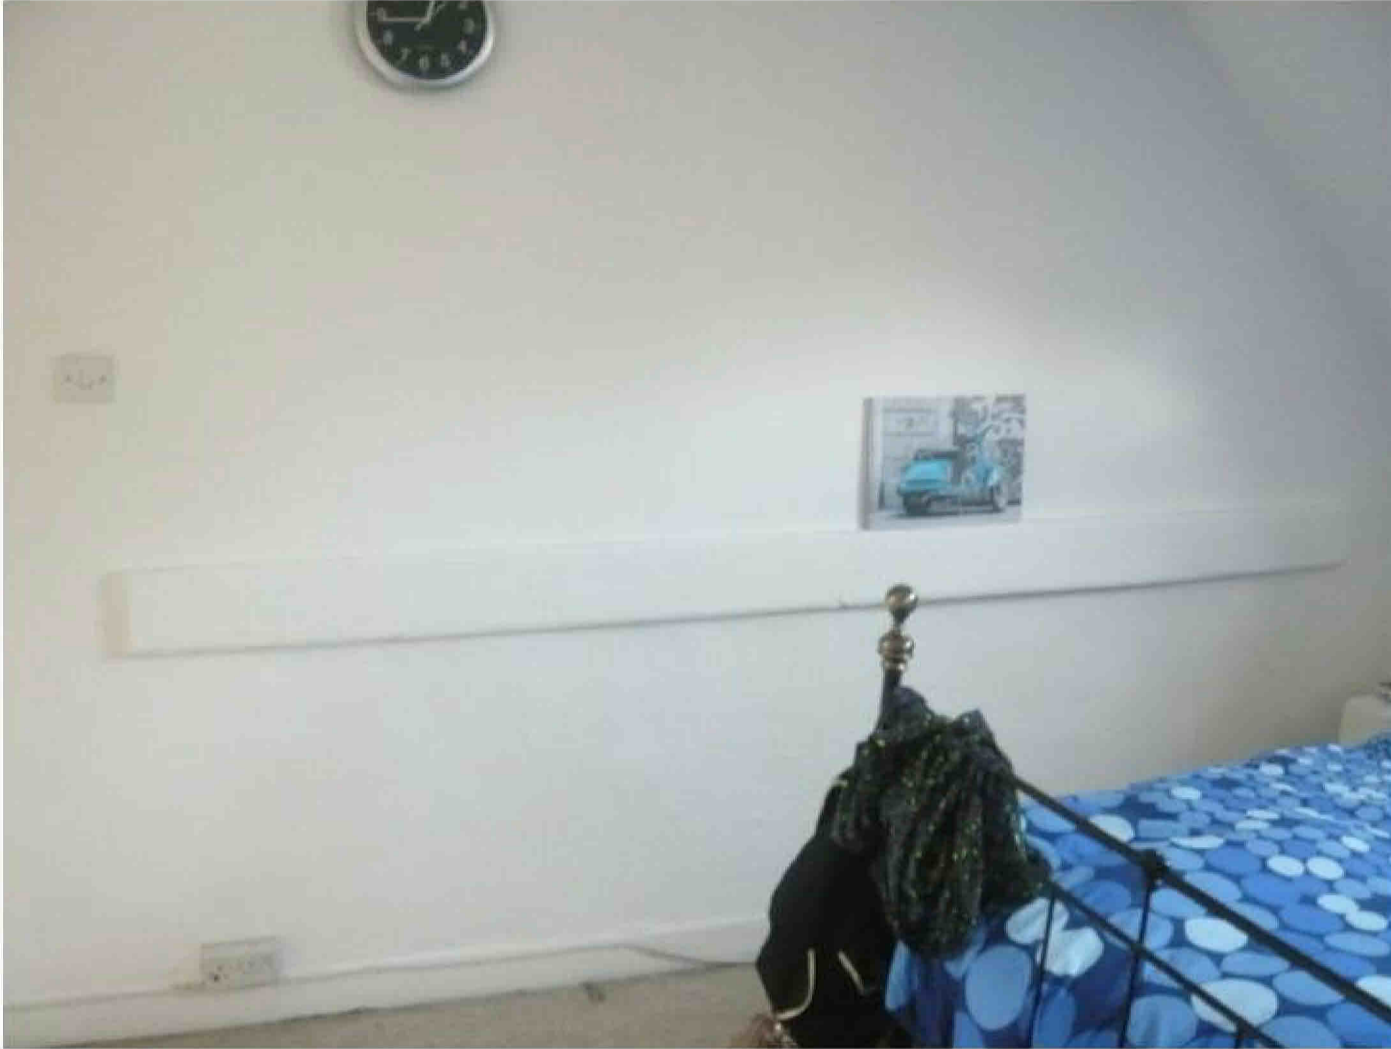
- 3.29 There is evidence in the ceiling where there was formerly a partition from the eastern edge of the fireplace across to the south wall. There is also indication of a blocked door opening in the south western corner of the room.
- 3.30 The southernmost rear projecting range contains a bathroom, WC and kitchen. There are no features worthy of particular note here.
- 3.31 The second floor/attic contains three rooms in the front range. These are within the slope of the roof. Part of the roof structure is visible and comprises a truss and tie-beam roof of three bays. The ties have been incorporated into the walls and some have been truncated in places.

Fig.12 Truncated tie-beam within the north wall of the southernmost room in the front range

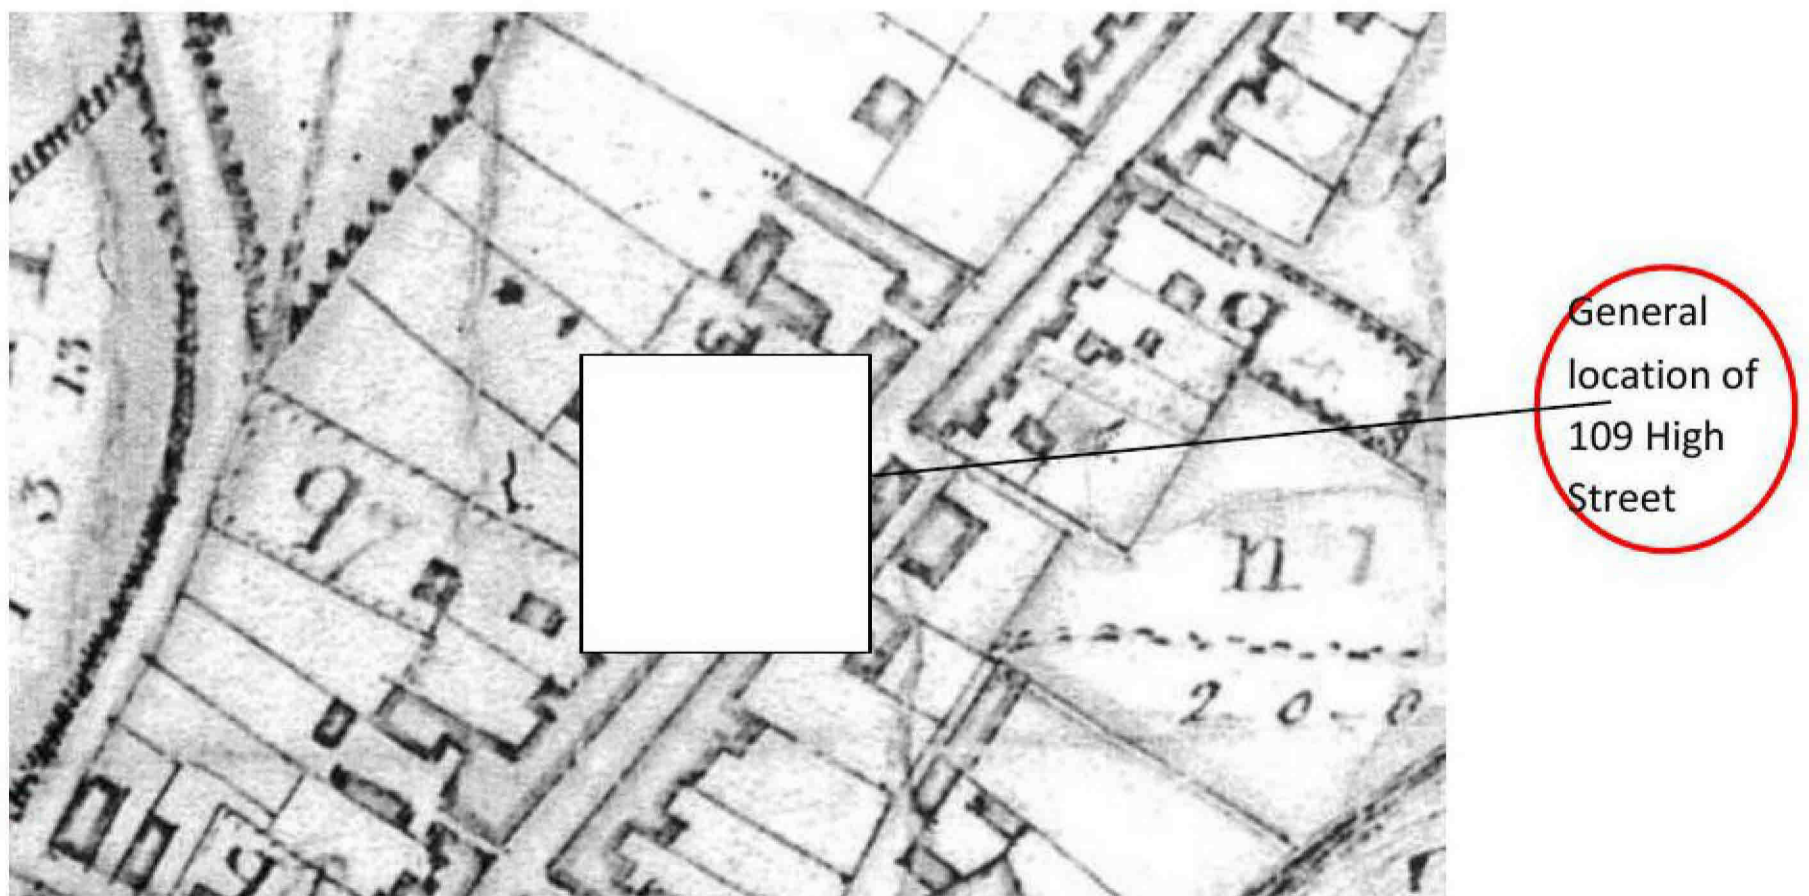
- 4.5 The earliest available maps of Eton, although they do not show the buildings to any sufficient level of detail, indicate there were buildings on the west side of High Street in the approximate location of No.109 from at least the early part of the 18th century. It is not until the plan of Eton parish in 1797 that clear outlines of the properties are distinguishable. 109 High Street would appear to form part of a continuous terrace of houses on the west side of the road (in the area circled red on the plan below). As there are no property numbers on the plan, it is not possible to identify the individual buildings.

Fig.14 Plan of Eton parish, 1797
