Window and Door Schedule

Ampney Brook House, School Lane, Ampney Crucis, GL7 5RT

On behalf of Mr J. Fagge

Date: 12/10/2023 | Pegasus Ref: P22- 0597

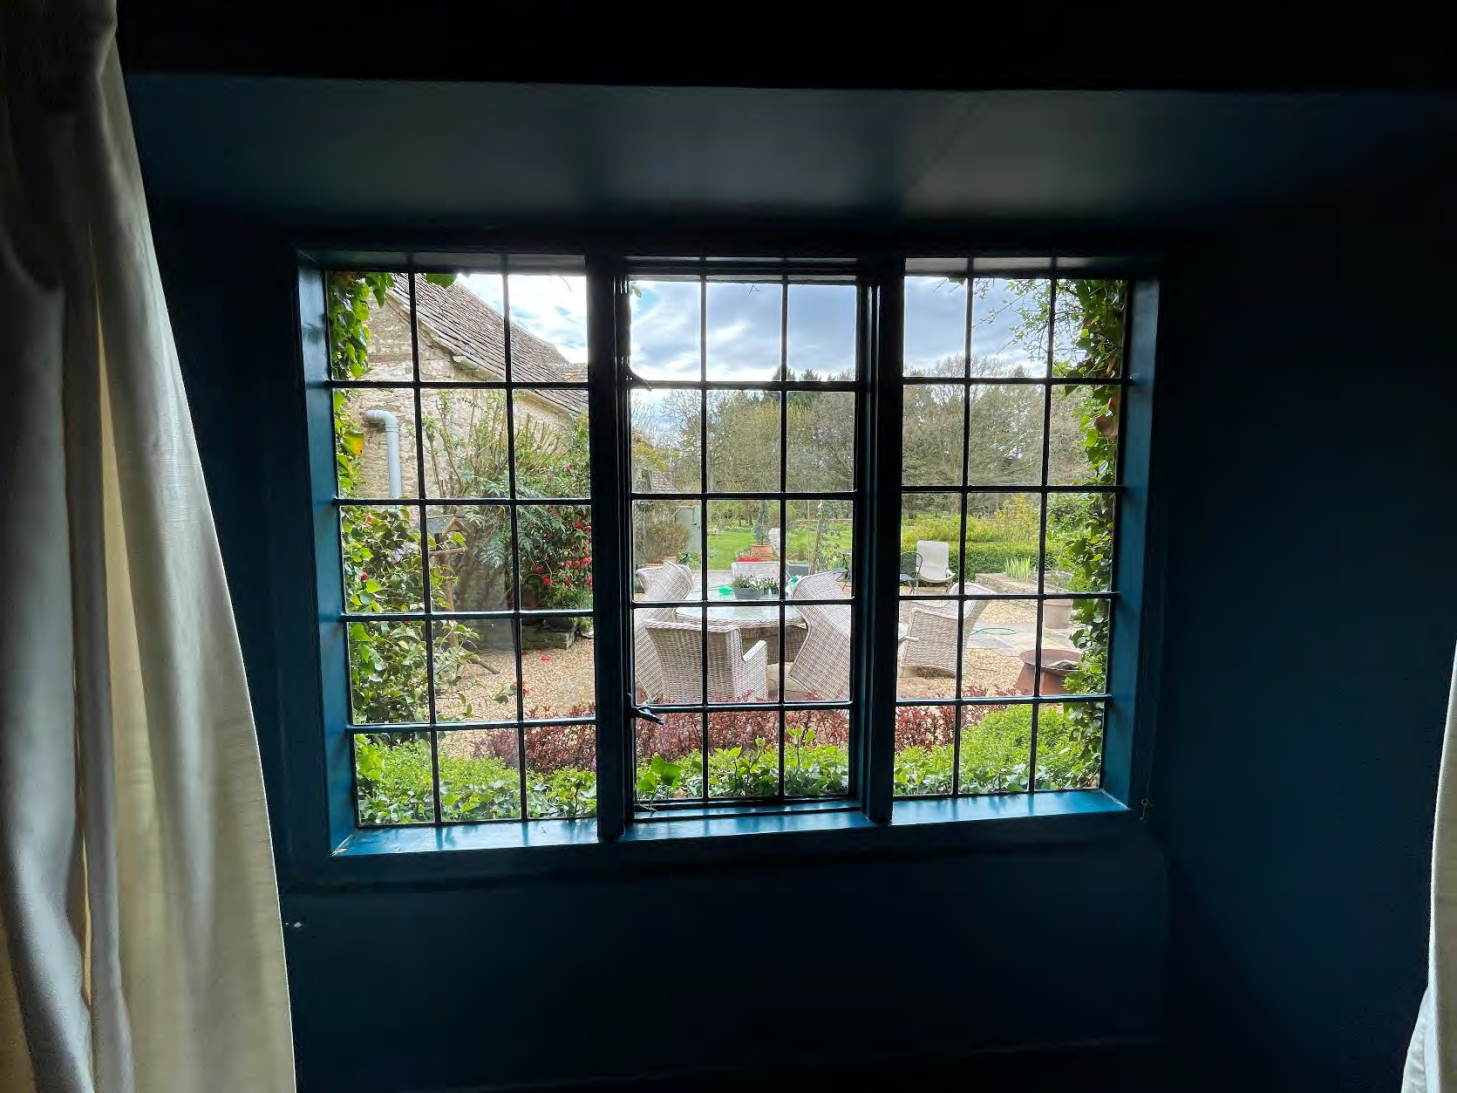
| Reference | Existing Description and Condition | Proposed Change |
|---|--|--|
| WG-01 | <p>Description – single-glazed, three-light, leaded casement; one pane incised “John Akerman / May 1st 1837”.</p> <p>Condition – good.</p> | No change (retention). |

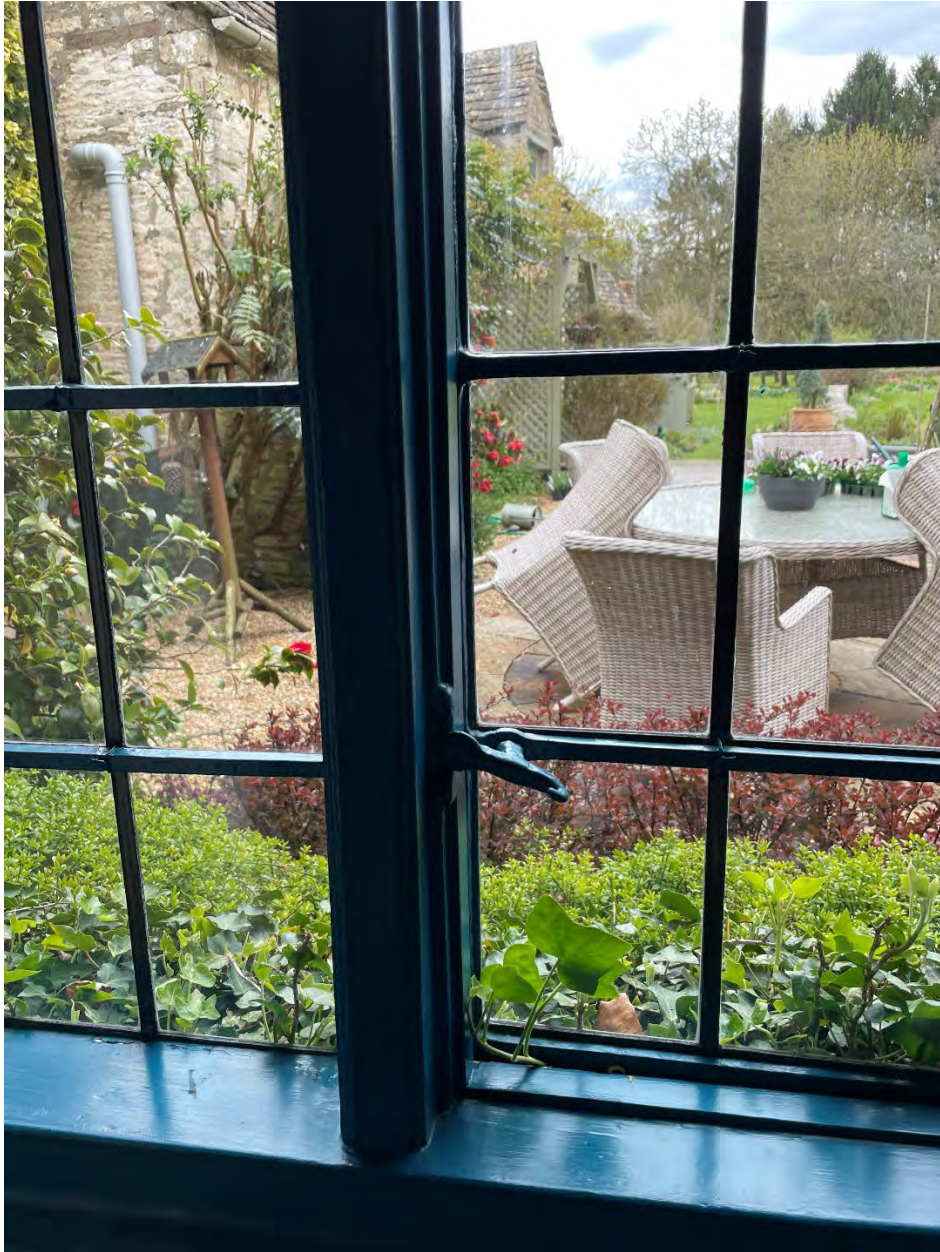
| Reference | Existing Description and Condition | Proposed Change |
|---|--|--|
| WG-02 | <p>Description – single-glazed, fixed, single-pane, timber-frame casement.</p> <p>Condition – good.</p> | New replacement window (Type 1); frame to be retained. |

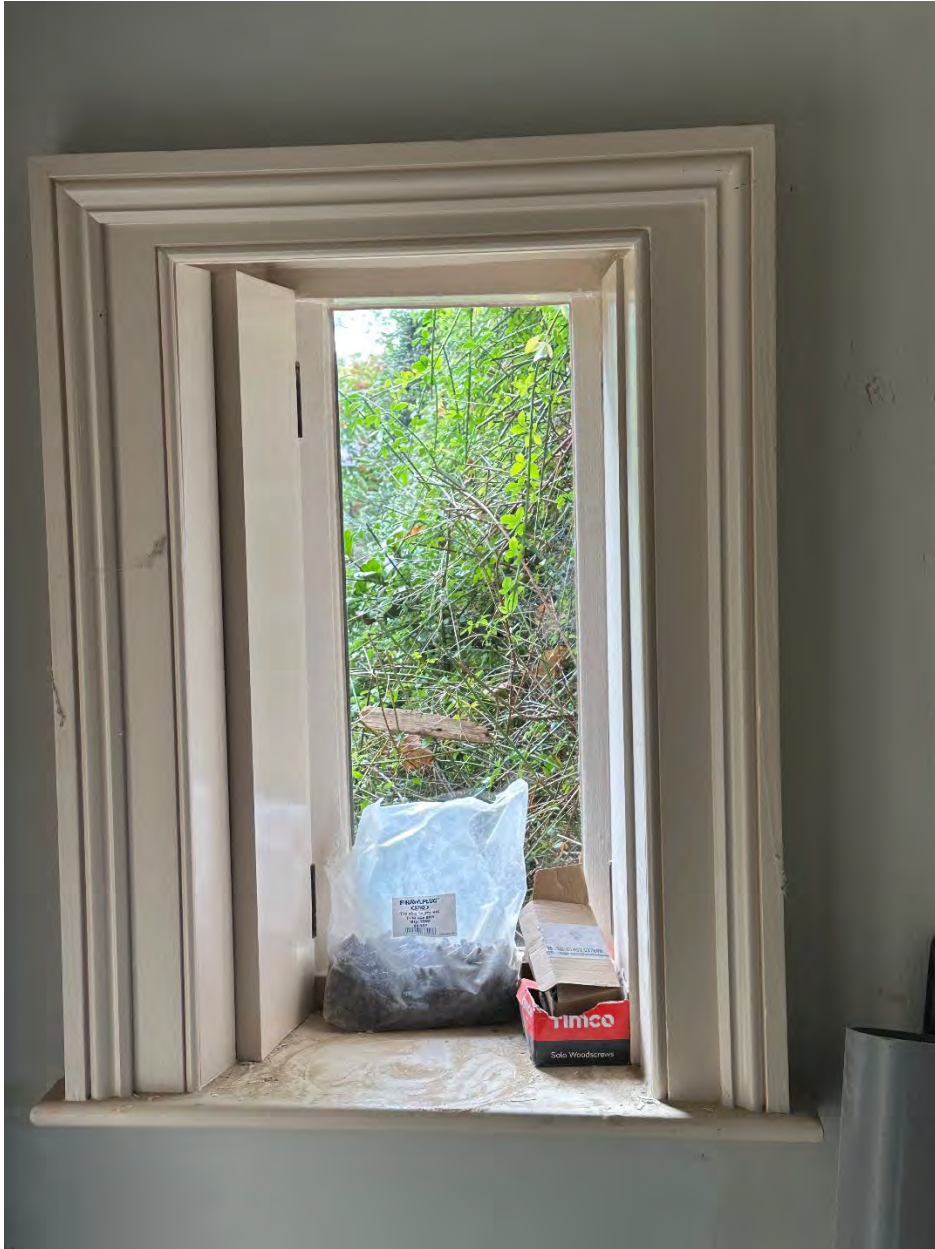
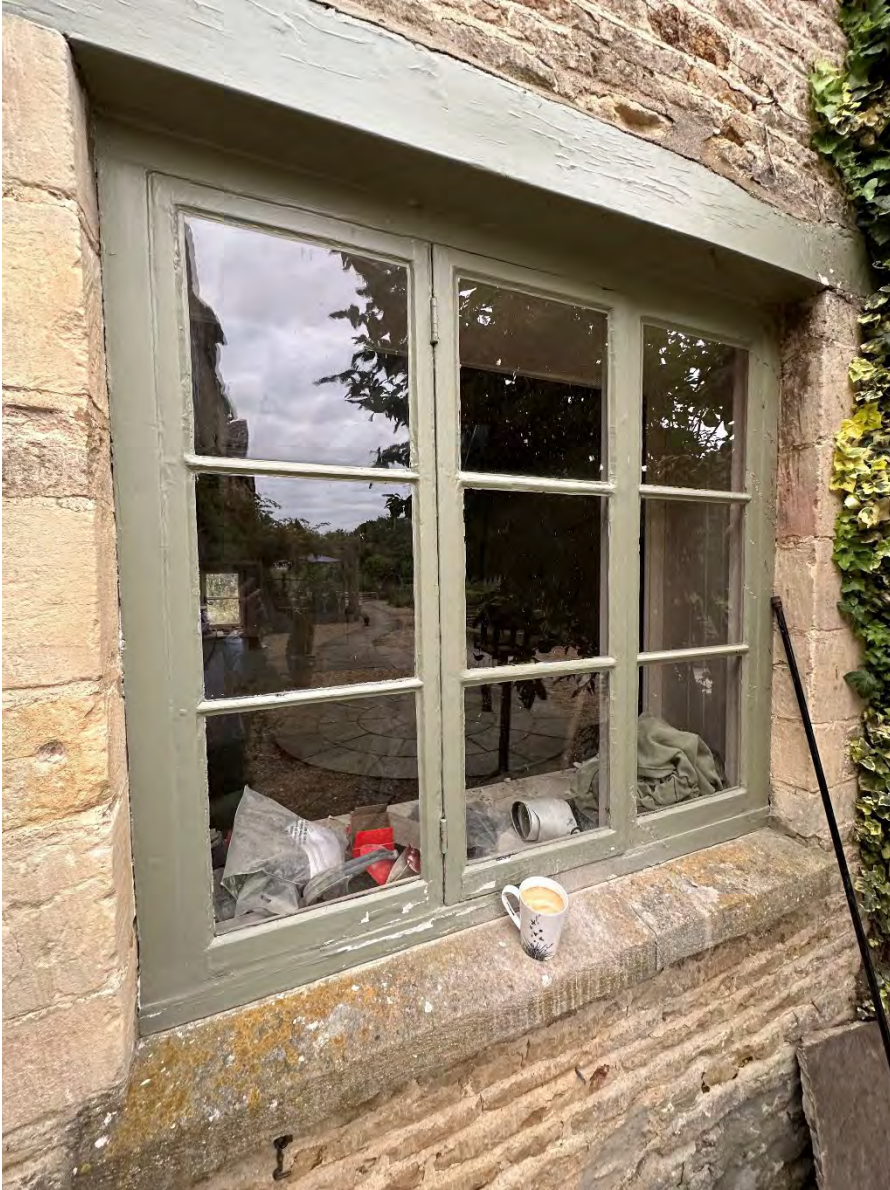
| Reference | Existing Description and Condition | Proposed Change |
|---|--|--|
| WG-03 | <p>Description – single-glazed, three-light, timber-frame casement. Simply chamfered timber mullions and glazing bars. Modern hinges.</p> <p>Condition – good; evidence of repainting and possible repair.</p> | New replacement window (Type 1); frame to be retained. |

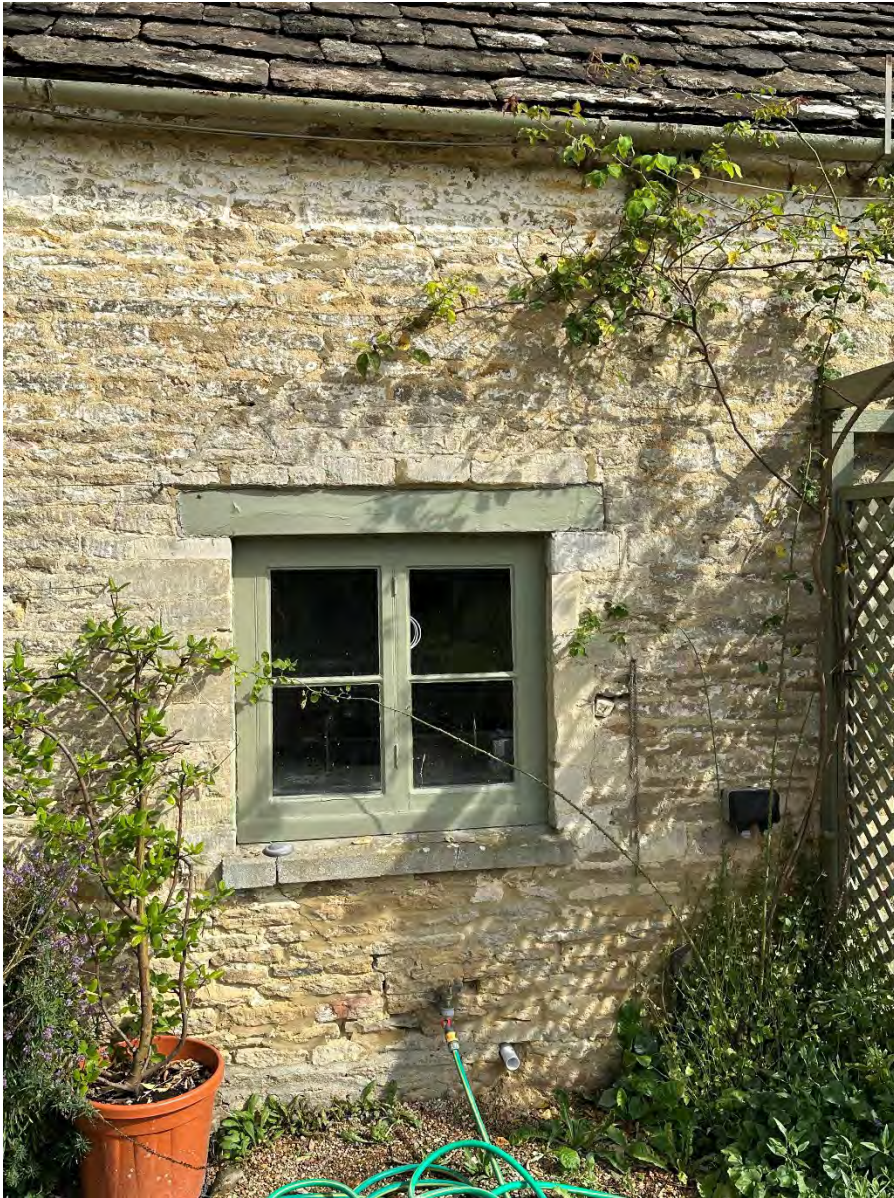
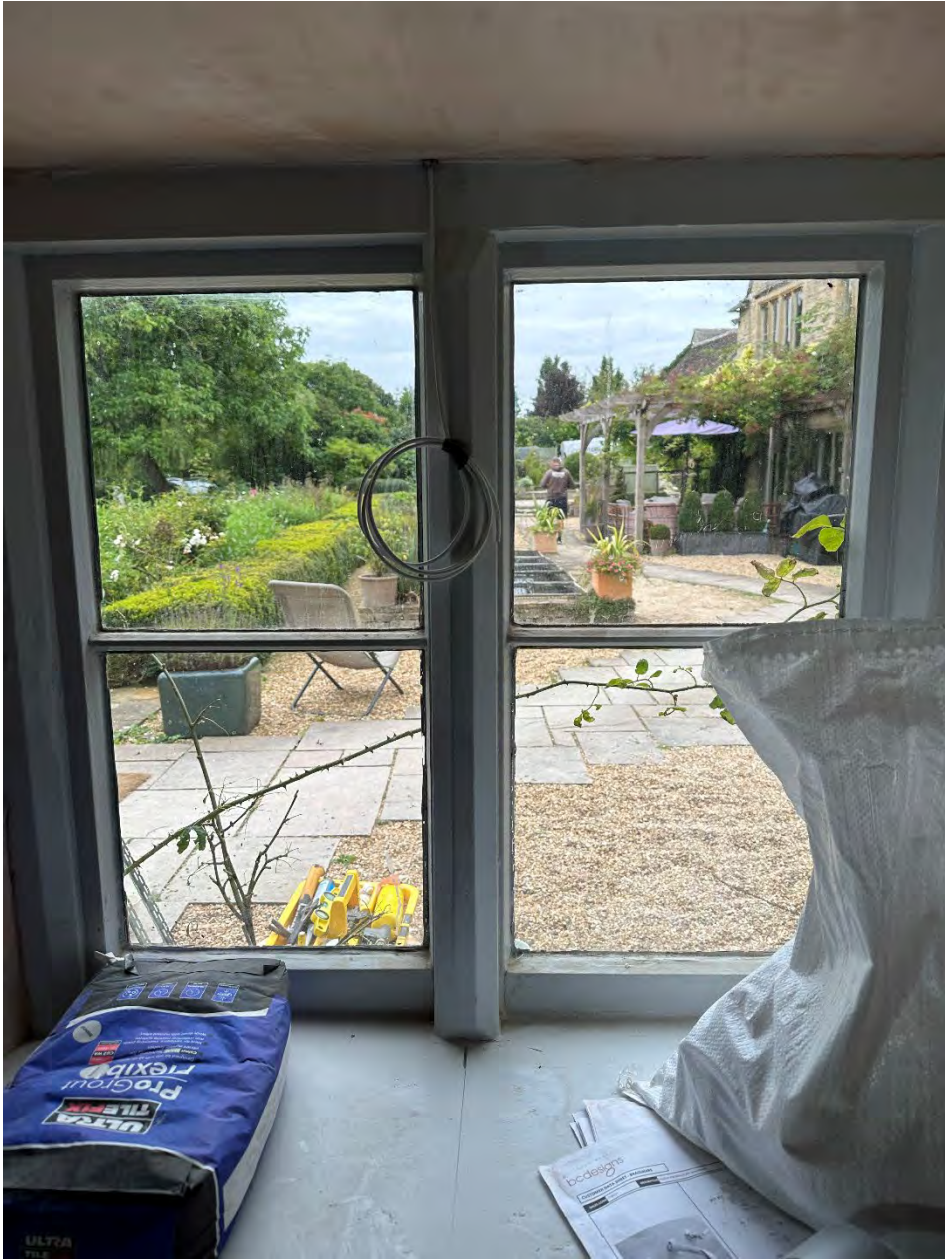
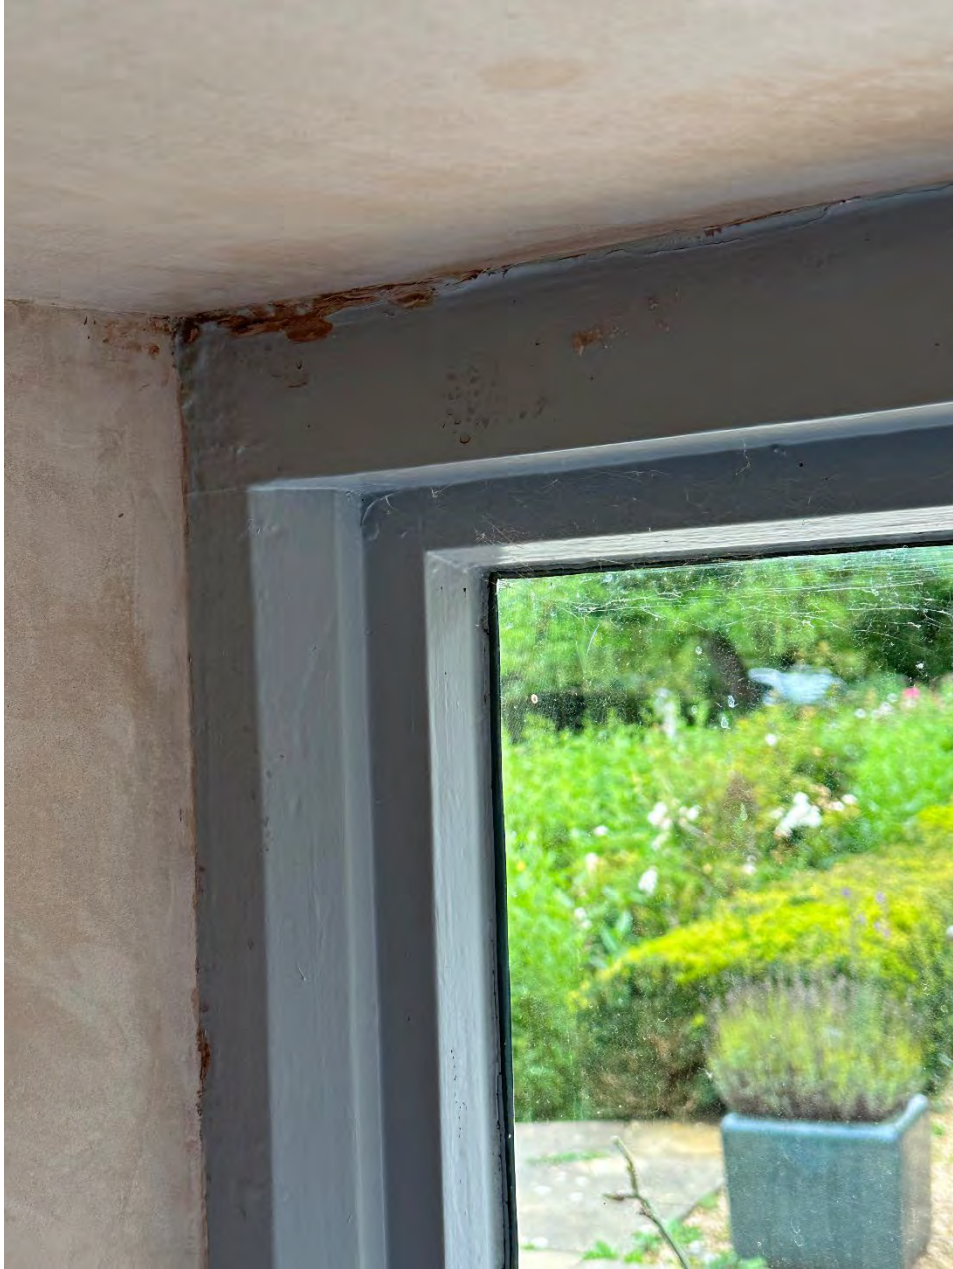
| Reference | Existing Description and Condition | Proposed Change |
|---|--|--|
| WG-04 | <p>Description – single-glazed, two-light, timber-frame casement. Timber frame and chamfered mullion are visibly modern. Glazing bar profiles the same as WG-03.</p> <p>Condition – good, although signs of deteriorating paintwork.</p> | New replacement window (Type 1). |

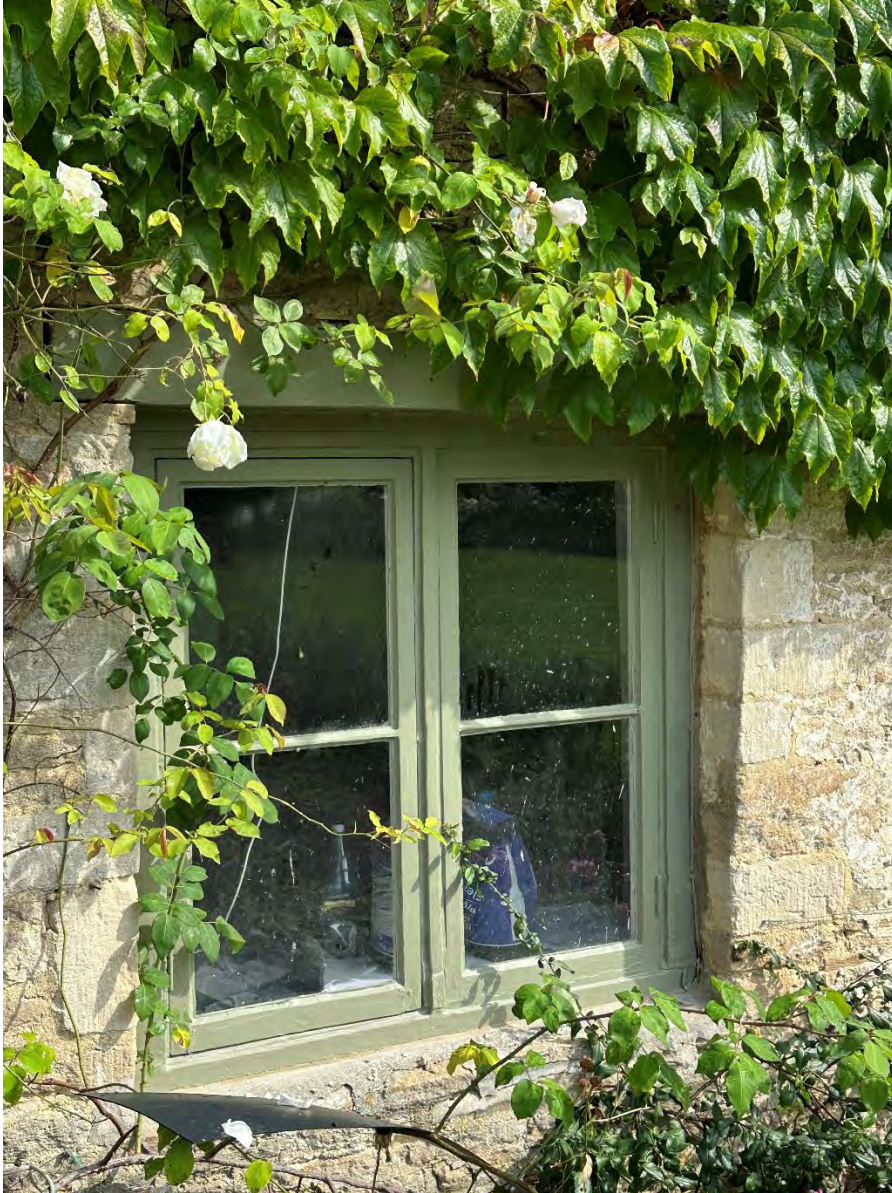
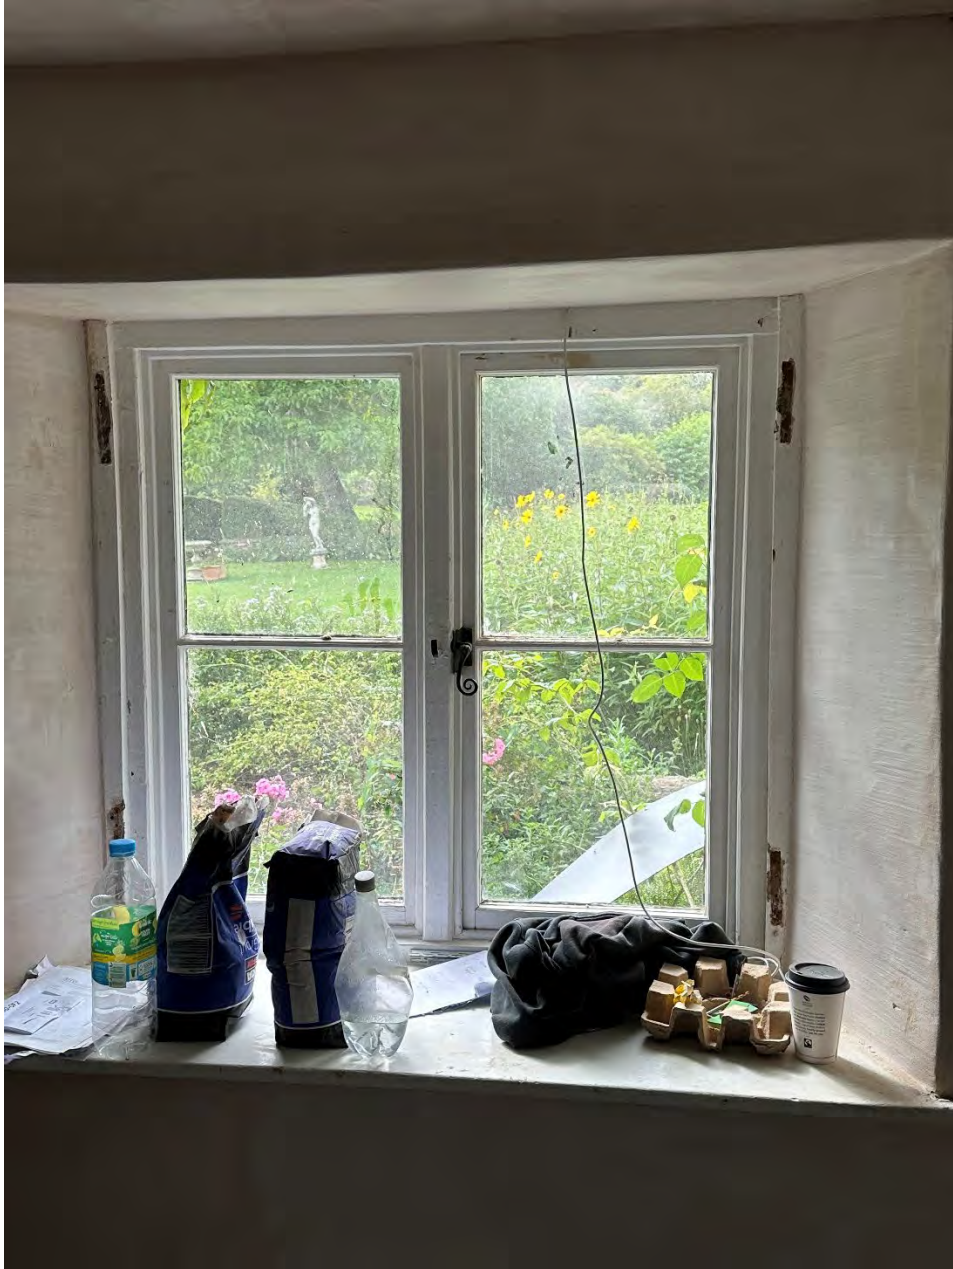
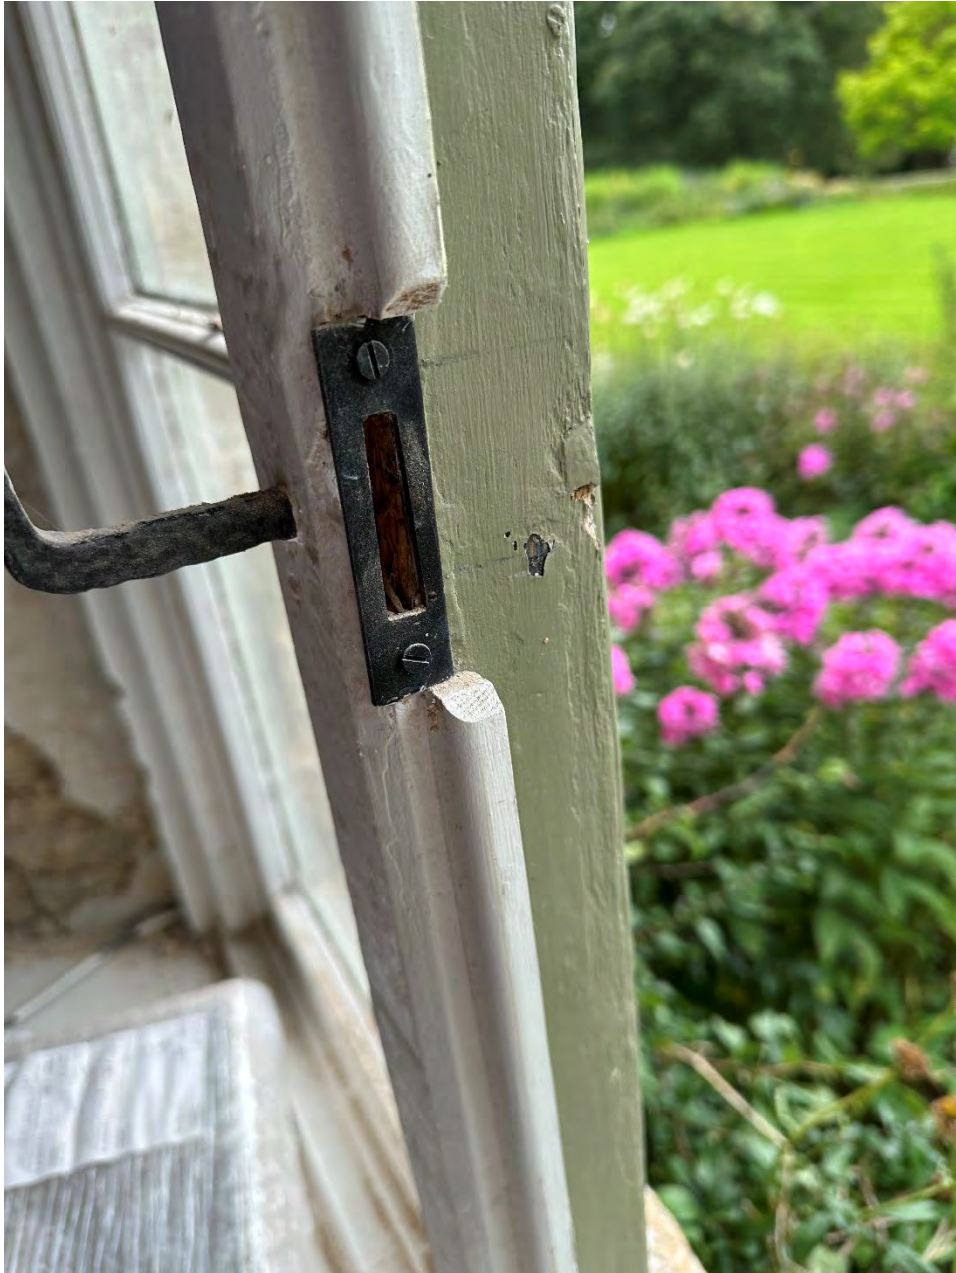
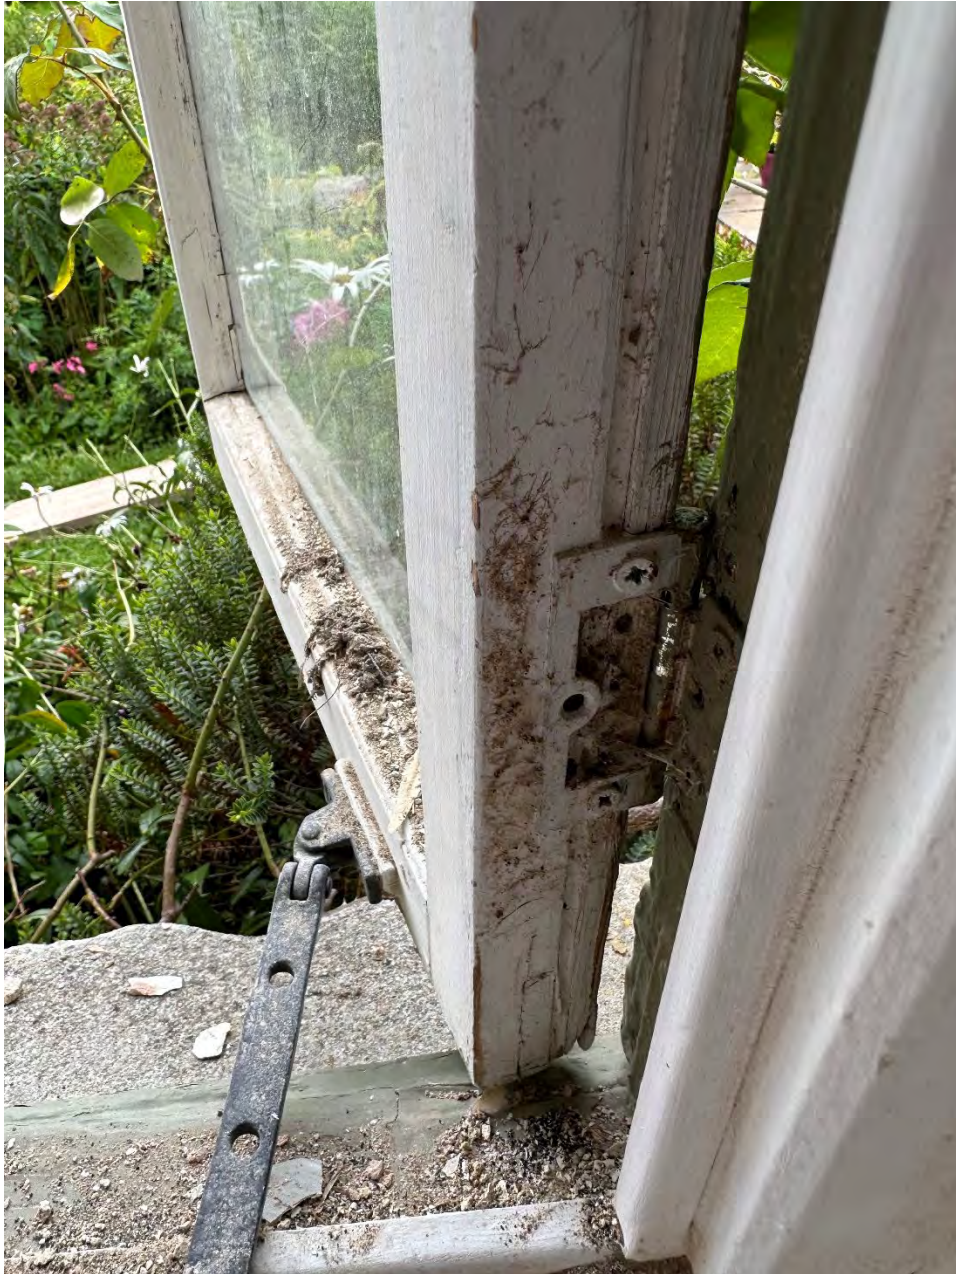
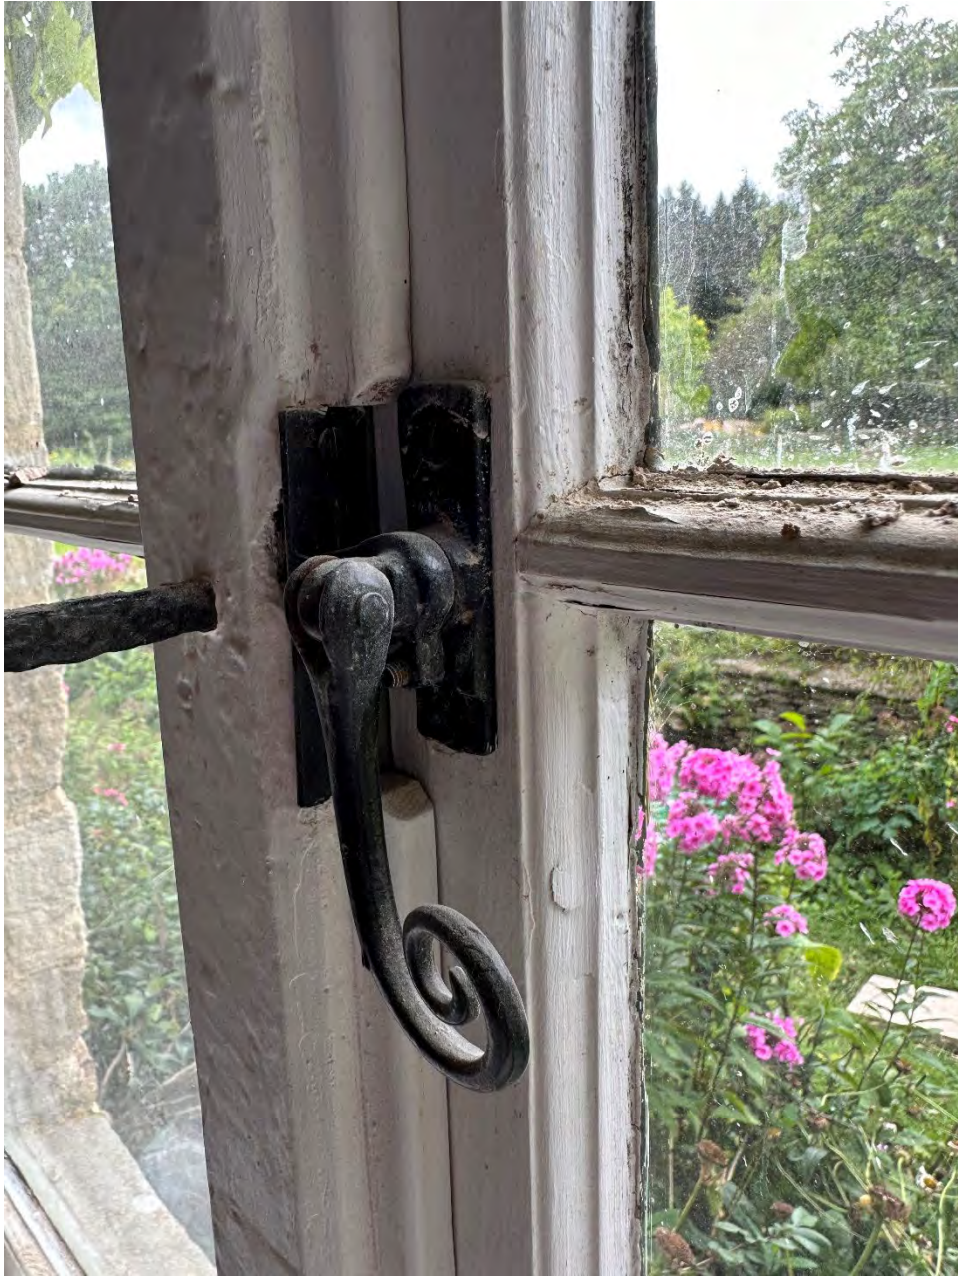
| Reference | Existing Description and Condition | Proposed Change |
|---|--|--|
| WG-05 | <p>Description – single-glazed, two-light, timber-frame casement. The casements are visibly modern due to the style of the hinges, monkey tail catch and other fixings, as well as the profile of the moulded glazing bars. The frame and mullion have a stepped profile and appear to be earlier. There is a residual metal fastener fixed to mullion and the timber has been cut to accommodate the later casement and catch mechanism. Hinge</p> | New replacement window (Type 1); frame to be retained. |

| Reference | Existing Description and Condition | Proposed Change |
|---|---|---|
| | <p>marks on frame suggest there were formerly shutters (now missing).</p> <p>Condition – good, although signs of deteriorating paintwork.</p> | |

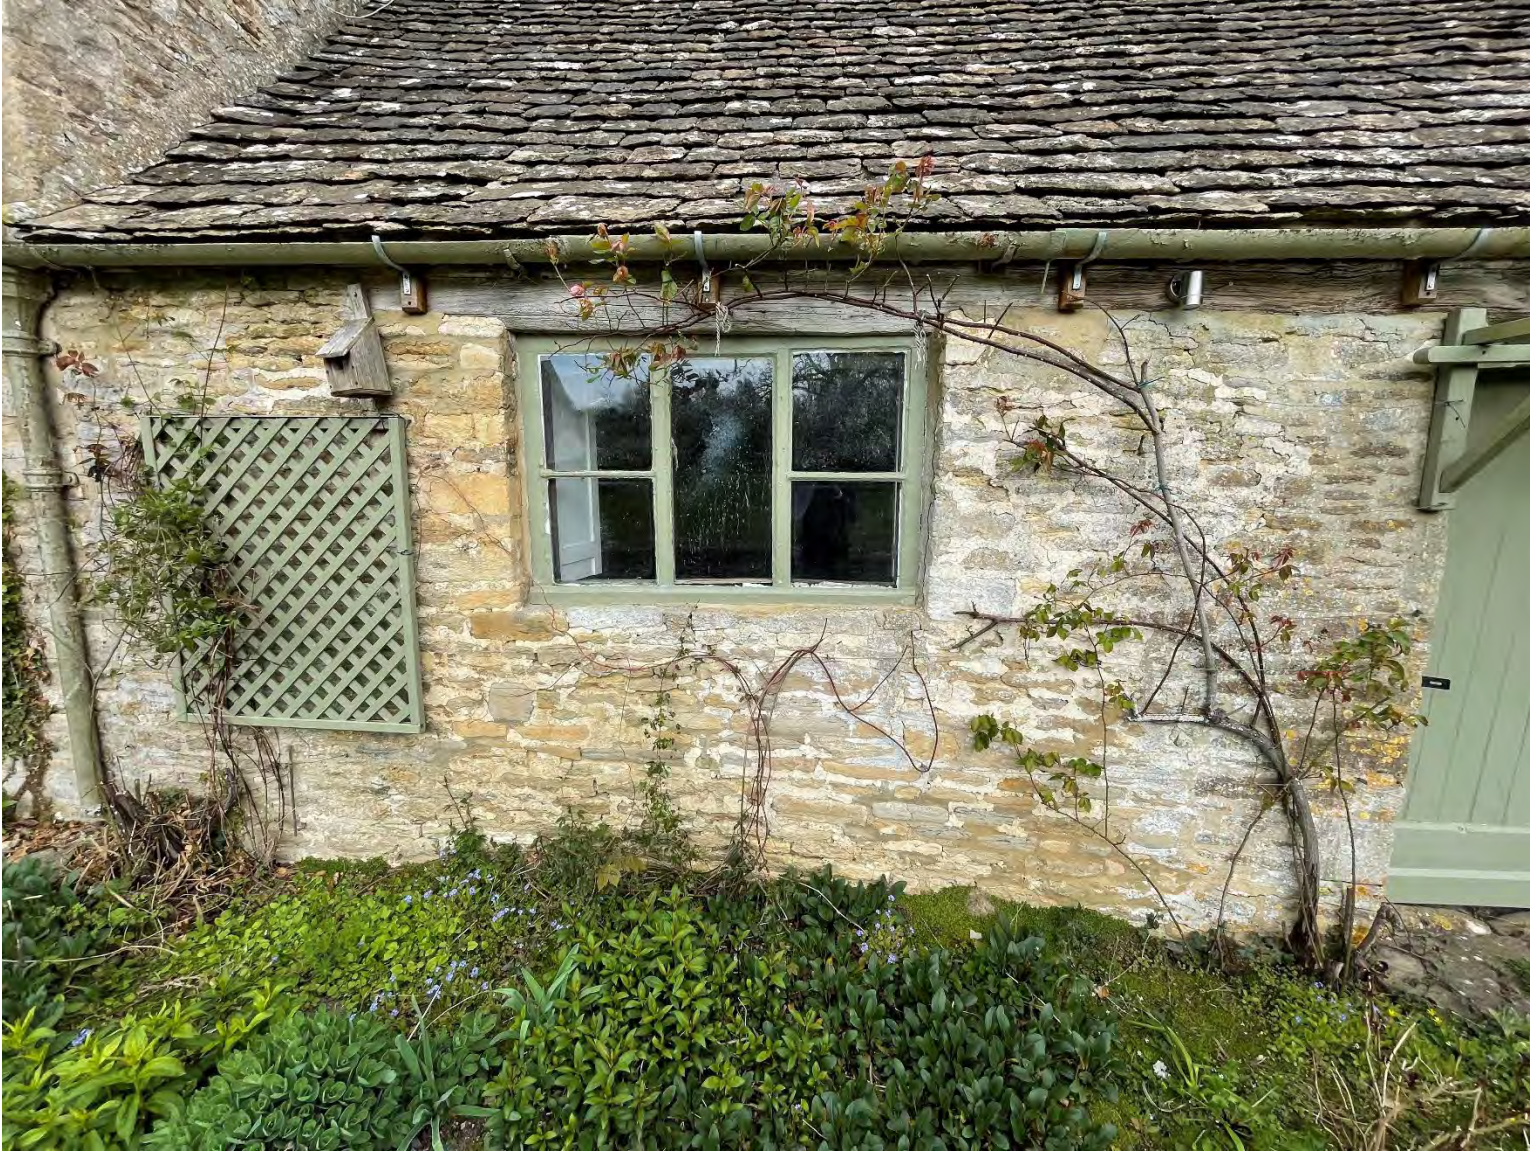
| Reference | Existing Description and Condition | Proposed Change |
|---|---|---|
| WG-06 | <p>Description – single-glazed, three-light timber-frame casement.</p> <p>Condition – poor with signs of deteriorated and rotten timber.</p> | No objection to proposed replacement as part of LPA ref. 23/O1537/COMPLY. |

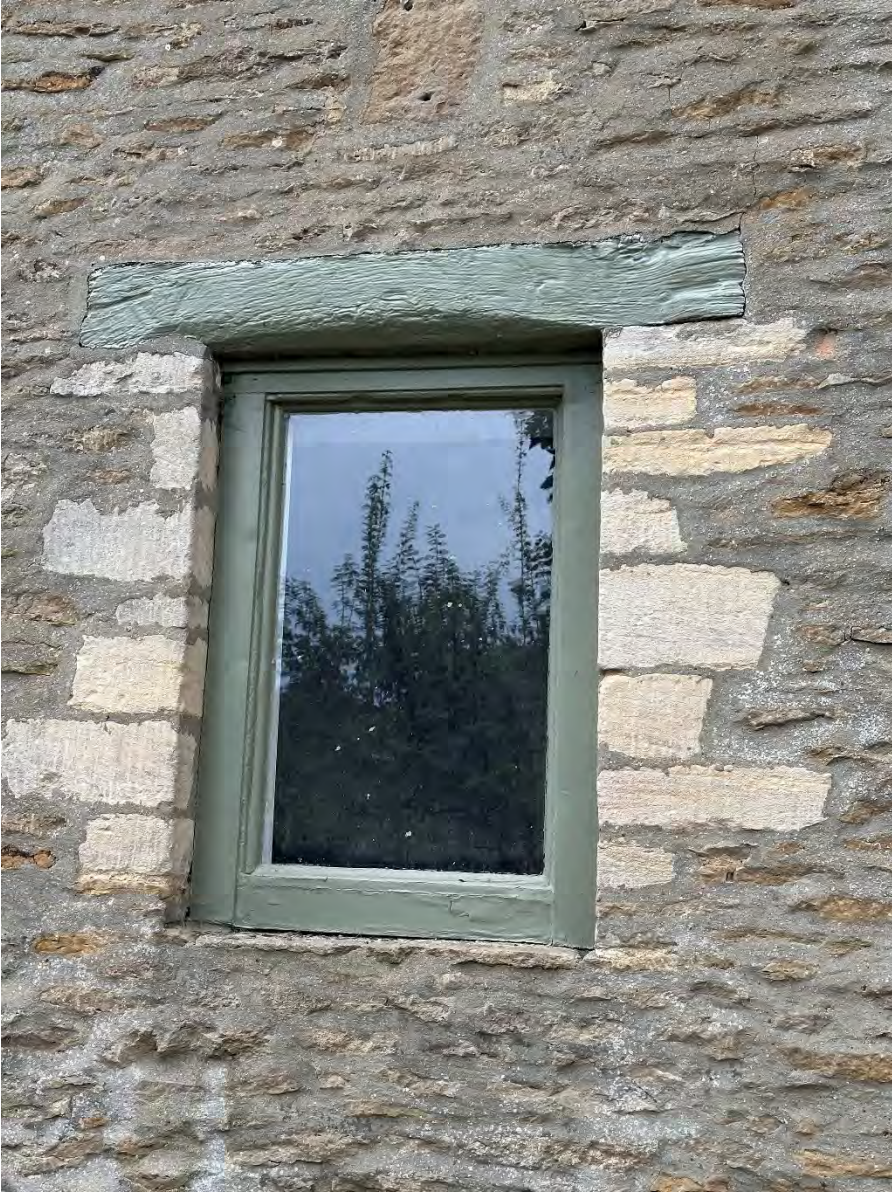
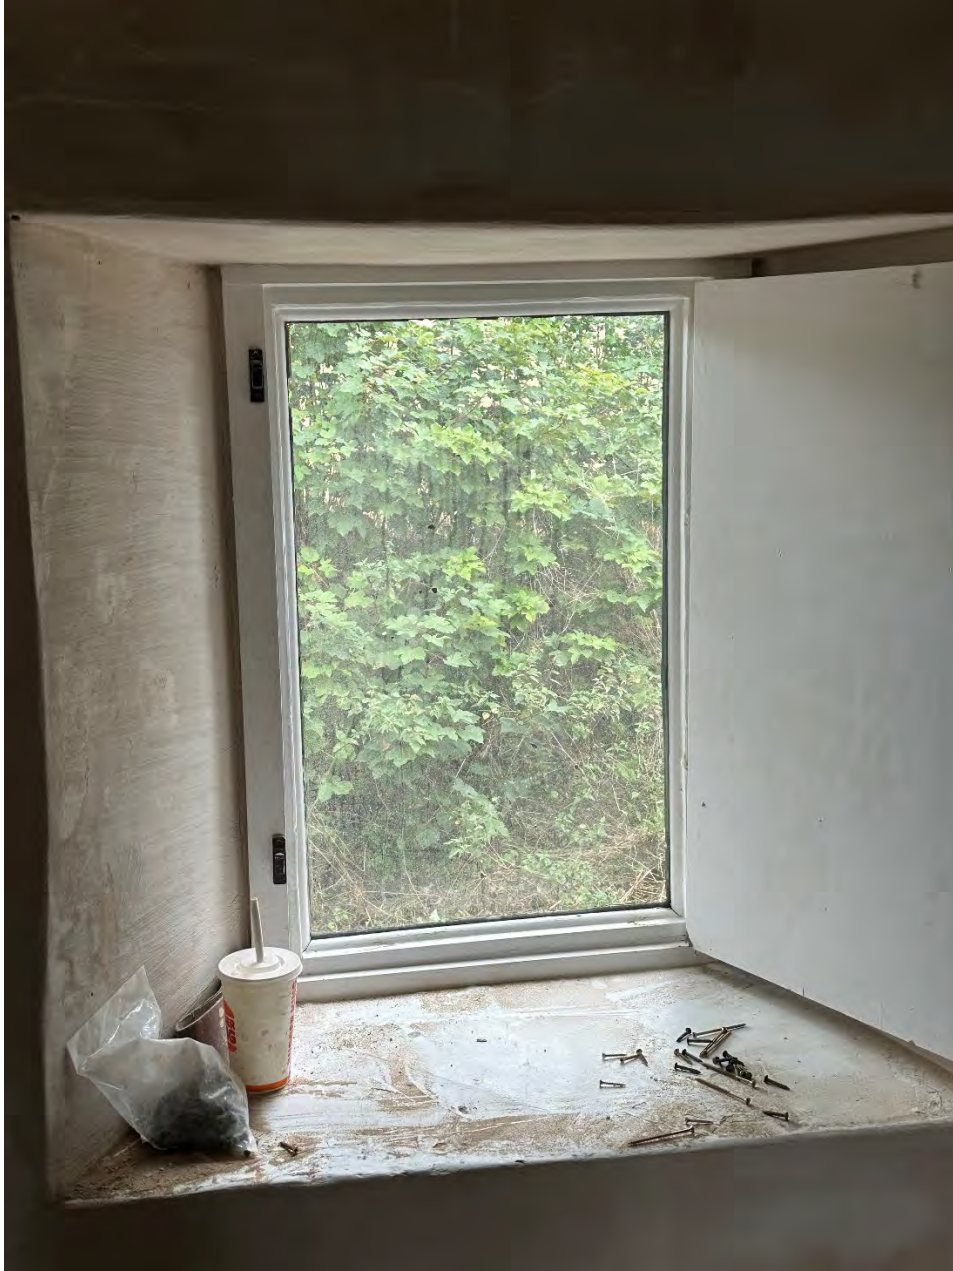
| Reference | Existing Description and Condition | Proposed Change |
|---|---|---|
| WG-07 | <p>Description – single-glazed, fixed, single-pane, timber-frame casement. Internal inspection of the frame reveals this to have been modified, although elements appear to be historic.</p> <p>Condition – good, although signs of deteriorating paintwork.</p> | New replacement window (Type 1); frame to be retained. |

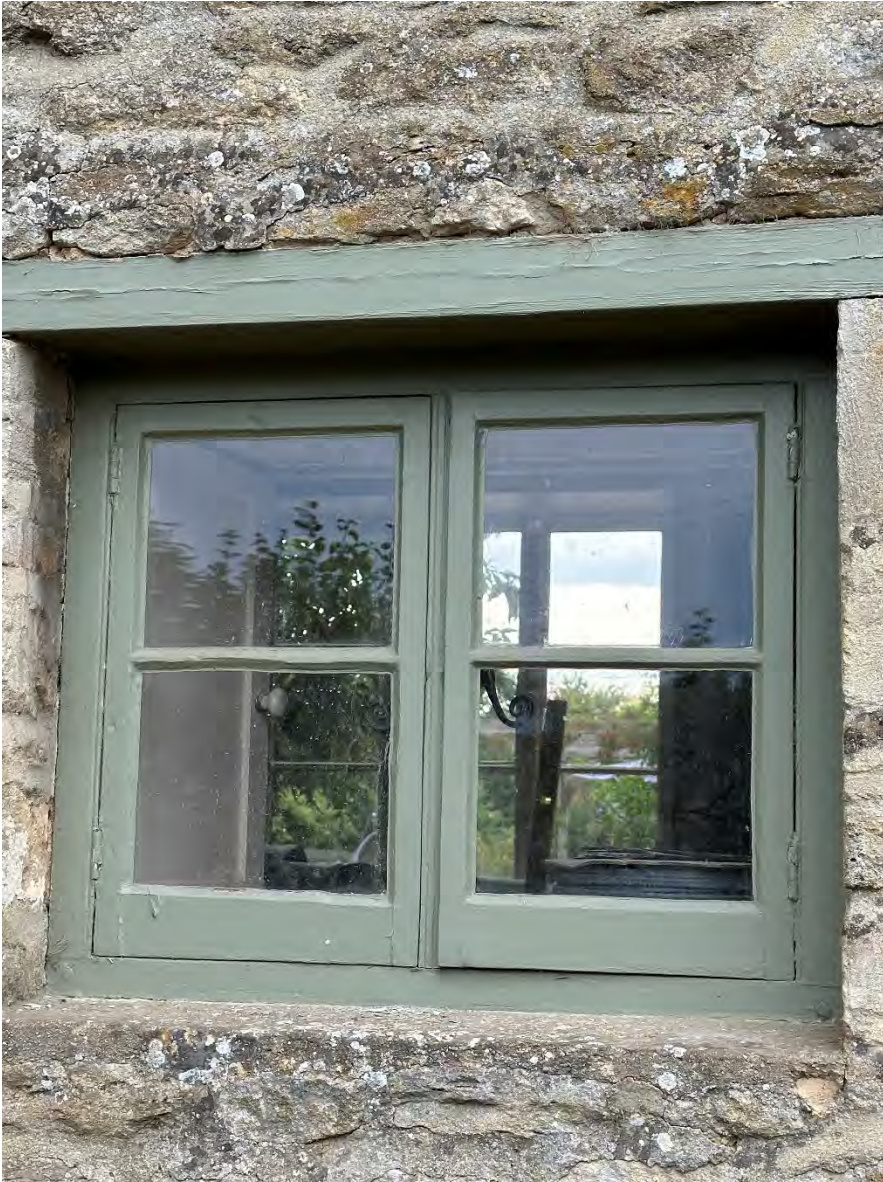
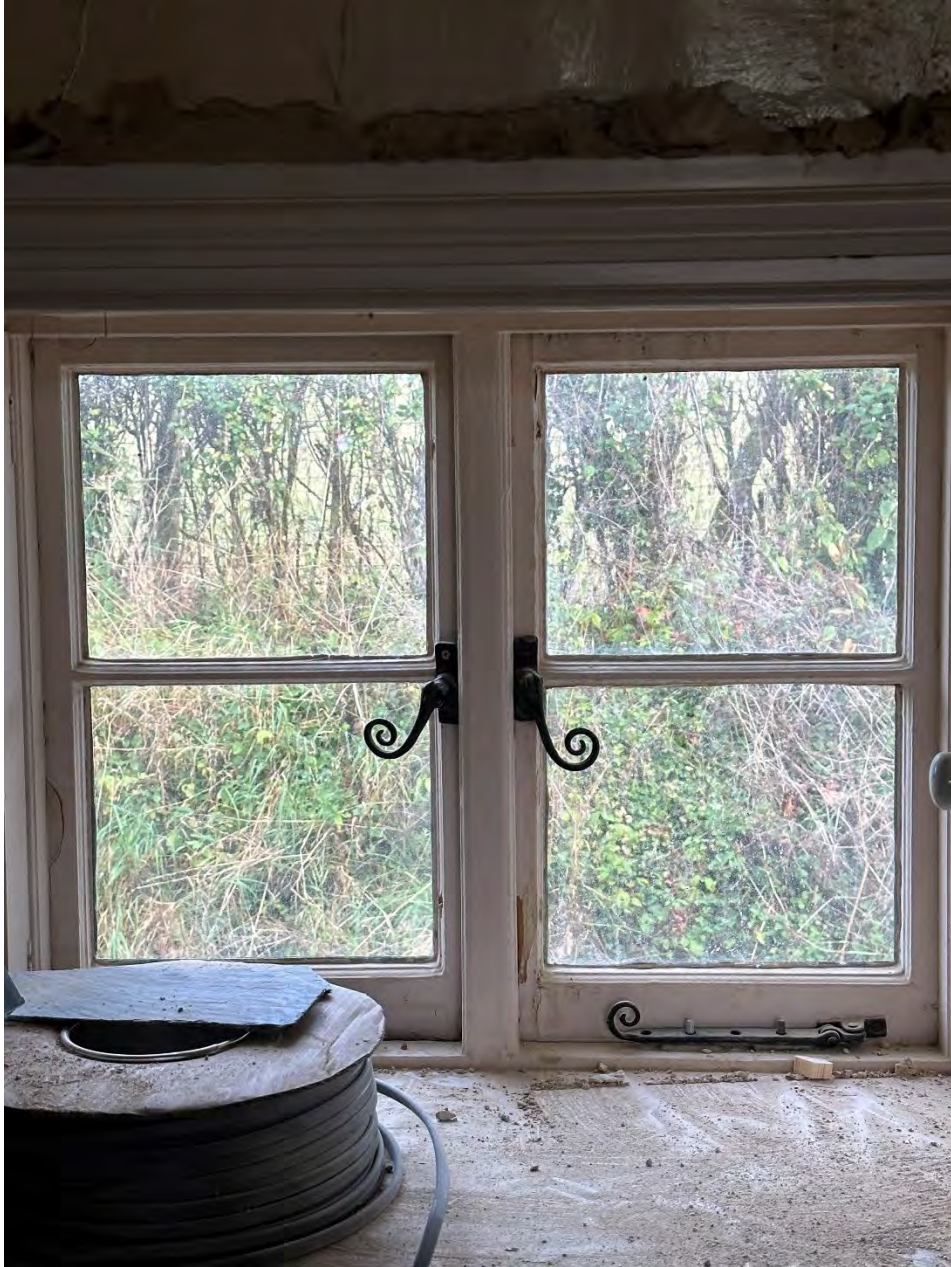
| Reference | Existing Description and Condition | Proposed Change |
|---|---|---|
| WG-08 | <p>Description – single-glazed, two-light, timber-frame casement. Moulded glazing bars. Monkey tail catches and stays are later replacements. The frame and mullion have delicate roll mouldings at their corners.</p> <p>Condition – fair, although signs of deteriorating paintwork and timber.</p> | No change (retention). |
