Window and Door Schedule

Ampney Brook House, School Lane, Ampney Crucis, GL7 5RT

On behalf of Mr J. Fagge

Date: 12/10/2023 | Pegasus Ref: P22- 0597

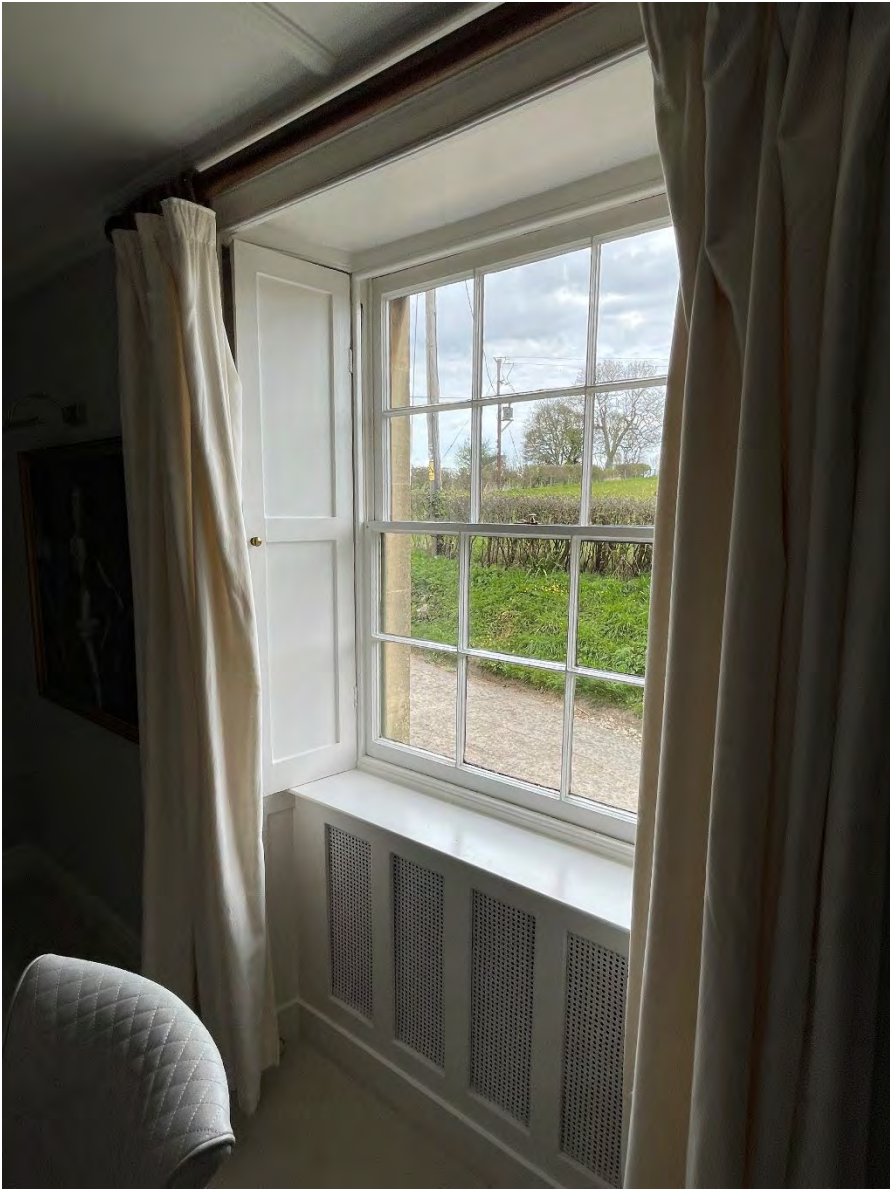
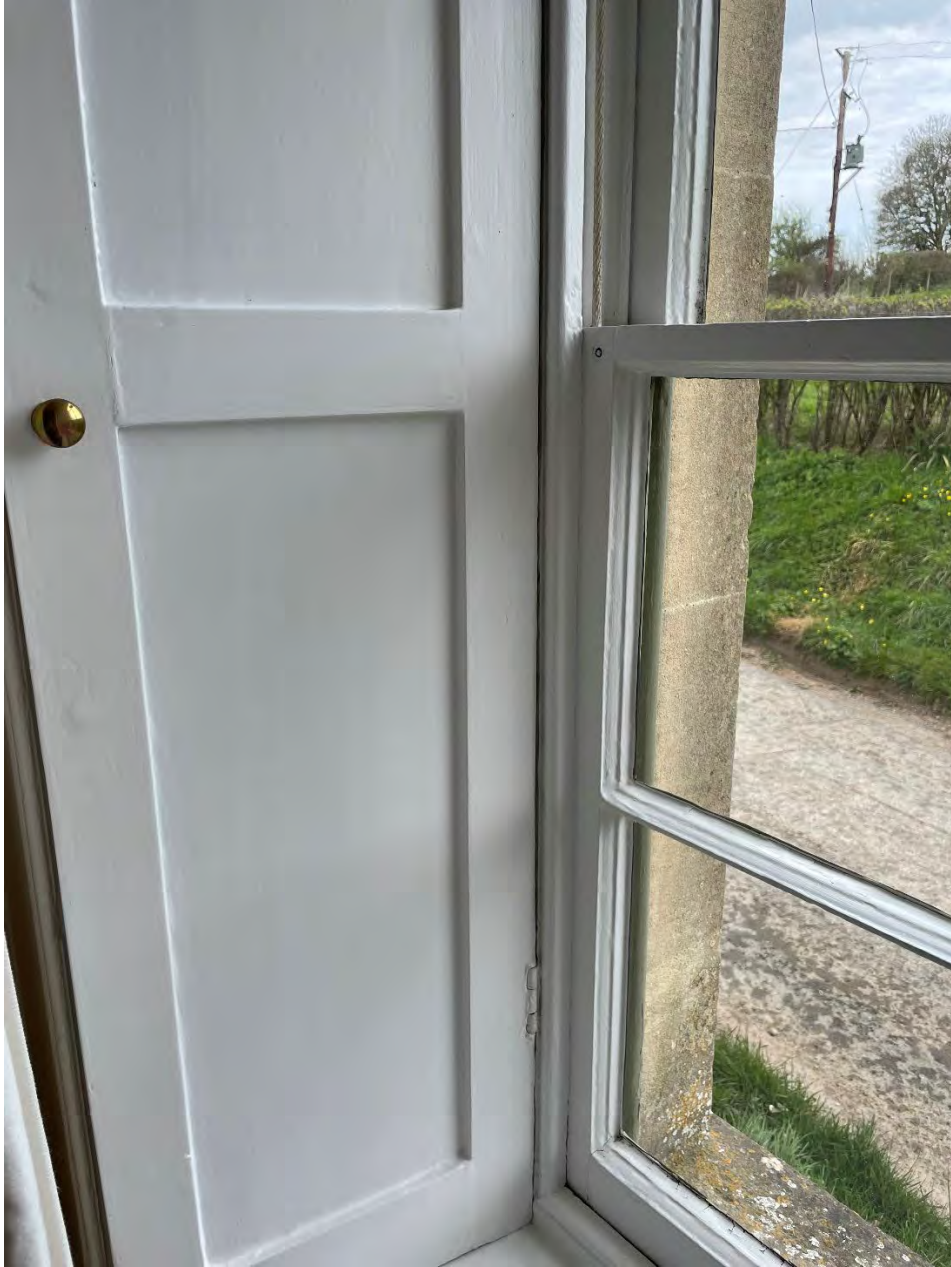
| Reference | Existing Description and Condition | Proposed Change |
|---|---|---|
| WG-09 | <p>Description – single-glazed, six-over-six, box sash without horns. Brass fittings appear to be modern replacements.</p> <p>Condition – good.</p> | No change (retention). |

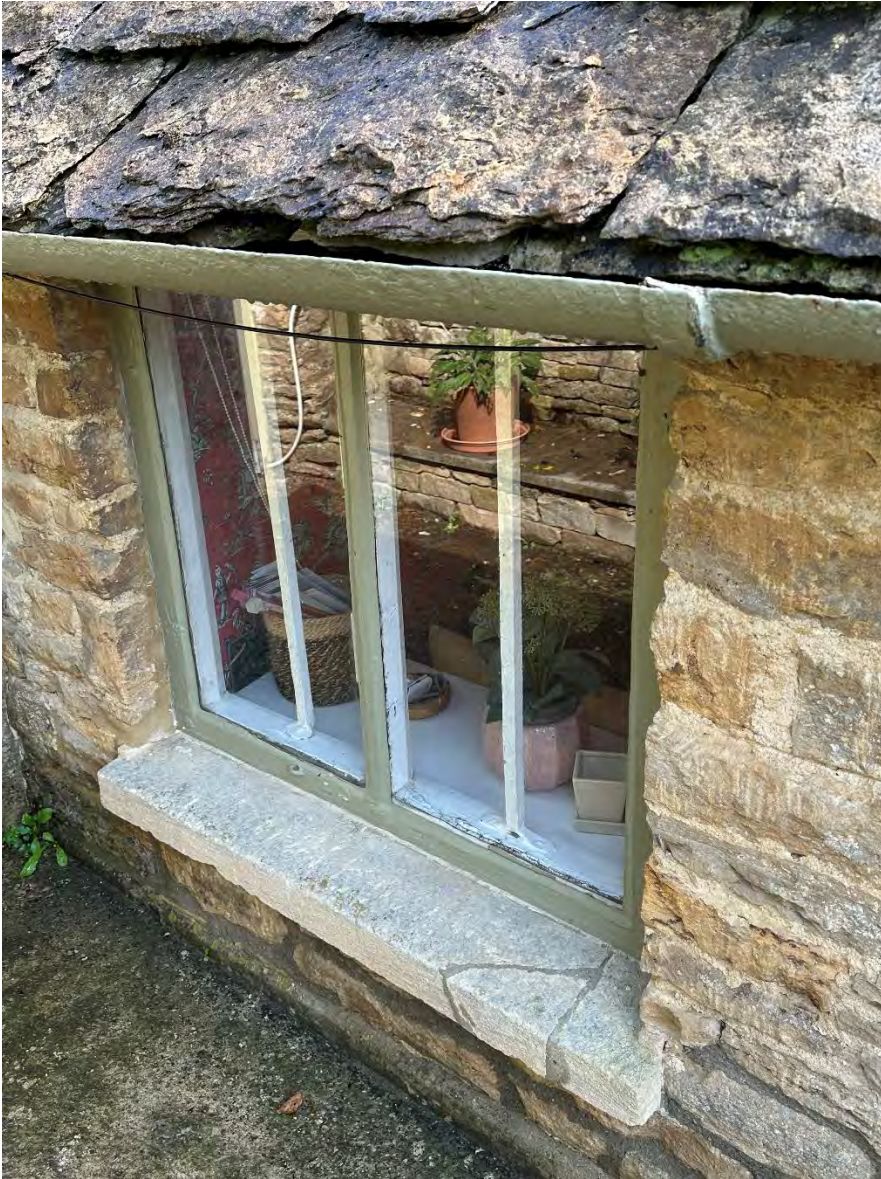
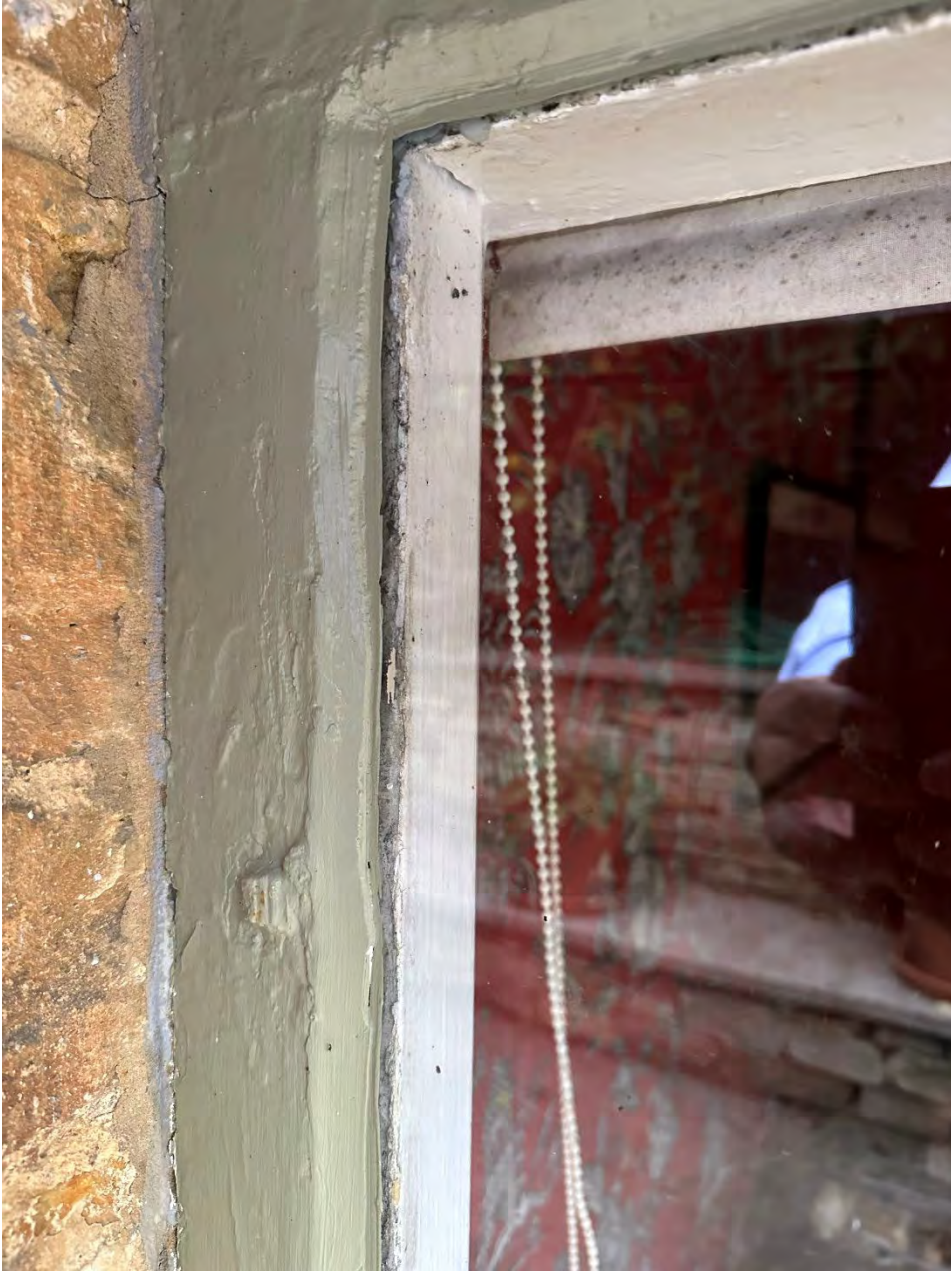
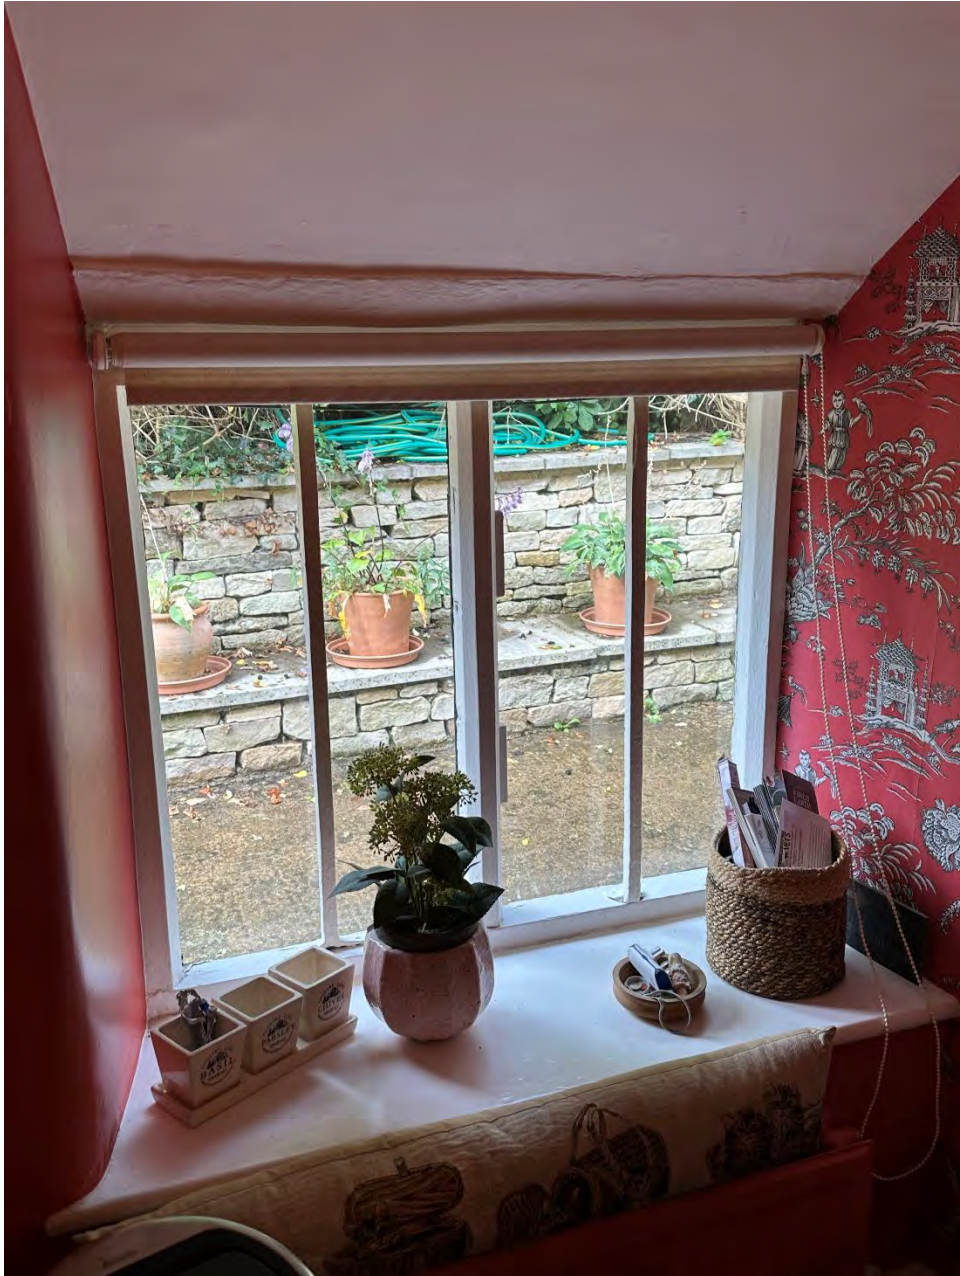
| Reference | Existing Description and Condition | Proposed Change |
|---|---|---|
| WG-10 | <p>Description – single-glazed, fixed, two-light, timber-frame casement. Simply chamfered mullion and frame with evidence</p> | New replacement window (Type 1); frame to be retained. |

| Reference | Existing Description and Condition | Proposed Change |
|---|---|--|
| | <p>of joints for missing horizontal glazing bars. Fitted internally with iron bars.</p> <p>Condition – fair; signs of deteriorating paintwork and timber.</p> | |

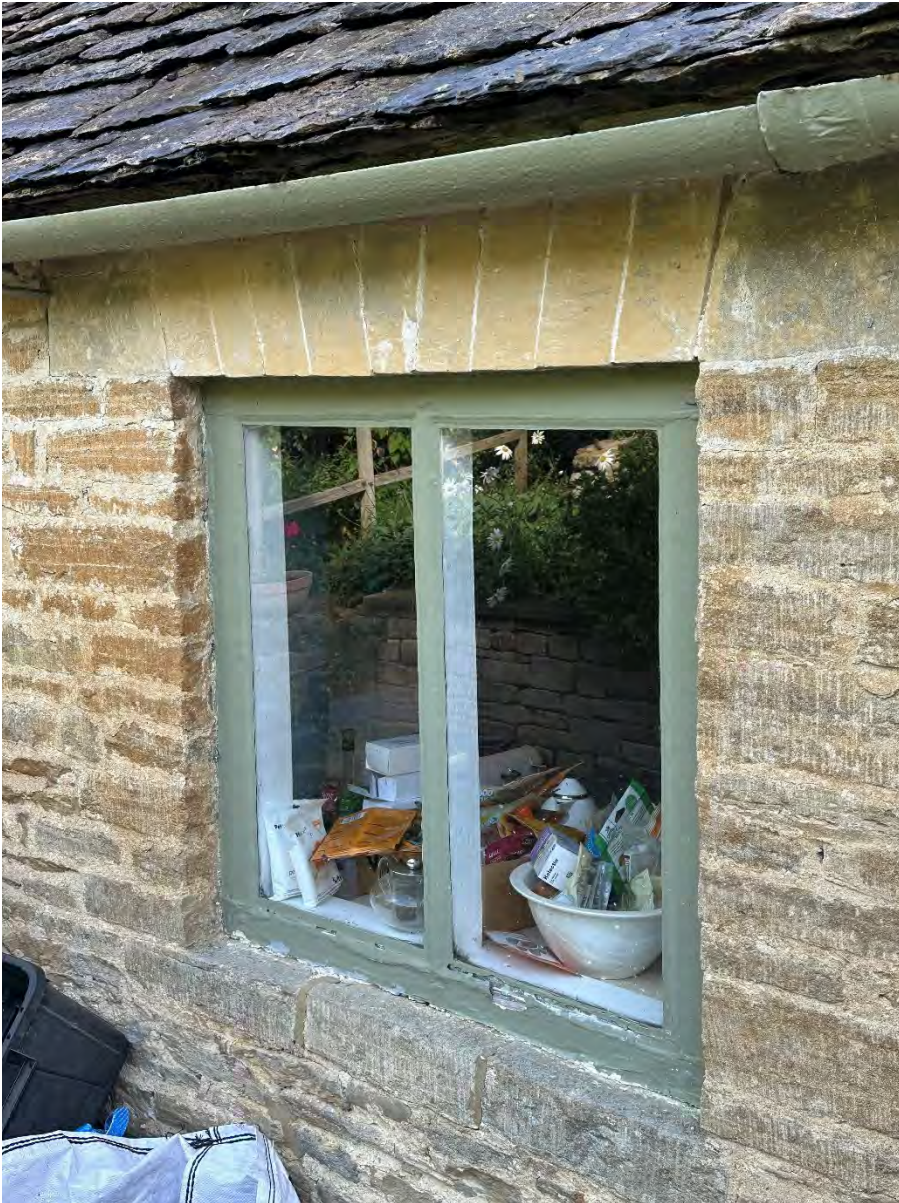
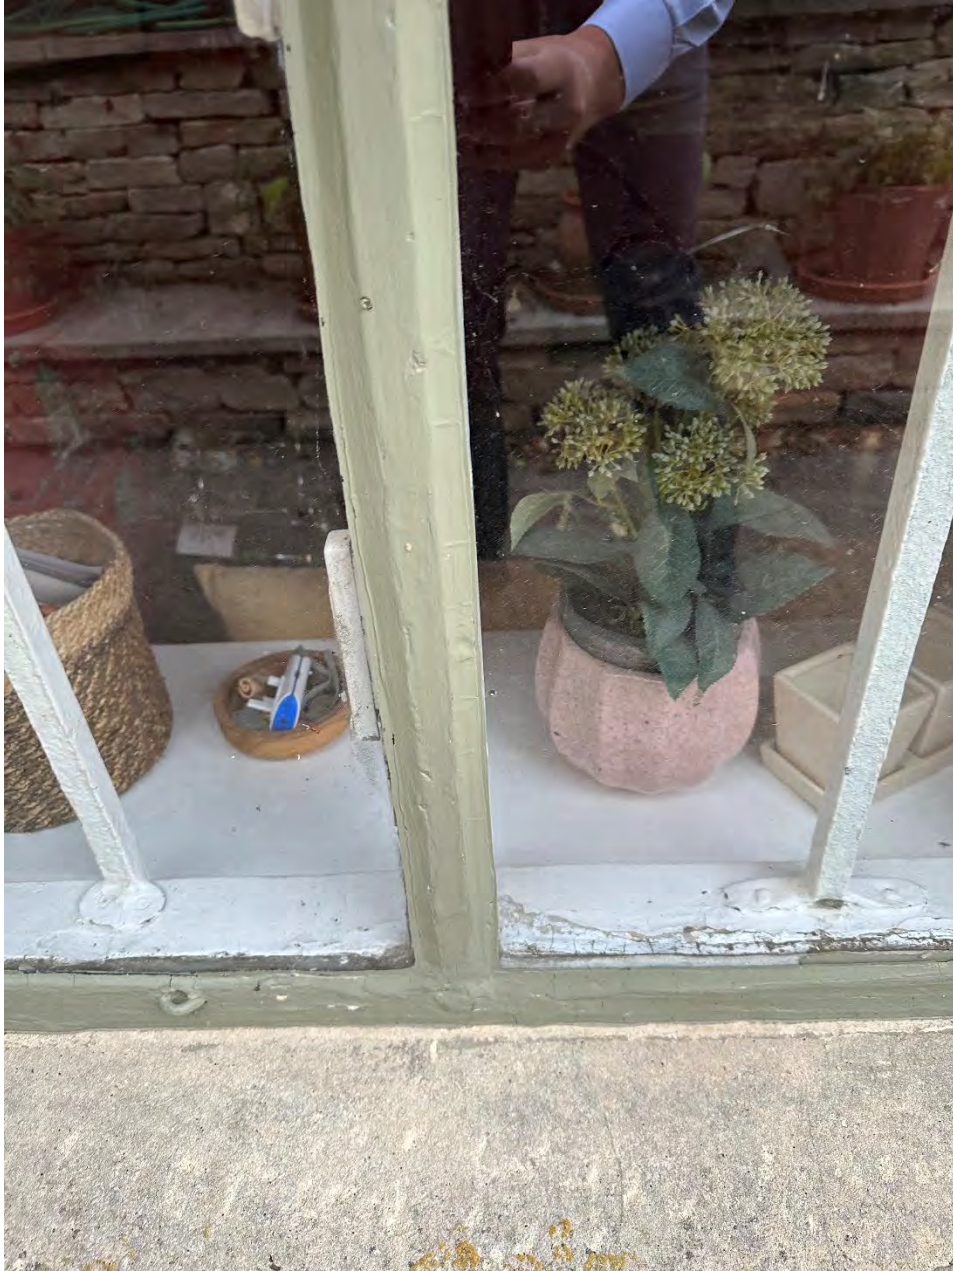
| Reference | Existing Description and Condition | Proposed Change |
|---|---|--|
| WG-11 | <p>Description – similar to WG-10 but with unchamfered timber mullion and without iron bars.</p> <p>Condition – good.</p> | New replacement window (Type 1). |

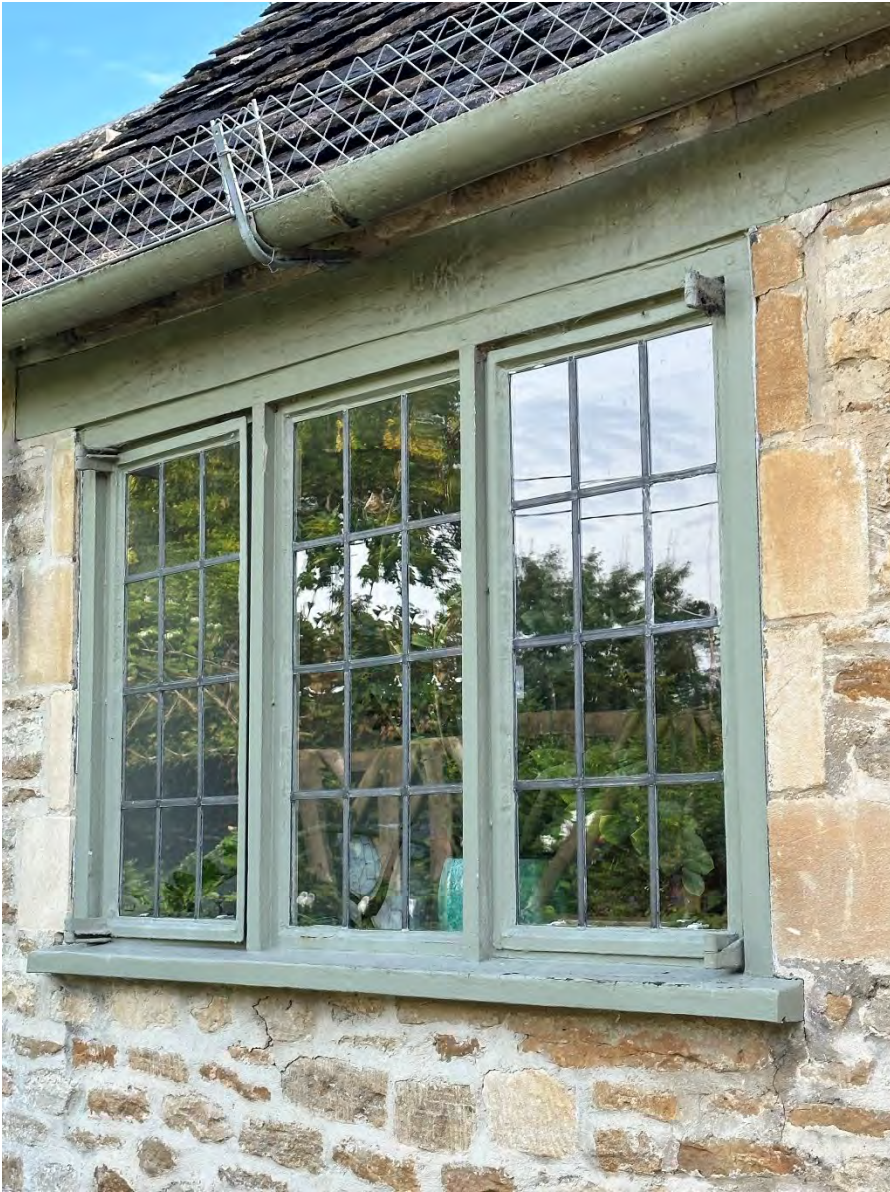
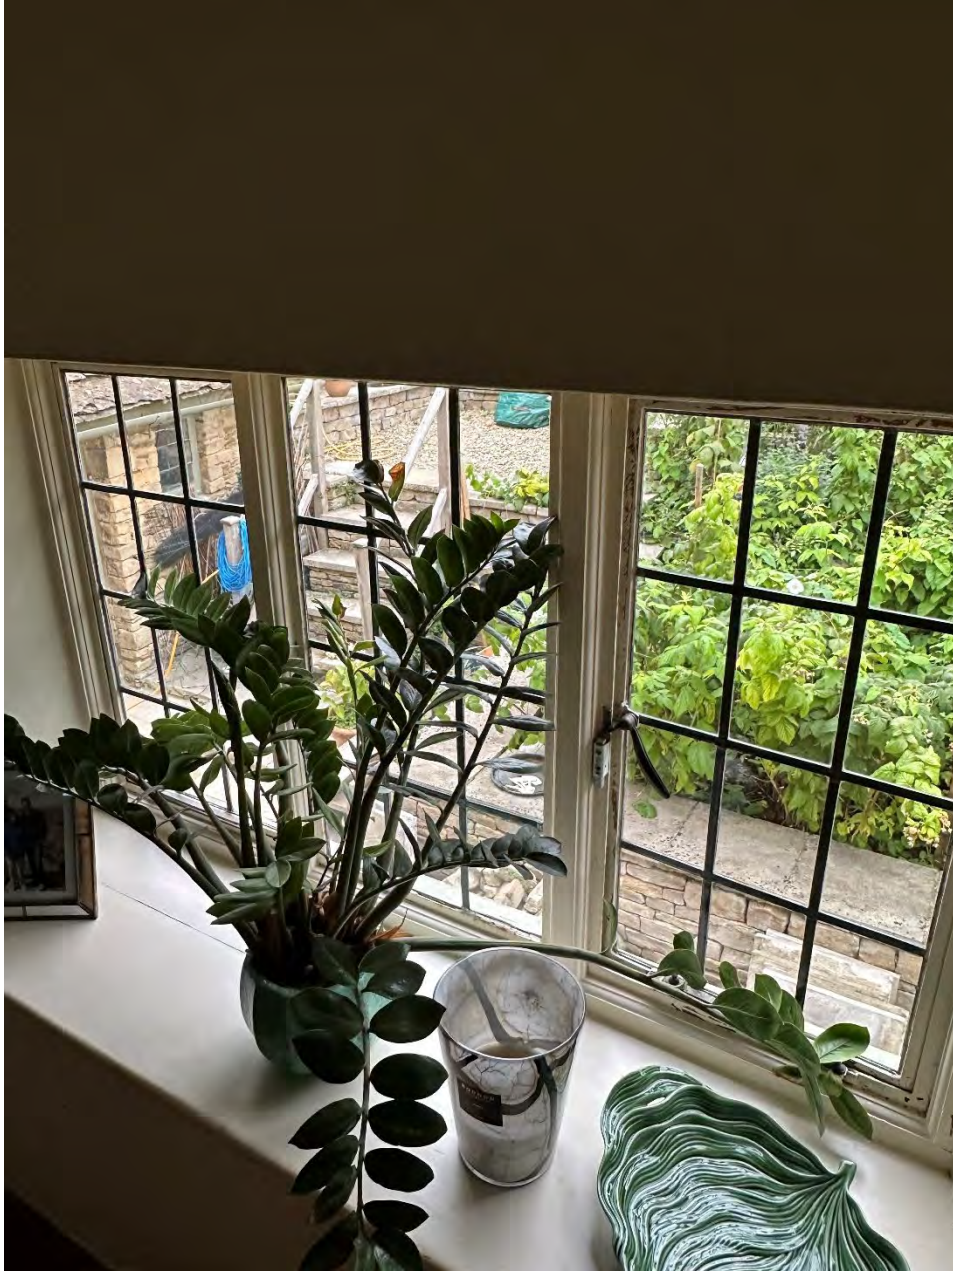
| Reference | Existing Description and Condition | Proposed Change |
|---|---|--|
| WG-12 | <p>Description – single-glazed, metal casement set within timber frames. The frames and mullions have wide roll mouldings at their corners. Part of the c. 1945 extension.</p> <p>Condition – good, although signs of deterioration to metal catches.</p> | New replacement window (Type 1). |

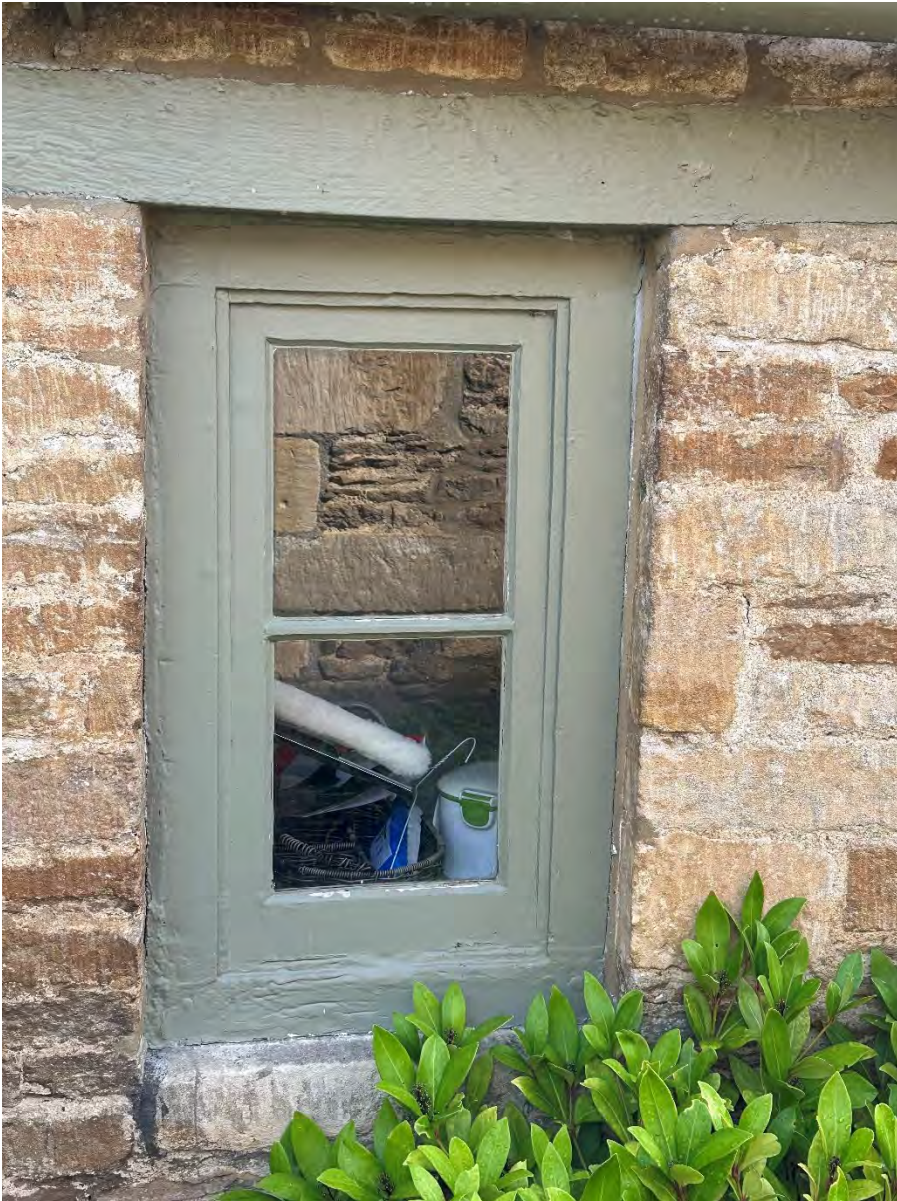
| Reference | Existing Description and Condition | Proposed Change |
|---|---|--|
| WG-13 | <p>Description – single-glazed, fixed, single-pane, timber-frame casement. Simply moulded glazing bar. The frame has a stepped profile.</p> <p>Condition – good.</p> | No change (retention). |

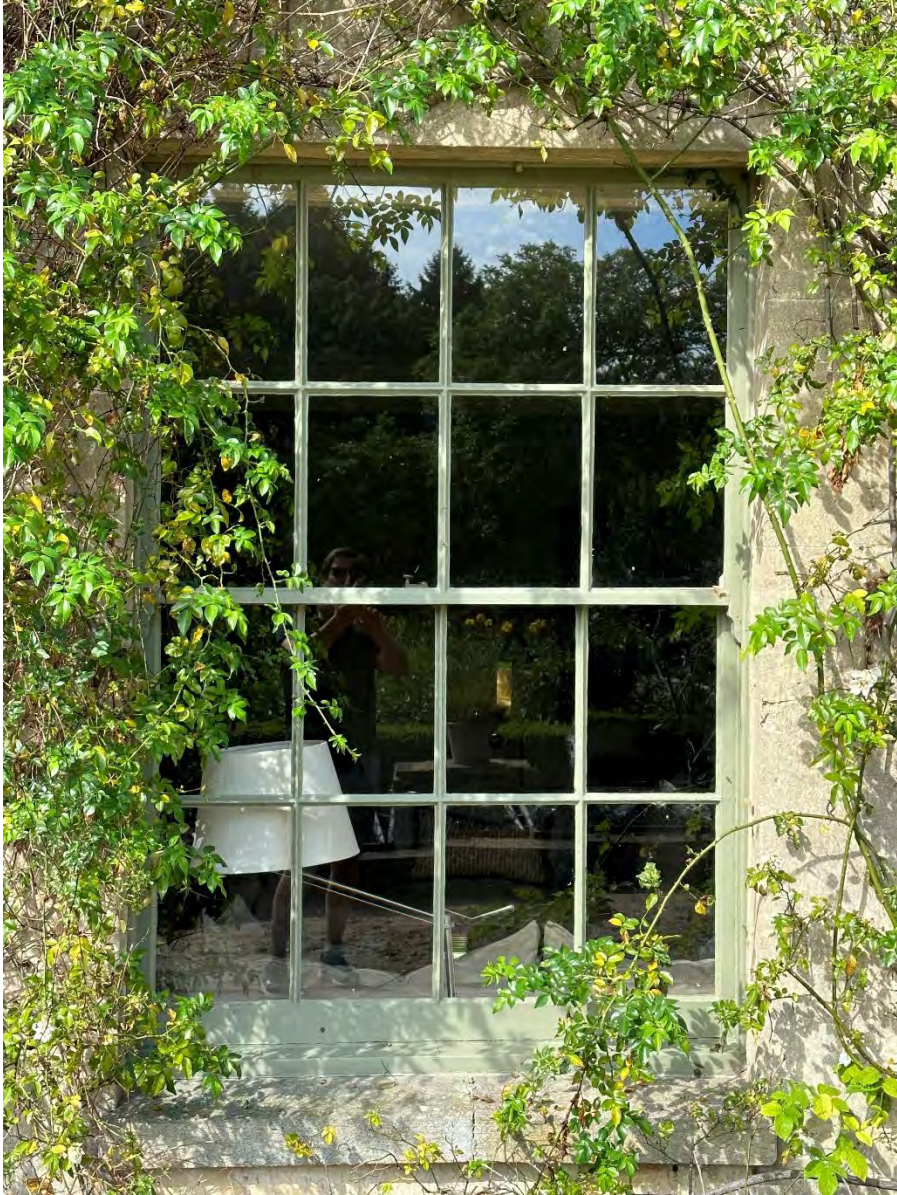
| Reference | Existing Description and Condition | Proposed Change |
|---|--|--|
| WG-18 | <p>Description – modern, six-over-six, box sash window installed c. 1988 as confirmed by photographs and plans submitted as part of consented application CT.LBC586.</p> <p>Condition – good.</p> | New replacement window (Type 2). |

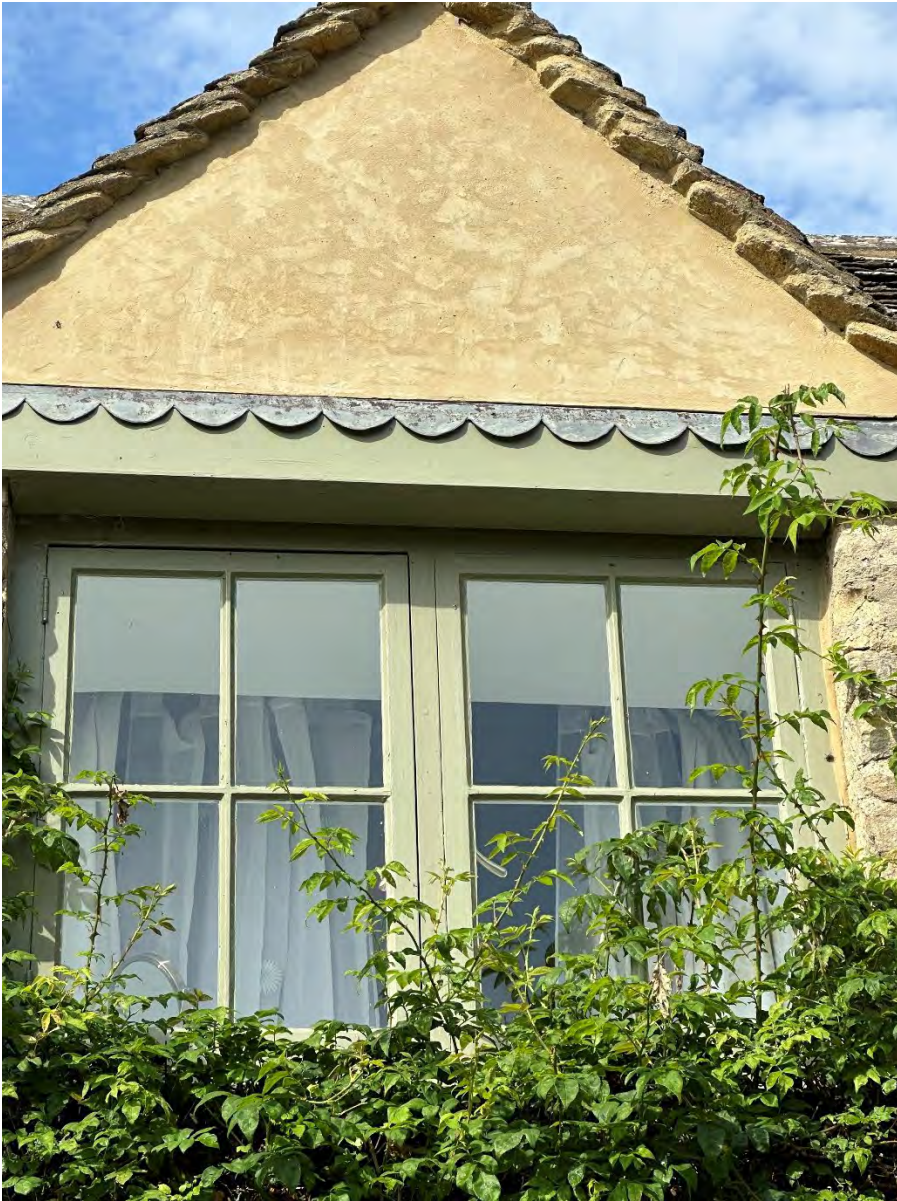
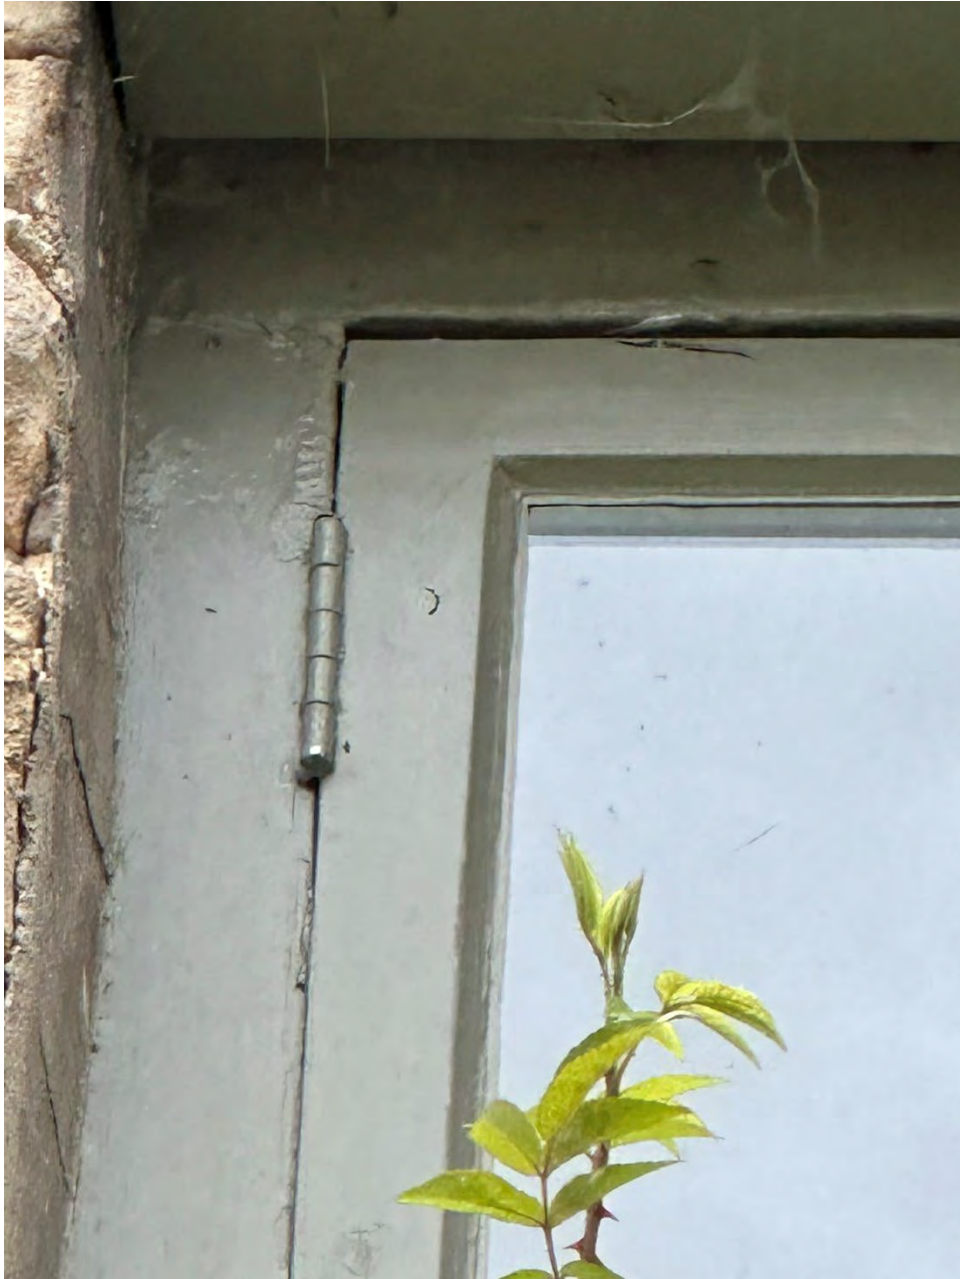
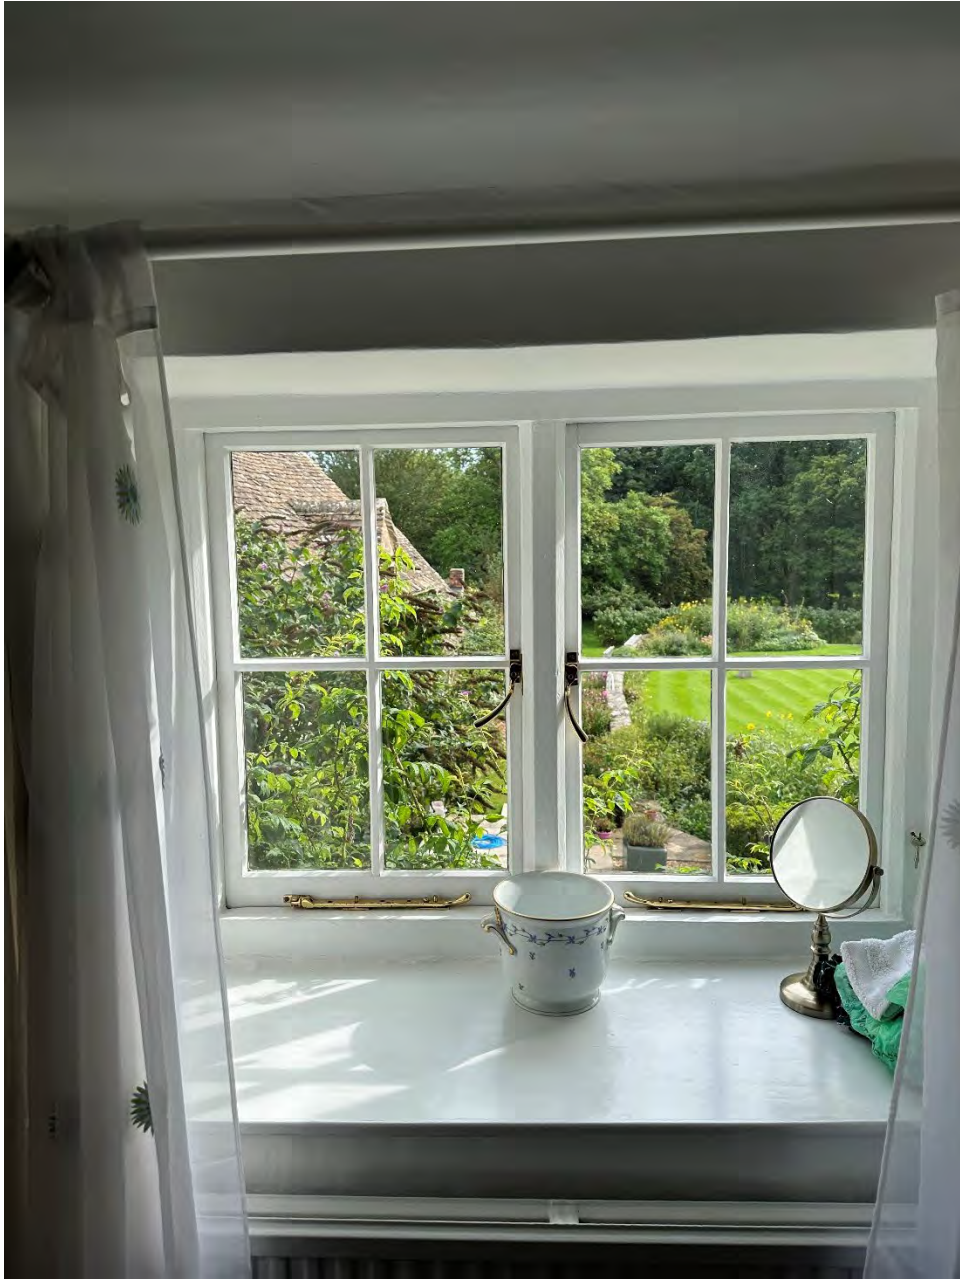
| Reference | Existing Description and Condition | Proposed Change |
|---|--|--|
| WF-01 | <p>Description – single-glazed, two-light, timber-frame casement. The casements have angular glazing bar profiles and modern fittings. The frame and mullion are chamfered and appear to be earlier. A photograph taken in c. 1988 as part of planning application CT.LBC586 indicates that the dormer has since been repaired and the lintel replaced.</p> <p>Condition – good.</p> | New replacement window (Type 1); frame to be retained. |

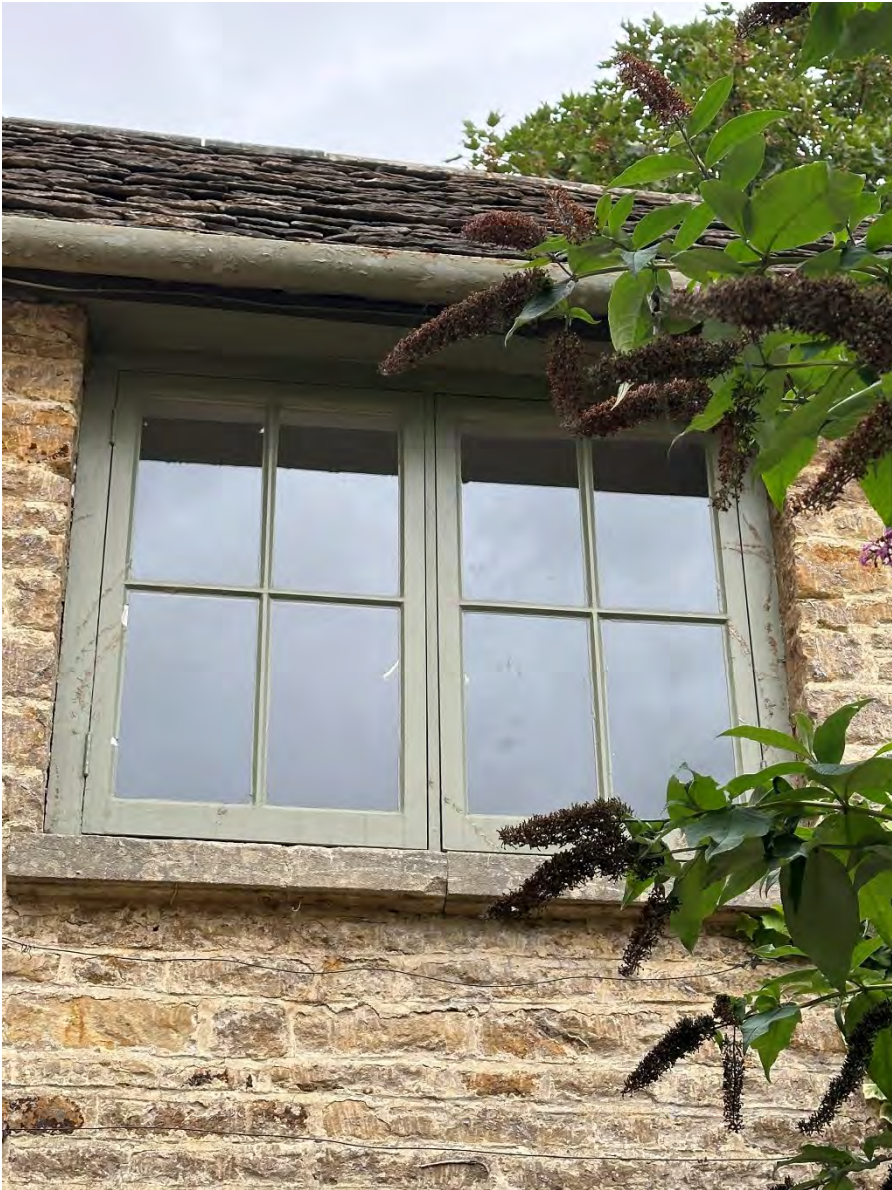
| Reference | Existing Description and Condition | Proposed Change |
|---|--|--|
| WF-02 | <p>Description – related to WF-01.</p> <p>Condition – good, although some signs of deteriorating paintwork.</p> | New replacement window (Type 1); frame to be retained. |

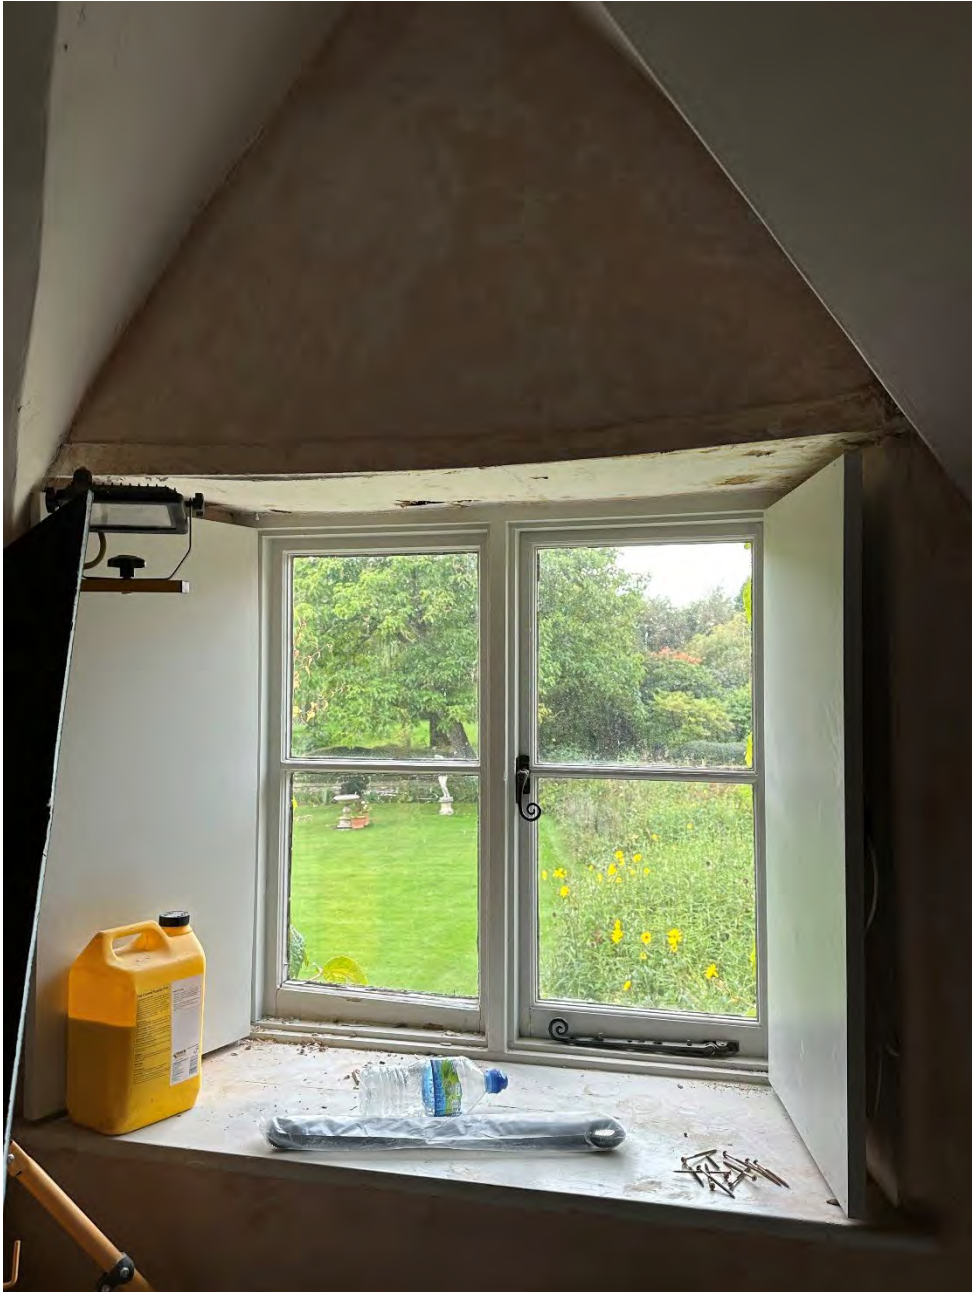
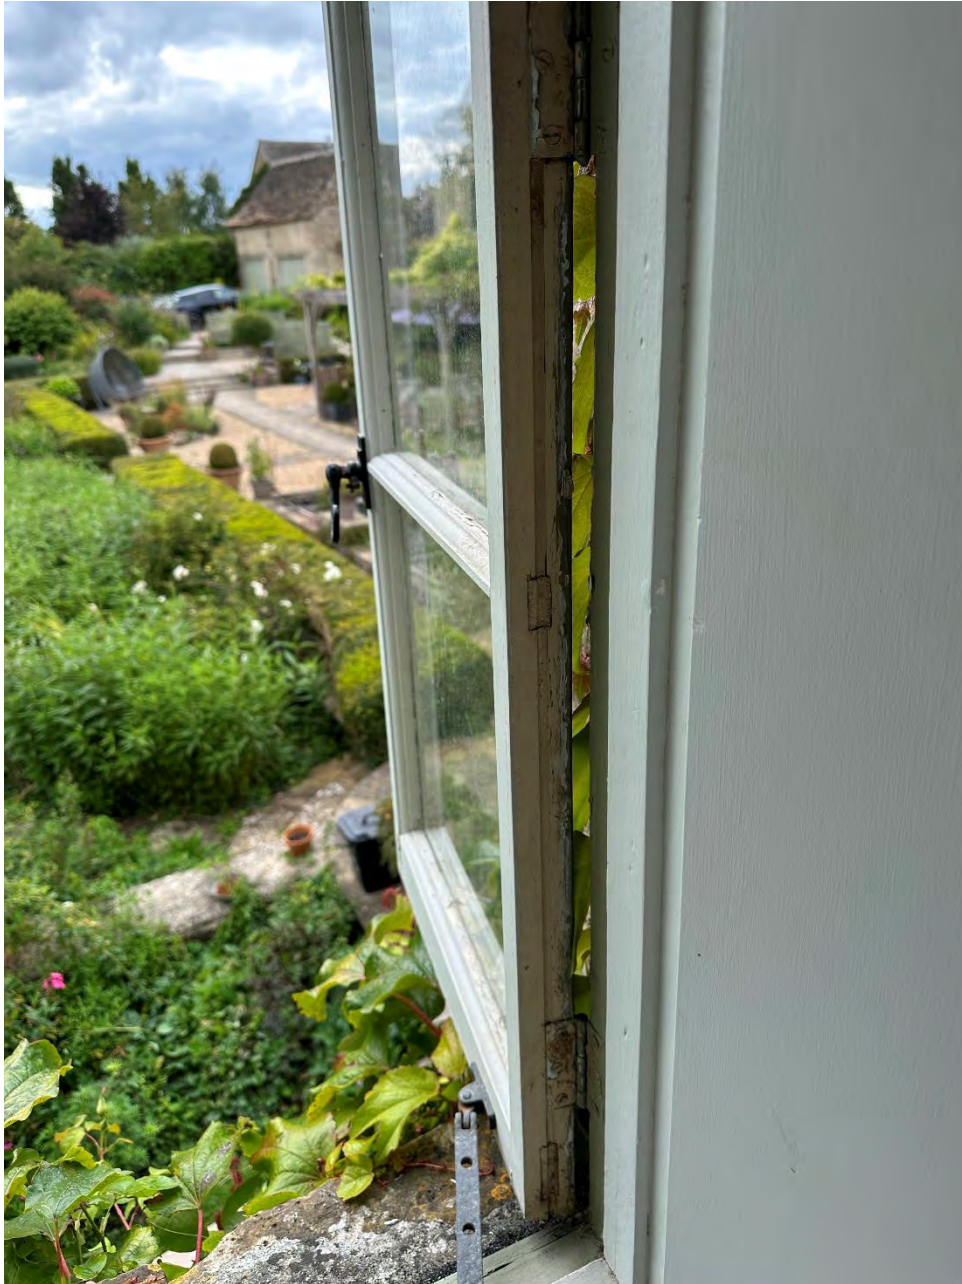
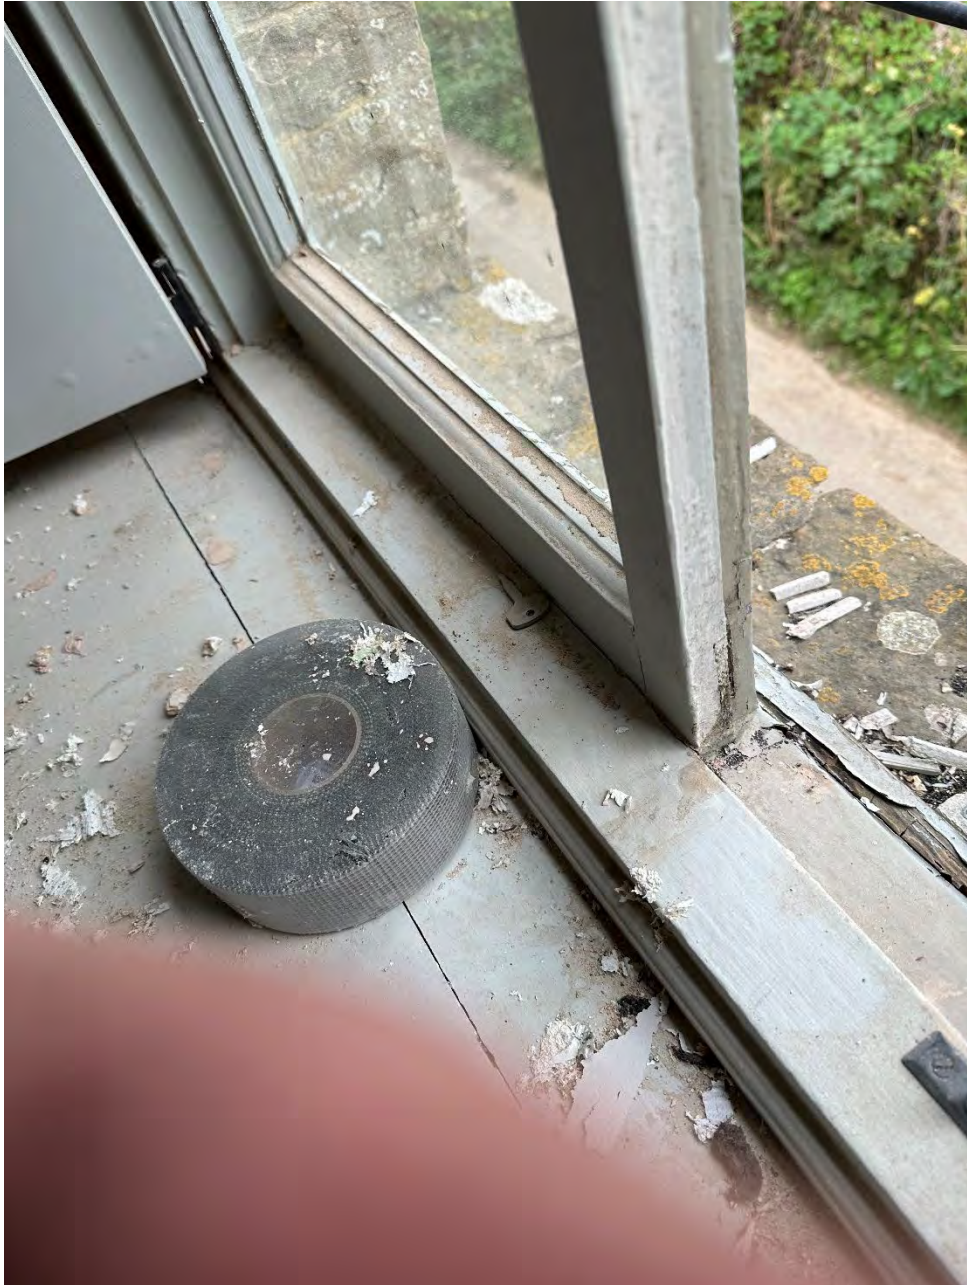
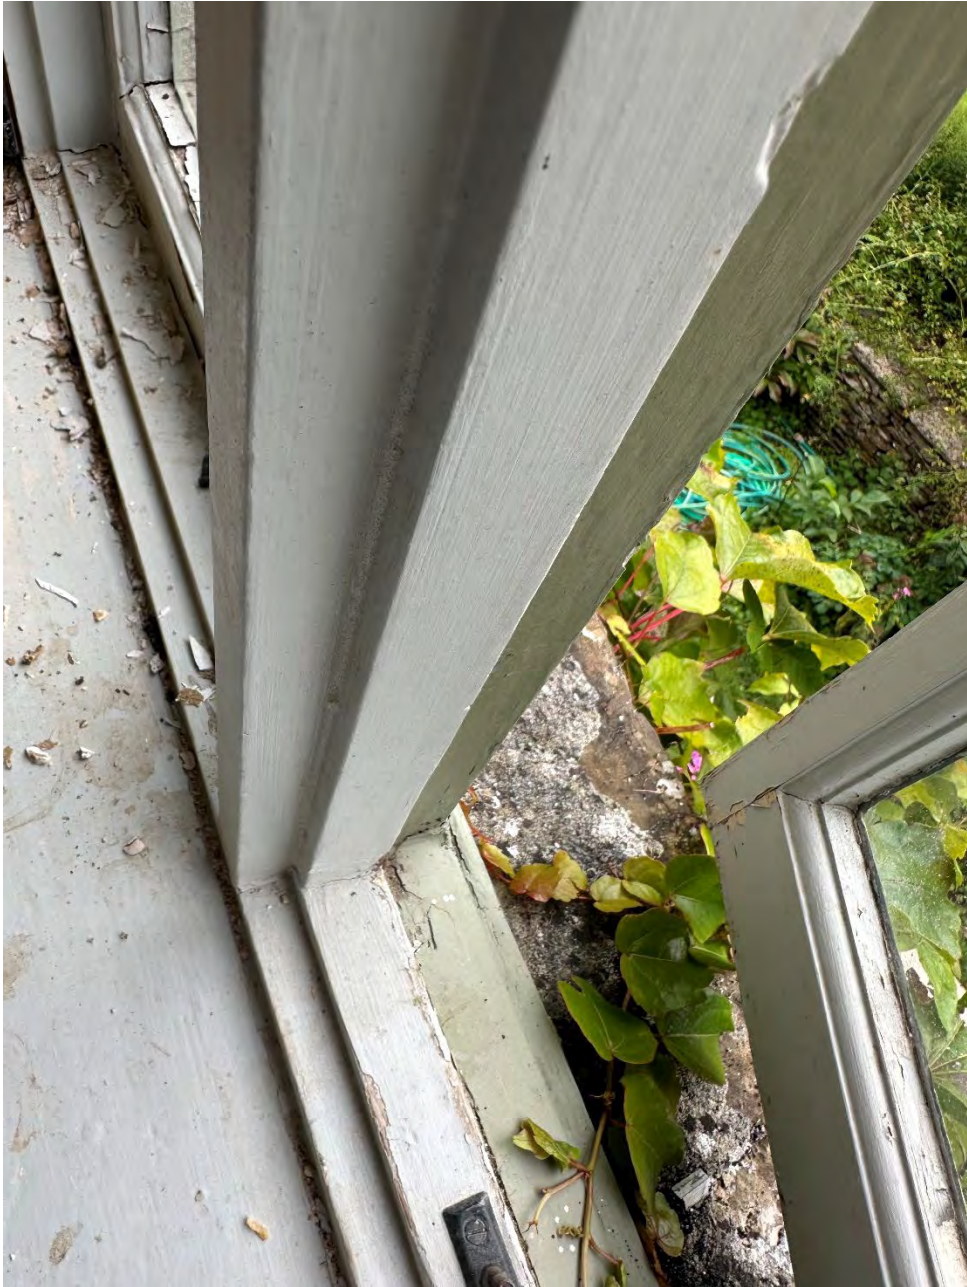
| Reference | Existing Description and Condition | Proposed Change |
|---|---|--|
| WF-03 | <p>Description – single-glazed, timber-frame casement. From the interior, the right-hand casement is legible as a modern replacement with modern monkey tail catch and stay. The left-hand casement and frame and mullion (with stepped profiles) appear to be earlier.</p> <p>Condition – deteriorating paintwork and possible deterioration of timber.</p> | New replacement window (Type 1); frame to be retained. |
