Window and Door Schedule

Ampney Brook House, School Lane, Ampney Crucis, GL7 5RT

On behalf of Mr J. Fagge

Date: 12/10/2023 | Pegasus Ref: P22- 0597

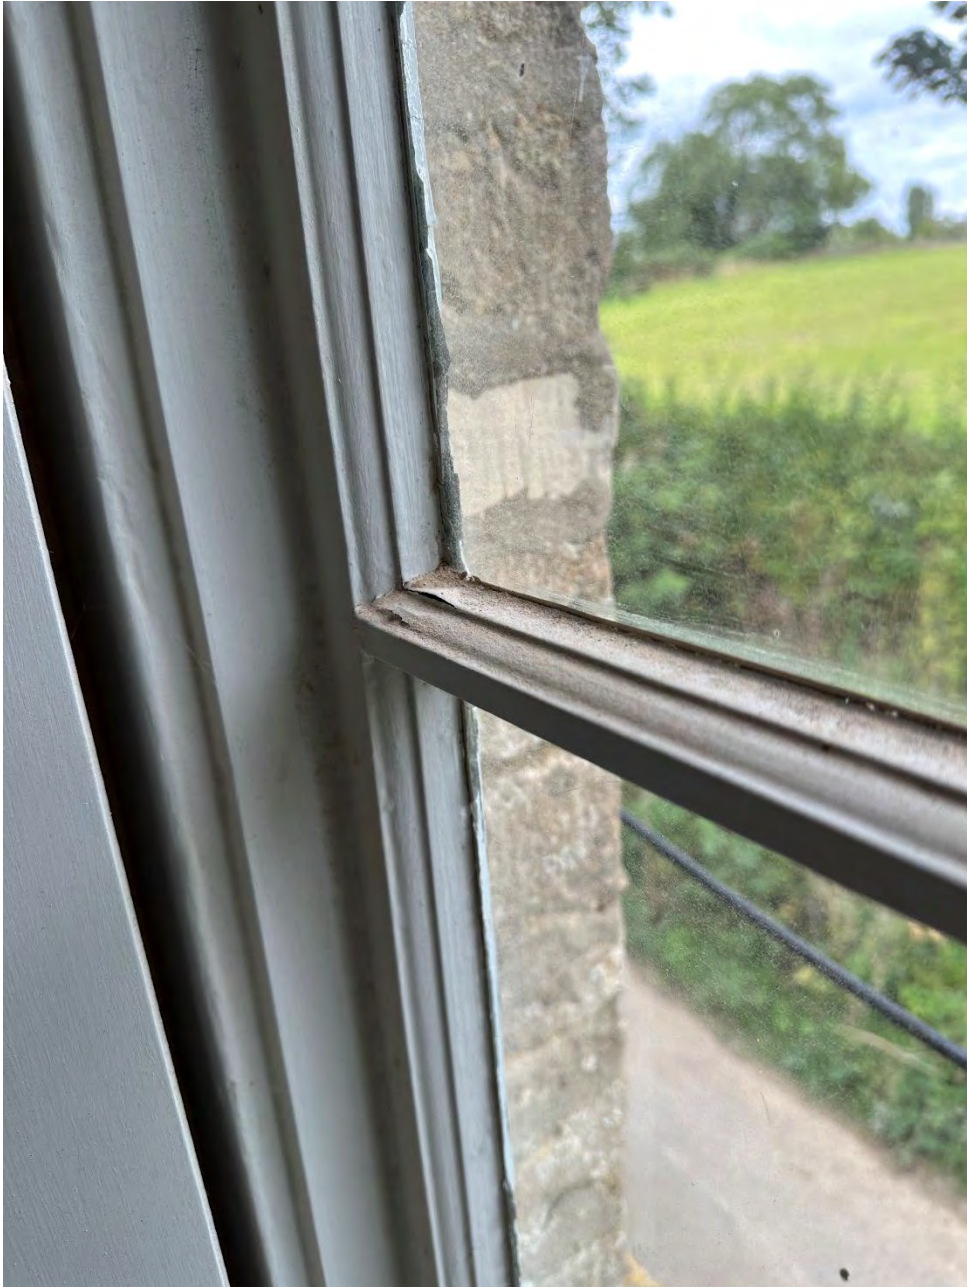
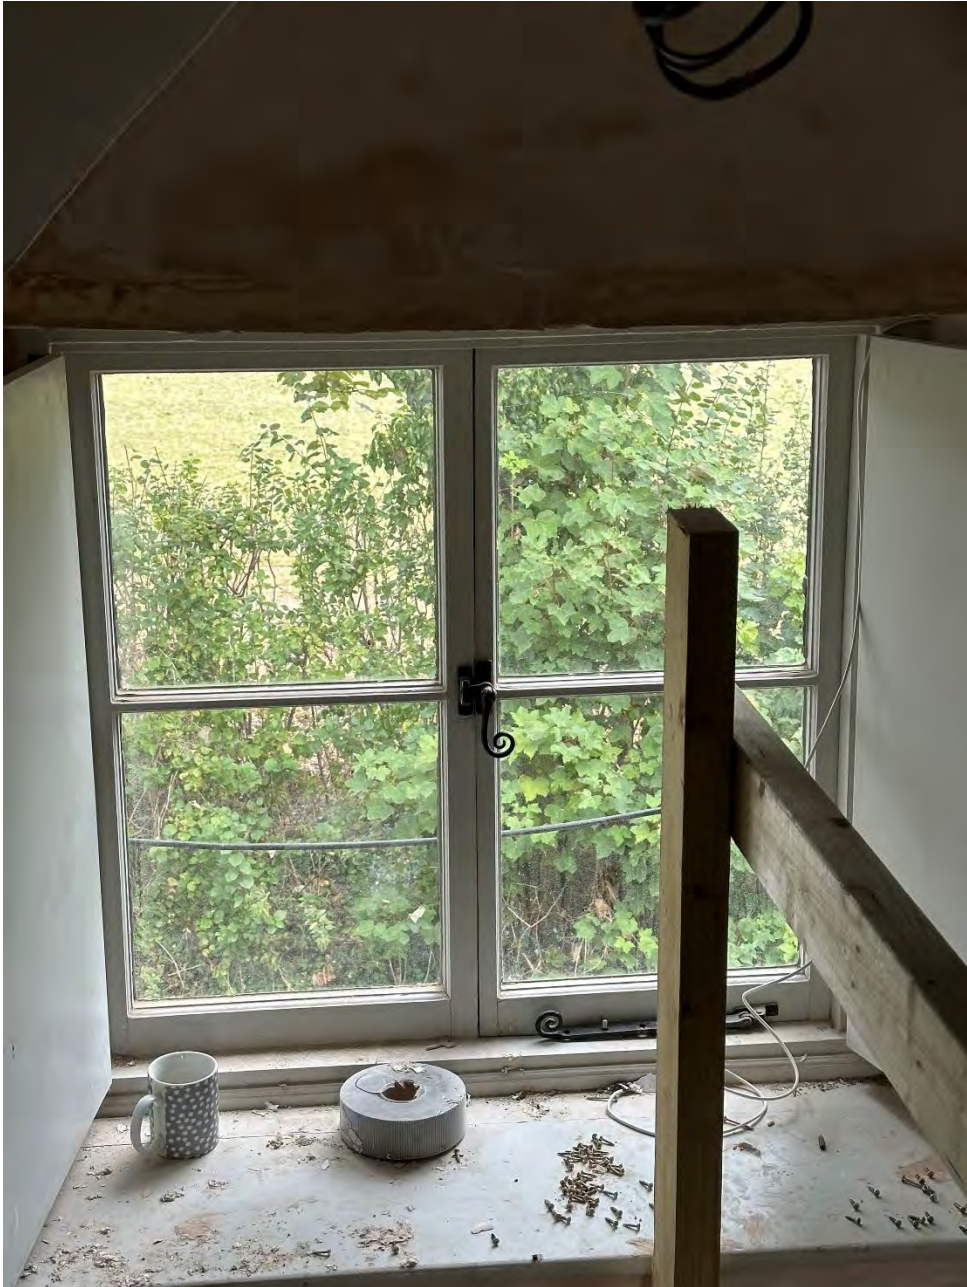
| Reference | Existing Description and Condition | Proposed Change |
|---|---|--|
| WF-04 | <p>Description – single-glazed, timber-frame casement. The casements have modern glazing bars, hinges, catch and stay. The frame appears to be earlier and has a stepped profile.</p> <p>Condition – deteriorating paintwork and timber.</p> | New replacement window (Type 1); frame to be retained. |

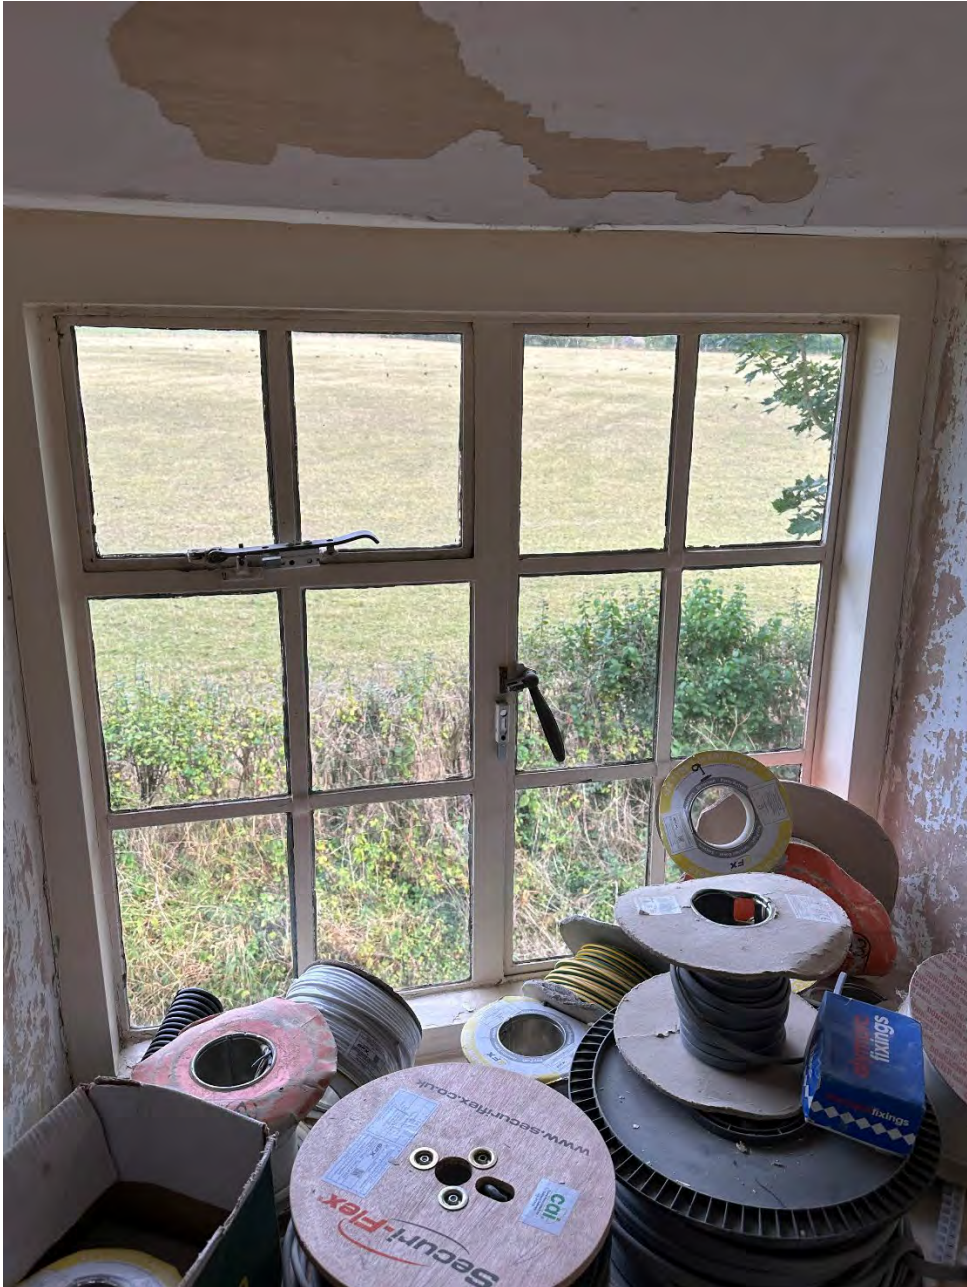
| Reference | Existing Description and Condition | Proposed Change |
|---|---|--|
| WF-05 | <p>Description – single-glazed, modern metal casement.</p> <p>Condition – signs of deterioration, including failing of paintwork.</p> | New replacement window (Type 1). |

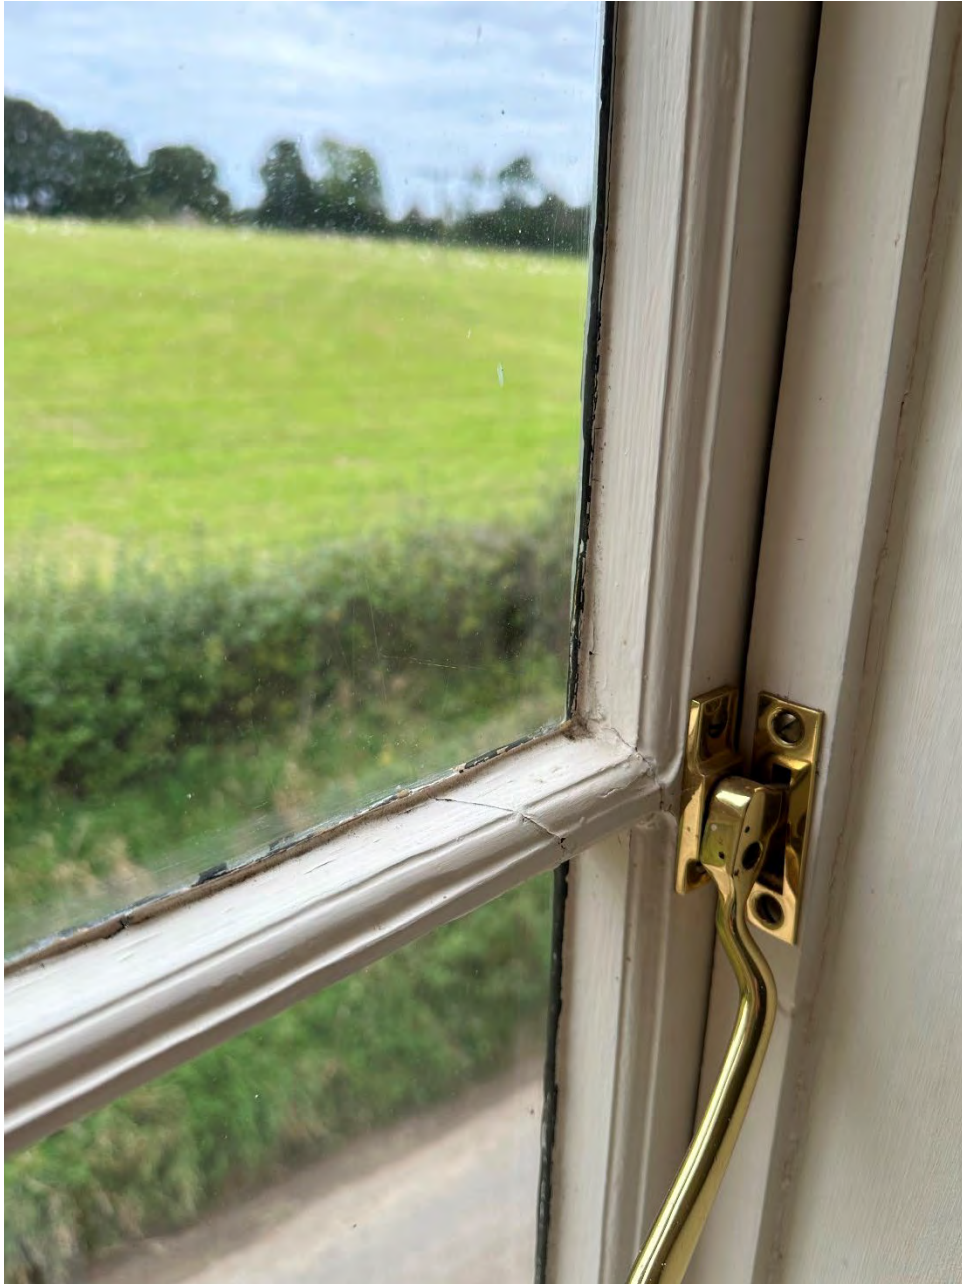
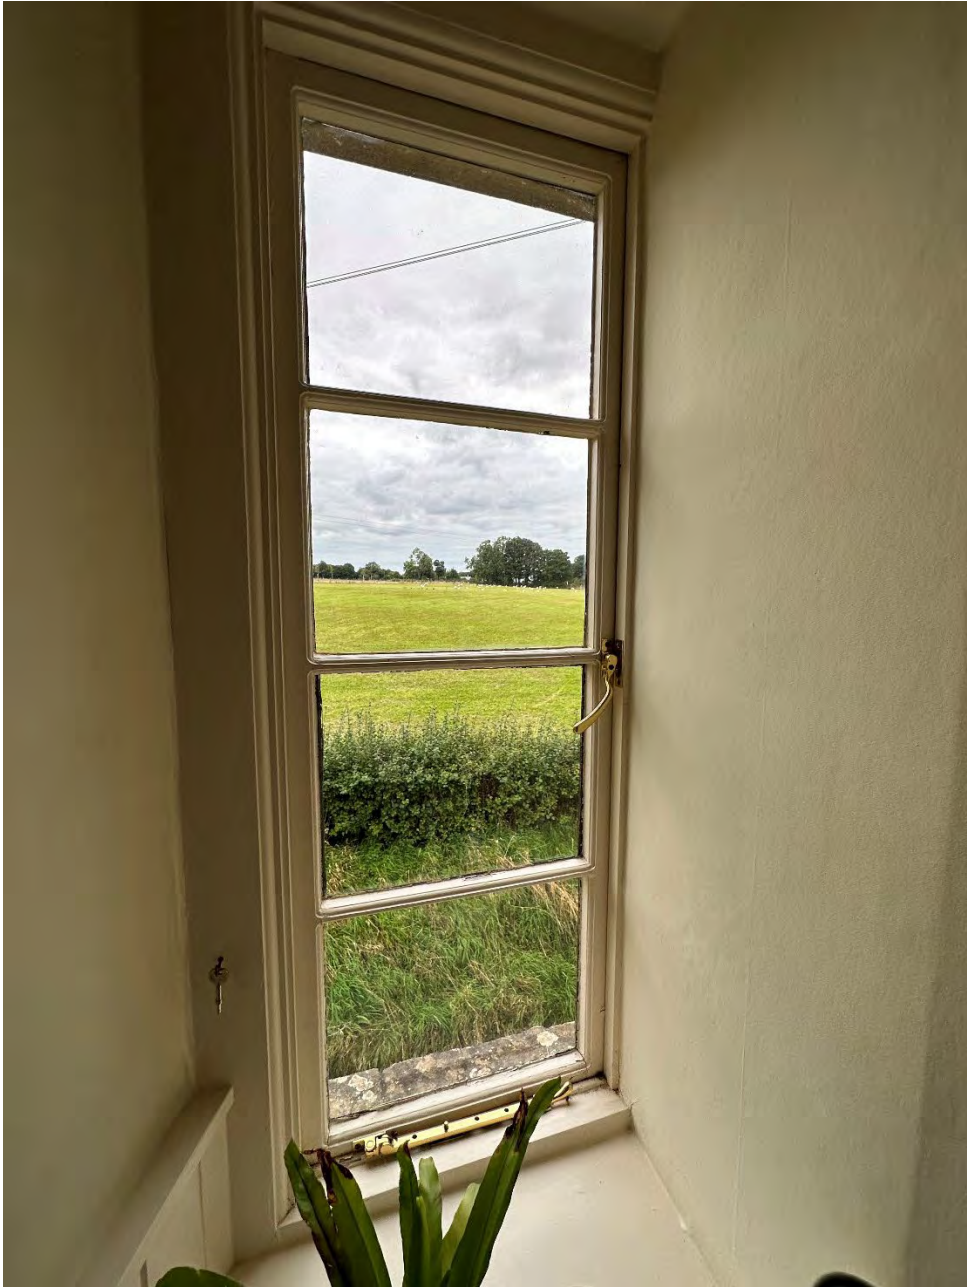
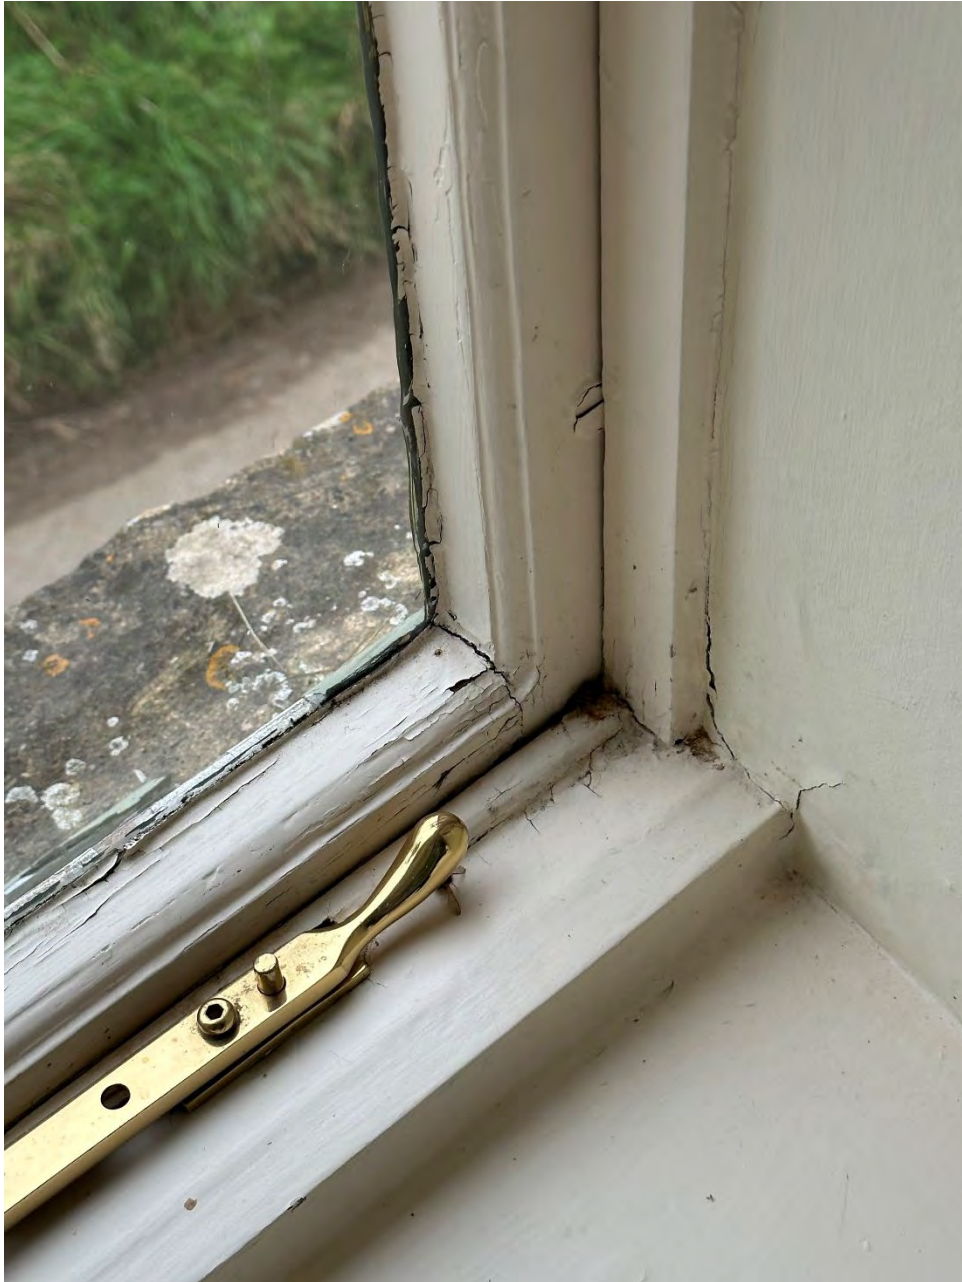
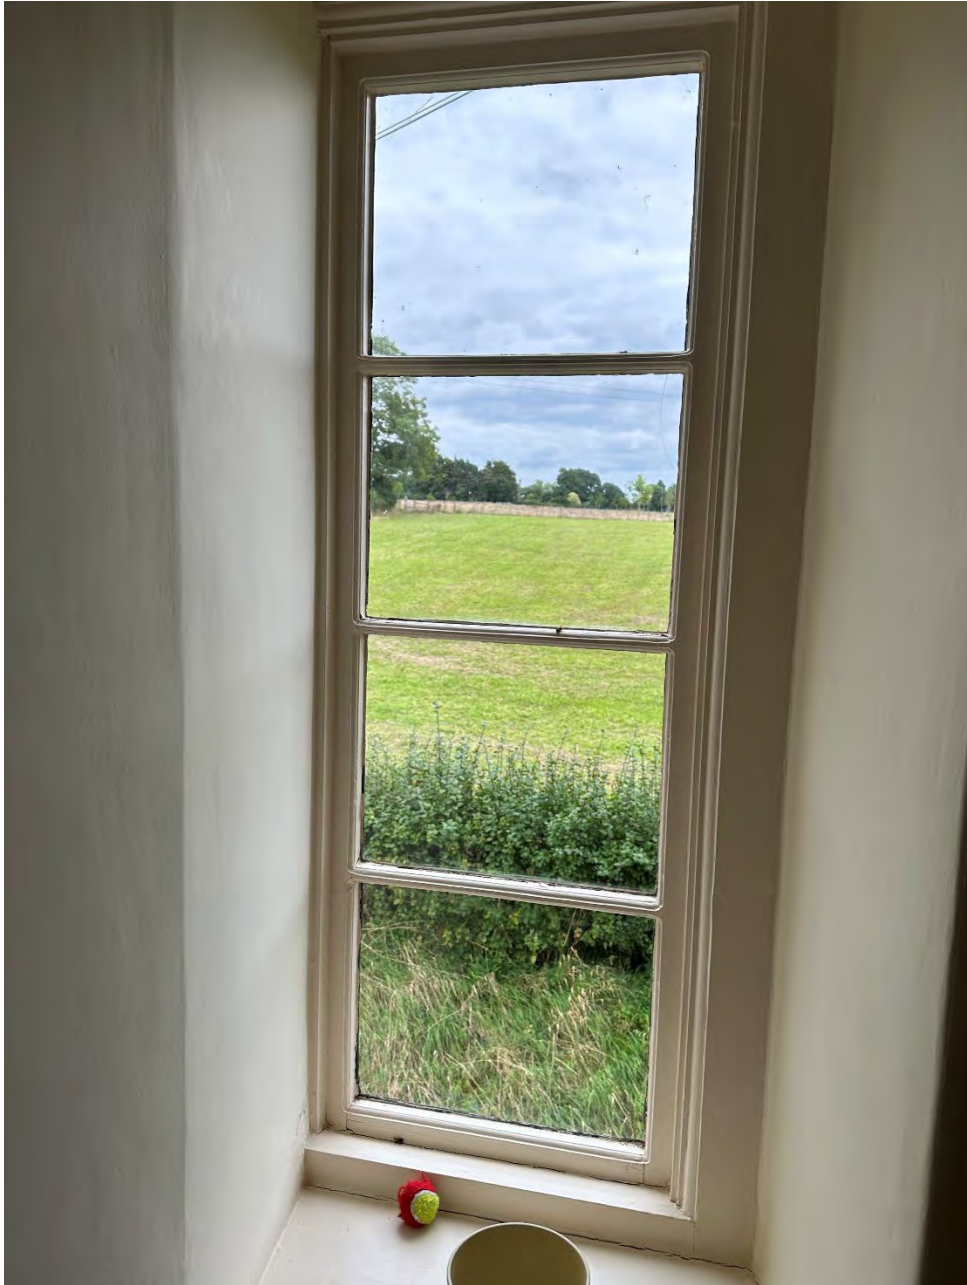
| Reference | Existing Description and Condition | Proposed Change |
|---|---|--|
| WF-06 | <p>Description –single-glazed, timber-frame casement internally divided by modern partition Glazing bar profiles are square externally and rounded internally. Legible as a relatively recent replacement inserted during modern subdivision to create new corridor and bathroom facilities. Historically, this opening probably accommodated a sash as per WG-09.</p> <p>Condition – fair; deteriorating paintwork and possible deterioration of timber.</p> | New replacement window (Type 2). |

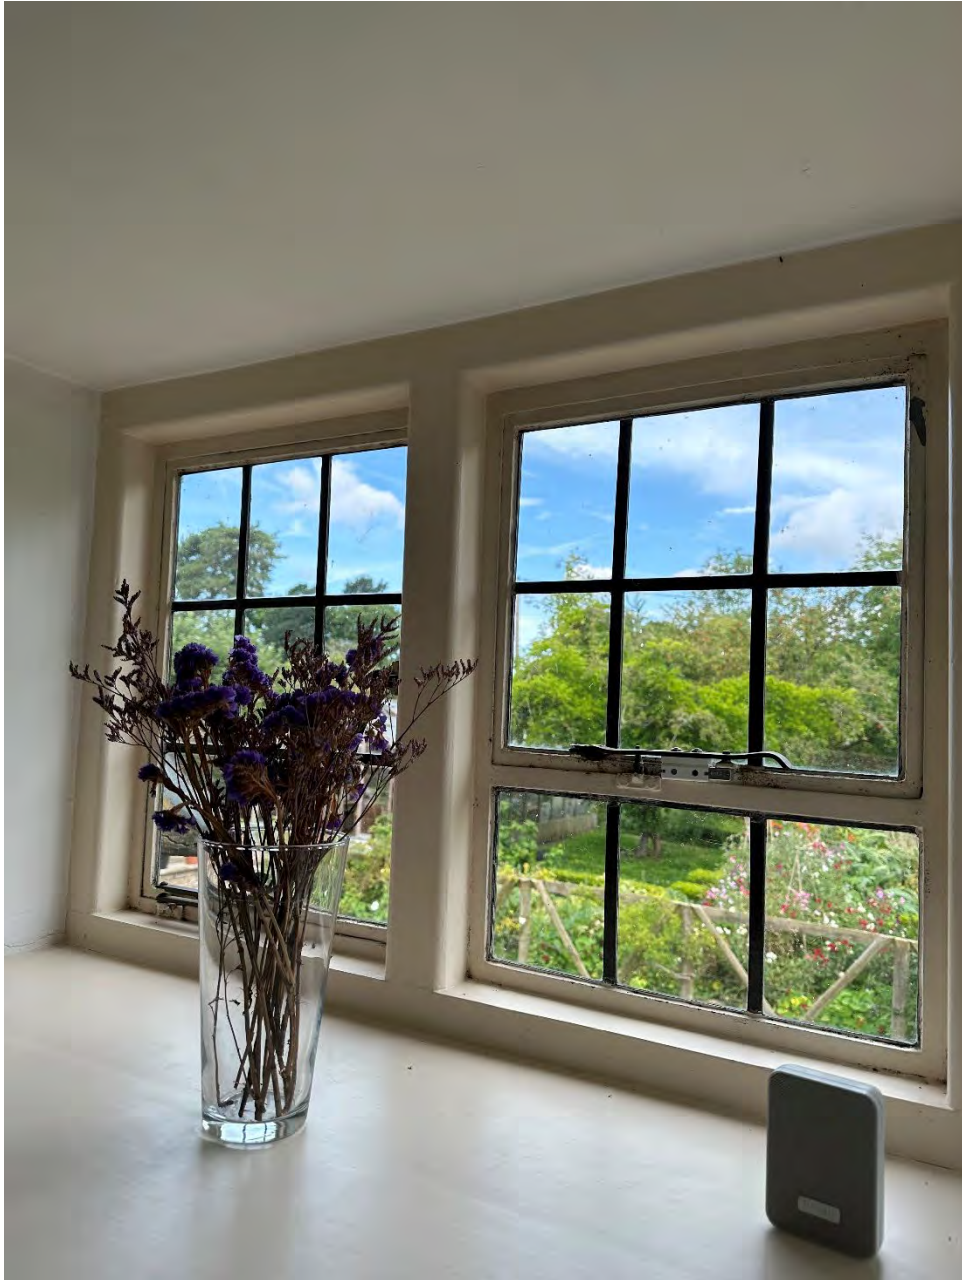
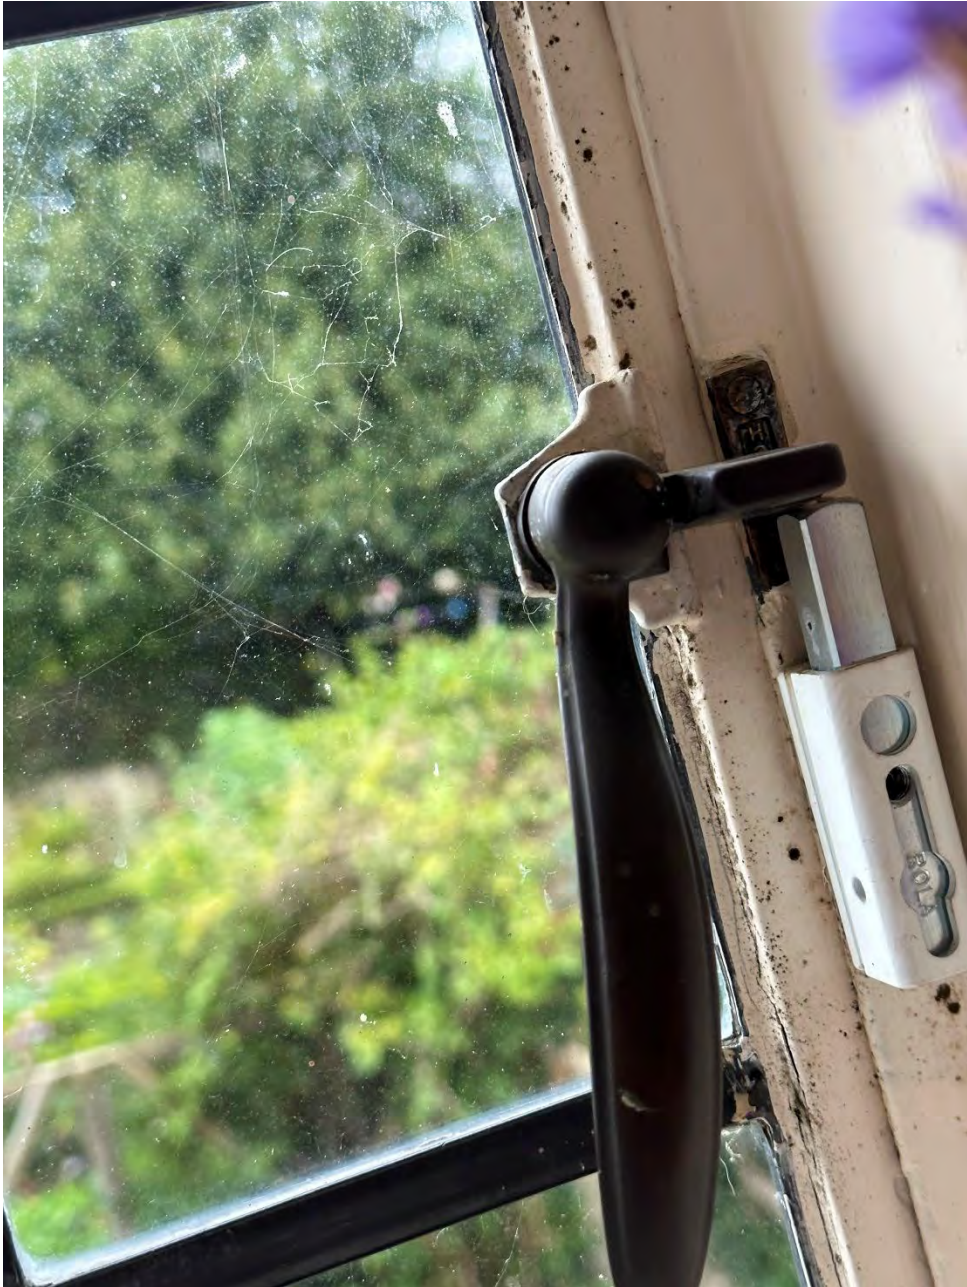
| Reference | Existing Description and Condition | Proposed Change |
|---|---|---|
| WF-07 | <p>Description – modern, single-glazed, metal casement set within timber frames (cf. WG-12). Part of a dormer which is legible as a later addition.</p> <p>Condition – fair; minor signs of deterioration.</p> | New replacement window (Type 1). |

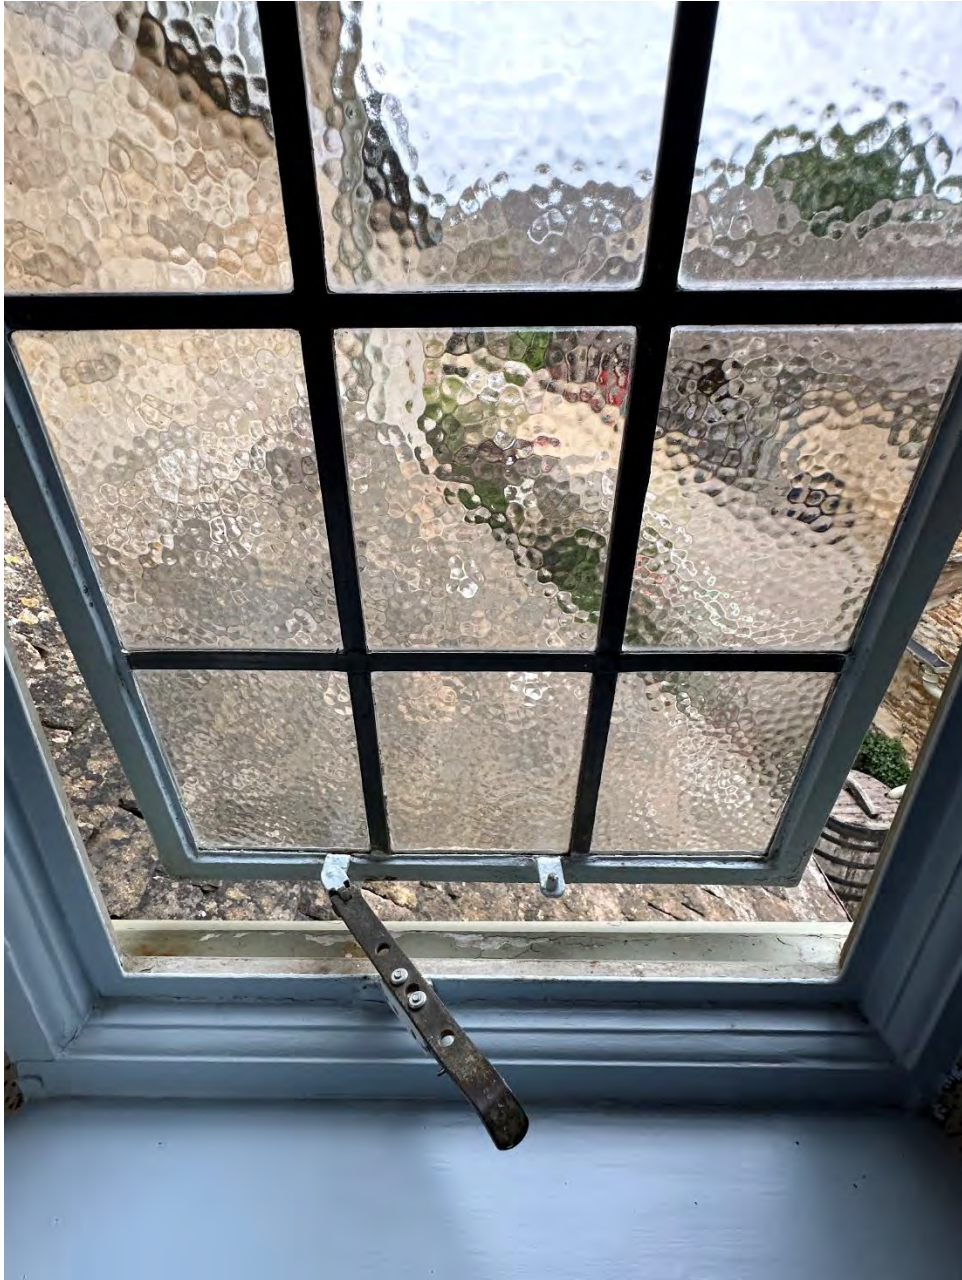
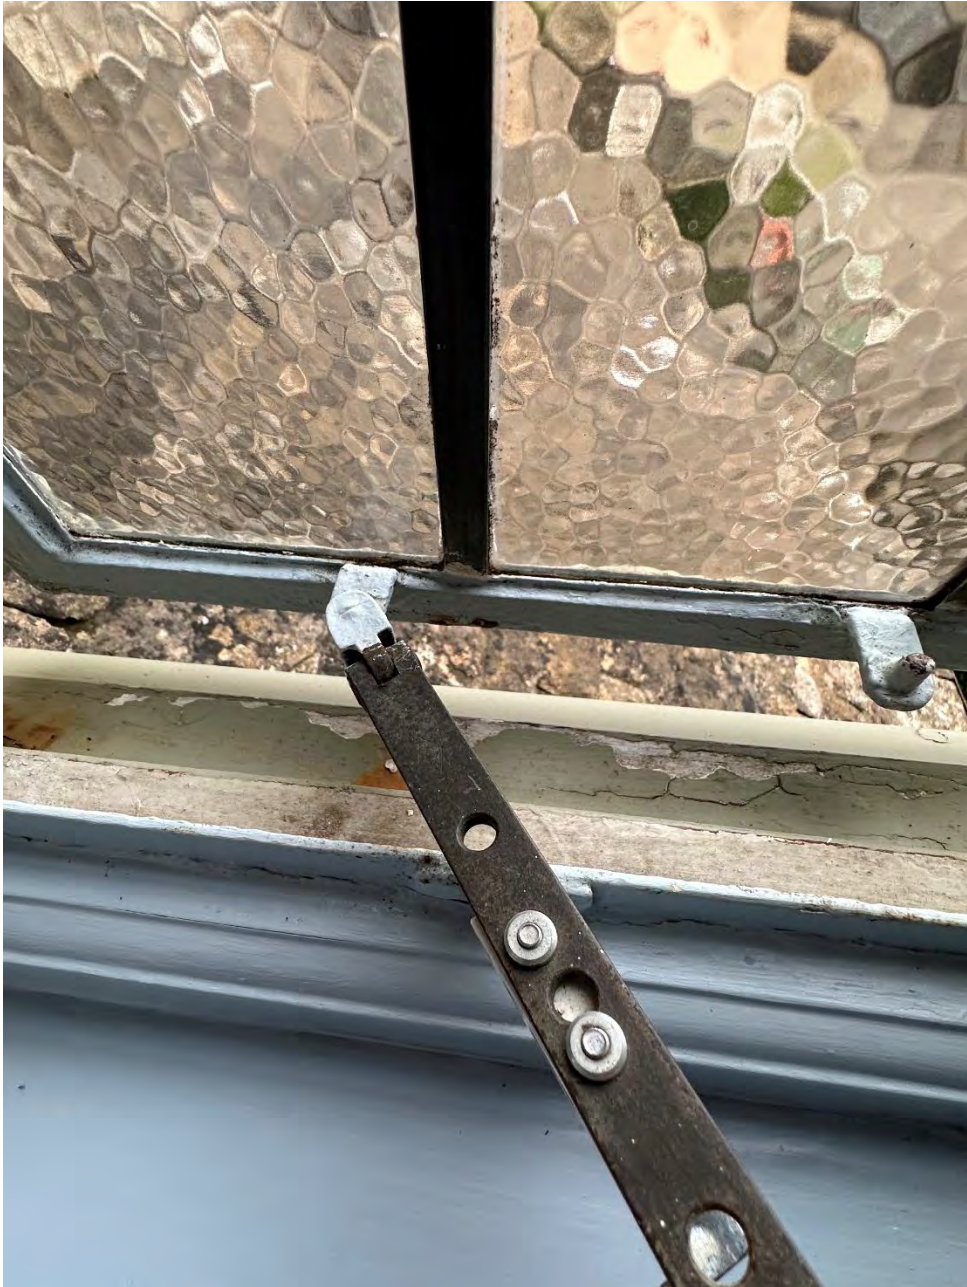
| Reference | Existing Description and Condition | Proposed Change |
|---|---|---|
| WF-08 | <p>Description – modern, single-glazed, vertically opening, metal casement set within timber frame. Frosted glazing.</p> <p>Condition – some of the paintwork has failed and signs of deterioration to metal.</p> | New replacement window (Type 1). |

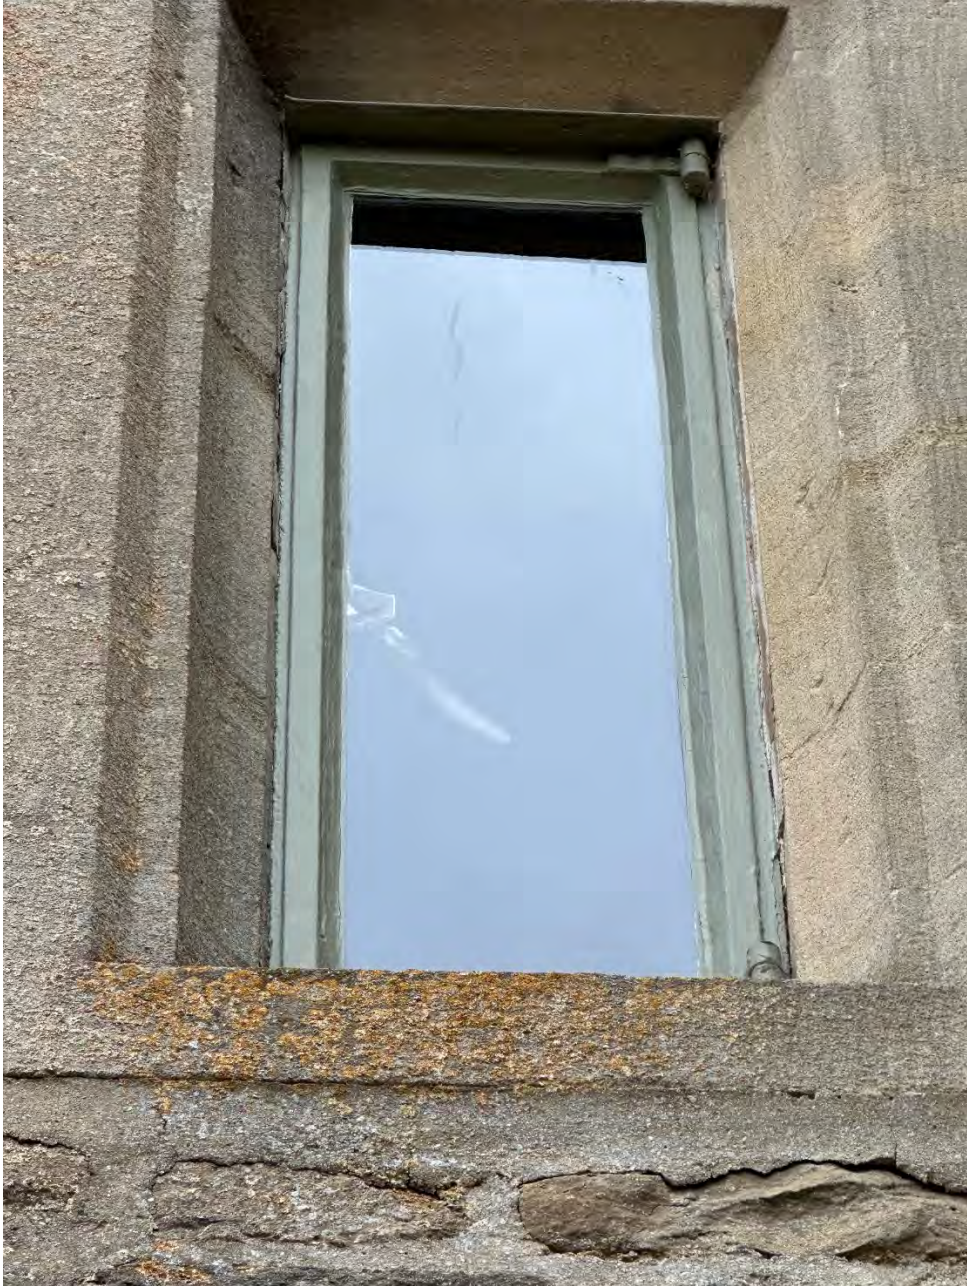
WF-09 & WF-10

| Reference | Existing Description and Condition | Proposed Change |
|---|---|---|
| WF-09 | <p>Description – modern, single-glazed, metal casement located within c. 1945 extension.</p> <p>Condition – fair; minor signs of deterioration to paintwork and metalwork.</p> | New replacement window (Type 3). |
| WF-10 | <p>Description – same as WF-09.</p> <p>Condition – fair; minor signs of deterioration to paintwork and metalwork.</p> | New replacement window (Type 3). |

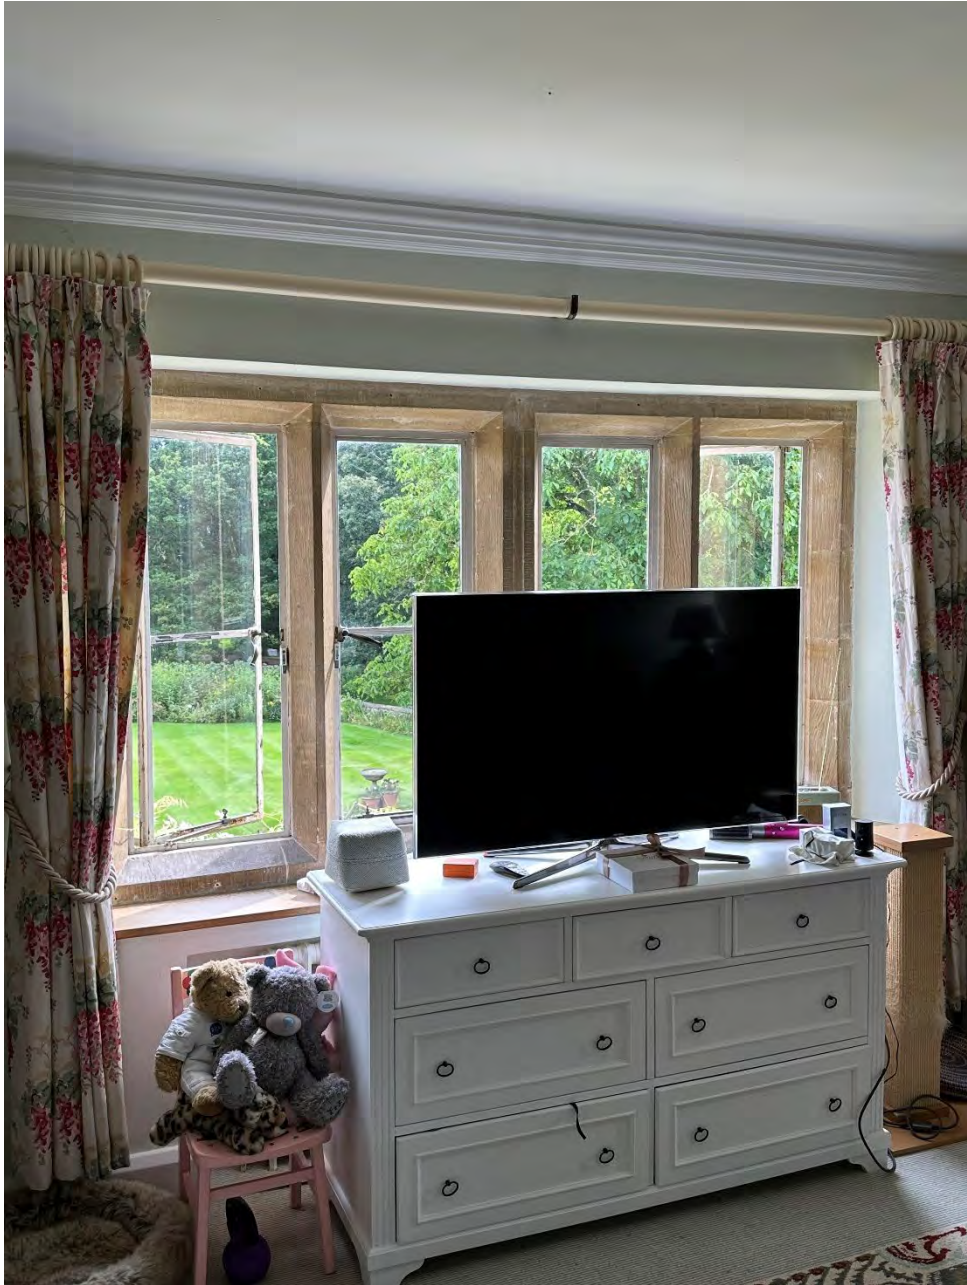
| Reference | Existing Description and Condition | Proposed Change |
|---|---|---|
| WF-11 | <p>Description – modern, single-glazed, metal casements set within stone mullions. Part of c. 1945 extension.</p> <p>Condition – signs of deteriorating paintwork, and warping and corroding metal.</p> | New replacement window (Type 3). |

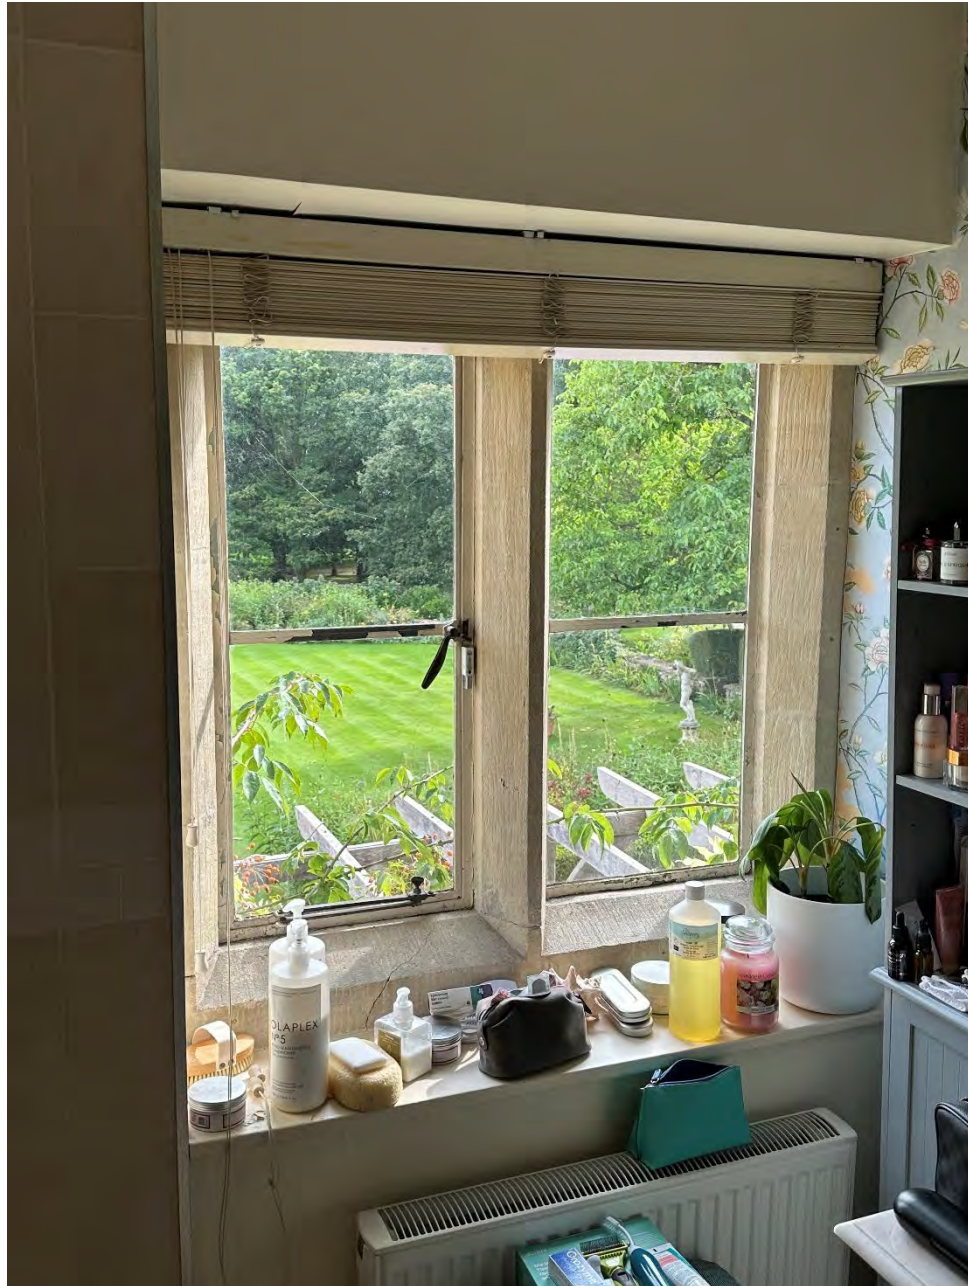
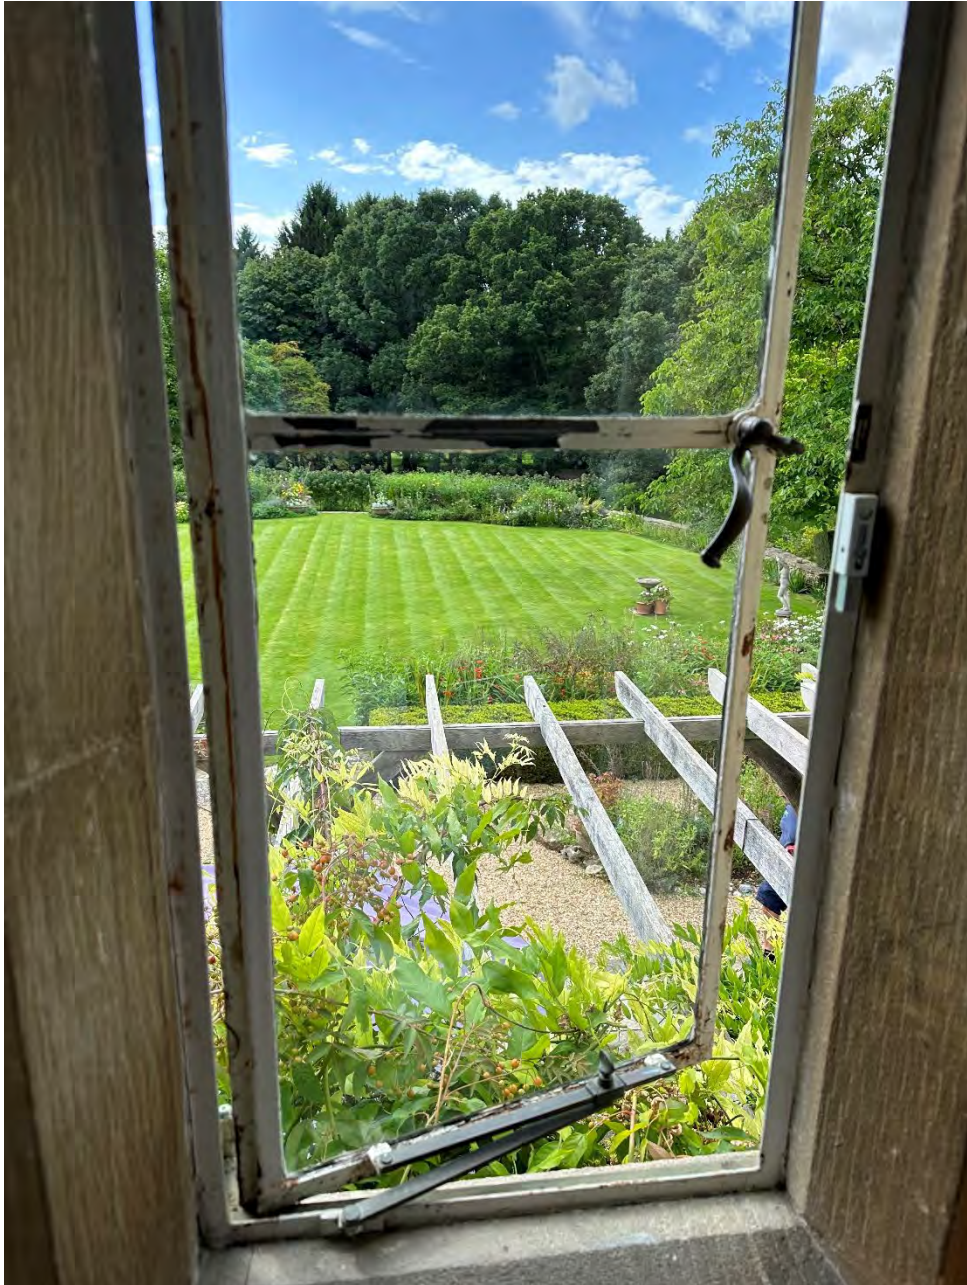
| Reference | Existing Description and Condition | Proposed Change |
|---|---|---|
| WF-12 | <p>Description – related to WF-11.</p> | New replacement window (Type 3). |

| Reference | Existing Description and Condition | Proposed Change |
|---|--|---|
| | <p>Condition – signs of deteriorating paintwork, and warping and corroding metal.</p> | |

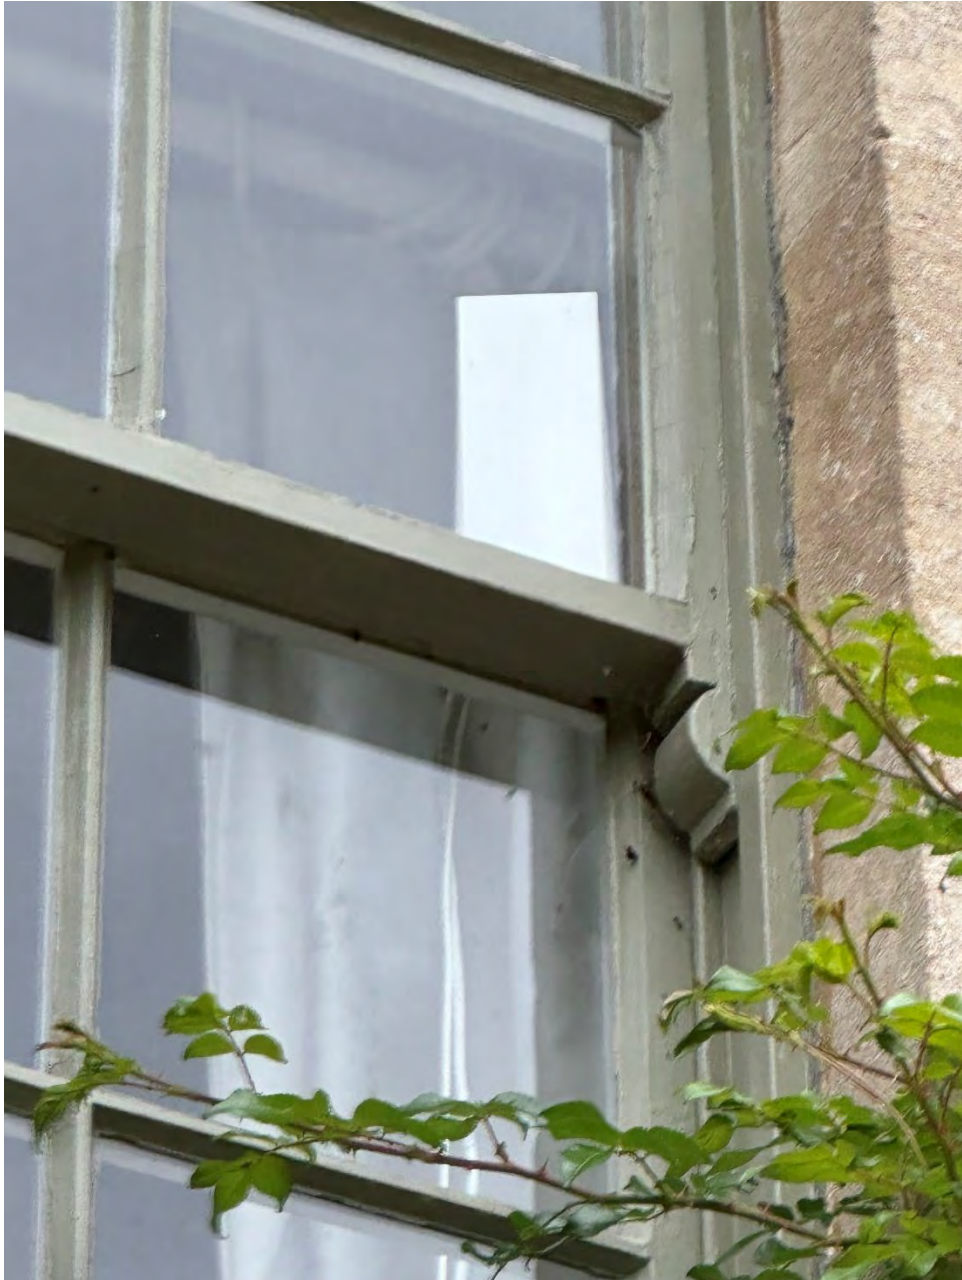
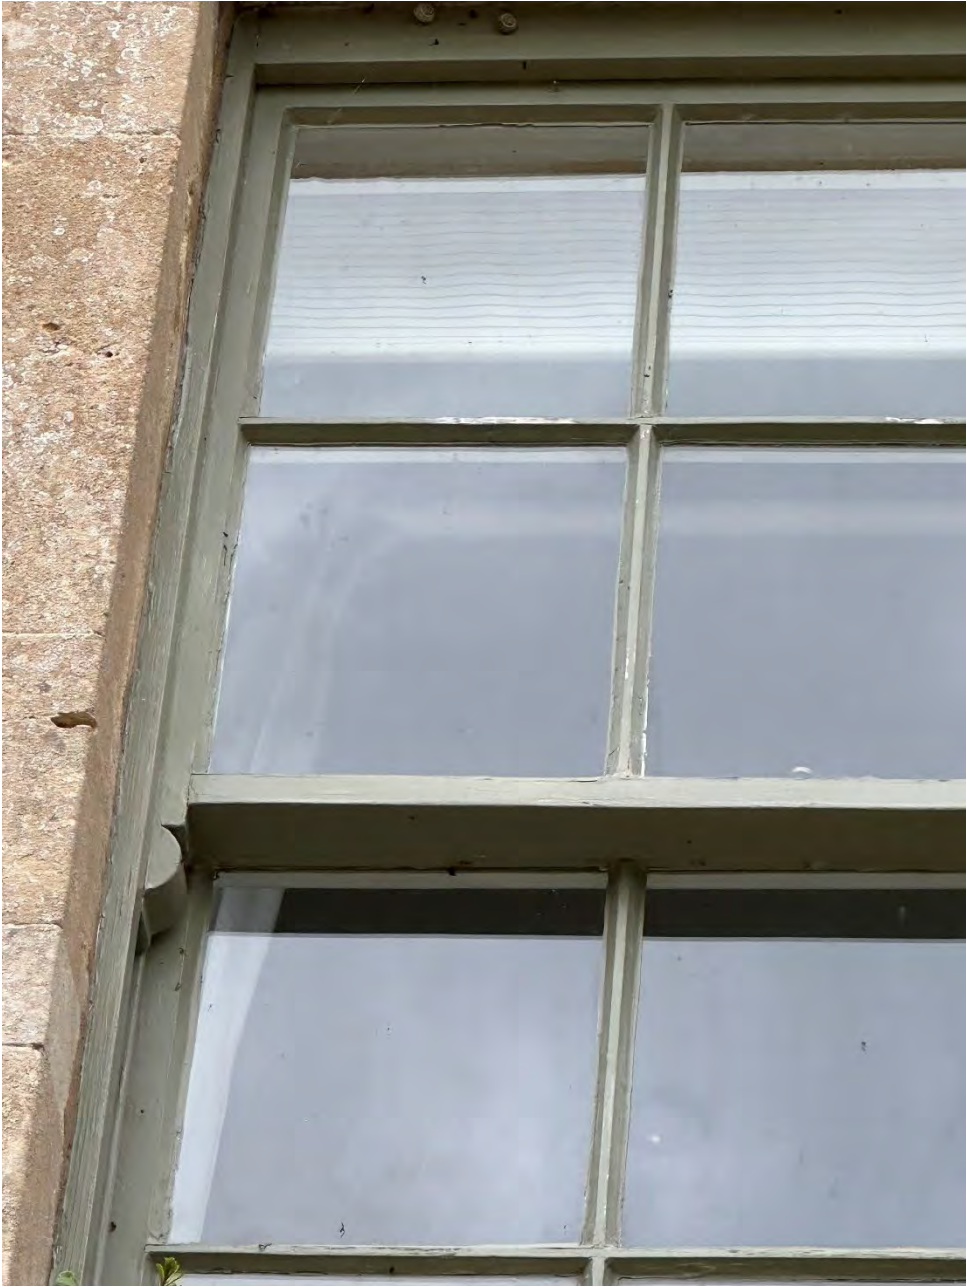
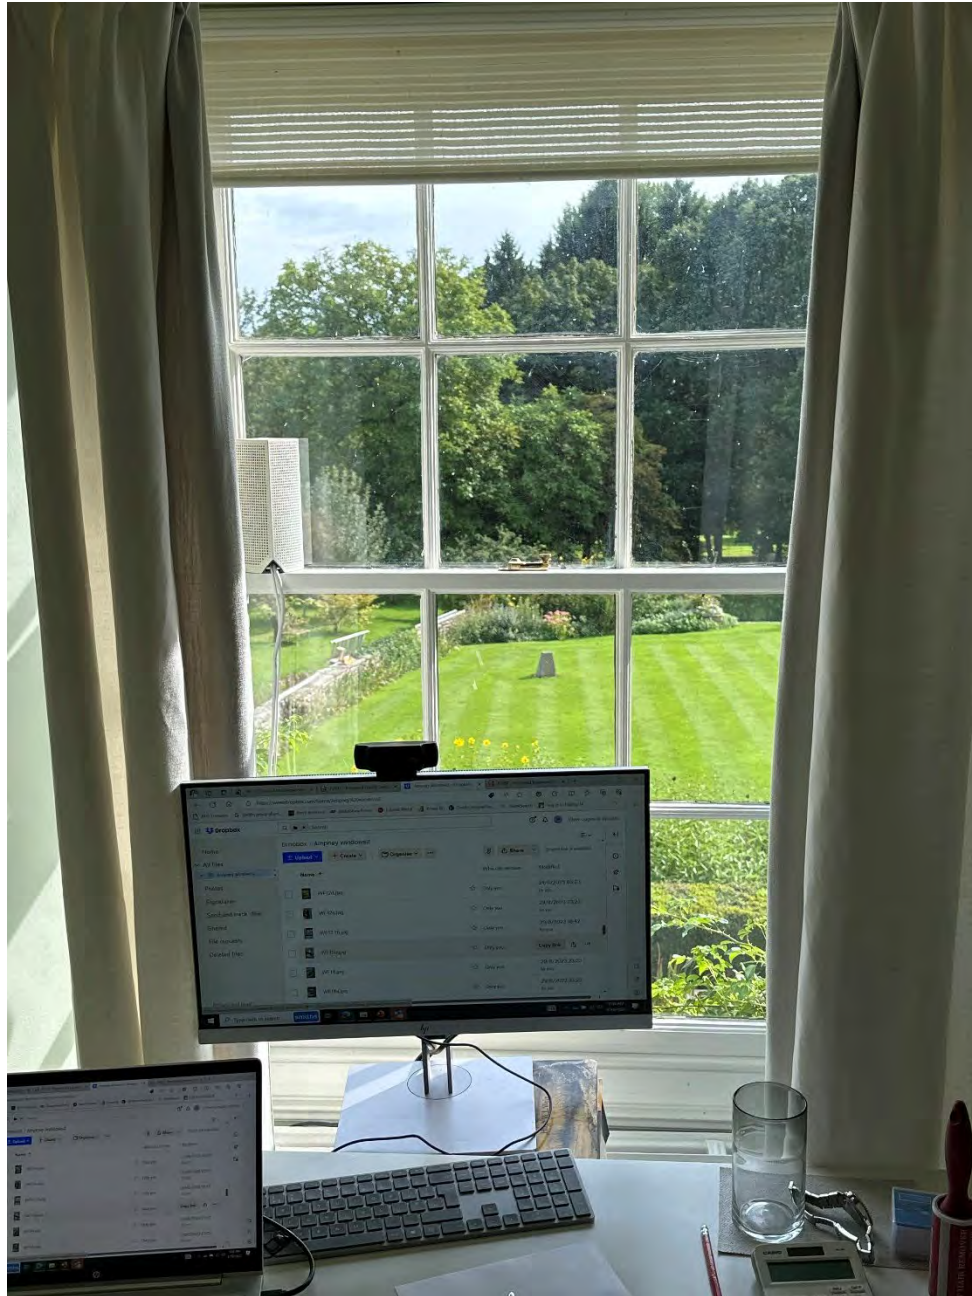
| Reference | Existing Description and Condition | Proposed Change |
|---|--|---|
| WF-13 | <p>Description – single-glazed, six-over-six sash window with horns. The profiles of the glazing bars are the same as GF-18. Modern brass fastener.</p> <p>Condition – good.</p> | New replacement window (Type 2). |
