Window and Door Schedule

Ampney Brook House, School Lane, Ampney Crucis, GL7 5RT

On behalf of Mr J. Fagge

Date: 12/10/2023 | Pegasus Ref: P22- 0597

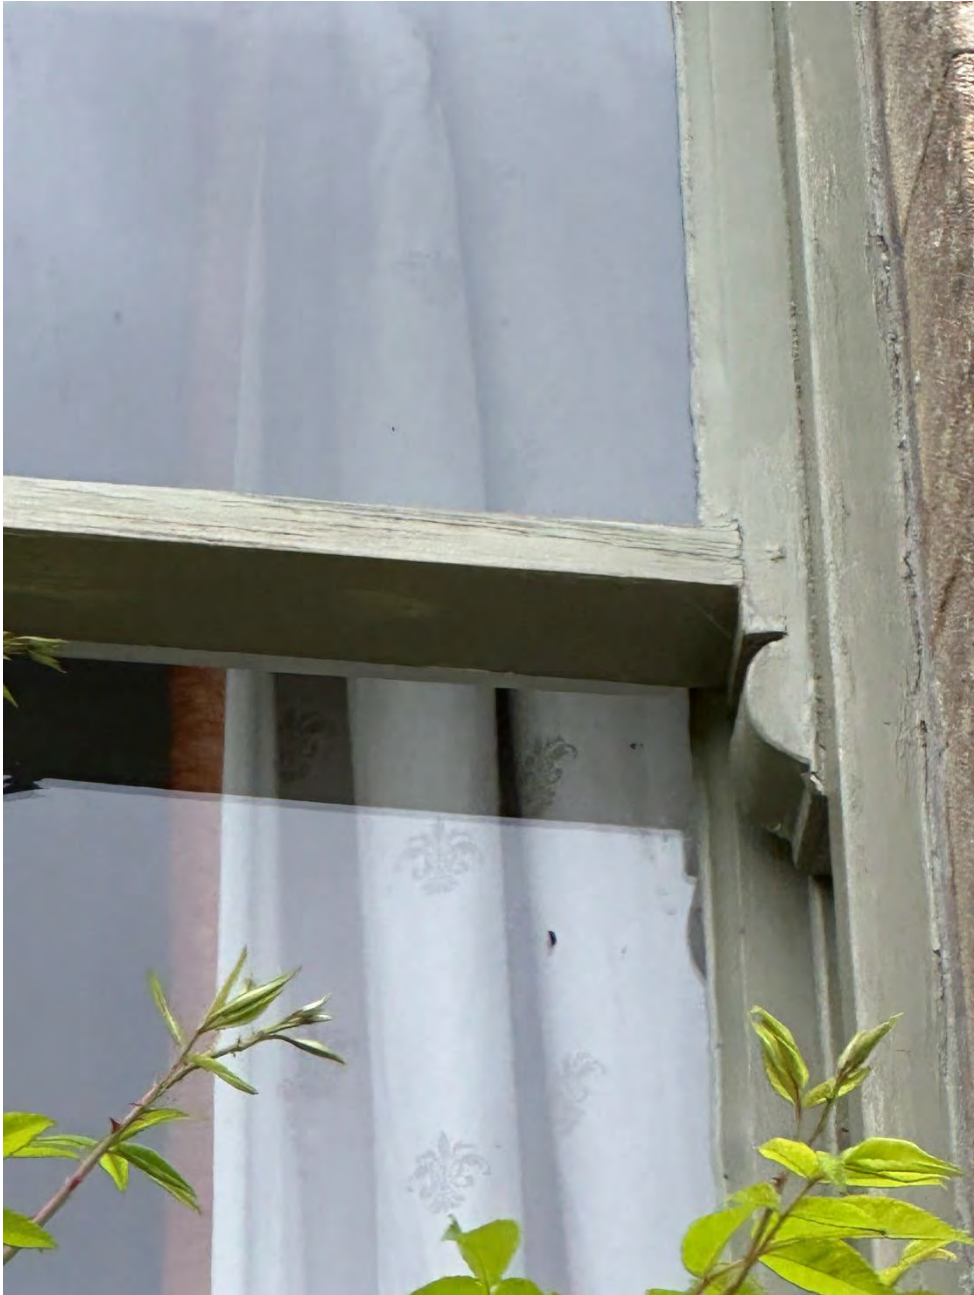
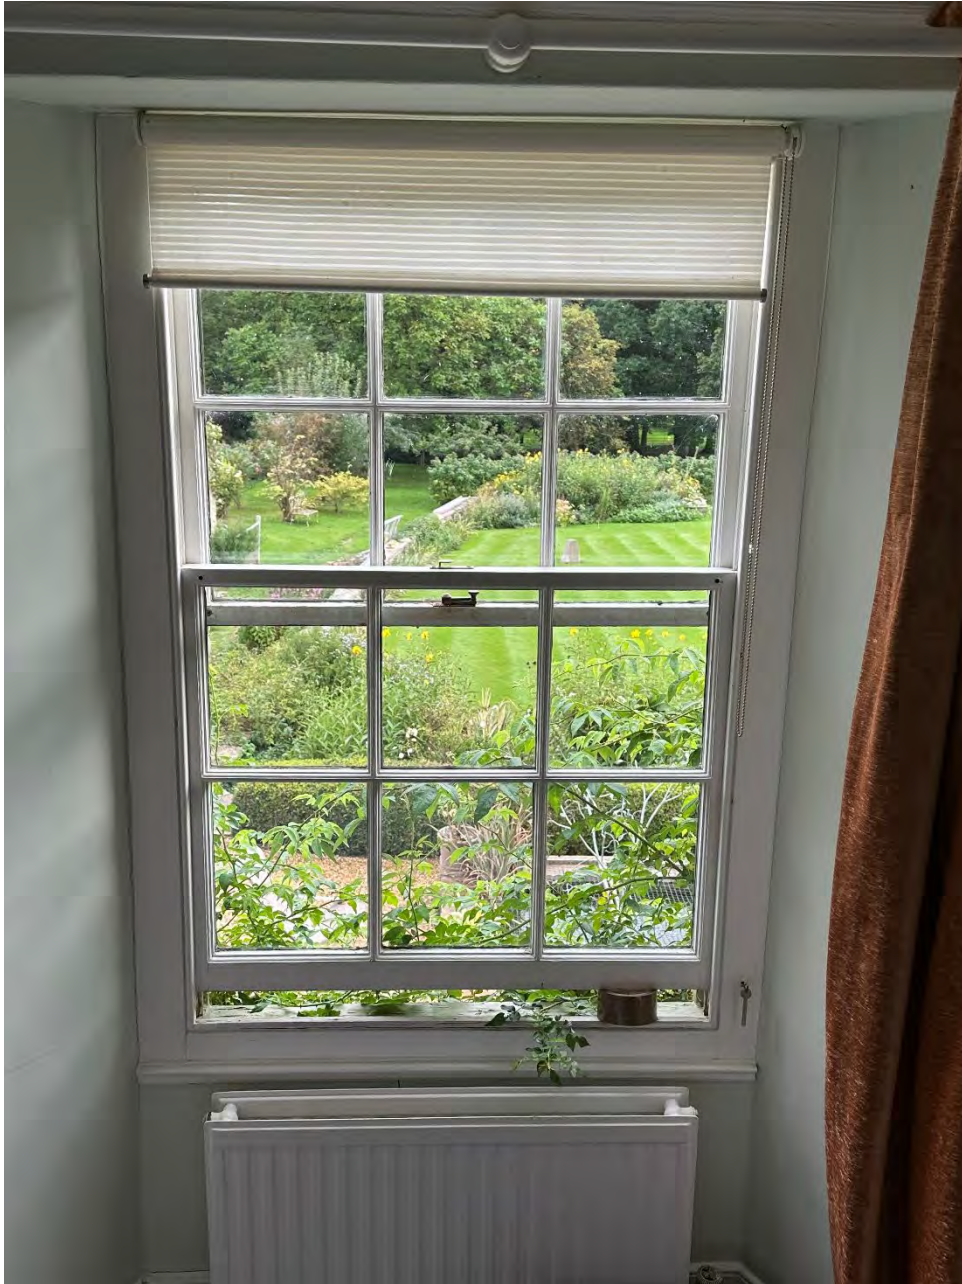
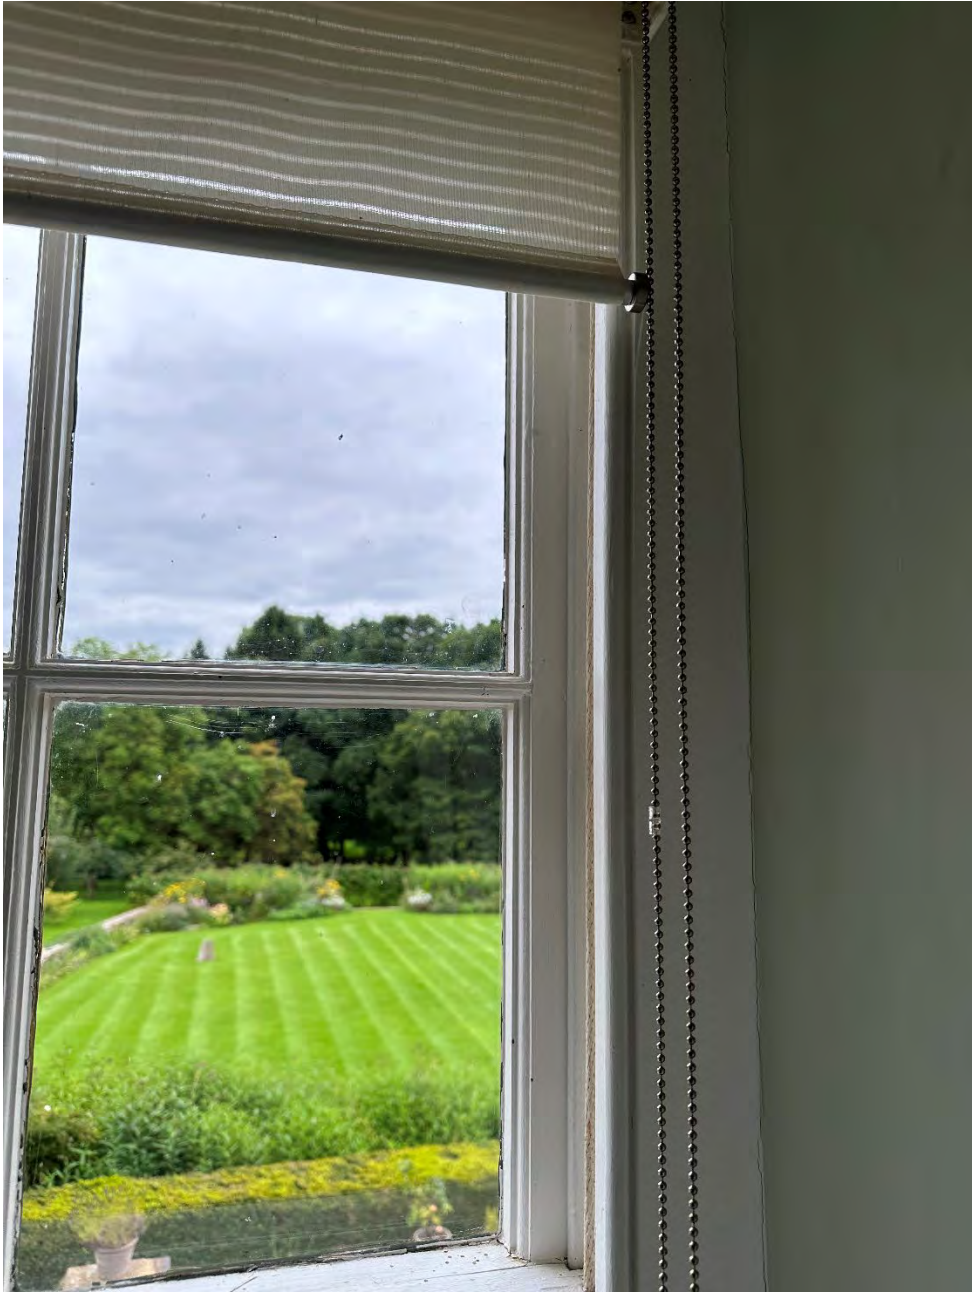
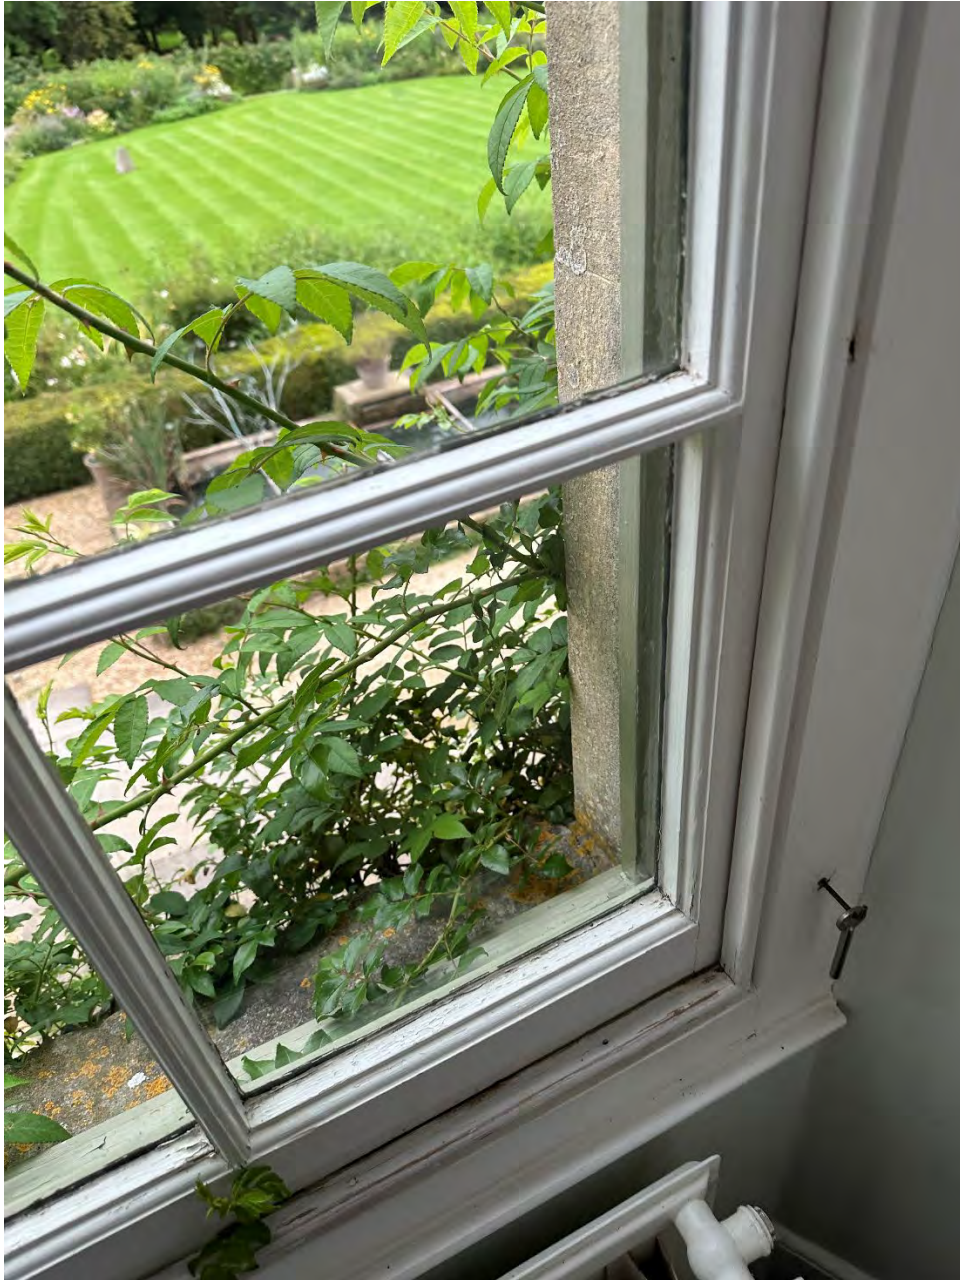
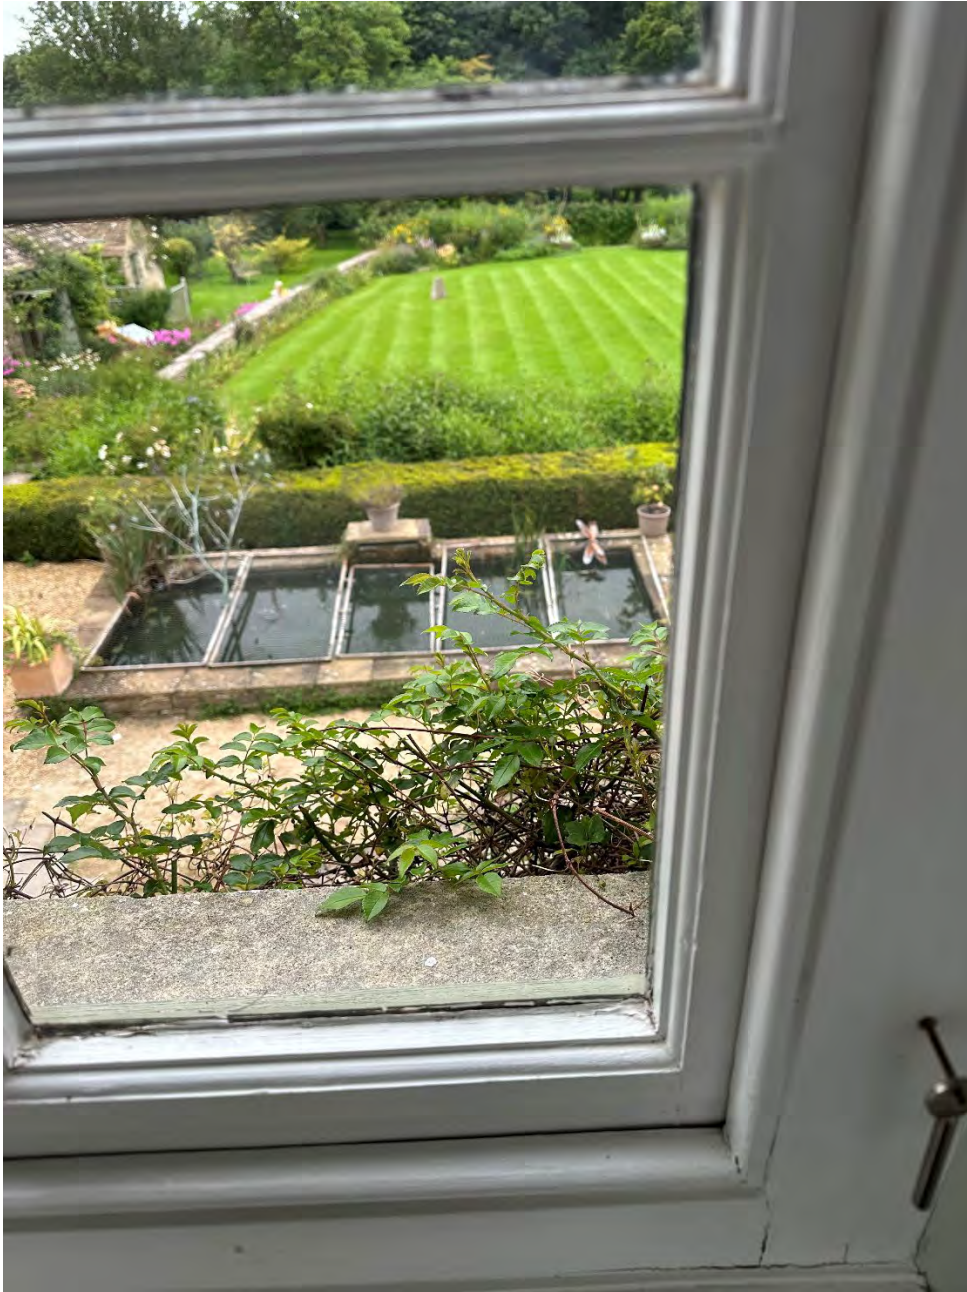
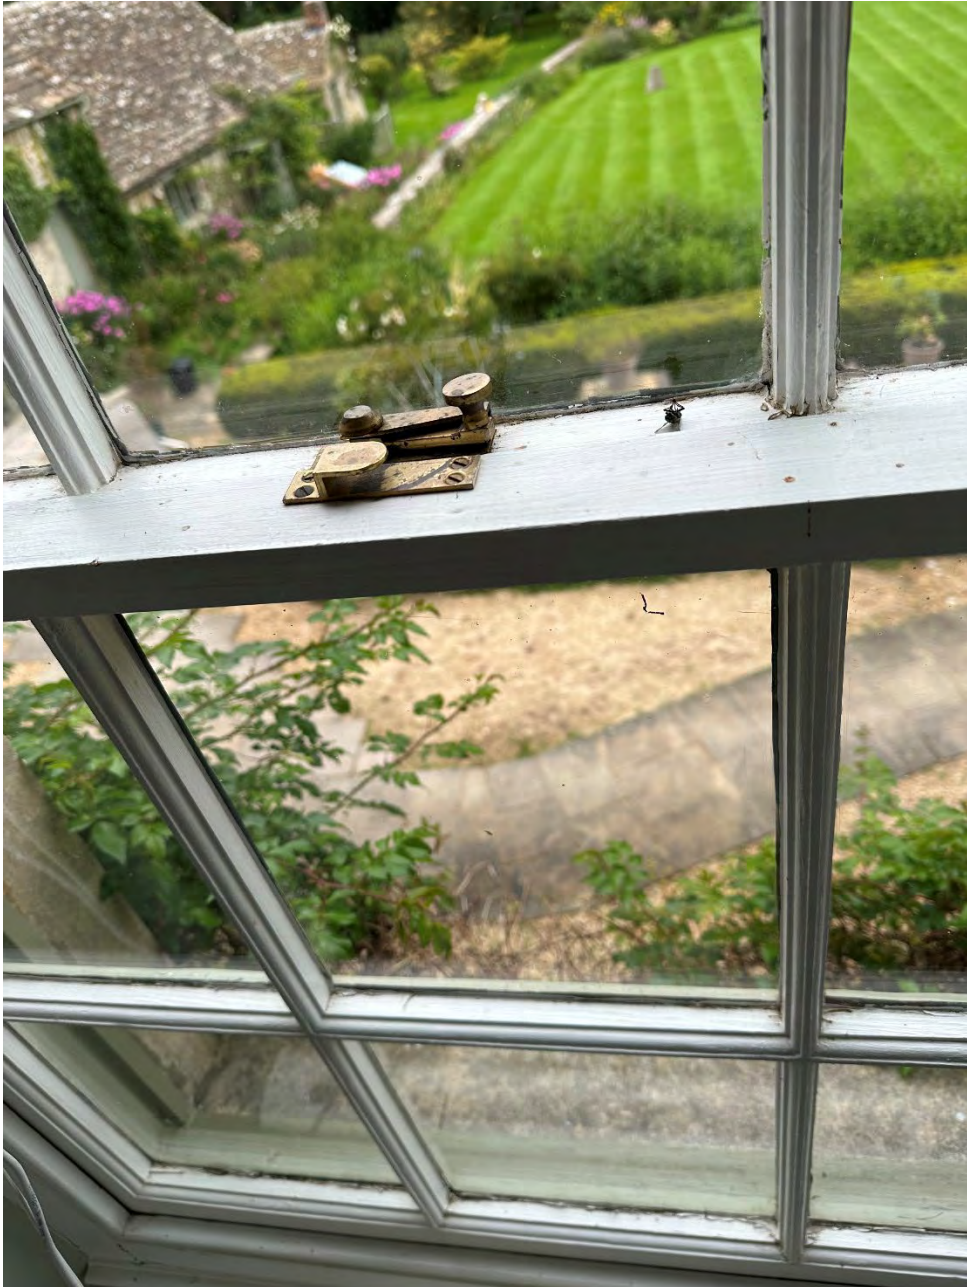
| Reference | Existing Description and Condition | Proposed Change |
|---|--|---|
| WF-14 | <p>Description – same as WF13.</p> <p>Condition – good.</p> | New replacement window (Type 2). |

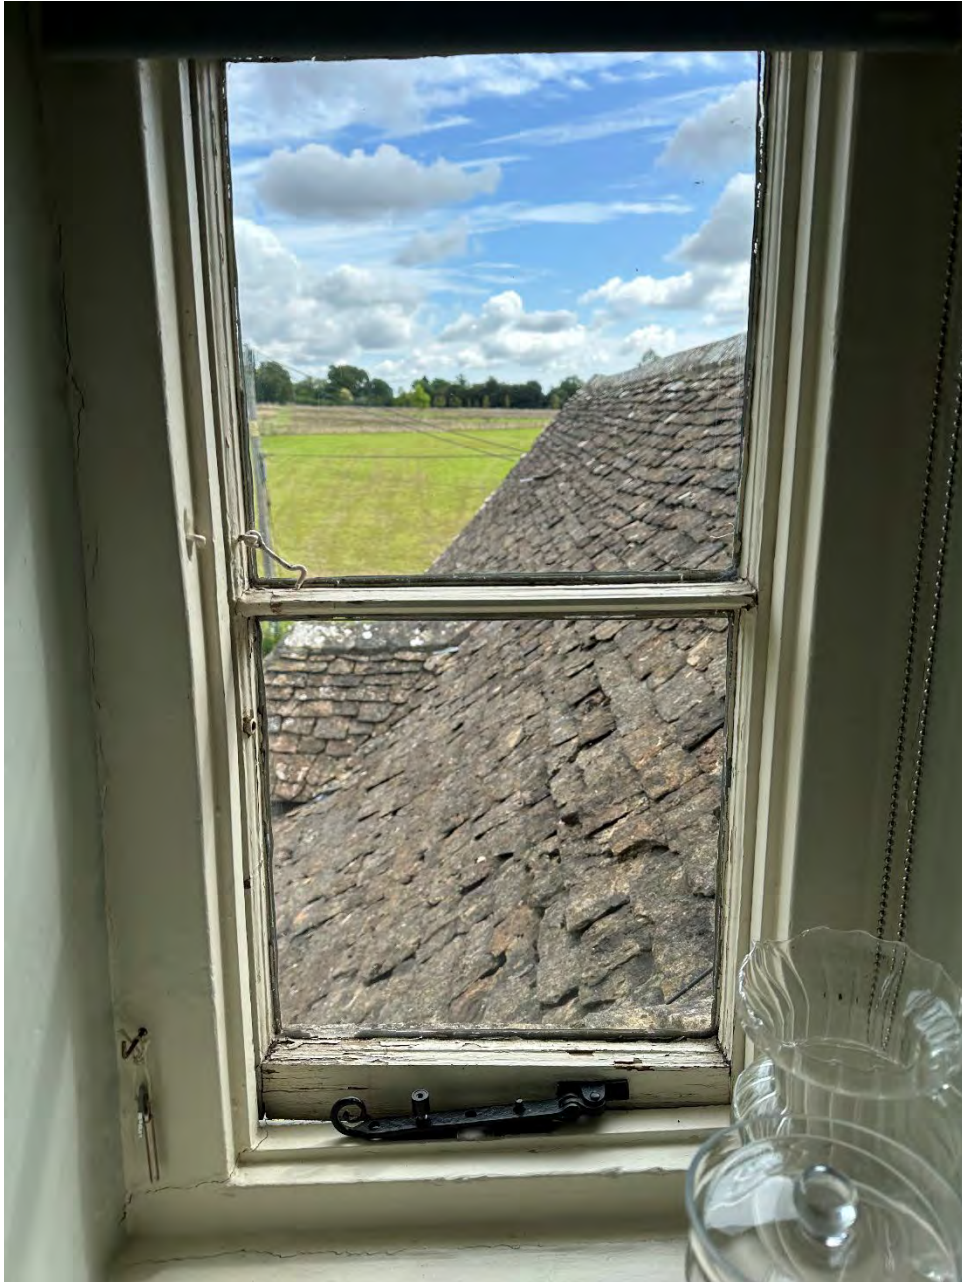
| Reference | Existing Description and Condition | Proposed Change |
|---|--|---|
| WS-01 | <p>Description – single-glazed, timber-frame casement. Modern catch and stay. Frame with stepped profile.</p> <p>Condition – signs of considerable deterioration to timber, such that the window no longer closes.</p> | New replacement window (Type 1); frame to be retained. |

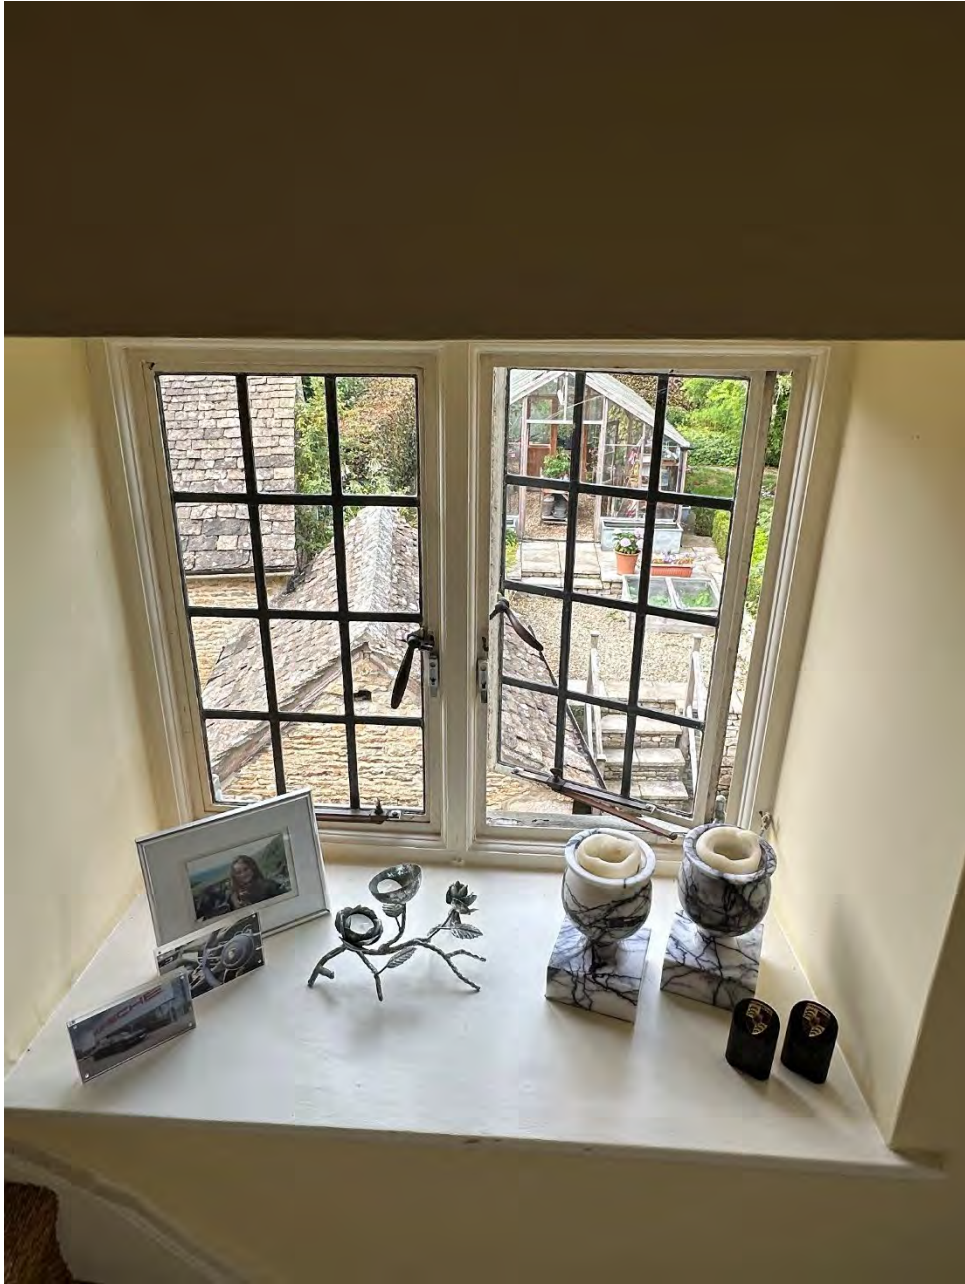
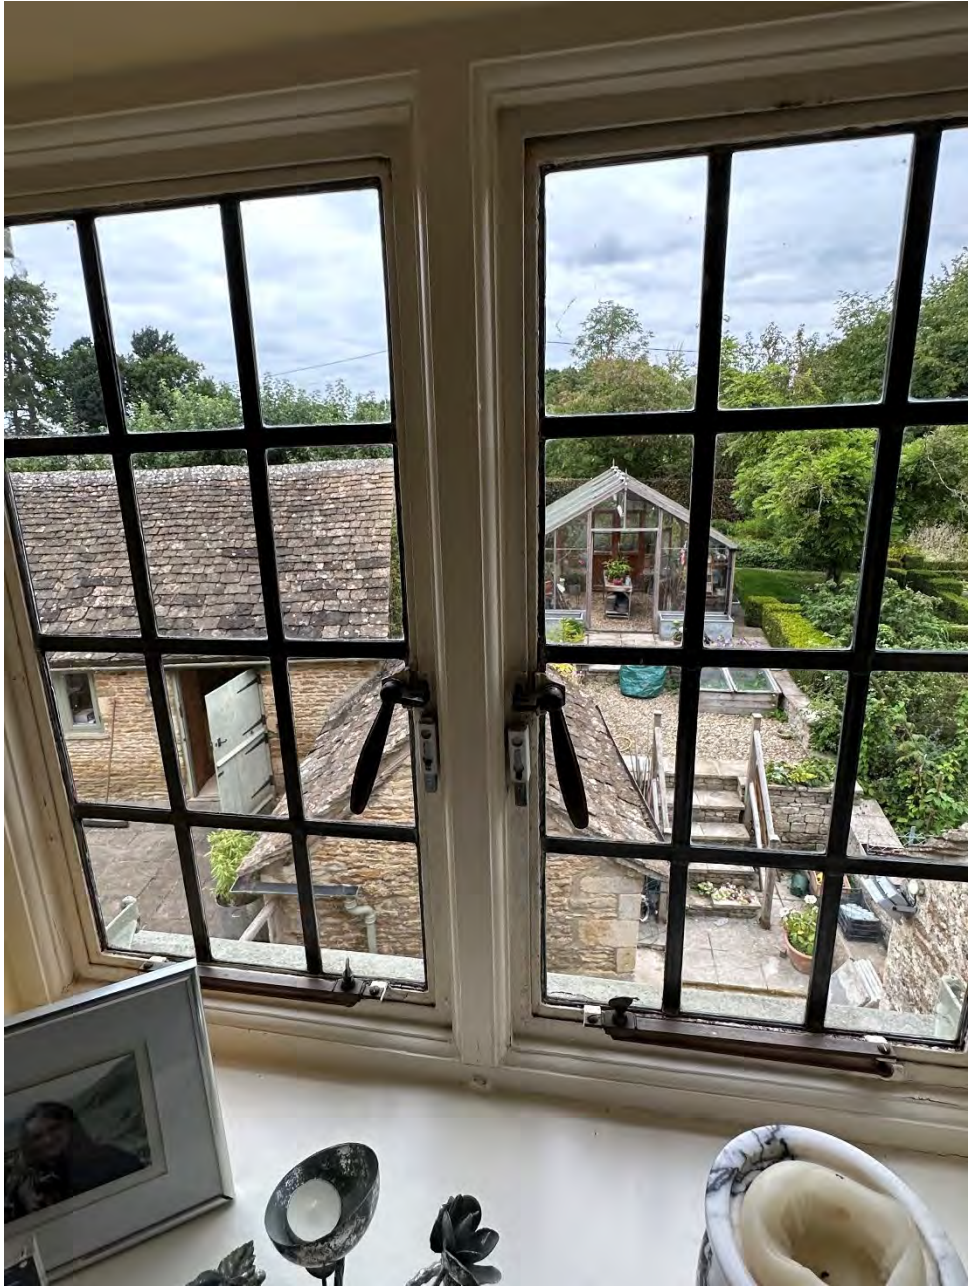
| Reference | Existing Description and Condition | Proposed Change |
|---|--|---|
| WS-02 | <p>Description – modern, single-glazed, metal casement set within timber frame (cf. WG-12).</p> <p>Condition – fair; some signs of deterioration to paintwork and metal.</p> | New replacement window (Type 1). |

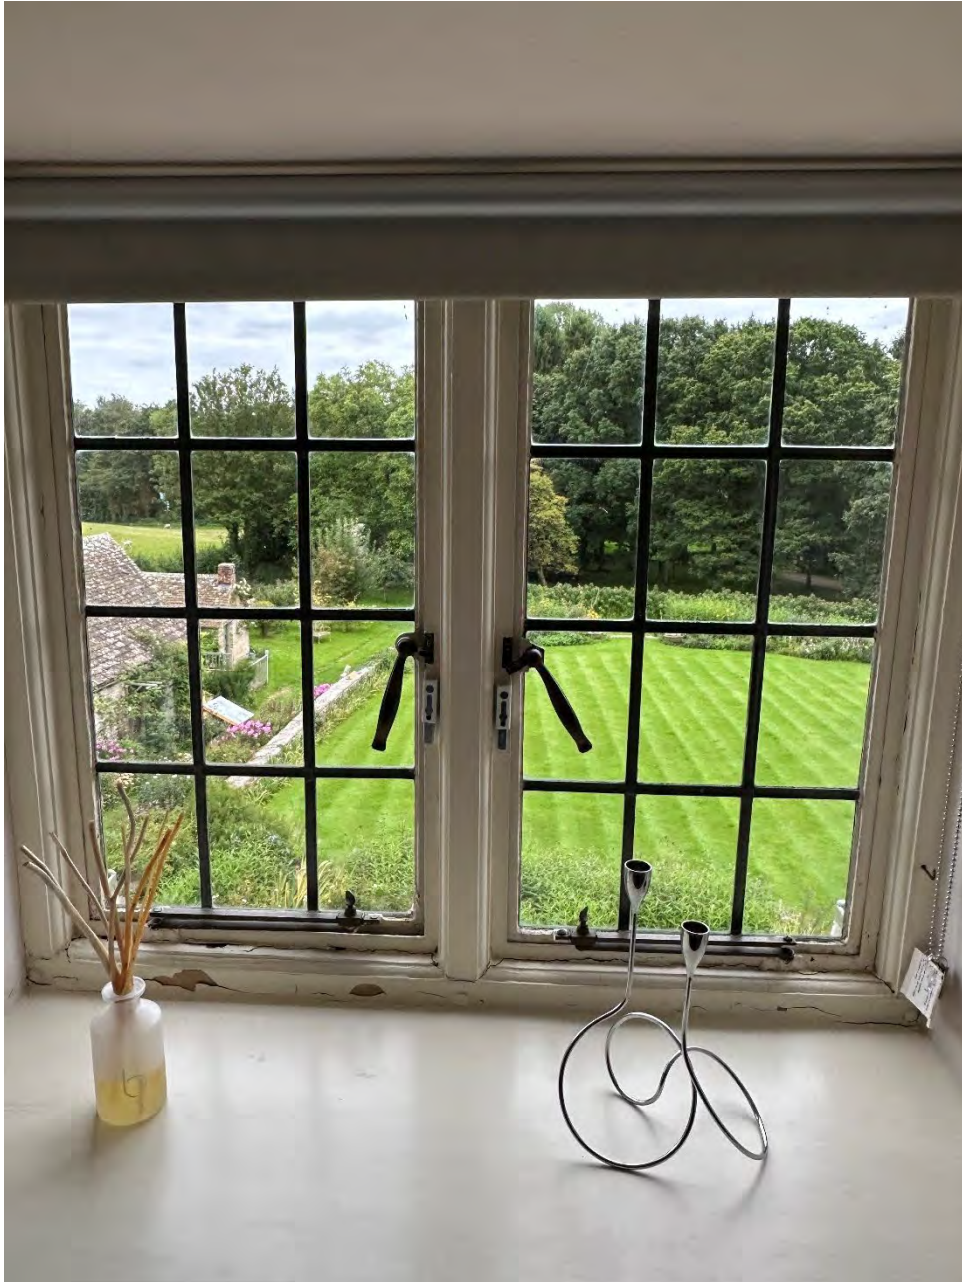
| Reference | Existing Description and Condition | Proposed Change |
|---|---|--|
| WS-06 | <p>Description – related to WS-02.</p> <p>Condition – signs of deterioration to metalwork.</p> | New replacement window (Type 1). |

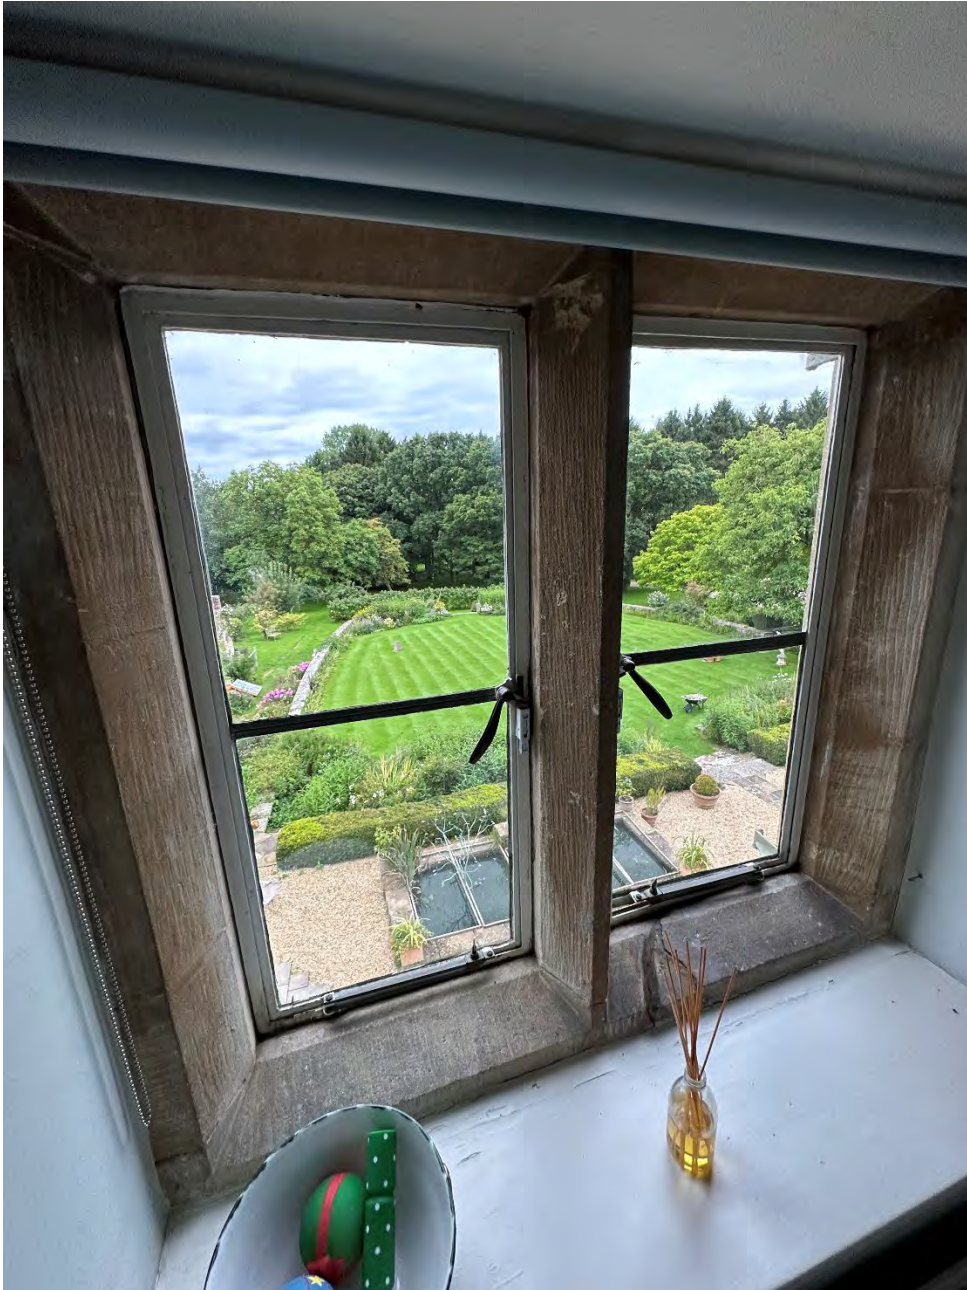
| Reference | Existing Description and Condition | Proposed Change |
|---|---|--|
| WS-07 | <p>Description – modern, single-glazed, metal casements set within stone surround and mullion (related to WF-11 & WF-12).</p> <p>Condition – modern, single-glazed, metal casement.</p> | New replacement window (Type 3). |

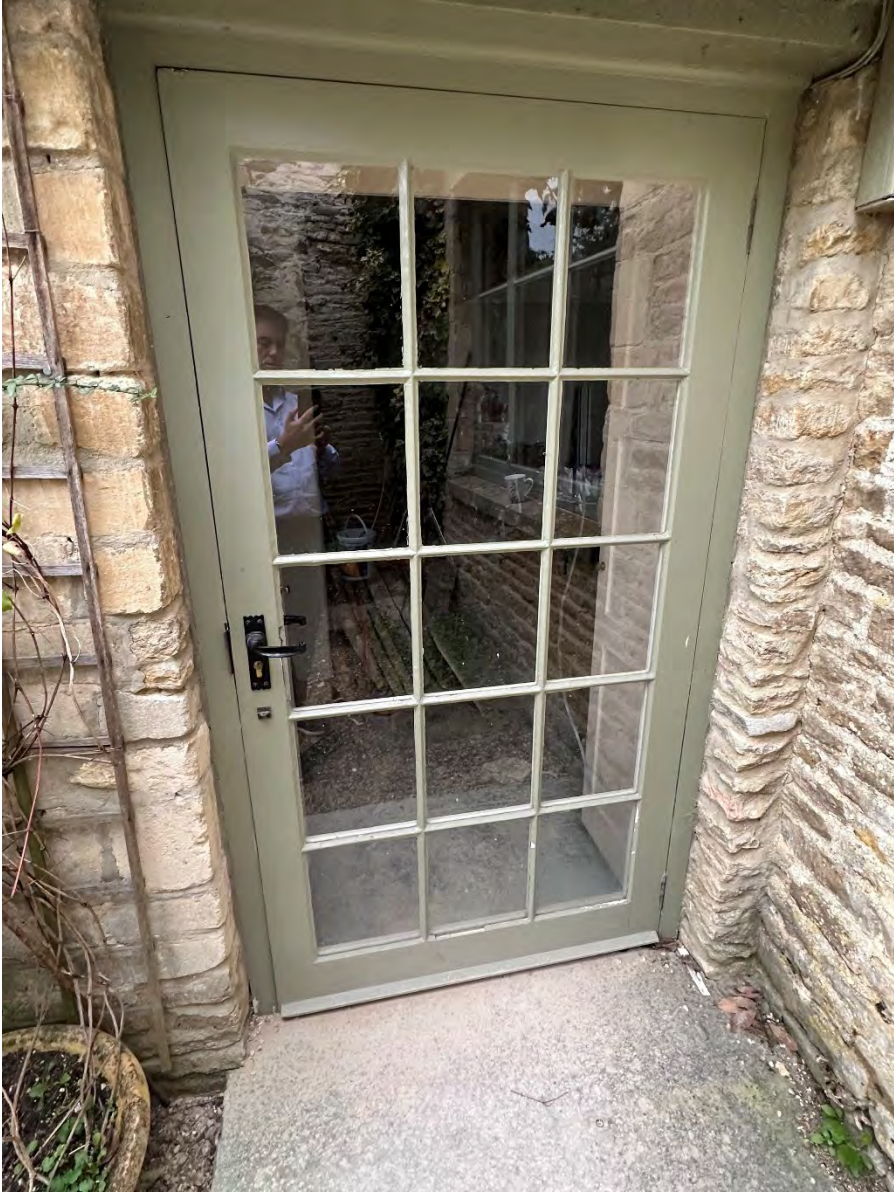
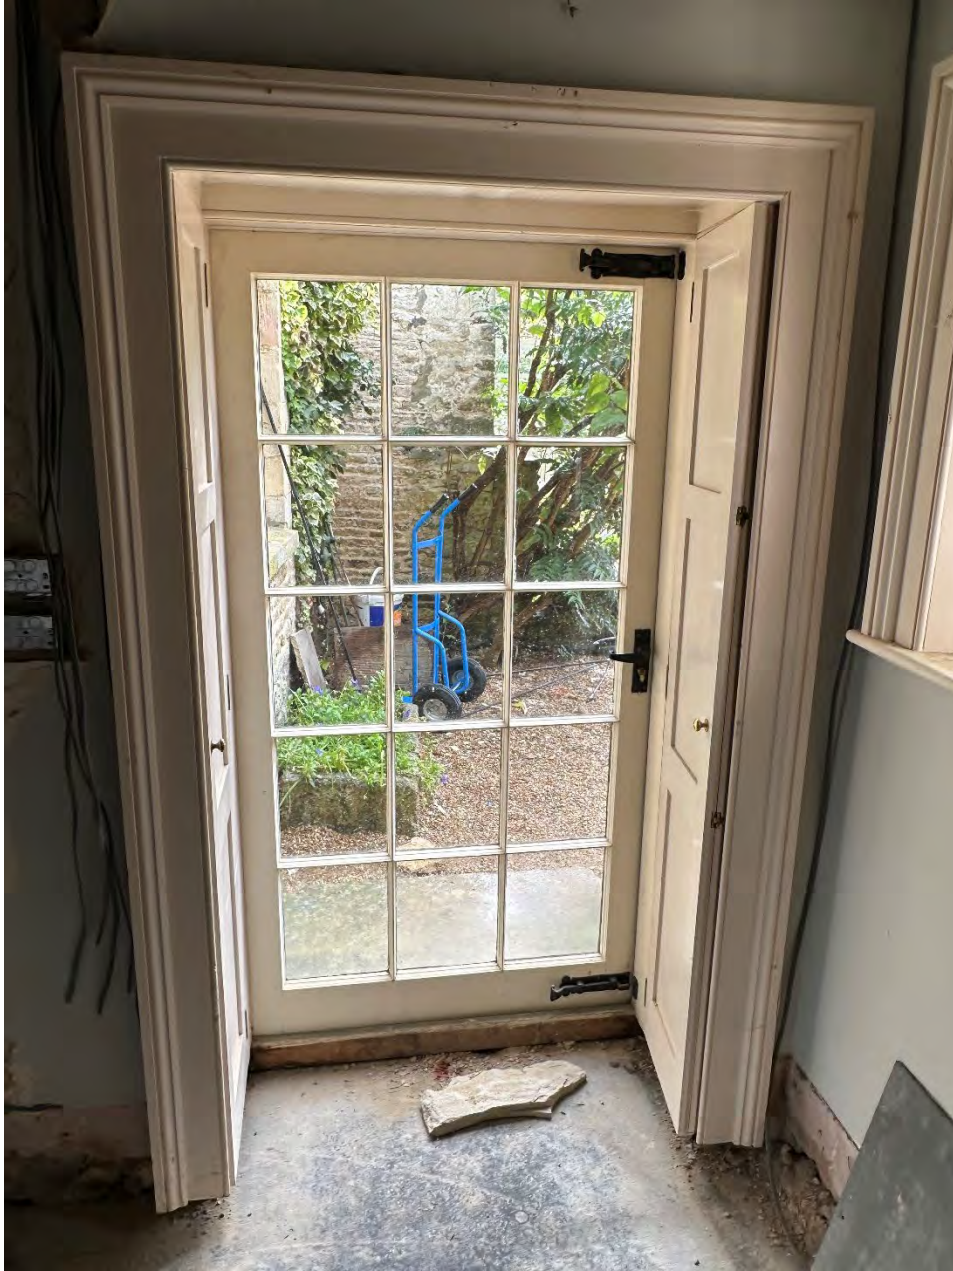
| Reference | Existing Description and Condition | Proposed Change |
|---|---|--|
| EX-DG-01 | <p>Description – modern, timber, 15-pane, glazed door. The current unit was inserted after 1988 to replace a previous door, as evidenced by a photograph taken as part of planning application CT.LBC586.</p> <p>Condition – good.</p> | New replacement door (External Door Type 1). |

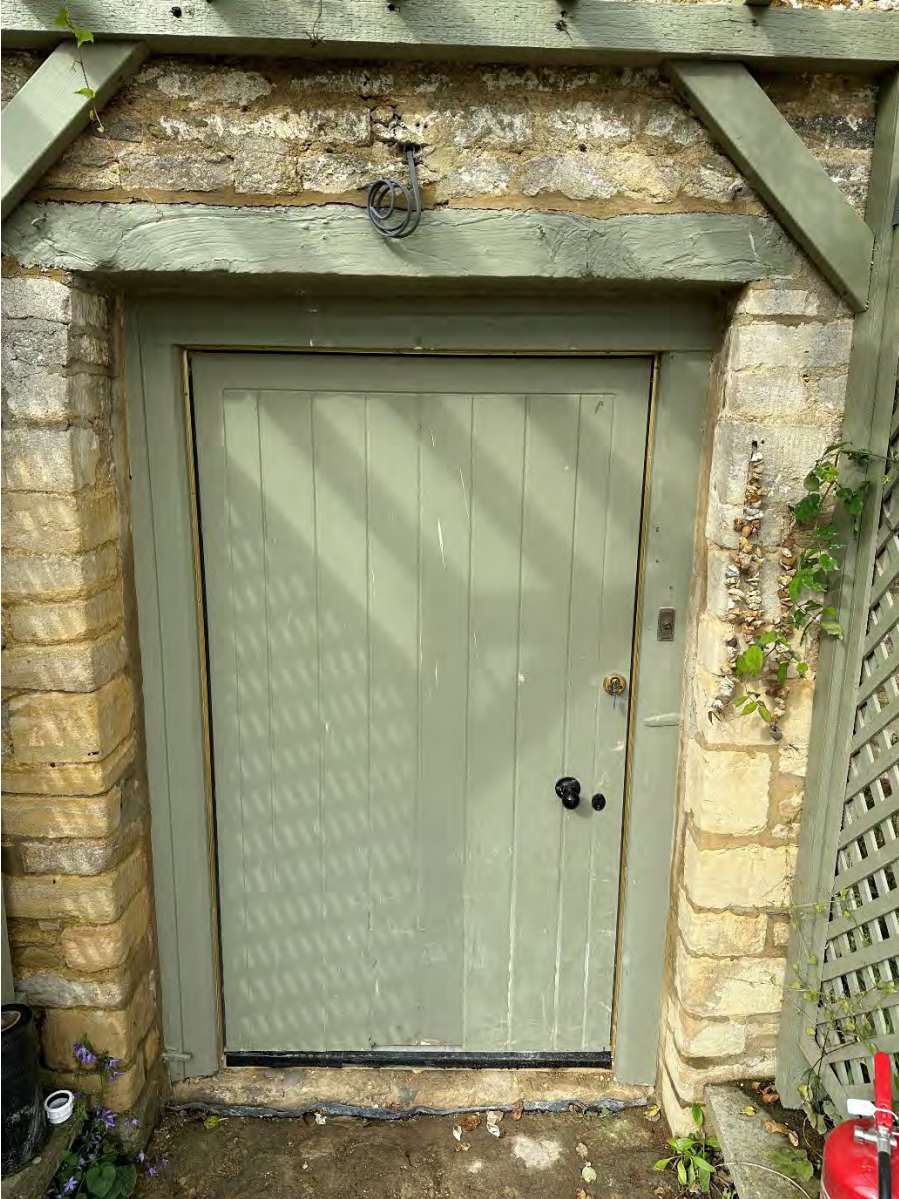
| Reference | Existing Description and Condition | Proposed Change |
|---|---|--|
| EX-DG-02 | <p>Description – ledged and braced timber plank door with modern door furniture.</p> <p>Condition – some signs of damage to timber and patch repairs.</p> | New replacement door (External Door Type 1). |

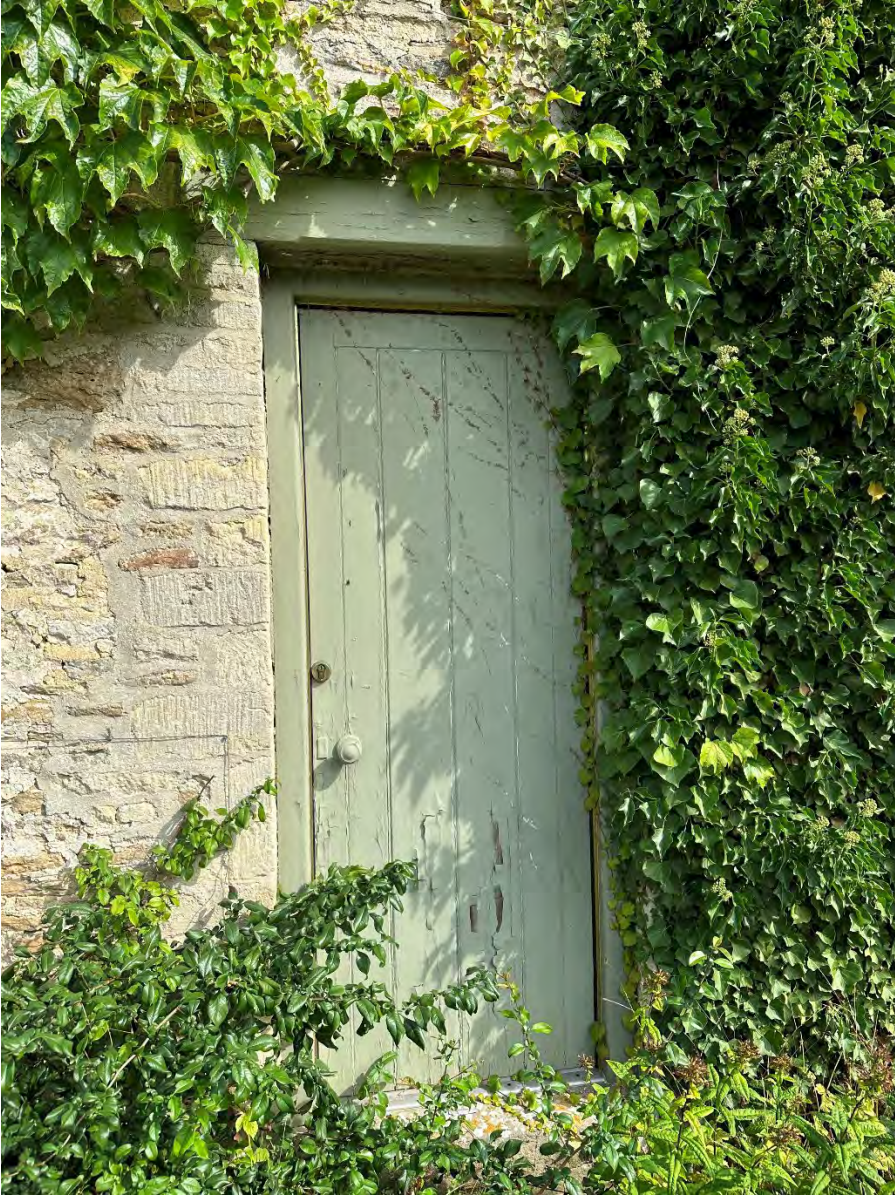
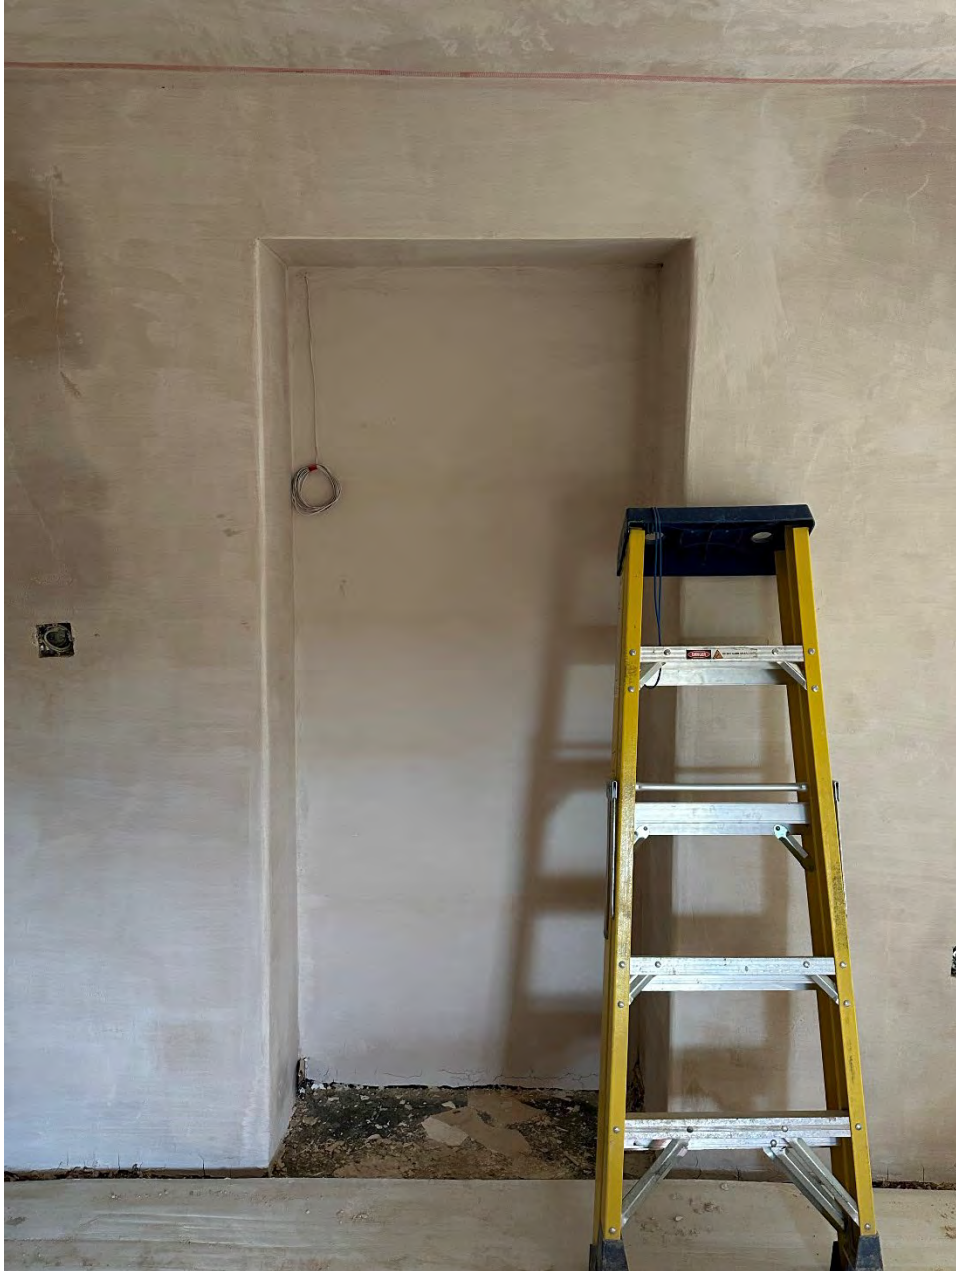
| Reference | Existing Description and Condition | Proposed Change |
|---|---|--|
| EX-DG-03 | <p>Description – plank door with modern door furniture, apparently of the same type as EX-DG-02. Internal face has been blocked and plastered over.</p> <p>Condition – visible deterioration of paintwork and possible deterioration of timber.</p> | New replacement door (External Door Type 1). |

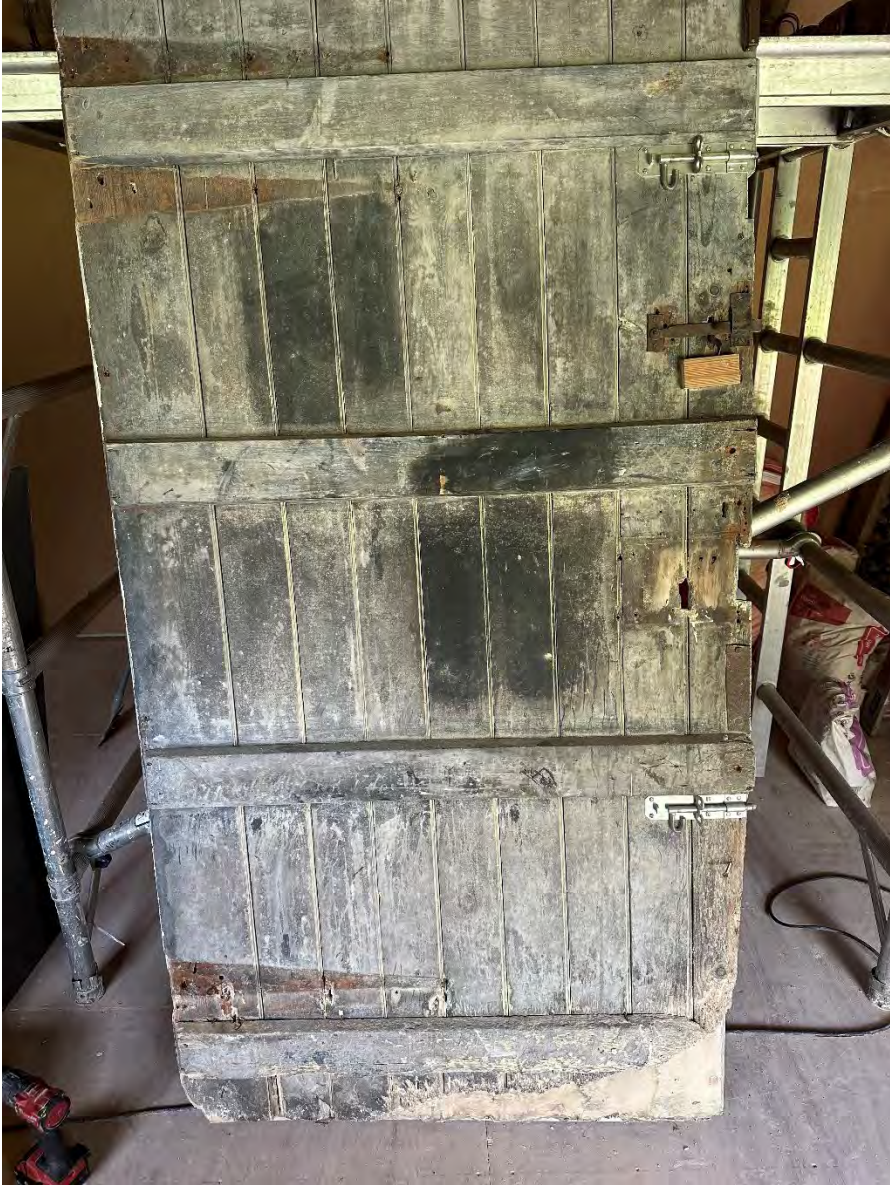
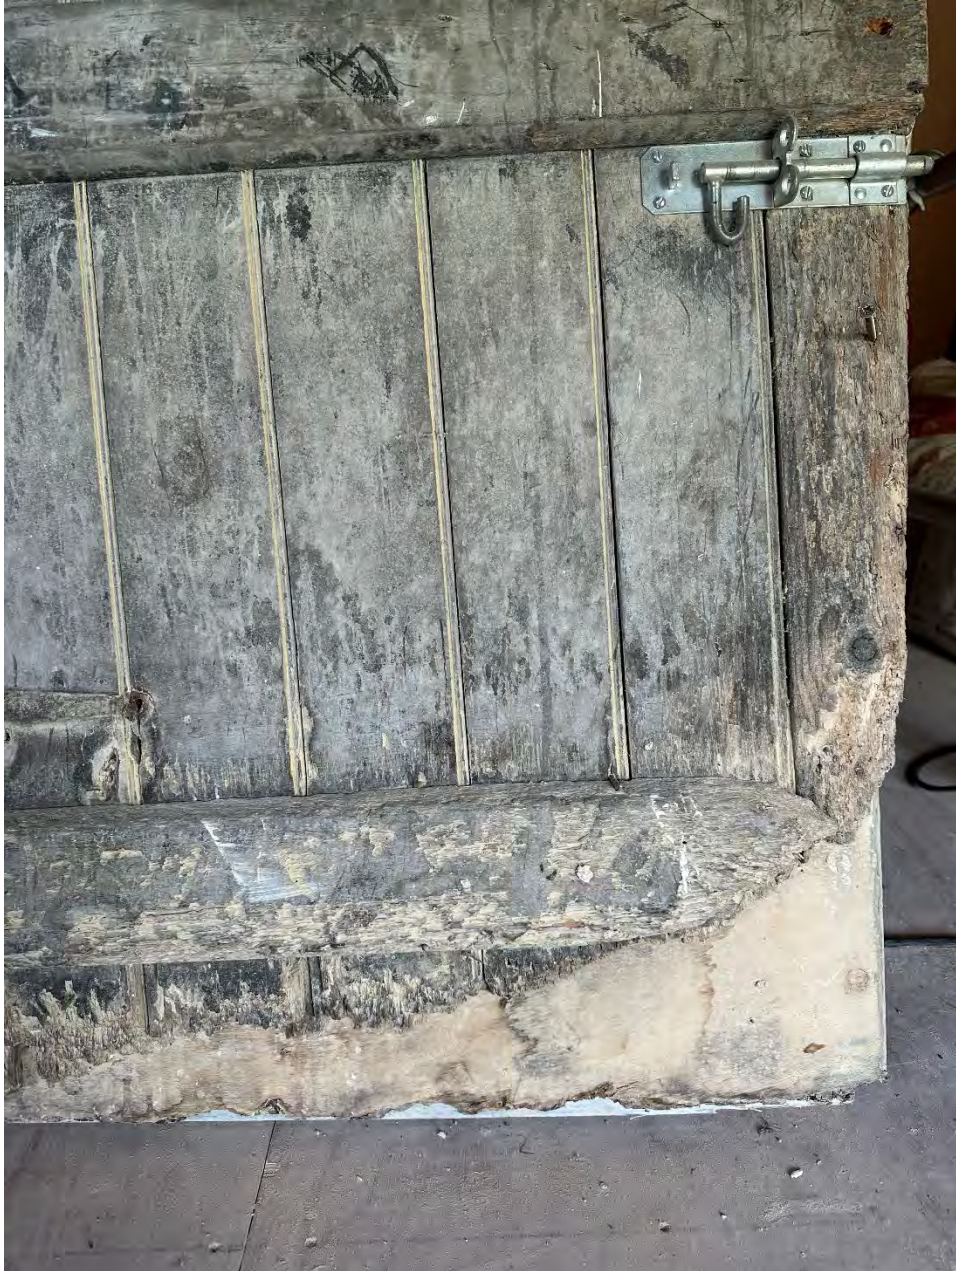
| Reference | Existing Description and Condition | Proposed Change |
|---|---|--|
| EX-DG-04 | <p>Description – ledged timber plank door with round end iron strap hinges and a simple iron latch. This door furniture is suggestive of a late 19th century date. Modern door furniture is also in evidence. The door has been taken off its hinges and stored for protection.</p> <p>Condition – very poor; sections of timber have broken or rotted away and there is evidence of later repair.</p> | New replacement door (External Door Type 1). |
