Window and Door Schedule

Ampney Brook House, School Lane, Ampney Crucis, GL7 5RT

On behalf of Mr J. Fagge

Date: 12/10/2023 | Pegasus Ref: P22- 0597

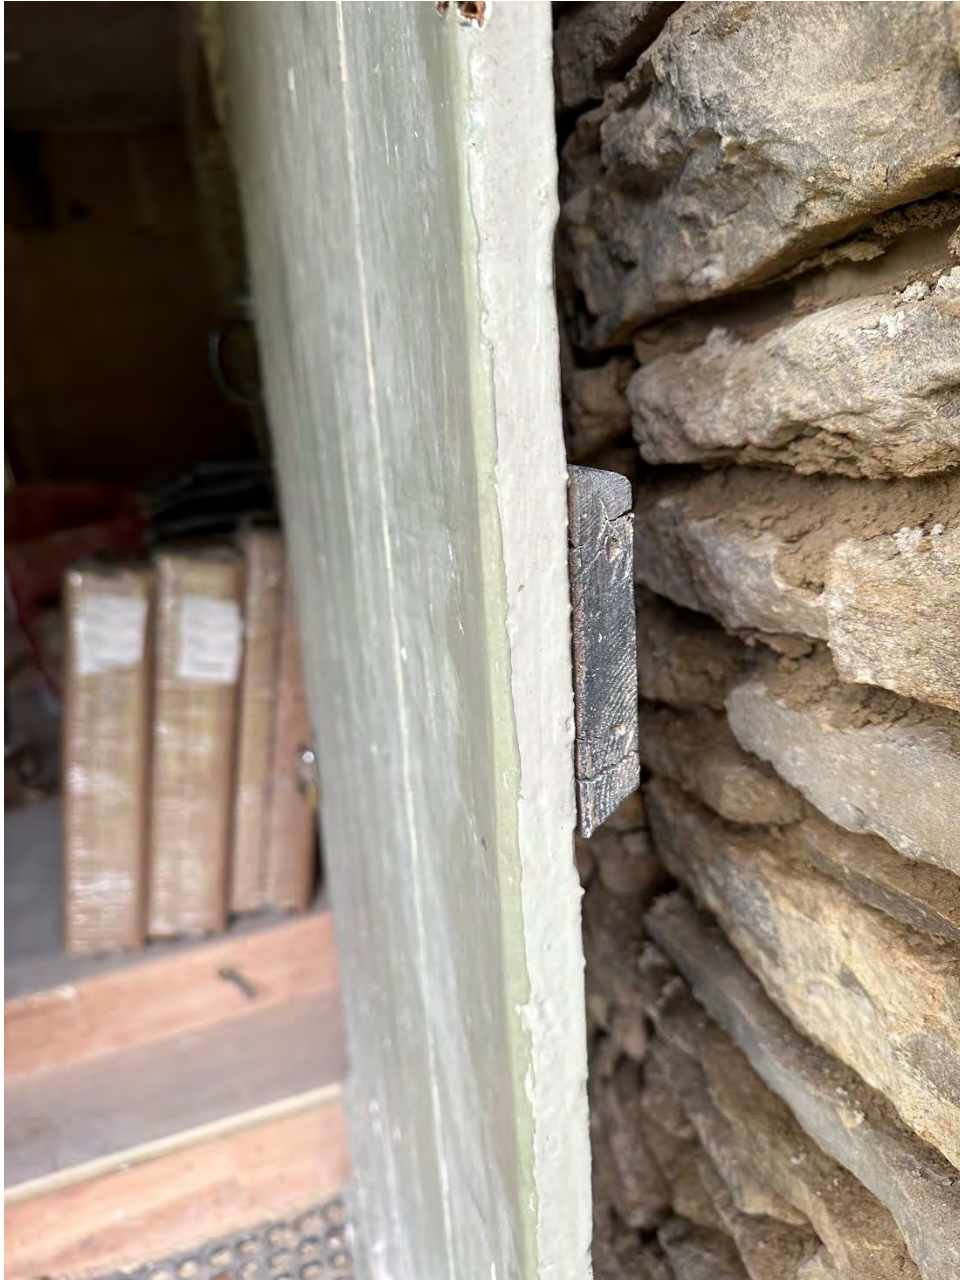
| Reference | Existing Description and Condition | Proposed Change |
|---|---|--|
| EX-DG-04 | <p>Description – ledged timber plank door with round end iron strap hinges and a simple iron latch. This door furniture is suggestive of a late 19th century date. Modern door furniture is also in evidence. The door has been taken off its hinges and stored for protection.</p> <p>Condition – very poor; sections of timber have broken or rotted away and there is evidence of later repair.</p> | New replacement door (External Door Type 1). |

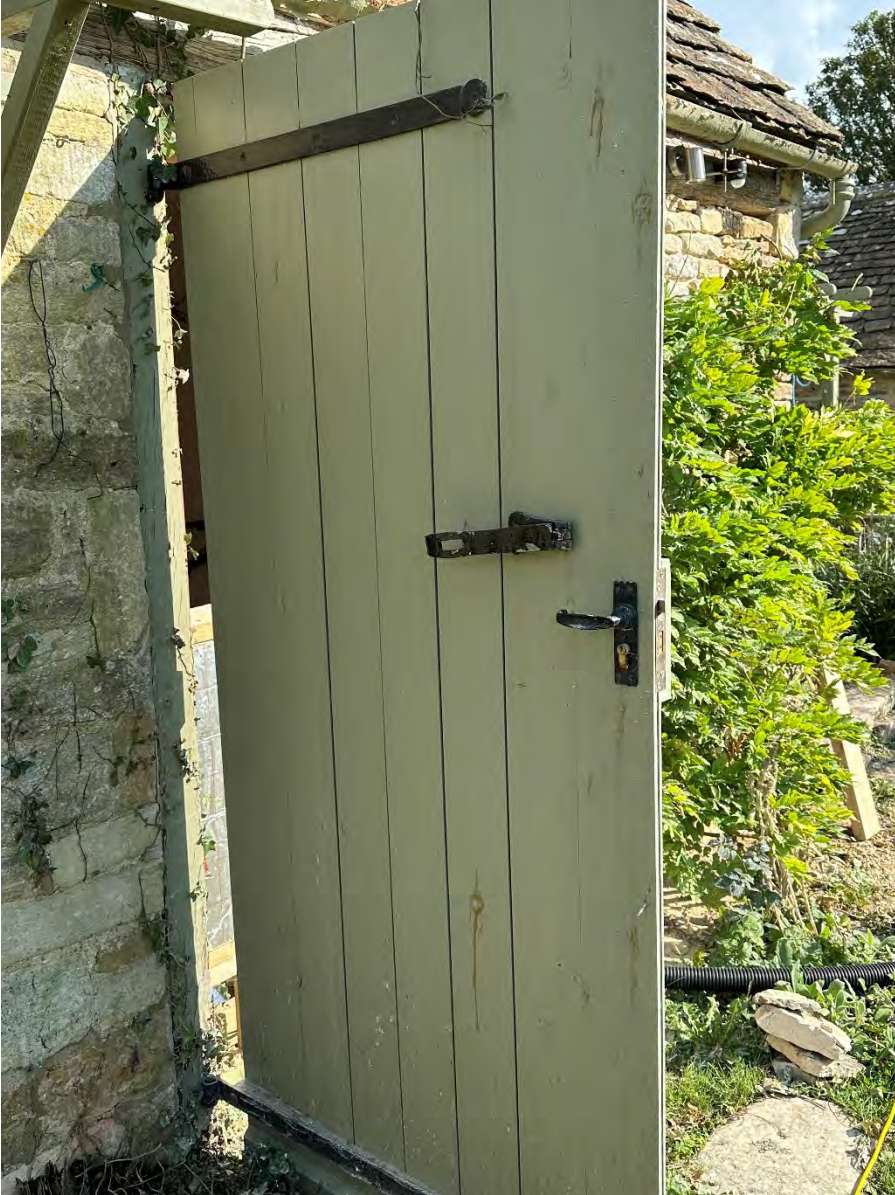
| Reference | Existing Description and Condition | Proposed Change |
|---|---|--|
| EX-DG-05 | <p>Description – modern braced and ledged plan door. All door furniture is modern, including round end iron strap hinges.</p> <p>Condition – good; minor signs of damage.</p> | Consent already granted for new replacement door (LPA ref. 23/O1537/COMPLY). |

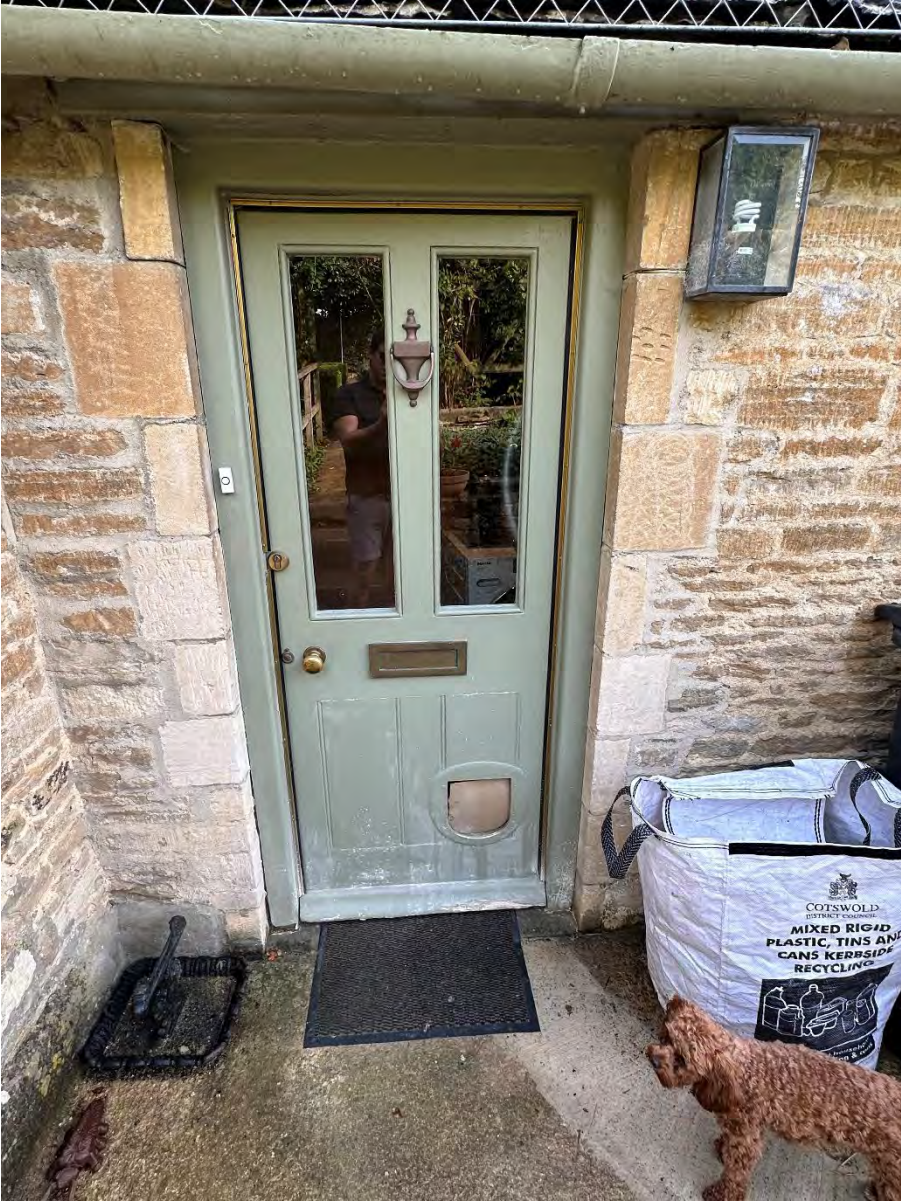
| Reference | Existing Description and Condition | Proposed Change |
|---|---|--|
| EX-DG-06 | <p>Description – modern, part-glazed door. All door furniture modern.</p> <p>Condition – good; minor signs of damage.</p> | New replacement door (External Door Type 1). |

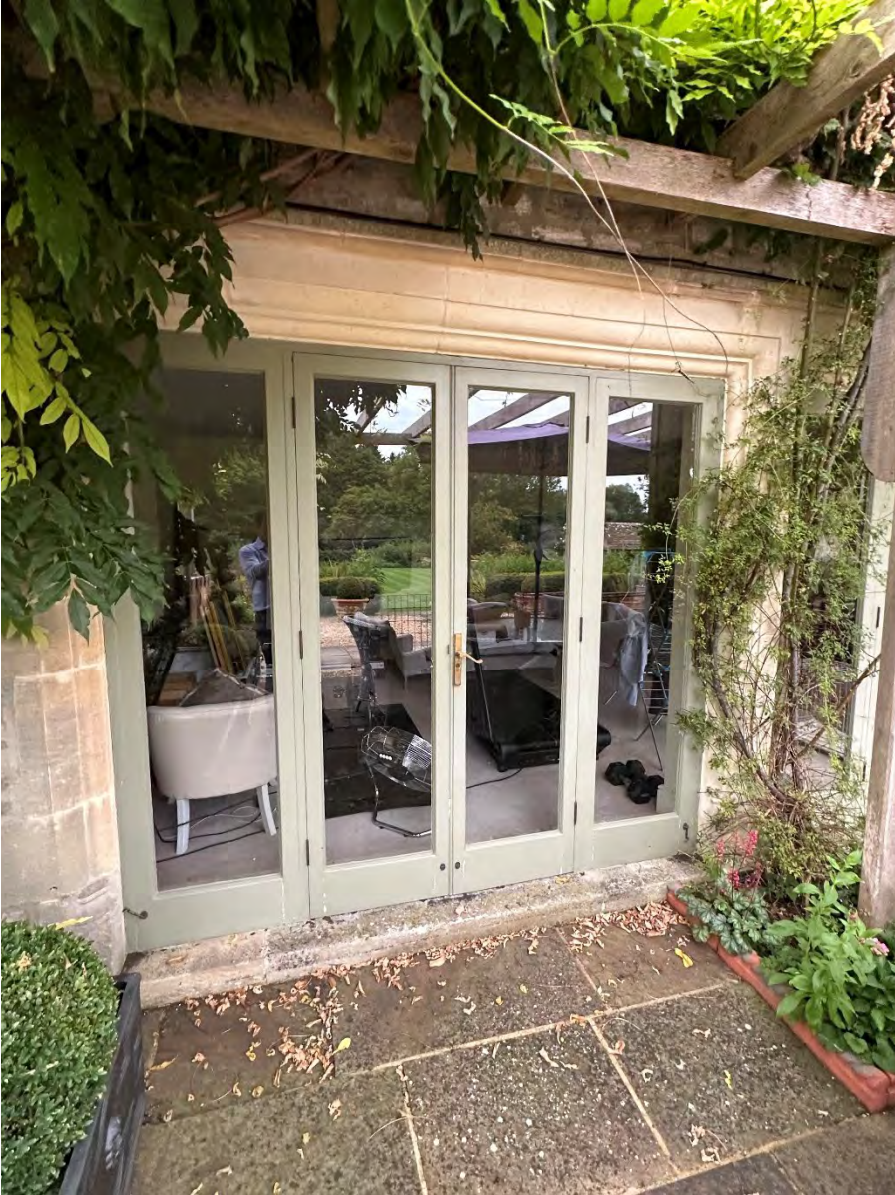
EX-DG-10 & EX-DG-11

| Reference | Existing Description and Condition | Proposed Change |
|---|---|--|
| EX-DG-10 | <p>Description – modern, single-glazed French doors; replacement approved in 1988 as part of CT.LBC586.</p> <p>Condition – good.</p> | New replacement doors (External Door Type 5) already approved as part of LPA refs. 22/O2948/FUL & 22/O2949/LBC. |

| Reference | Existing Description and Condition | Proposed Change |
|---|---|--|
| EX-DG-11 | <p>Description – the same as EX-DG-11.</p> <p>Condition – good.</p> | New replacement door (External Door Type 5) already approved as part of LPA refs. 22/02948/FUL & 22/02949/LBC. |

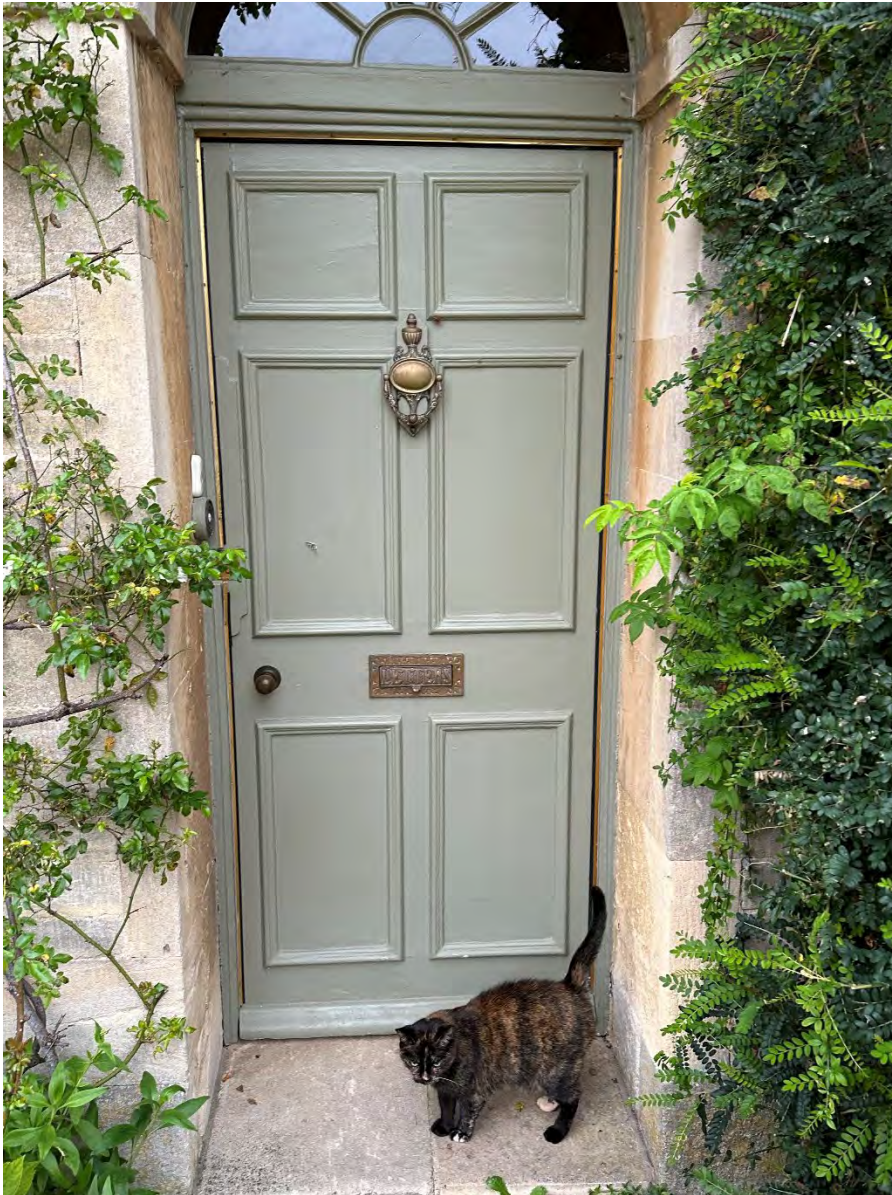
| Reference | Existing Description and Condition | Proposed Change |
|---|---|--|
| EX-DG-12 | <p>Description – six-panel door legible as a modern replacement due to the door furniture and timberwork. The frame appears to be earlier but has been cut/modified to accommodate the modern door.</p> <p>Condition – good; very minor deterioration of paintwork.</p> | New replacement door (External Door Type 4). |

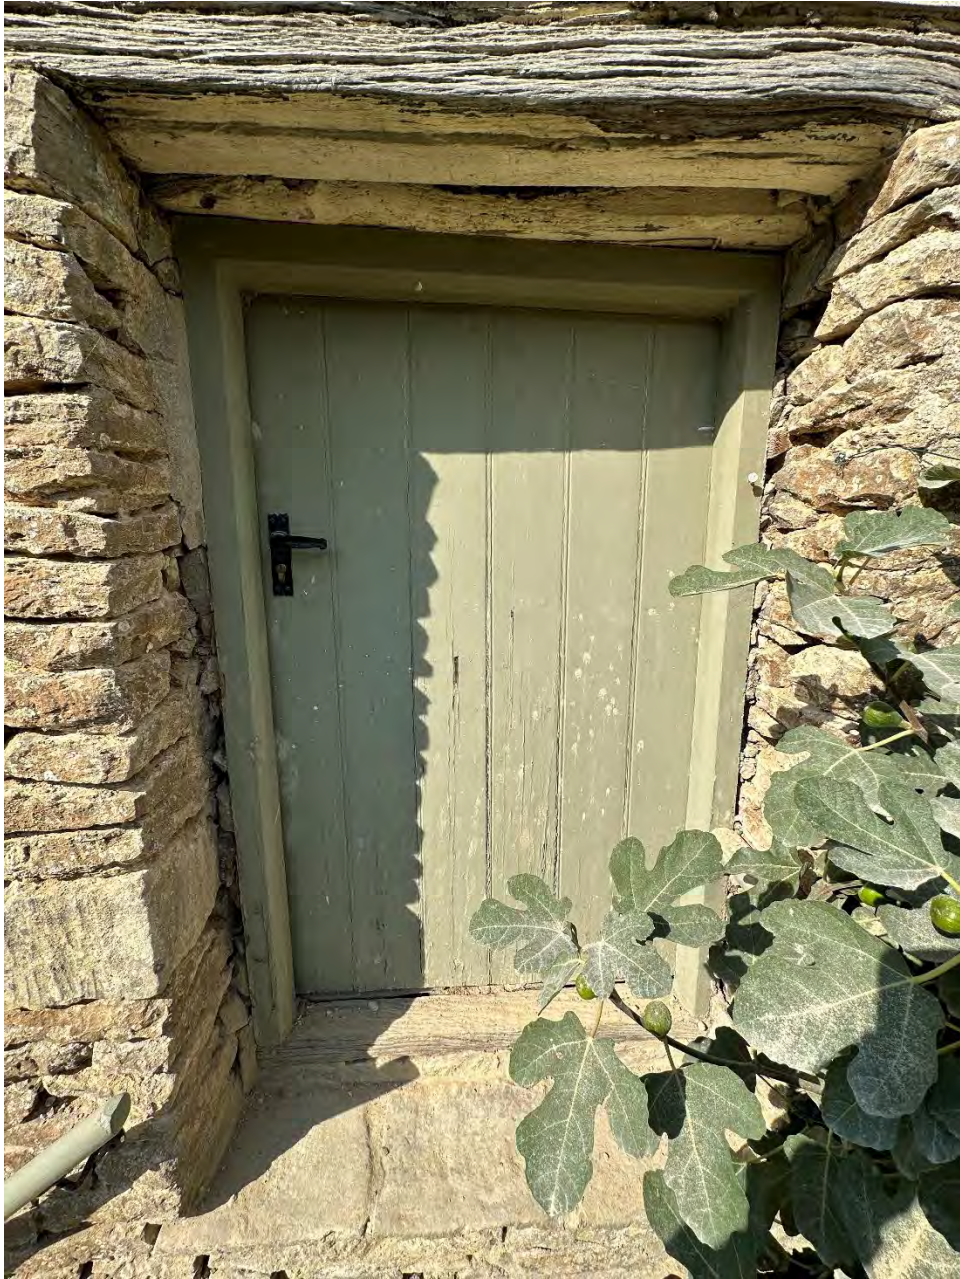
| Reference | Existing Description and Condition | Proposed Change |
|---|---|--|
| EX-DF-01 | <p>Description – ledged plank door. Heavily refurbished/renewed, although round end hinge straps appear to be a residual late 19th-century feature.</p> <p>Condition – door is in fair condition, although the frame does not properly fit the opening. The earlier hinge straps are badly corroded.</p> | New replacement door (External Door Type 3). |

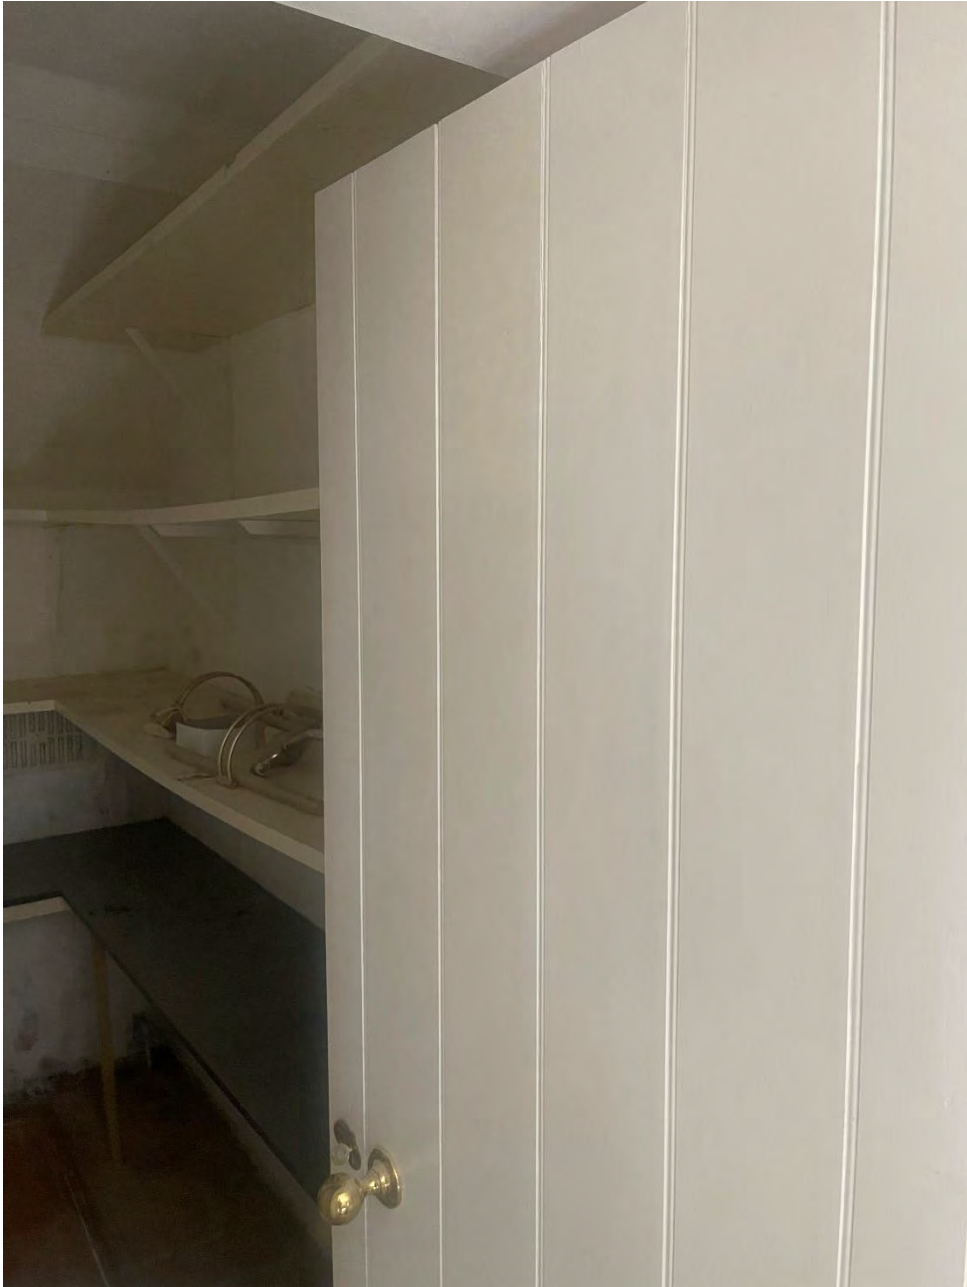
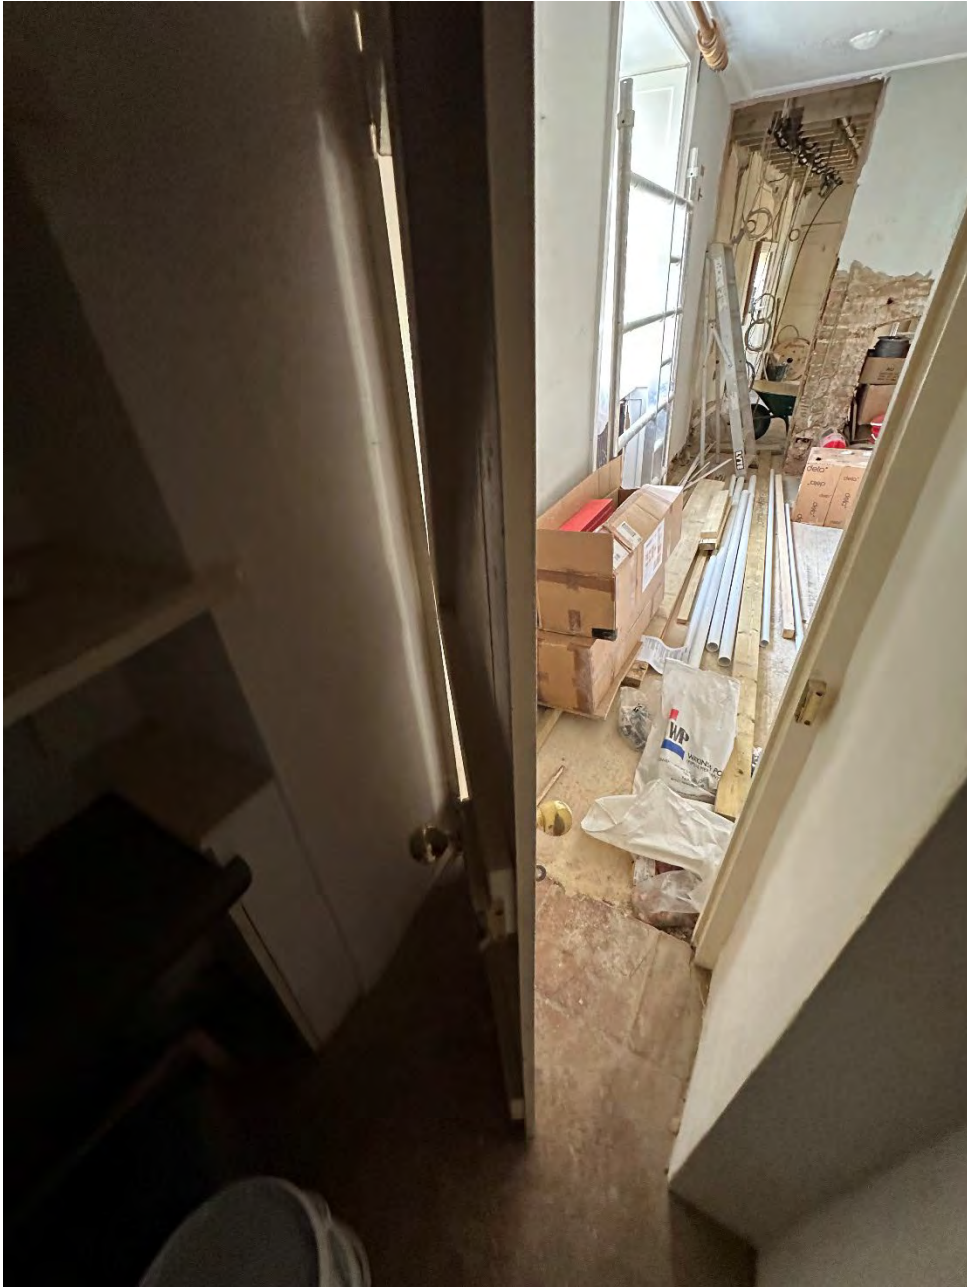
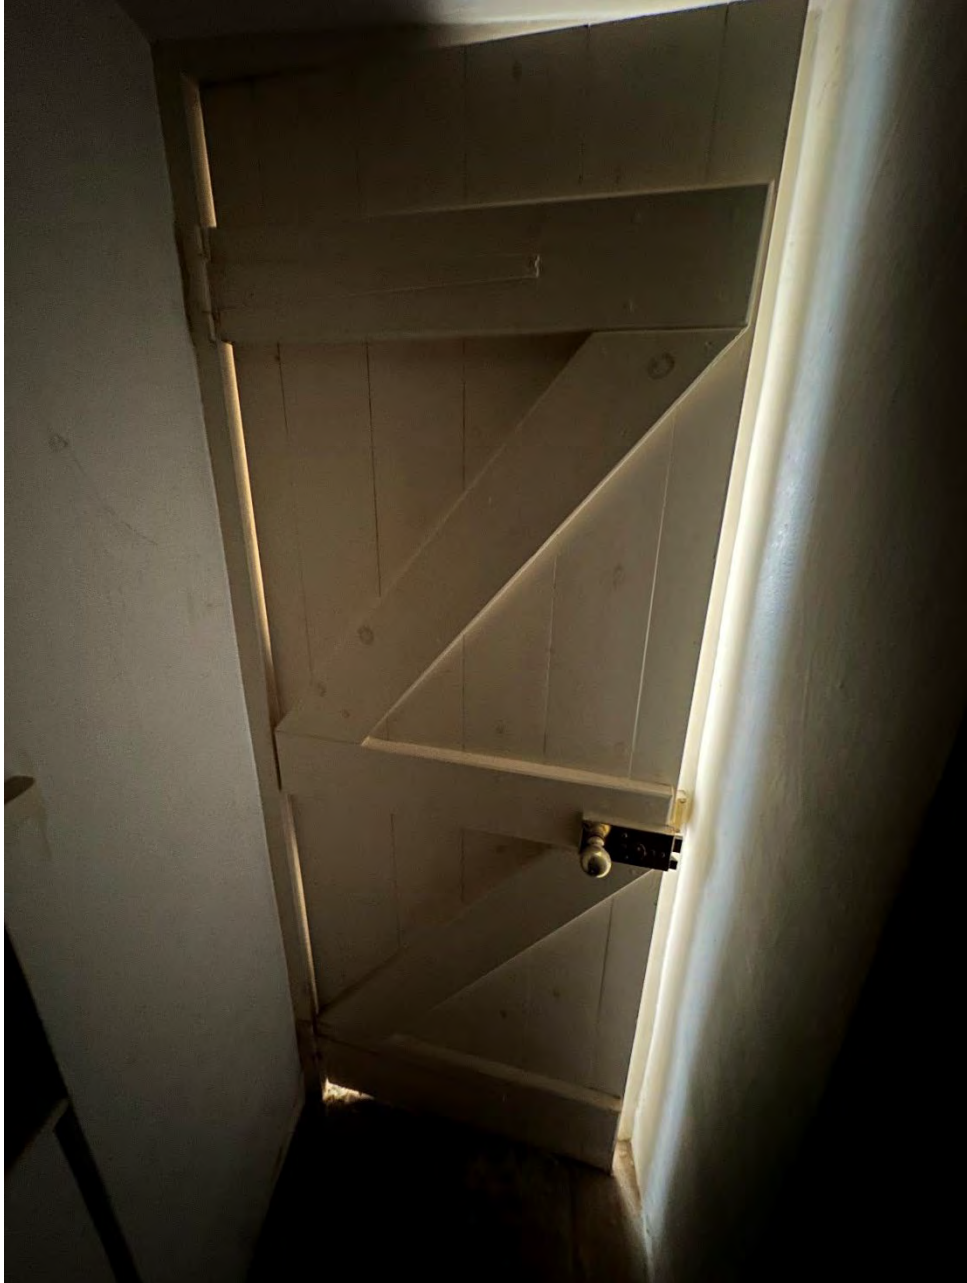
| Reference | Existing Description and Condition | Proposed Change |
|---|---|--|
| DG-07 | <p>Description – ledge and braced plank door with beading detail. The hinge straps have simply expanded ends. The other door furniture appears to be modern. The door has a traditional appearance and is likely to date from the 20th century. Historic plans indicate this doorway to be a 1980s formation, created when the old staircase was removed and the wall behind broken</p> | Door to be preserved in situ and concealed behind new jib door (Internal Door Type 3). |

| Reference | Existing Description and Condition | Proposed Change |
|---|--|---|
| | <p>through to form the present pantry cupboard. It is possible that the door itself was reused from elsewhere.</p> <p>Condition – good.</p> | |

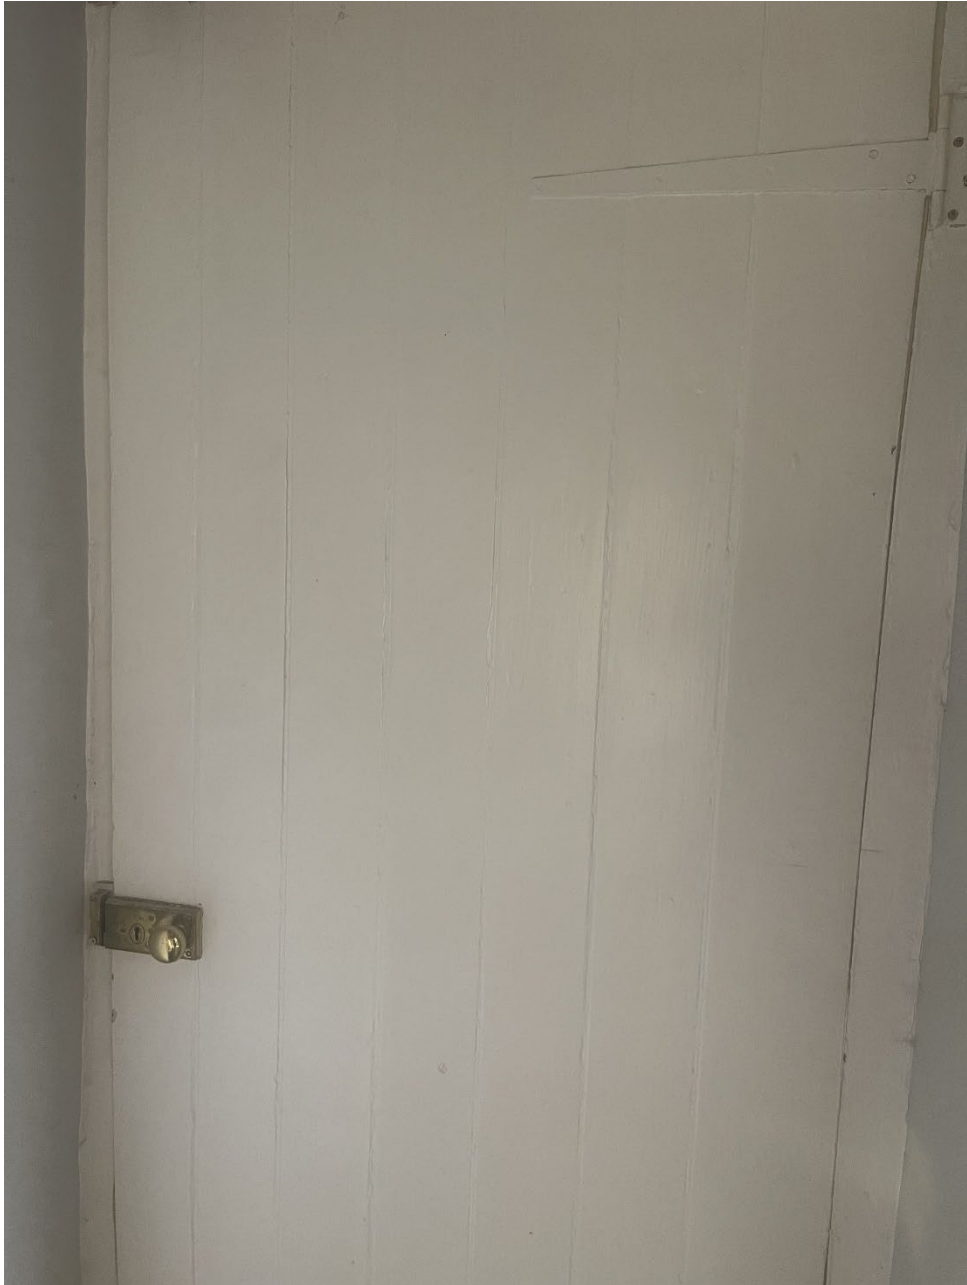
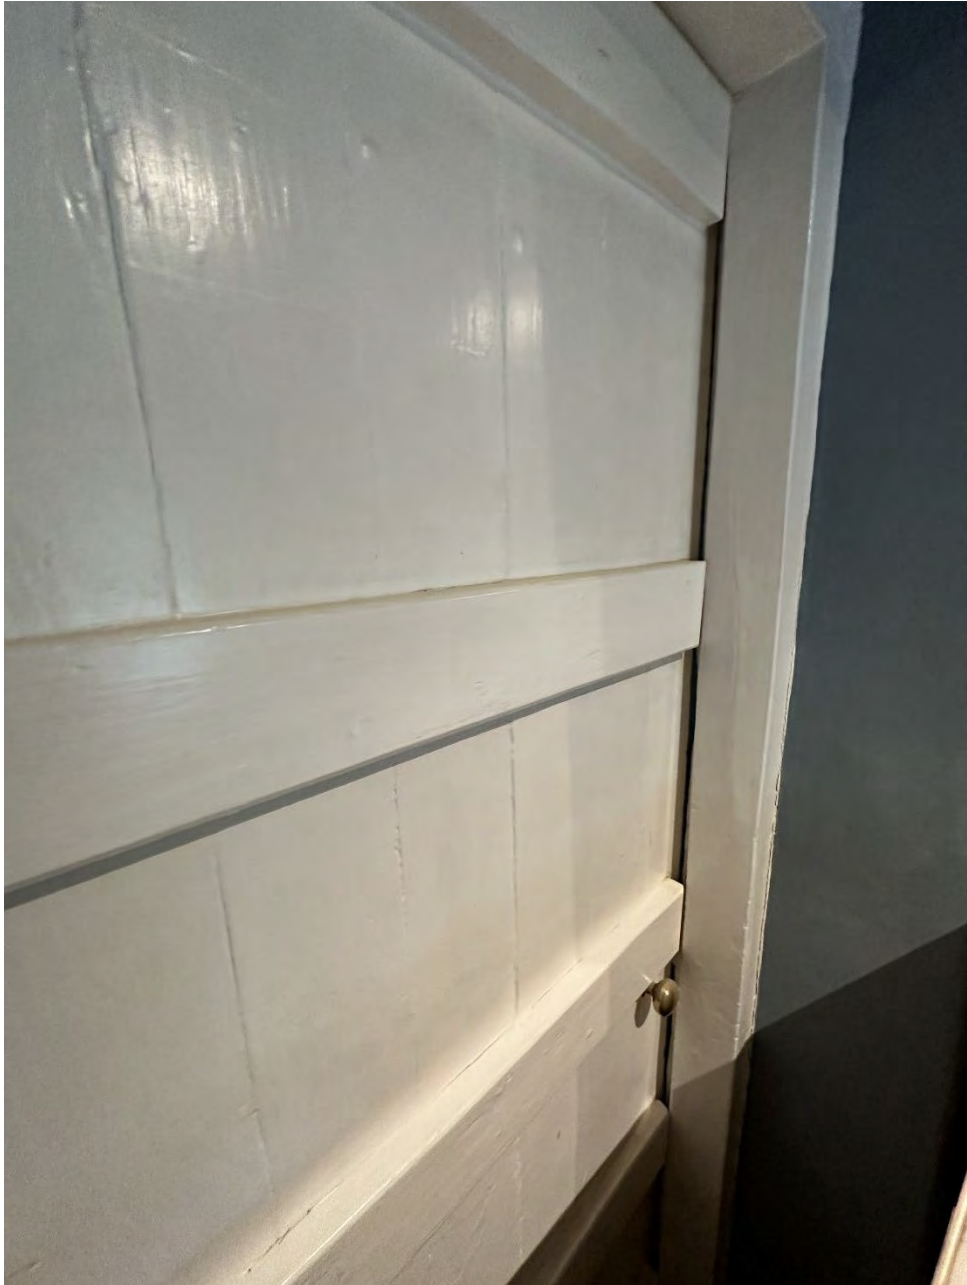
| Reference | Existing Description and Condition | Proposed Change |
|---|--|---|
| DG-08 | <p>Description – a simple, ledged plank door with beading detail comparable to DG-07. The hinge straps have plain ends. The other door furniture appears to be modern. A modern, white, gloss paint appears to have been applied.</p> <p>The position of the door and the ledges is indicative of this being fitted as an internal door which, in turn, suggests it was hung after the rear lean-to extension was added and this doorway was internalised, probably in the 19th century.</p> <p>Condition – good.</p> | New replacement door (Internal Door Type 2). |

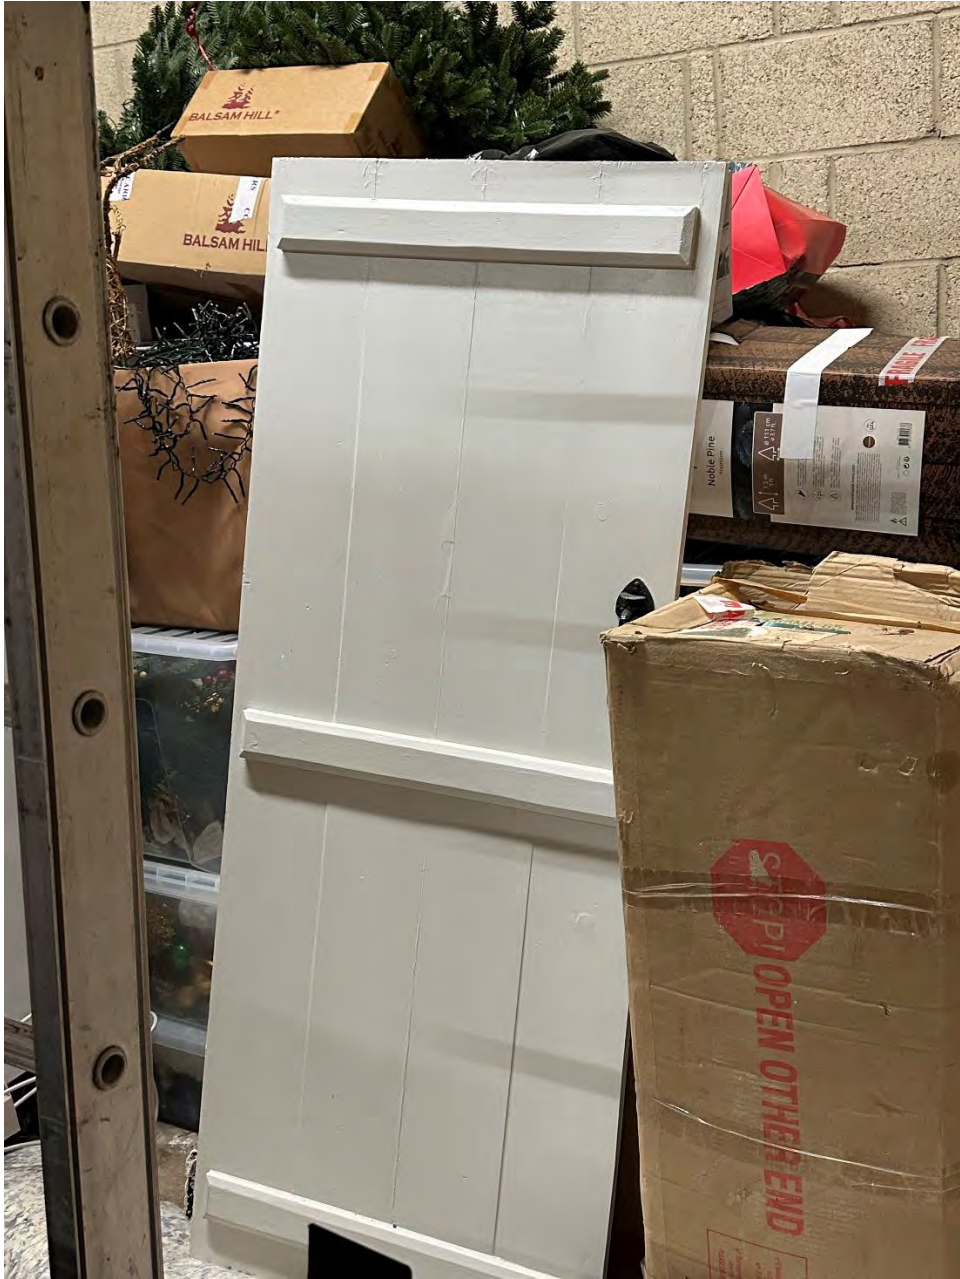
| Reference | Existing Description and Condition | Proposed Change |
|---|--|---|
| DF-01 | <p>Description – a ledged plank door currently off its hinges and in safe storage. The regular, machine-cut timbers and door furniture are indicative of this being a modern replacement.</p> <p>Condition – good.</p> | New replacement door (Internal Door Type 1). |
