REPORT ON SITE INVESTIGATION

**KILDONAN STREET, COATBRIDGE OFFICE CONVERSION
AND NEW BUILD HOUSING**

COLLECTIVE ARCHITECTURE - NORTH LANARKSHIRE

Version 1, October 2021

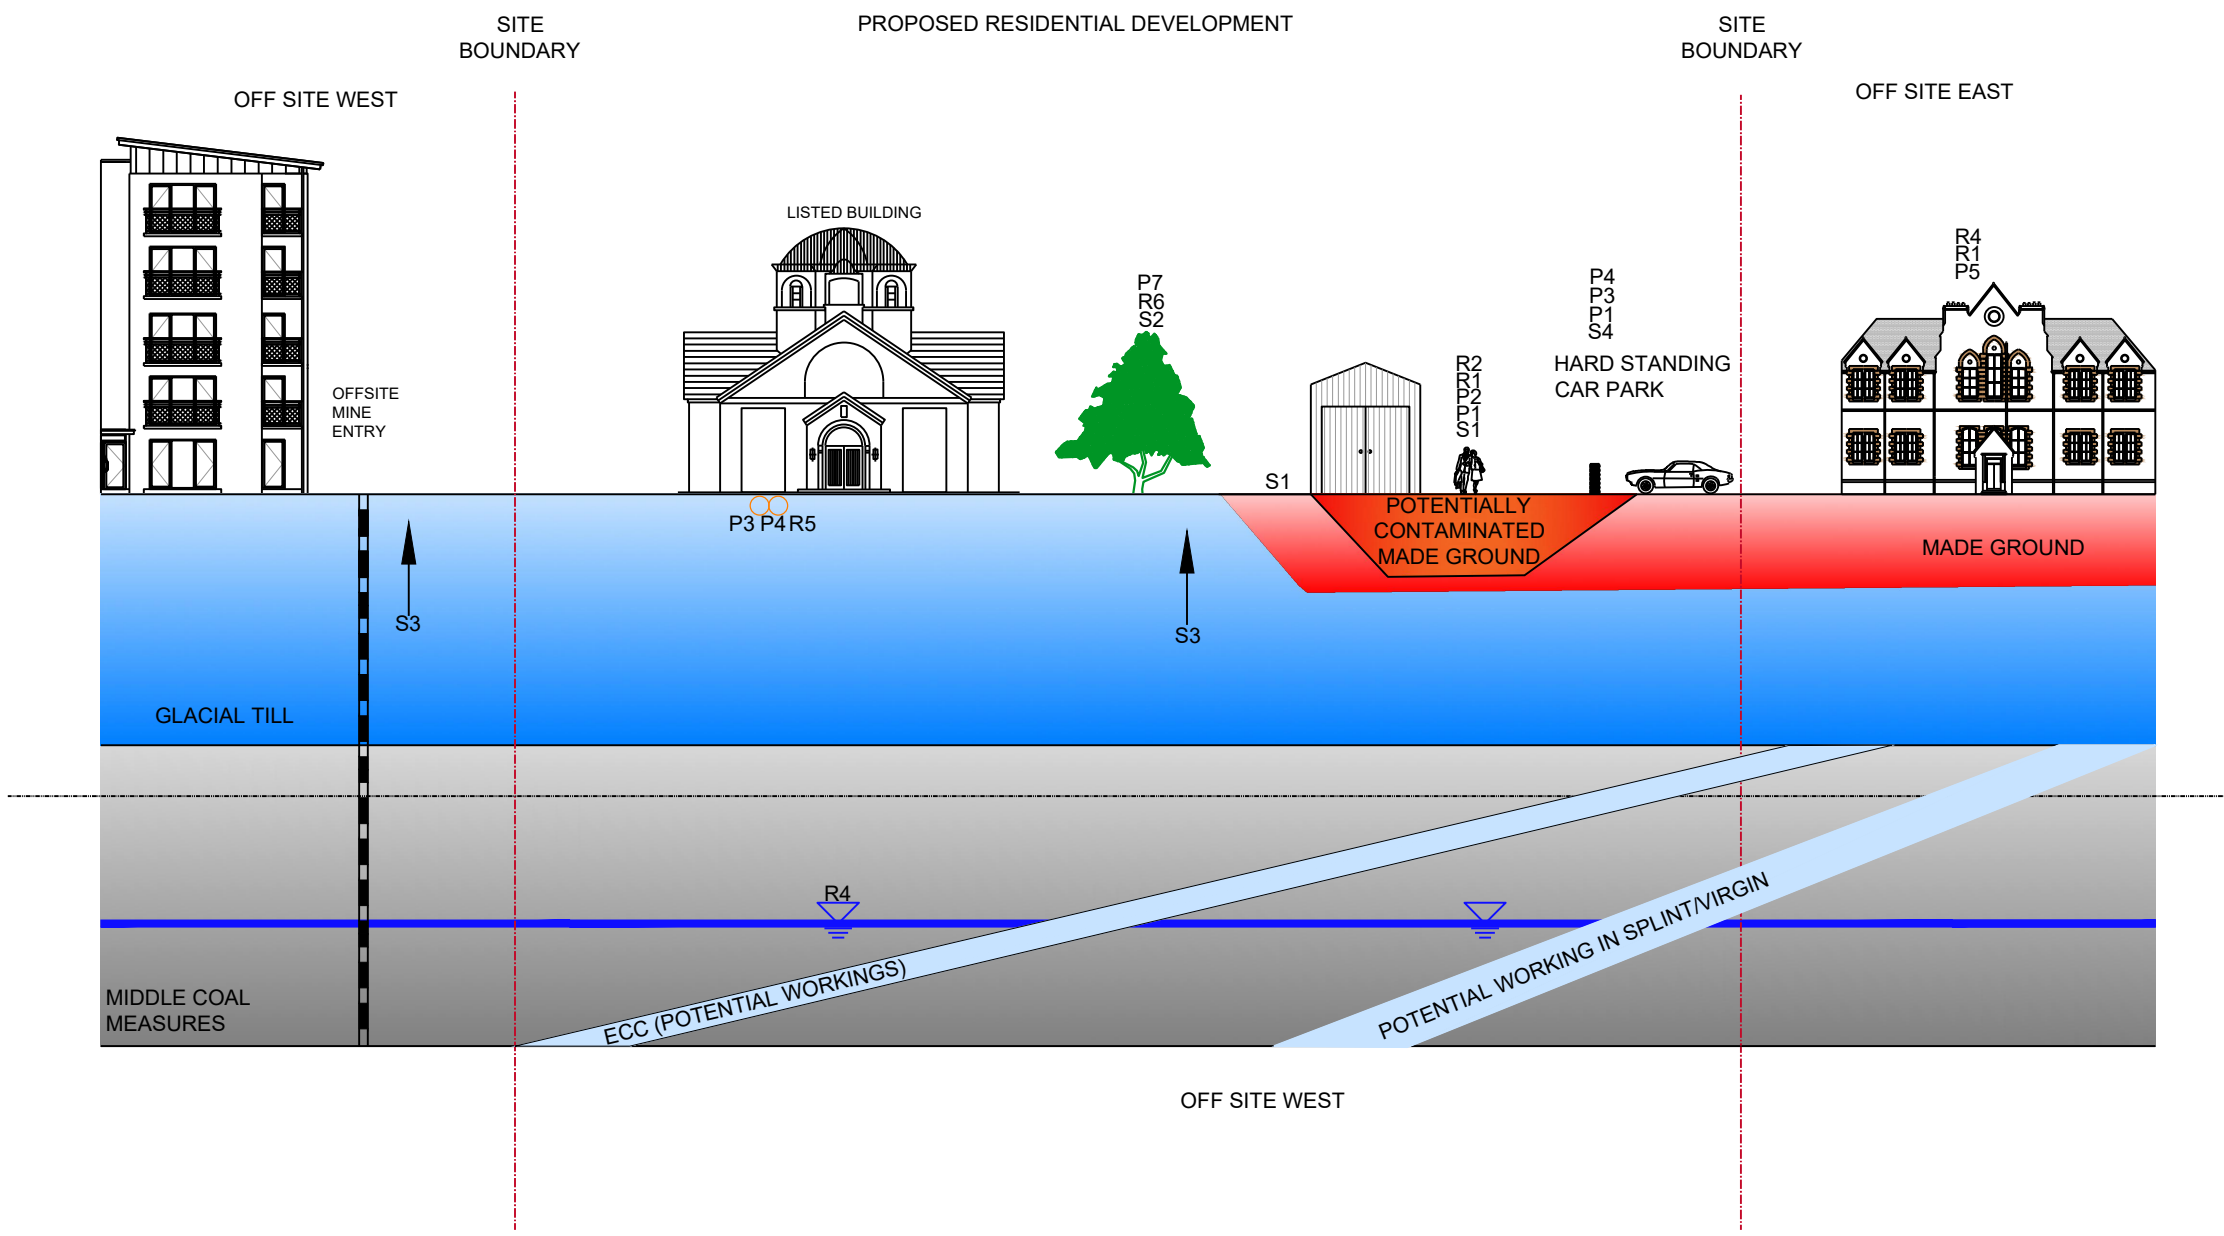
Drawing Number	J5194-SI-Fig 2	Revision	
----------------	----------------	----------	--

- POTENTIAL SOURCES**
- S1 POTENTIAL CONTAMINATION ASSOCIATED WITH CURRENT AND HISTORICAL ON-SITE LAND USE.
 - S2 POTENTIALLY CONTAMINATED MADE GROUND DEPOSITED FROM AN OFF-SITE SOURCE
 - S3 POTENTIAL GROUND GAS AND MINE GAS.
 - S4 POTENTIAL SPILLAGES OF FUEL OR OIL.

- POSSIBLE PATHWAYS**
- P1 DERMAL CONTACT/INGESTION
 - P2 INHALATION OF CONTAMINATED DUST OR ASBESTOS FIBRES
 - P3 MIGRATION AND ACCUMULATION OF GROUND GAS OR VAPOUR
 - P4 LEACHING OF CONTAMINANTS AND MIGRATION THROUGH SOILS
 - P5 MIGRATION OF CONTAMINANTS IN GROUNDWATER
 - P6 DIRECT CONTACT
 - P7 ROOT UPTAKE

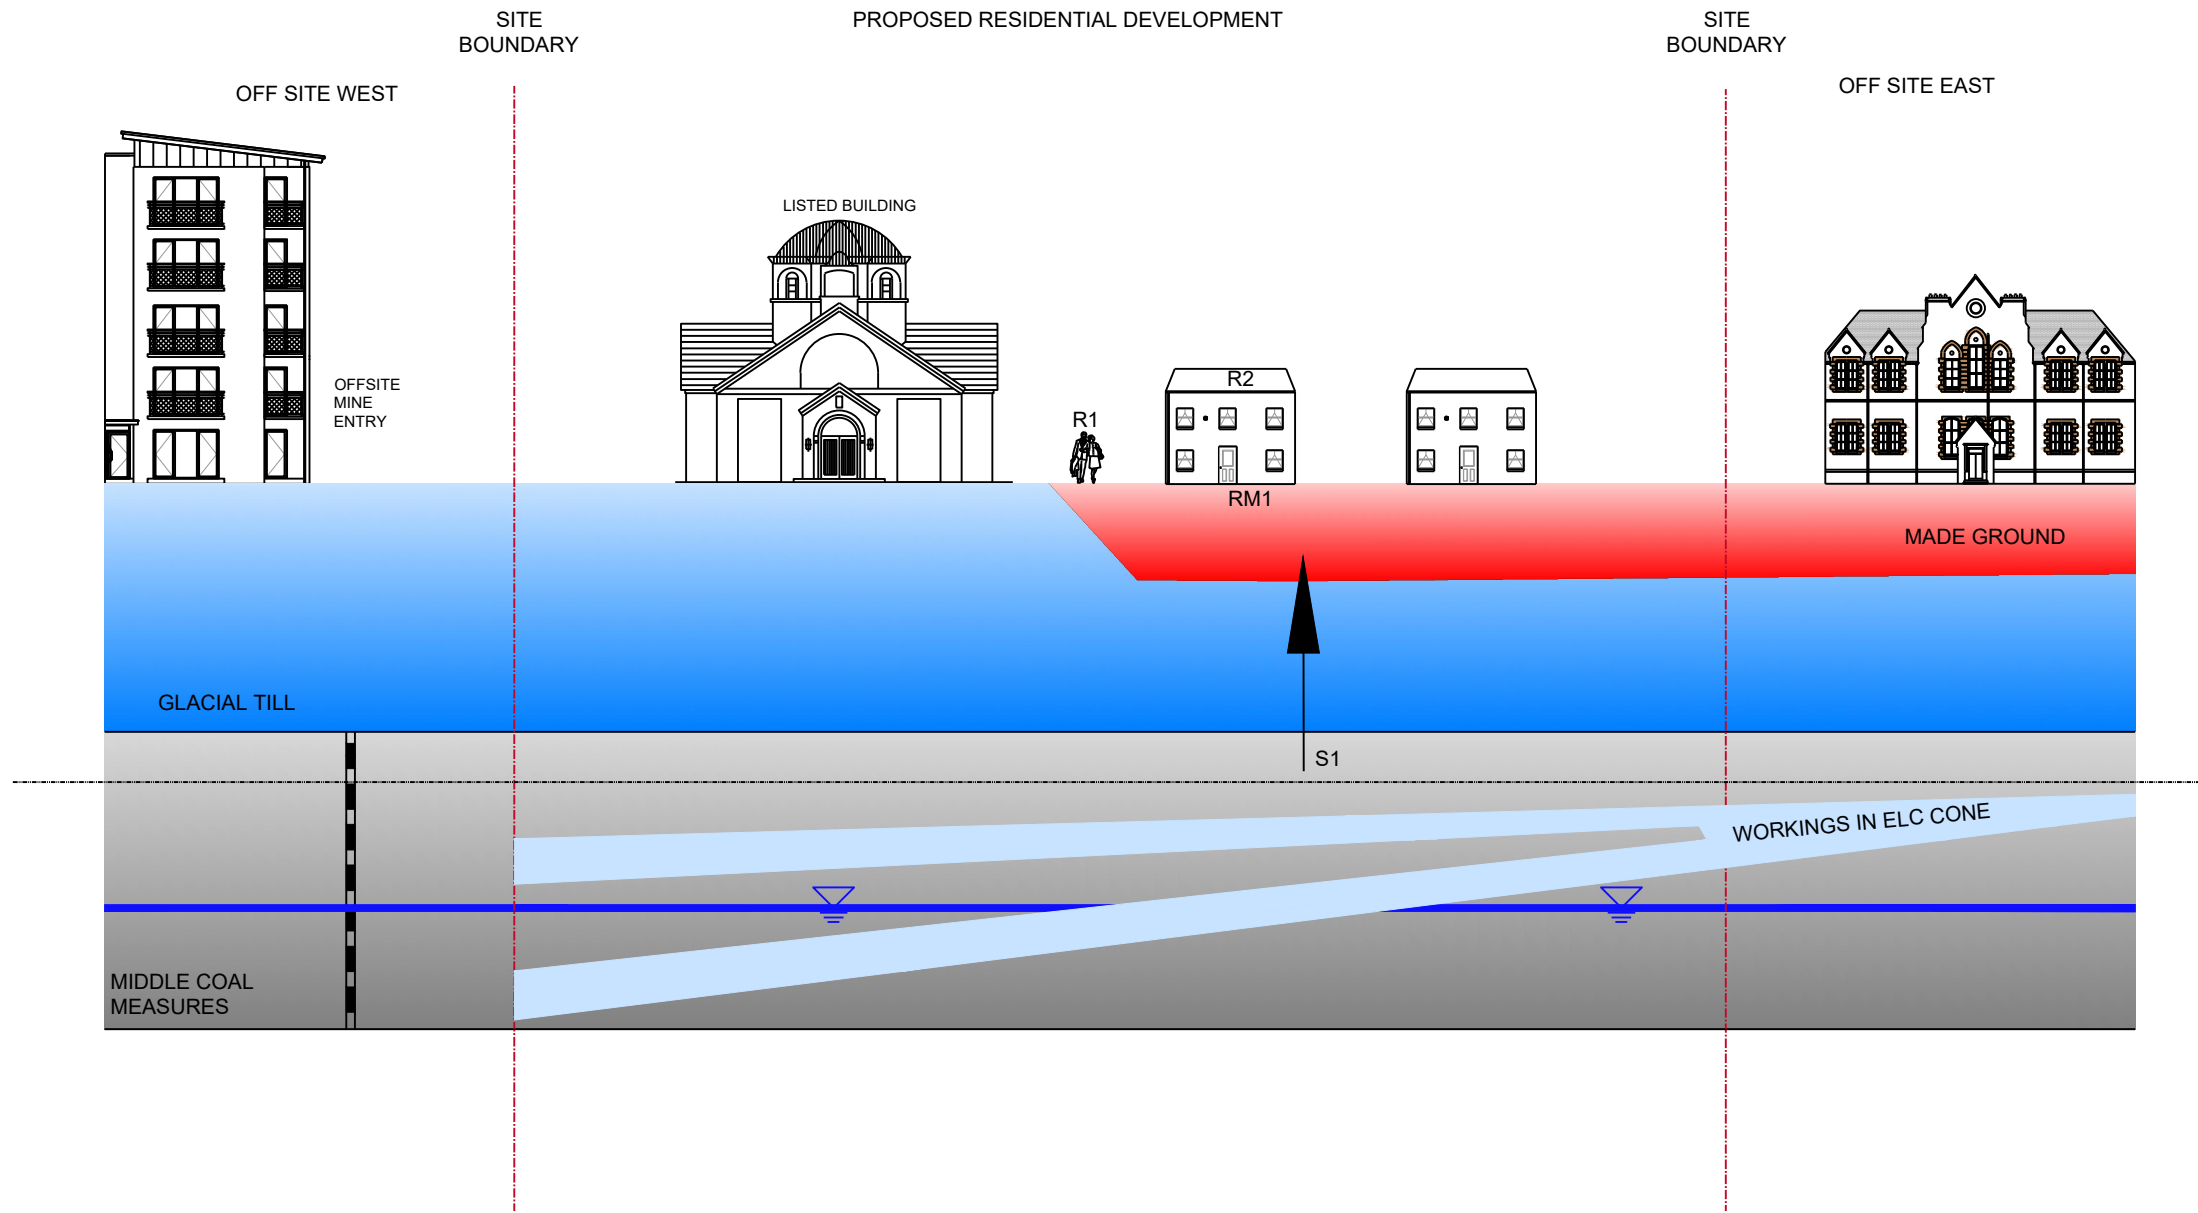
IDENTIFIED SOURCES
S1 POTENTIAL MINE GAS

RECEPTORS AT RISK
R1 FUTURE SITE RESIDENTS AND SITE VISITOR
R2 PROPERTY

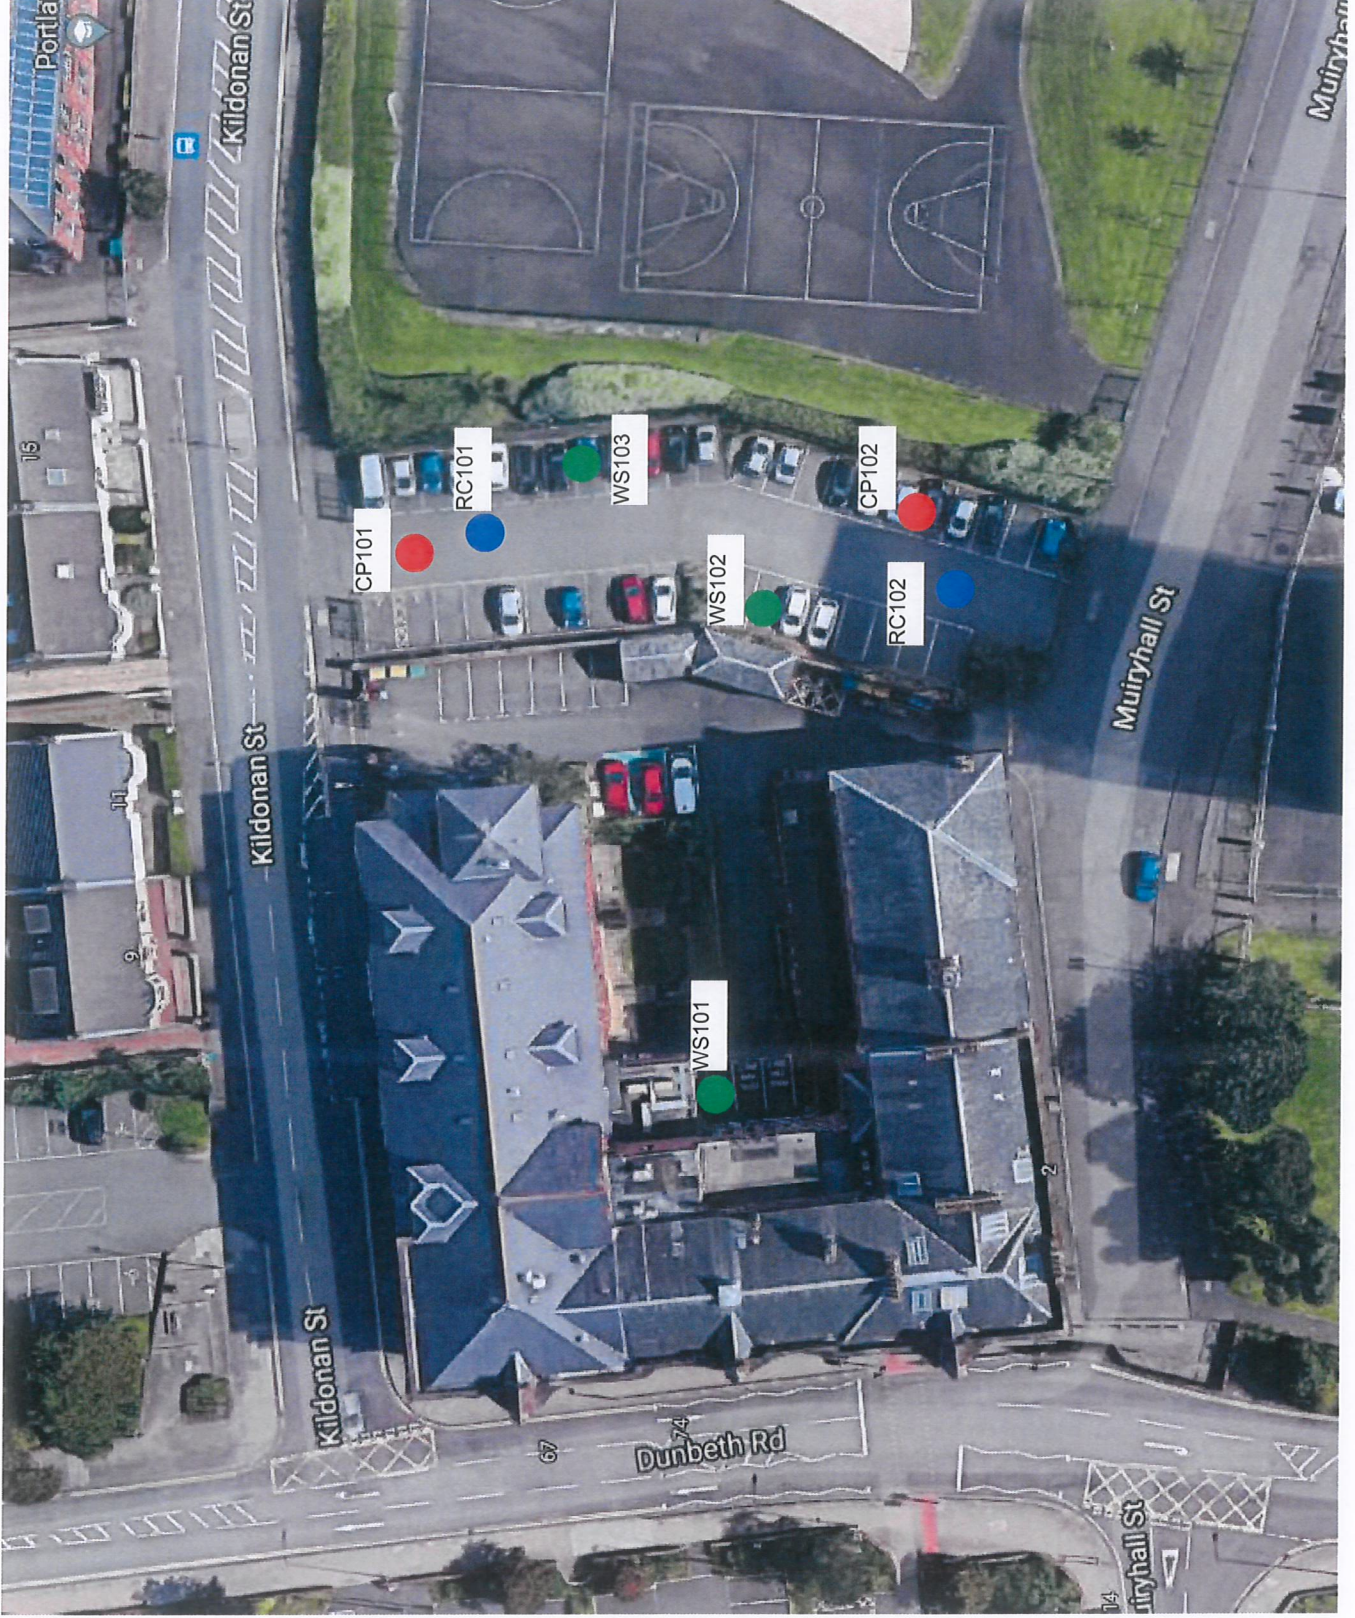
J5194 Kildonan Street, Coatbridge Sketch SI layout

● Cable Percussion borehole to 8m depth (with standpipe)

● Rotary cored borehole to 40m
