**Design and
 Access
 Statement
 incorporating
 Heritage
 Statement**
 Including Statement of
 Significance

PROJECT:	<u>1 ROSE COTTAGE, HIGH STREET, DAMERHAM, FORDINGBRIDGE, SP6 3EZ</u>
CLIENT:	Charles & Amanda Yaxley
ARCHITECT	WESTERN DESIGN LTD
DATE:	December 2023 / 005C-MW-NFDC

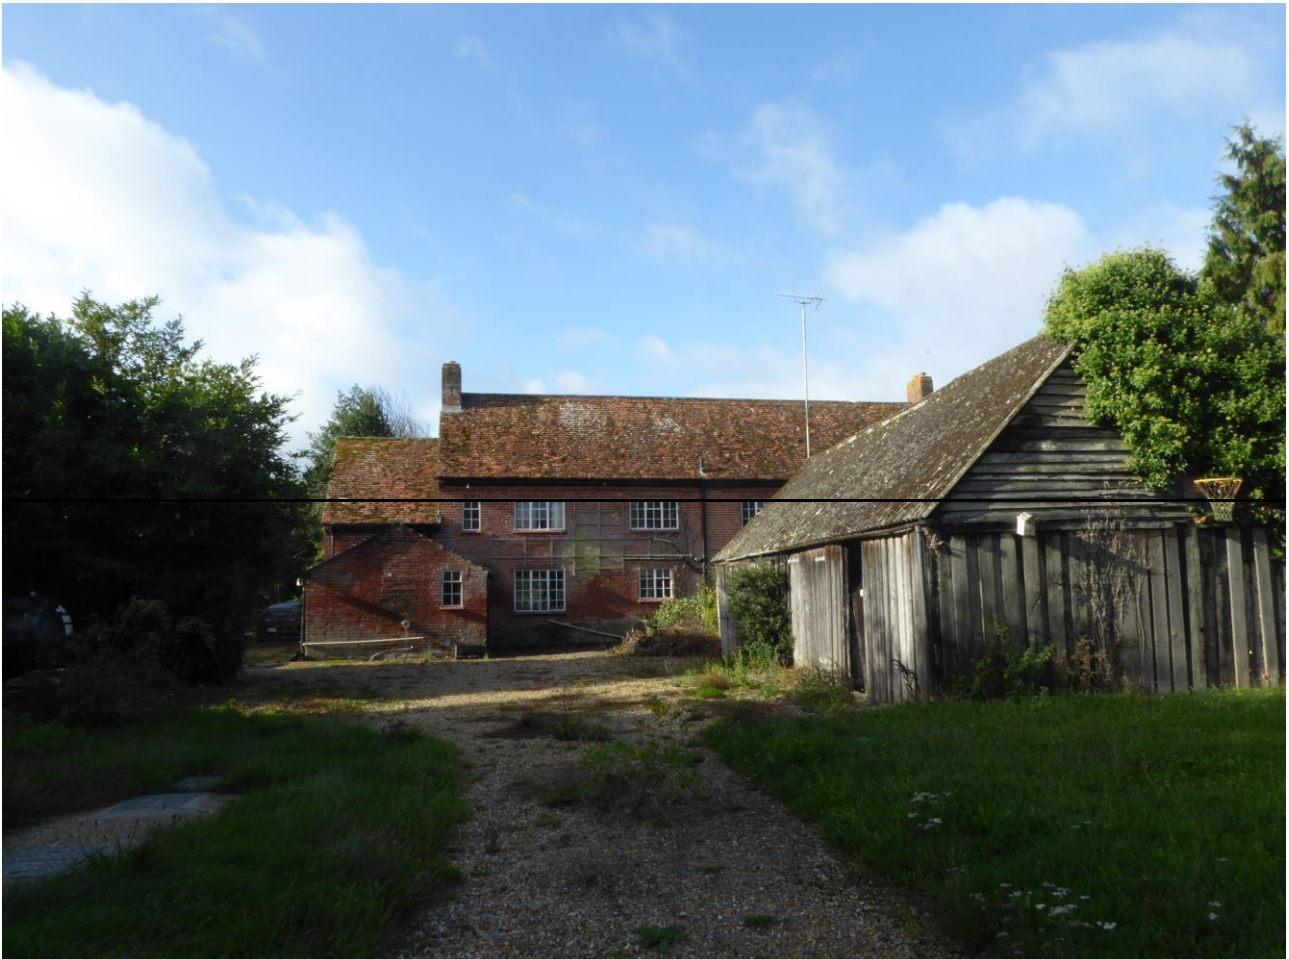
Fig 1 – View of rear elevation and outbuilding and parking area looking south west.

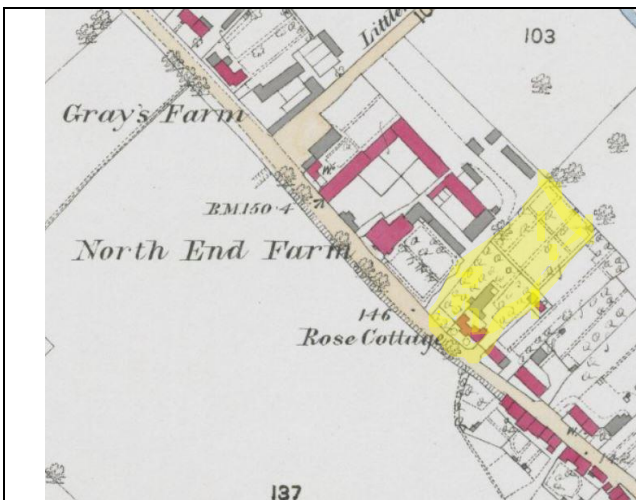
Fig 3 – 1876 OS map

3.1.1 Fig 3 shows Rose Cottage on an 1876 OS Map. It is notable on this plan that the later 19C north west extension to the house does not exist and the ancillary barn to the north east of the house is in a different format to the current barn, is detached from the dwelling and the lean too extension as it exist today is not present. It is also notable that the Glencoirn House is already present next to Rose Cottage.

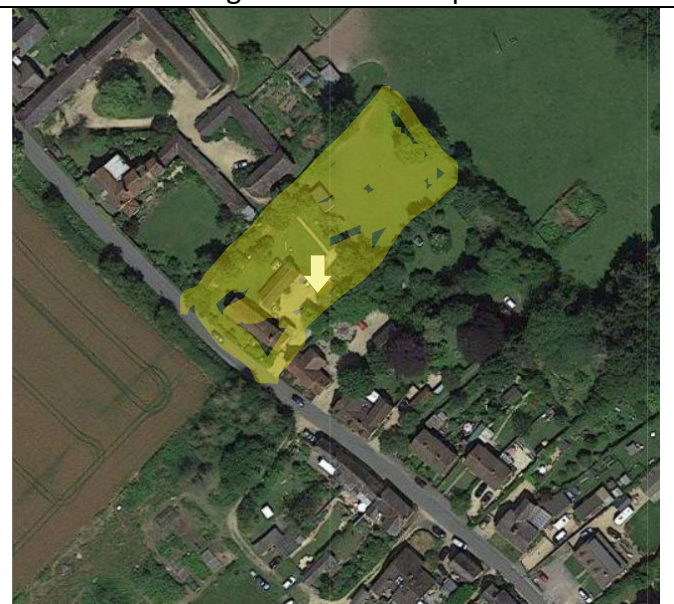
Fig 6 – 2009 – aerial image

- 3.1.4 Fig. 6 shows an aerial view of the site from 2002 Google Earth and the present relationship with the high street. The curtilage and building form of the main house is unchanged to present, while we can see for the first time the C20 one storey modern lean too extension at the back of the house.

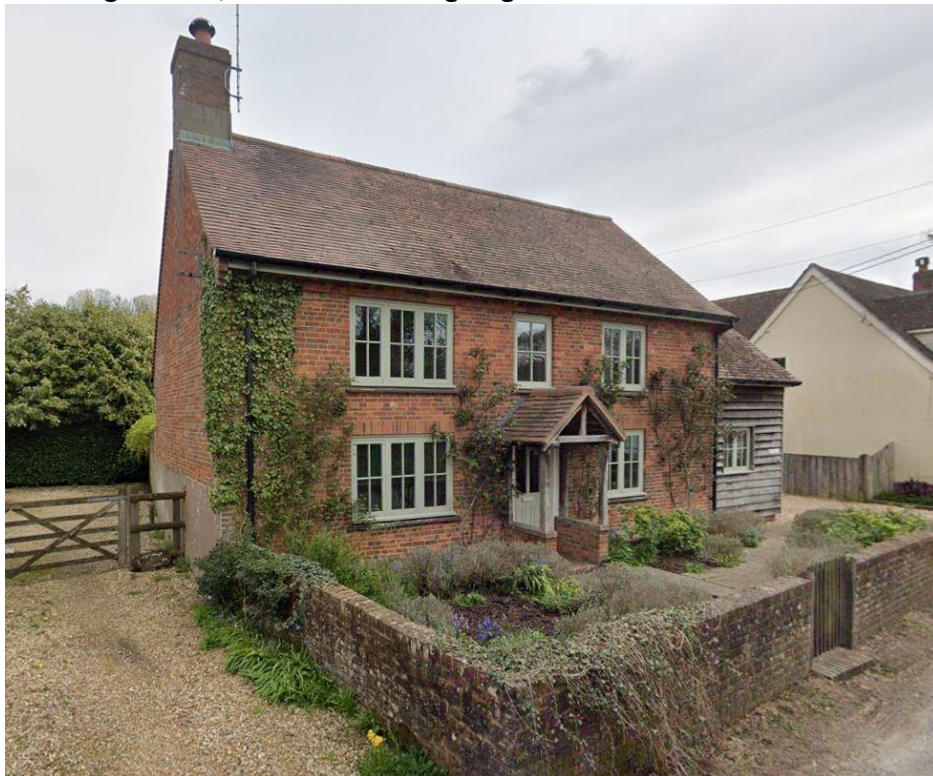
Fig 7 – View of the Glencoirn house street elevation.

- 3.1.5 Fig. 7 below shows an image of the next-door neighbour Glencoirn House which shows the historical brick porch entrance to the house. This type of brick porch is present along Damerham high street, in other houses going towards north.

6.5.1 The historical analysis presented before, shows that Glencoirn House share the same historical value and age of Rose Cottage. This late 18th century house presents the original brick and timber porch entrance which is part of the historic architecture of Damerham.

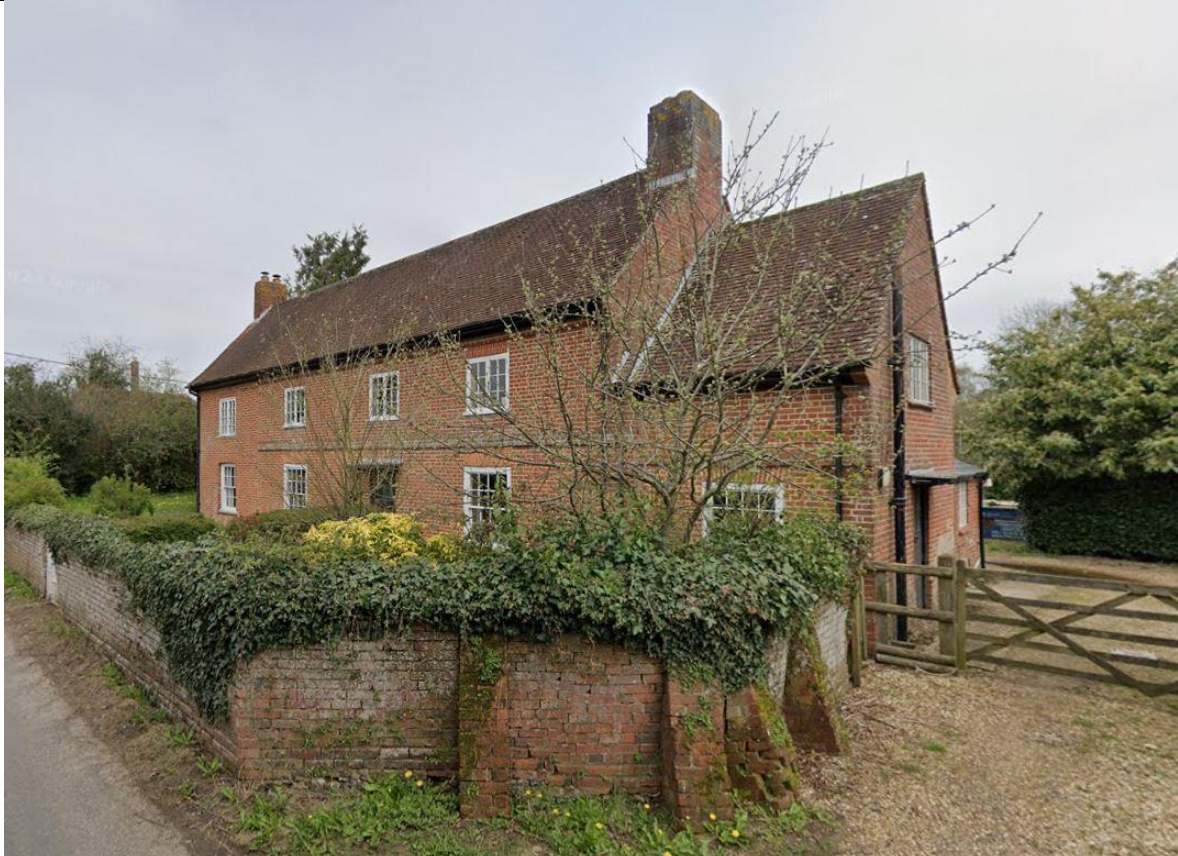
Fig 8 – View of the house southwest elevation from the driveway entrance.

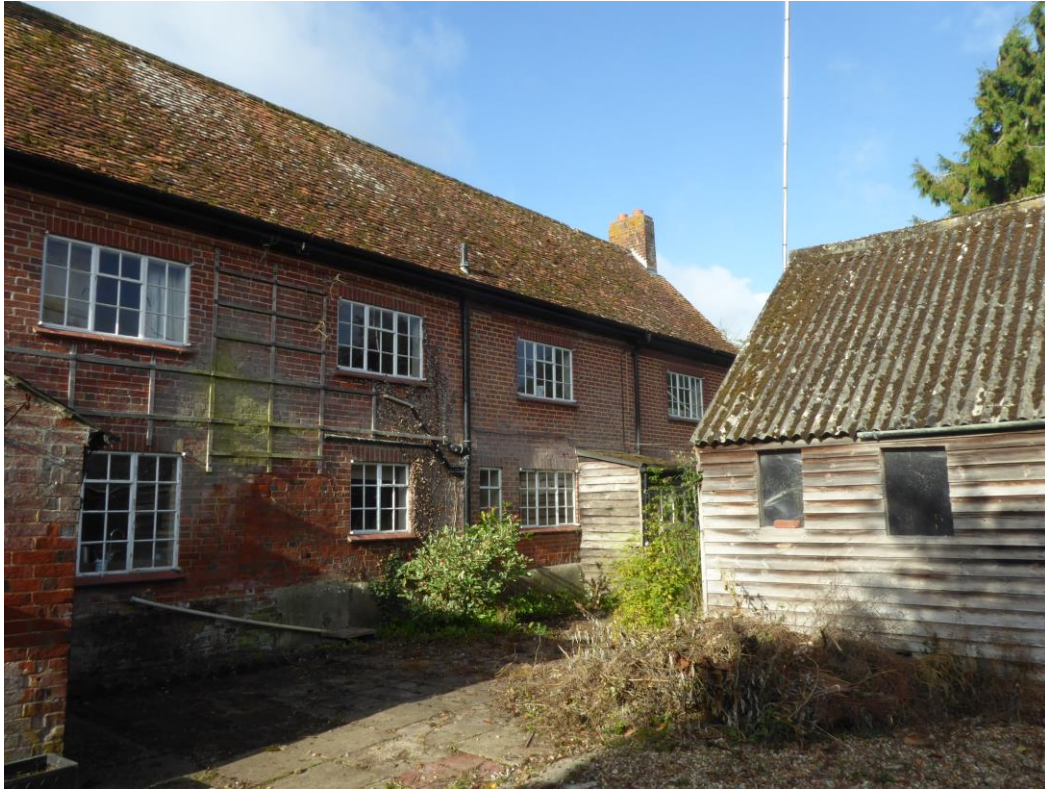
Fig 9 – View of the rear elevation of the house and the C20 one storey extension.

- 6.3.1 Rose Cottage is a substantial detached Grade II Listed residence with accommodation provided over 2.5 storeys. The cottage has a pitched roof with a chimney at either gable and a small one storey rear extension. The rear elevation has had C20 interventions with the replacement of the original timber windows with metal crittall casements.
