## **Design and Access Statement incorporating Heritage Statement**

Including Statement of  
Significance

<b>PROJECT:</b>	<b><u>1 ROSE COTTAGE, HIGH STREET, DAMERHAM, FORDINGBRIDGE, SP6 3EZ</u></b>
<b>CLIENT:</b>	<b>Charles &amp; Amanda Yaxley</b>
<b>ARCHITECT</b>	<b>WESTERN DESIGN LTD</b>
<b>DATE:</b>	<b>November 2023 / 005C-MW-NFDC</b>

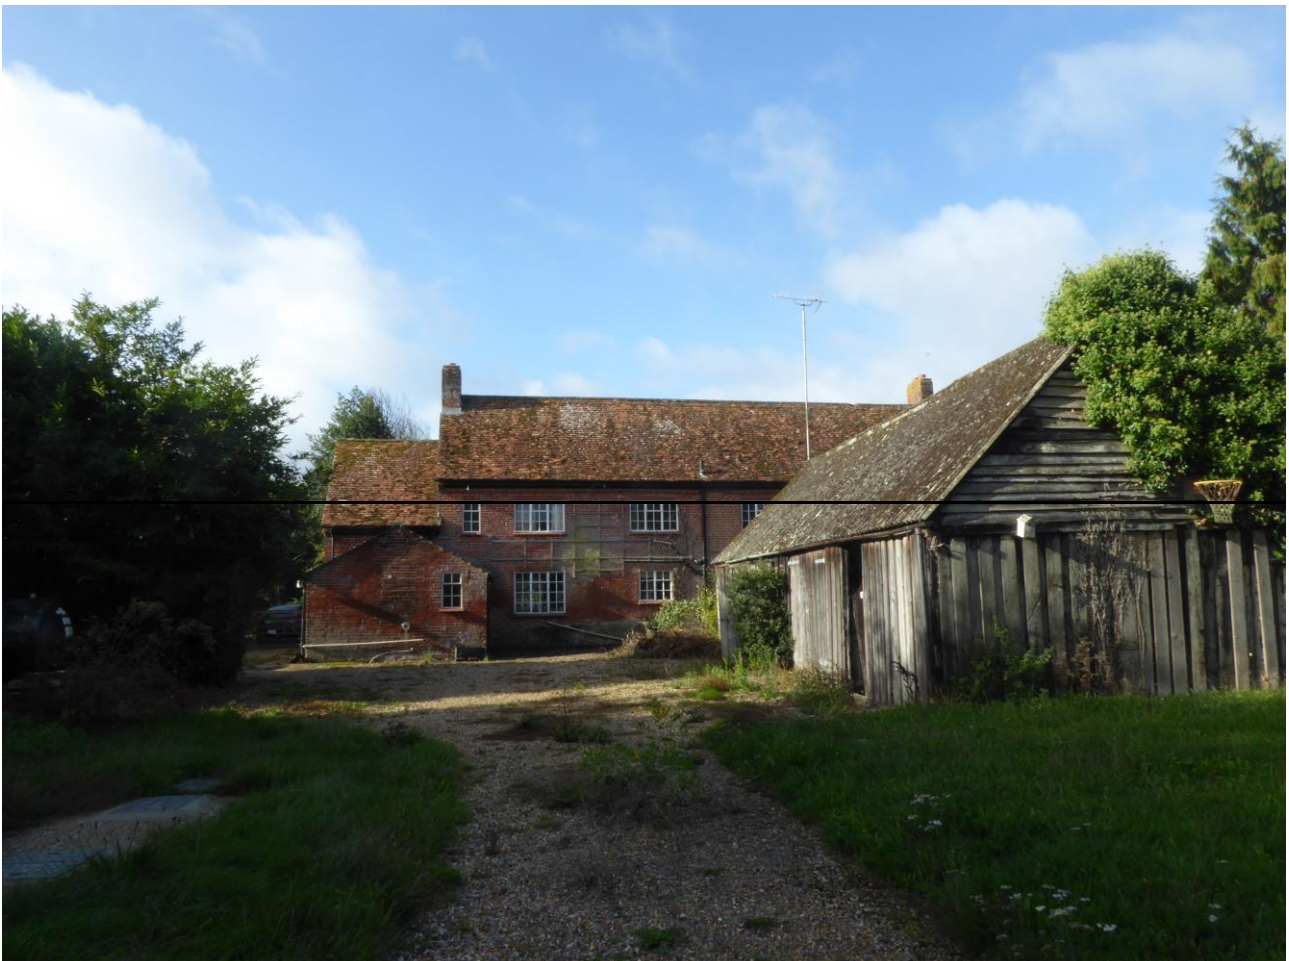
Fig 1 – View of rear elevation and outbuilding and parking area looking south west.

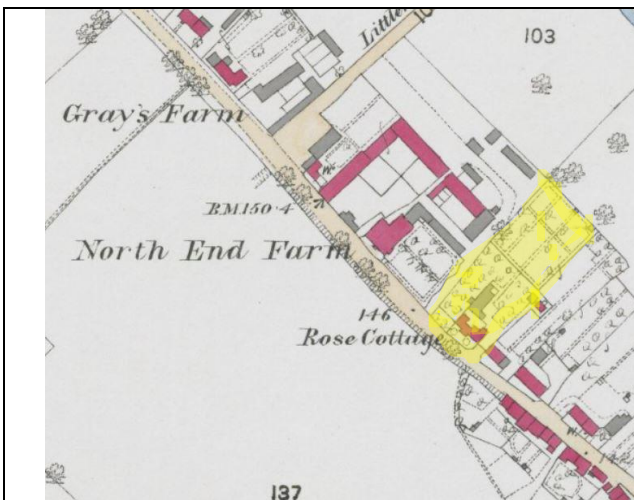
Fig 3 – 1876 OS map

3.1.1 Fig 3 shows Rose Cottage on an 1876 OS Map. It is notable on this plan that the later 19C north west extension to the house does not exist and the ancillary barn to the north east of the house is in a different format to the current barn, and is detached from the dwelling. It is also notable that the Glencoirn House is already present next to Rose Cottage.

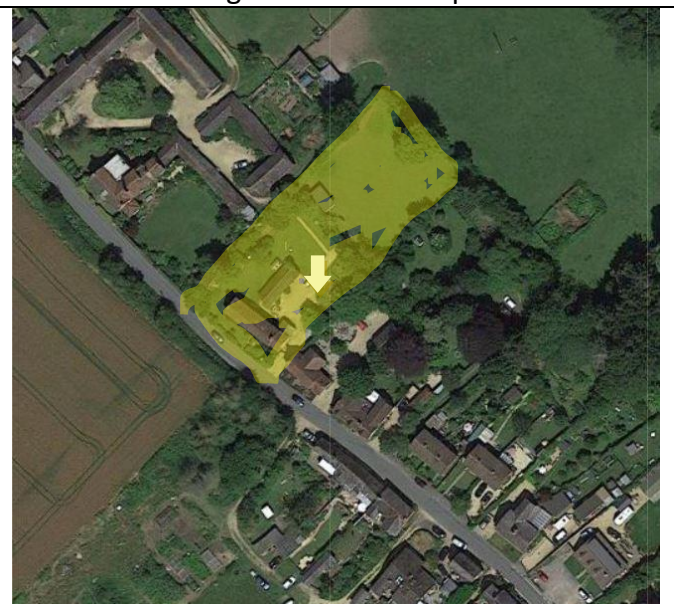
Fig 6 – 2009 – aerial image

- 3.1.4 Fig. 6 shows an aerial view of the site from 2002 Google Earth and the present relationship with the high street. The curtilage and building form then unchanged up to 2023.

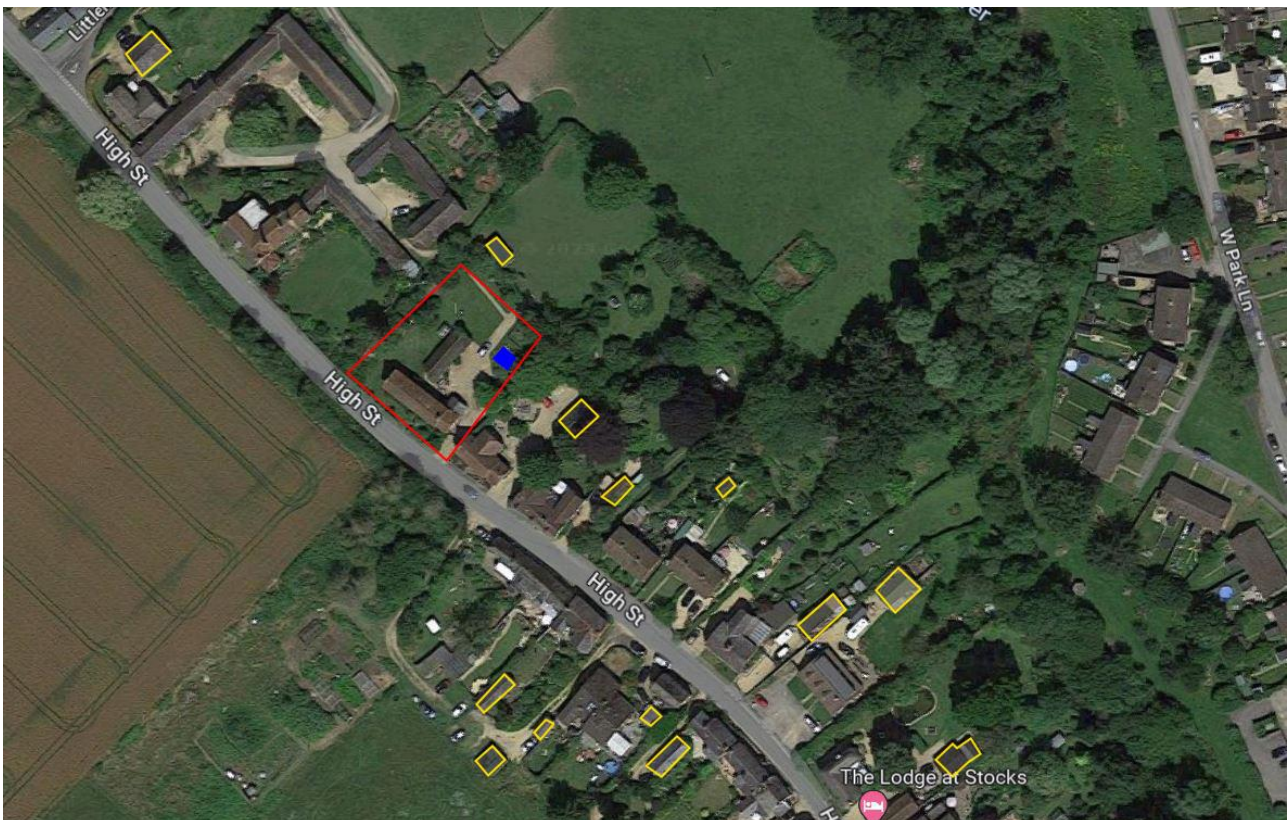
- 3.1.5 Fig. 7 shows an aerial view of the site from 2002 Google Earth and the garden buildings which are present around the application site. From this view it is clear that most of 1 Rose Cottages neighbours present an ancillary garden building.

Fig 7 – Aerial view of Rose Cottage’s surroundings and existing garden buildings.
