Pre-Deconstruction Audit

Site Address : Alba Gate, Stoneywood Park, Aberdeen, AB21 7DZ

Report Number: 2310/0603/A

Report by: Material Index Ltd

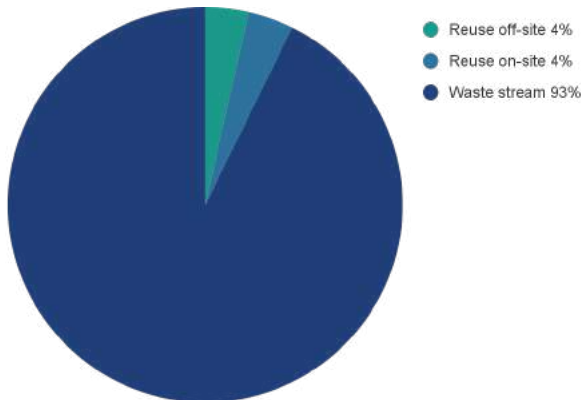
Chart 1: Total Material Pathway Distribution (kg)

The total sum weight of material identified within the site is 6.637 tonnes, with the majority of the existing building material, by weight, consisting of the concrete foundations and floor slab. The analysis suggests that 8% of material has the potential to be diverted from the waste stream through on-site and off-site reuse (Chart 1). This is considered appropriate given the challenge of the building’s materials, condition and typology.

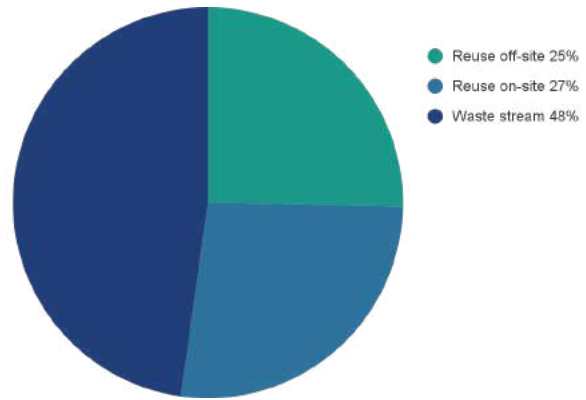
Chart 2: Pathway Distribution w/o foundation & slab (kg)

Once the concrete foundation and slab is removed from the analysis, the percentage of material currently designated for reuse (both on and off-site) is 52% (Charts 2), potentially saving over 400 tonnes of high-value, high embodied carbon materials.

For the purpose of setting reasonable but ambitious goals for this project we recommend analysing the re-use content without reference to the concrete foundations and slab. The current reuse level is 52% by weight in this scenario. We recommend a target of over 20% as being good and over 30% as being excellent. It is recommended that the targets below are communicated to the demolition contractors to ensure that maximum reuse and recycling is achieved.

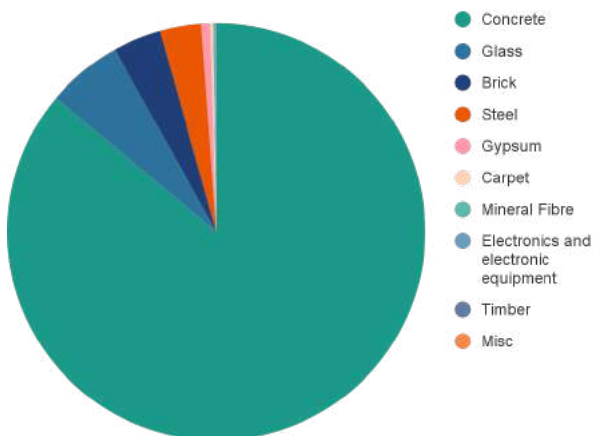
Chart 3: Distribution: Materials for Waste Stream by Weight (kg)

The total volume of waste arising is estimated to be 5,905 tonnes. Of the materials in the waste stream, a large percentage of the metals (Chart 4) can be recycled. Suggestions are made with regards to reducing concrete waste further in the report. Data is provided in Appendix A.

For the items entering the waste stream, given the current understanding of the materials on site, particularly given the relatively low amounts of insulation relative to other material categories, it is recommended the deconstruction contractor has a target of 99% diversion of waste from landfill.

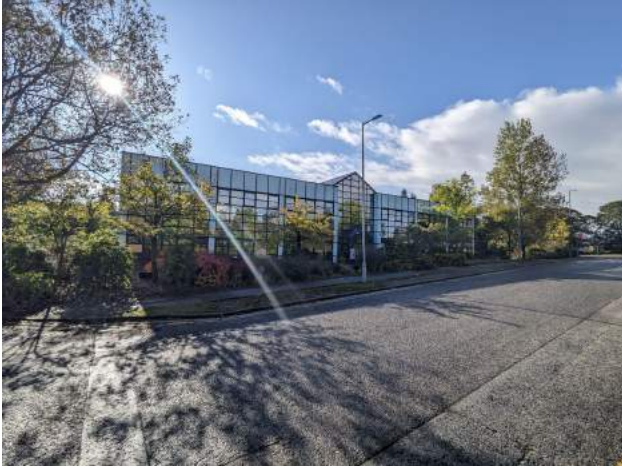
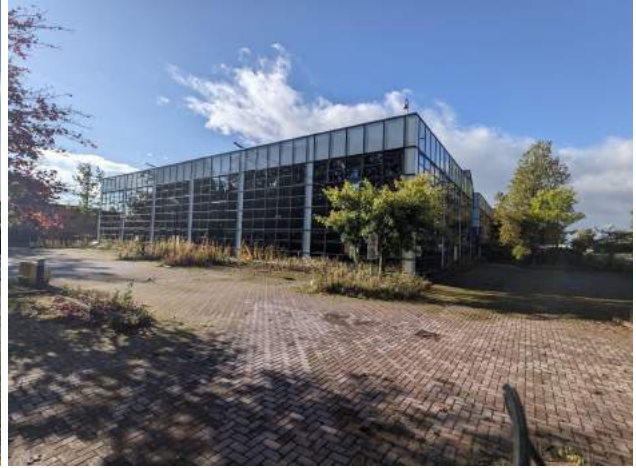
Exterior_Credit Material Index

The glass facade construction of Alba Gate has unfortunately left the site vulnerable to unauthorised entries. Despite attempts to secure the site, there is evidence of repeated break-ins and attempted fires. The building is in a state of serious disrepair and particular care was required due to the amount of broken glass, and falling roof panels/partitions and is a general risk to the public. The building is uninhabitable in its current state and should be considered a dangerous building. The owner should be aware that a dangerous building enforcement notice could be served at any time due to this. It is our understanding that the client does hope to replace the building with a high-quality mixed-use development of amenities, which will focus on supporting the local community, residents and workforce visiting the area.

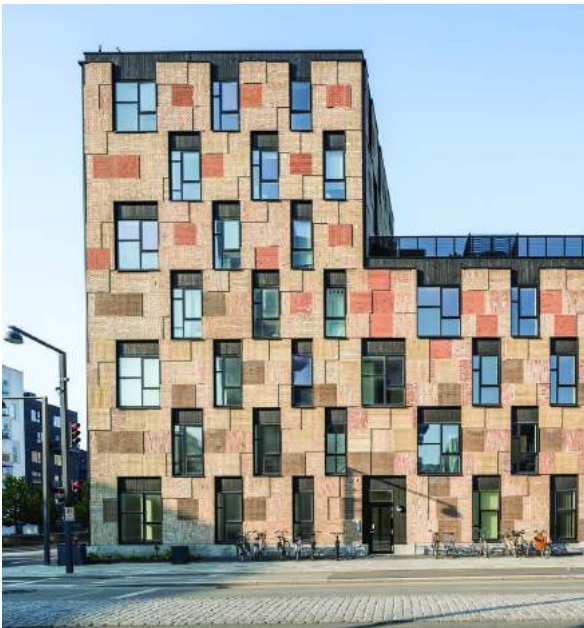
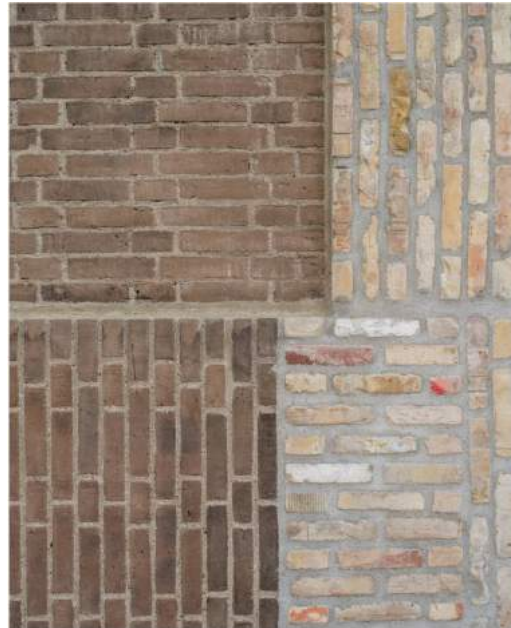
Fig 2. Example of Brick reuse - Brick Facade Panel - Source: Lendanger, Resource Rows
Brick mounted on-cement board panel. This could be an option for re-using the existing brick wall if disaggregation to brick is not effective.

Many items in the landscaping proposal could potentially be sourced from secondary stock. This includes 400m² of permeable paving on the ground floor, over a mixture of two paving types, porcelain paving on the roof plan, raised planters and timber seating. Raised brick planters and the wall along the South West boundary could potentially be constructed with bricks from the existing site.

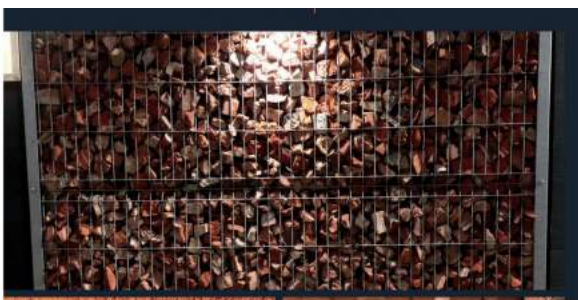
Fig 3. Example of Crushed Brick in a Gabion wall product - source: Dekorative Ziegel
Crushed concrete can also be used in a gabion product for planters.

Often it is with the landscaping of the scheme that there are the best opportunities for brick reuse, such as brick used in the fill for gabion walls or used whole in reconstituted boundary walls. Demolished brick can be crushed to make a useful aggregate, for example around foundations, either on site or off-site. Material Index can support assessments for on-site foundation fill requirements or landscape elements if required.
