Road Safety Audit Stage 1

Access to Richborough Road, Ash, Sandwich

Road Safety Answers reference no: RSA791

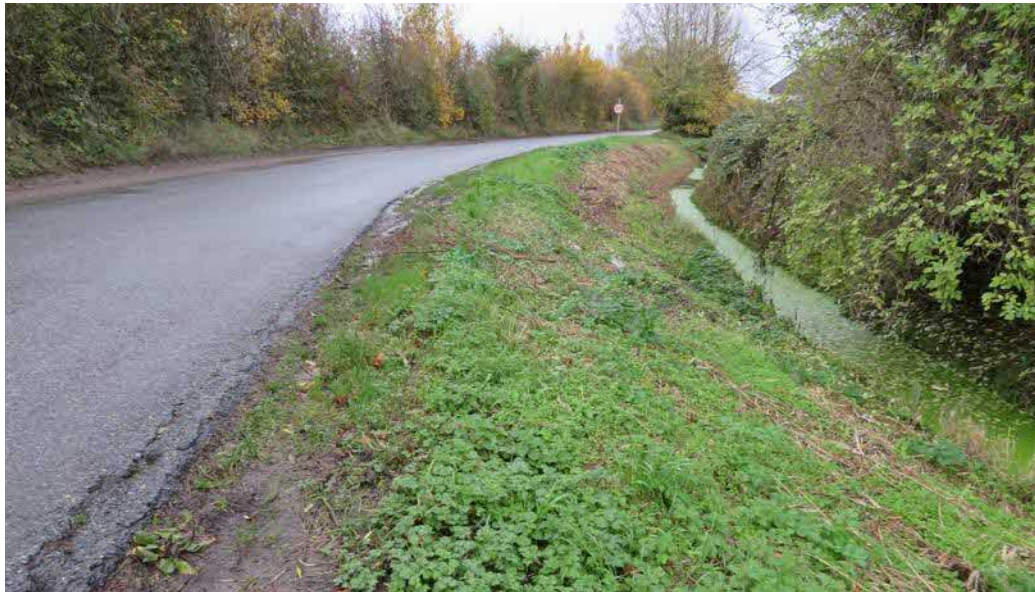
Photo 1: Deep ditch along the west side of Richborough Road

The verge on the west side of Richborough Road falls from what will be the back edge of the proposed 1.5m footway into the deep ditch that runs along this whole stretch of road (photo 1). Without a flat margin behind the footway onto which an errant pedestrian can step, the risk of the pedestrian losing their balance on the slope and falling into the ditch will be unnecessarily high.

Measures should be installed to ensure that pedestrians do not fall into the ditch.

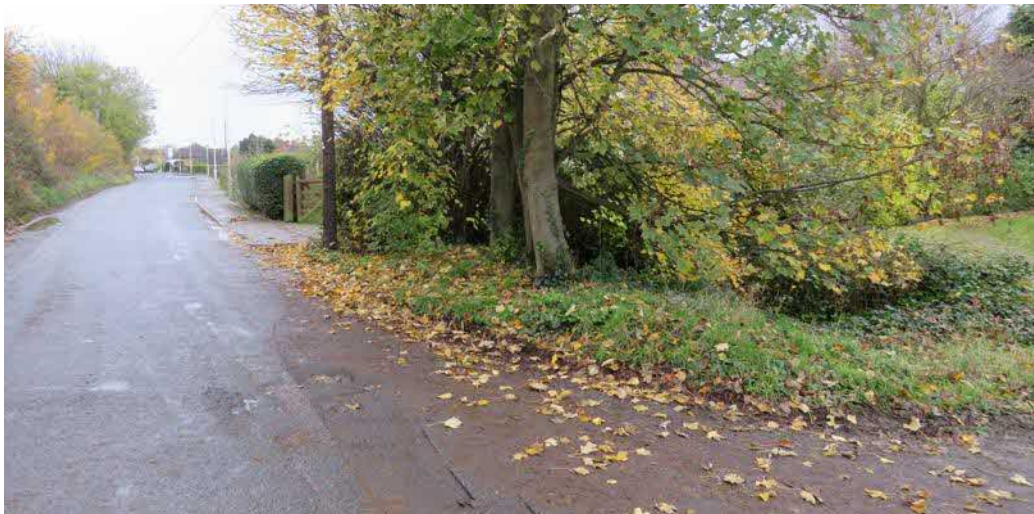
Photo 2: Verge will remain between the proposed and existing footways

Pedestrians will have to walk on the carriageway as the proposed footway will stop 19m short of the existing footway (photo 2), increasing their risk of collisions with passing vehicles.

The proposed footway should continue southwards to join the existing footway.

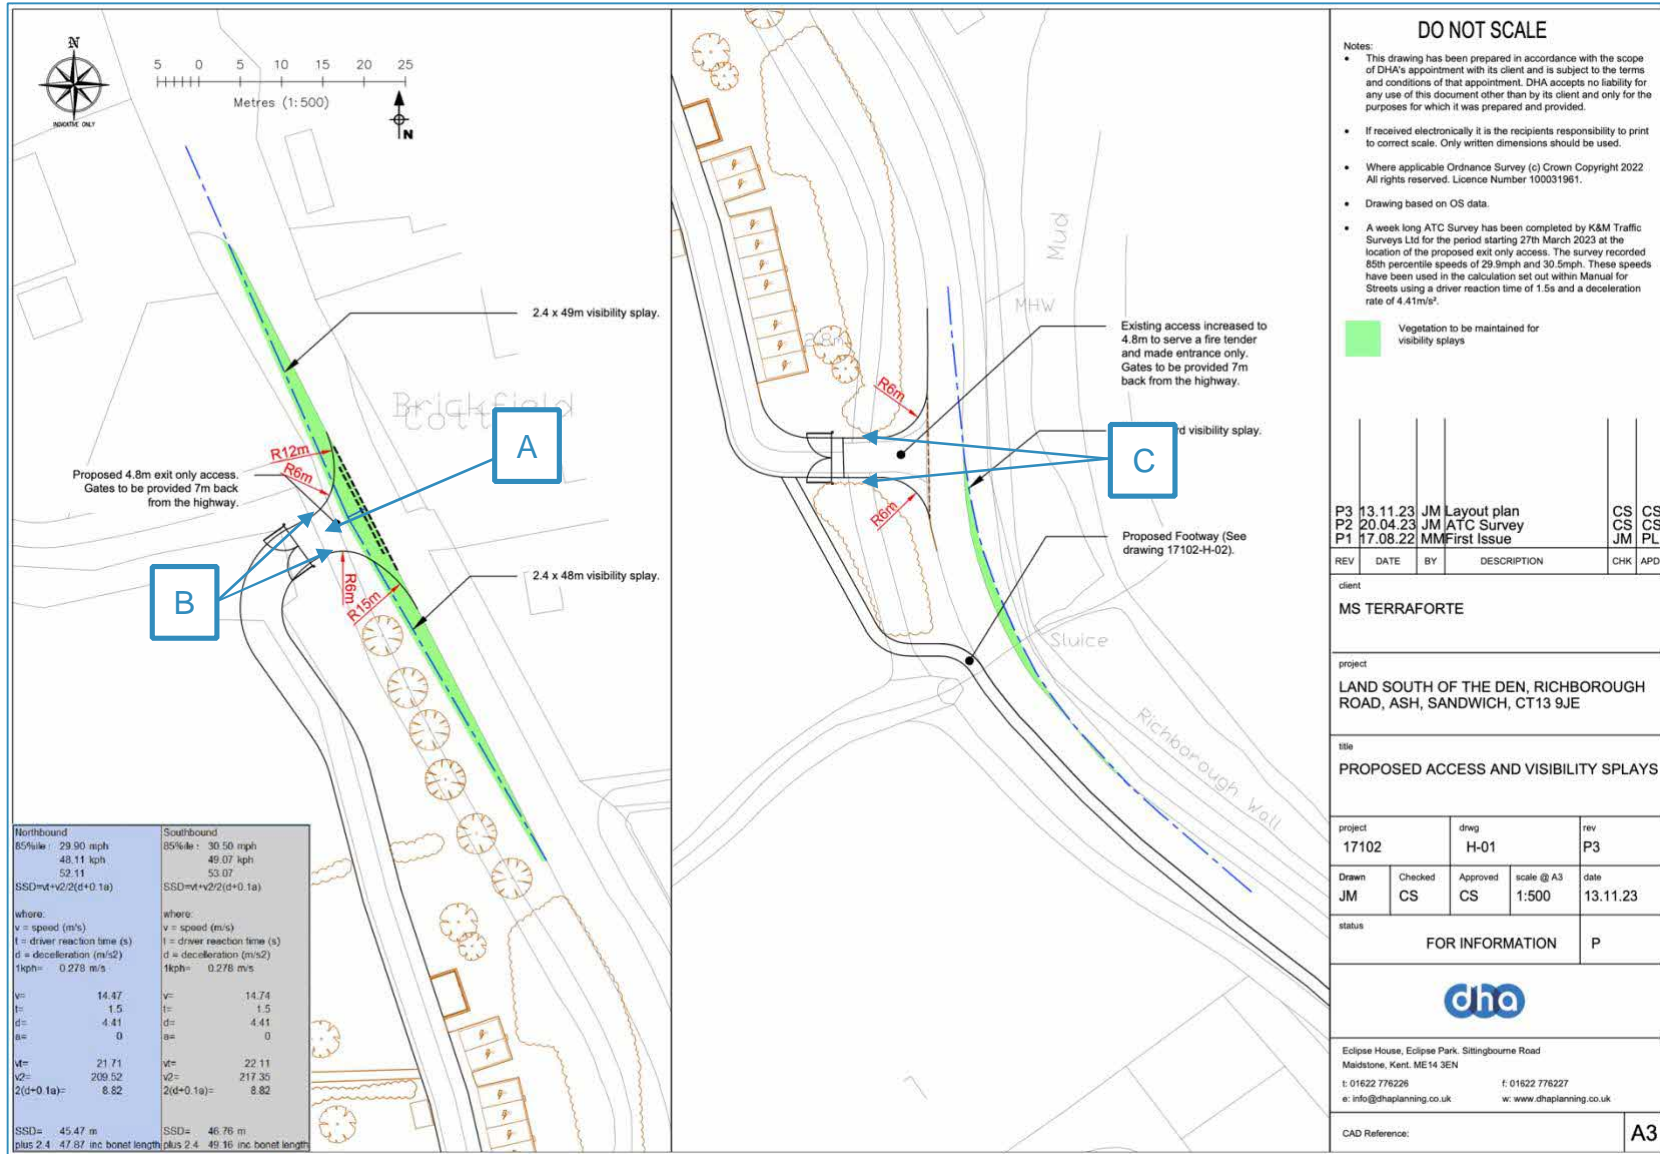
Problems Location Plans

Location: A – The Out-only egress onto Richborough Road (Dwg. 17102/H-01 Rev. P3).

There is currently a gradient up onto Richborough Road of approximately 1 in 8 from the development site. If this is maintained there will be a risk of an exiting vehicle rolling back onto a following vehicle, causing damage.

Location: B – The Out-only egress onto Richborough Road (Dwg. 17102/H-01 Rev. P3).

A relatively deep drainage ditch runs parallel to Richborough Road along the whole frontage of the site. The drawing implies that the exit road will be kerbed, but does not show any protection to stop an errant vehicle running off the side of the road into the drainage ditch as it turns the right angle to use the exit. The lack of a protective barrier, wall or verge on each side of the exit road, as it crosses the ditch, increases the risk of a vehicle falling into the ditch, with possible injuries to the vehicle occupants.

Locations: C – The In-only access from Richborough Road (Dwg. 17102/H-01 Rev. P3).

The drainage ditch that runs parallel to Richborough Road along the whole frontage of the site is particularly deep at the proposed access to the site. The drawing implies that the entry road will be kerbed, but does not show any protection to stop an errant vehicle running off the side of the road into the drainage ditch as it turns into the access. The lack of a protective barrier, wall or verge on each side of the exit road, as it crosses the ditch, increases the risk a vehicle falling into the ditch, with possible injuries to the vehicle occupants.

The egress should have a relatively level dwell area approaching Richborough Road.

The exit road should have protection on each side as it crosses the drainage ditch on the approach to Richborough Road.

The access road should have protection on each side as it crosses the drainage ditch next to Richborough Road.

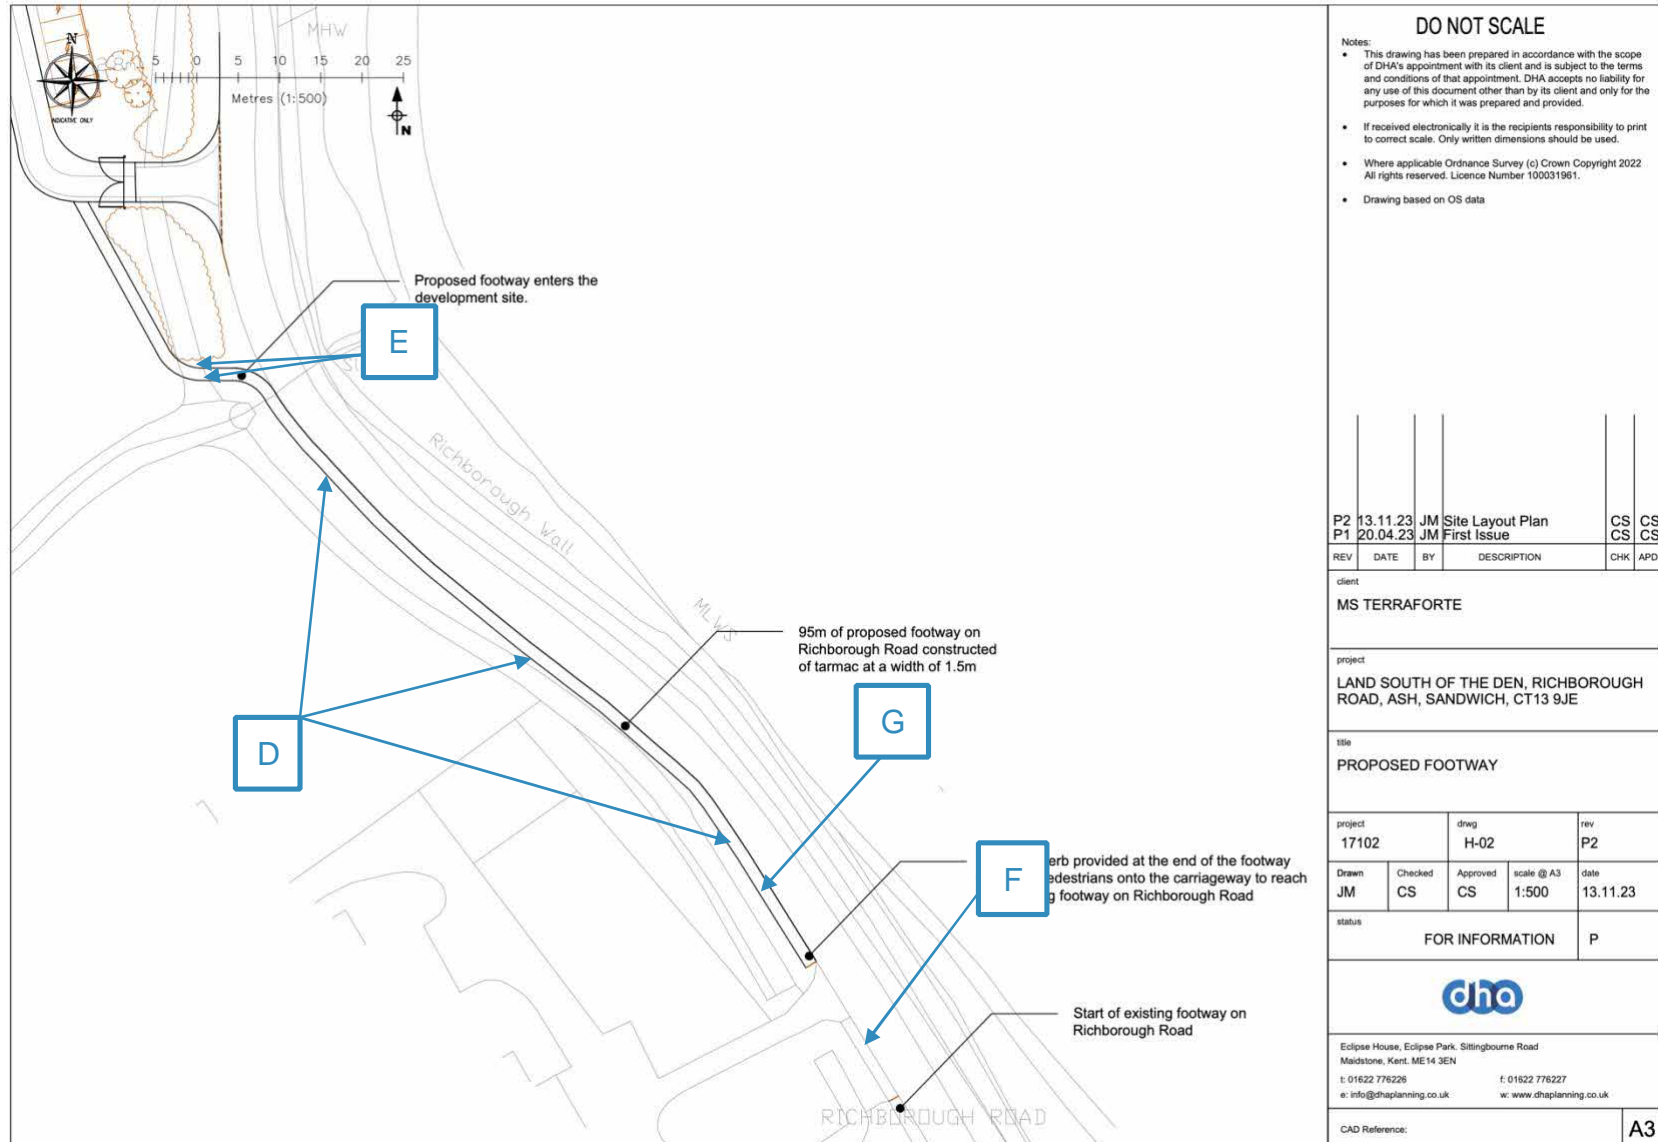
Location: D – The 95m of footway along the verge of Richborough Road (Dwg. 17102/H-02 Rev. P2).

Location: E – Northern end of the footway where it enters the development site (Dwg. 17102/H-02 Rev. P2).

As the footway leaves the edge of the carriageway of Richborough Road it will have to bridge across the deep ditch. Without any protection on each side the risk of errant pedestrians falling into the ditch will be unnecessarily high.

Location: F – Southern end of the proposed footway (Dwg. 17102/H-02 Rev. P2).

Location: G – Towards the southern end of the proposed footway (Dwg. 17102/H-02 Rev. P2).

The existing pole with the national speed limit/30mph signs is located in what will be the centre of the proposed footway. If left in situ, mobility impaired pedestrians using a mobility scooter will be unable to pass it on the footway and will have to travel on the carriageway for 120m to use the vehicle entrance to the development site, increasing their risk of being struck by a passing vehicle.

Measures should be installed to stop pedestrian falling into the ditch as they cross it on the bridge.

The speed limit pole and signs should be relocated to the verge behind the proposed footway.
