Change of use of Detached outbuilding at Hallgarth Manor House

Re: Outbuilding conversion at Hallgarth Manor House

PROJECT
Hallgarth Manor House Outbuilding
High Pittington
County Durham

DRAWING TITLE
Existing Plans and Elevations
Storage Building

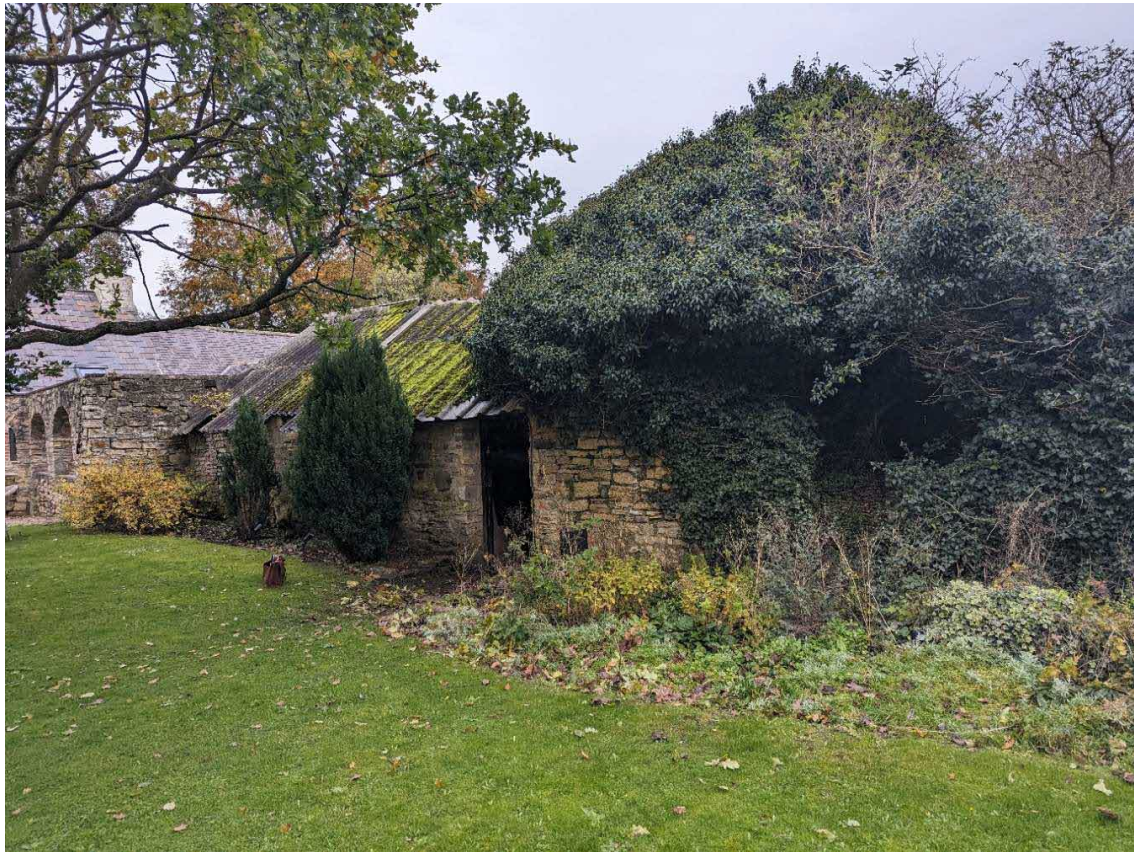
Figure 1 –Front Elevation

The masonry was in good condition with no significant cracking noted. There were large areas of vegetation present to the side elevation which prevented inspection of masonry behind. The vegetation will require removal and masonry inspected to these locations, there were no cracks found internally suggesting defects caused by the vegetation.

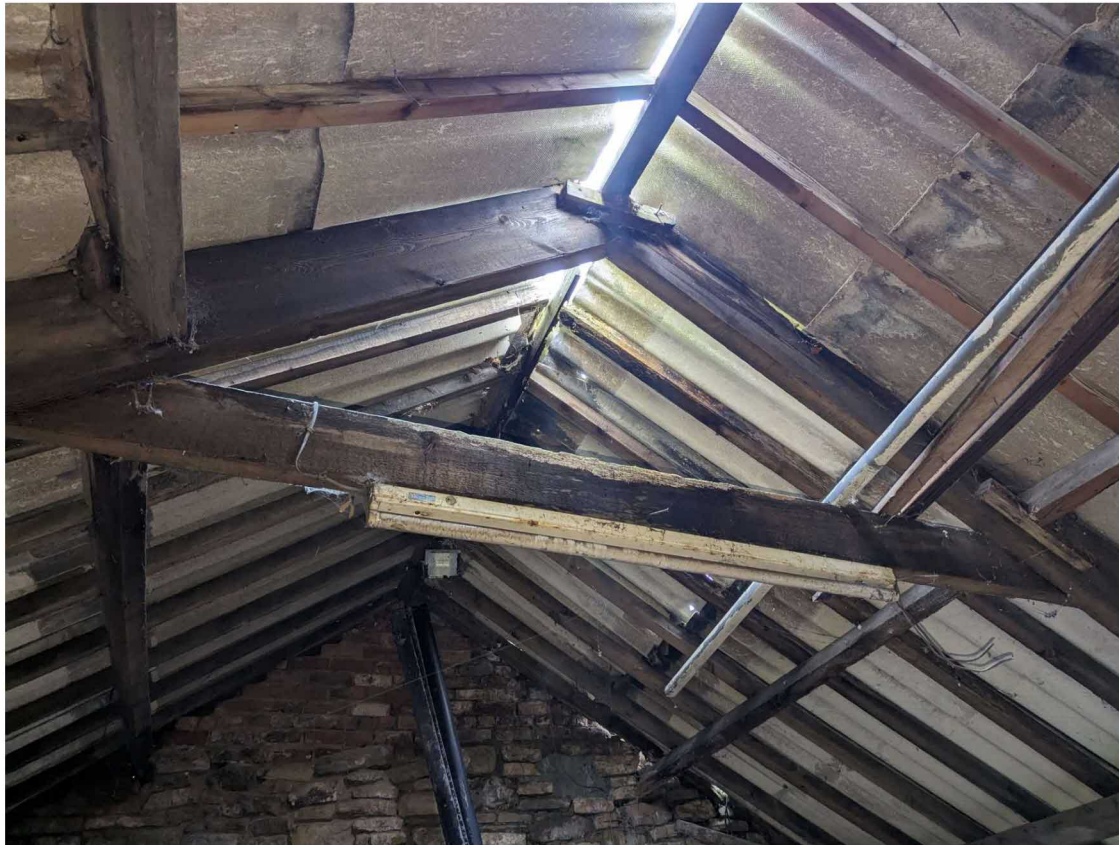
Figure 3 – Existing roof structure

The property is a single storey with a pitched roof and is currently being used as a garden store. The roof is constructed in timber consisting of A-frame trusses supporting purlins and rafters over. The roof is covered in corrugated sheeting. The walls were constructed in solid stonework construction with areas of brickwork noted towards the peak of the gables. The ground floor slab was constructed in concrete and was ground bearing.

The roofing sheets were in poor condition with voids in a number of locations. The roofing sheet construction material will require testing to confirm that no hazardous materials such as asbestos are present prior to completion of any works. There were areas of deteriorated timber to the roof trusses noted.

The roof structure will require replacement to accommodate existing defects and insulation requirements to suit change of use.

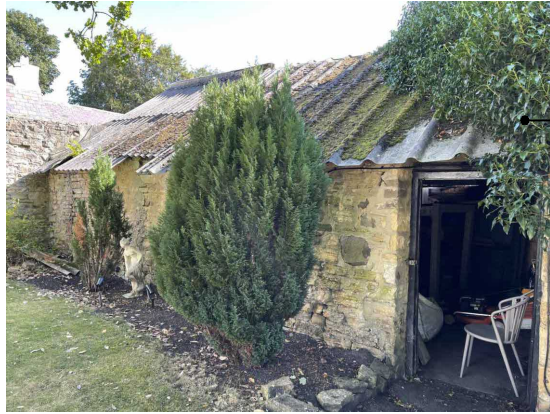
Photo of Front Elevation

Large Amounts of vegetation cover the external walls and roof to the rear
