# Phase 1: Desk Study

Hallgarth Manor Hotel House, Durham

GWA

S231005

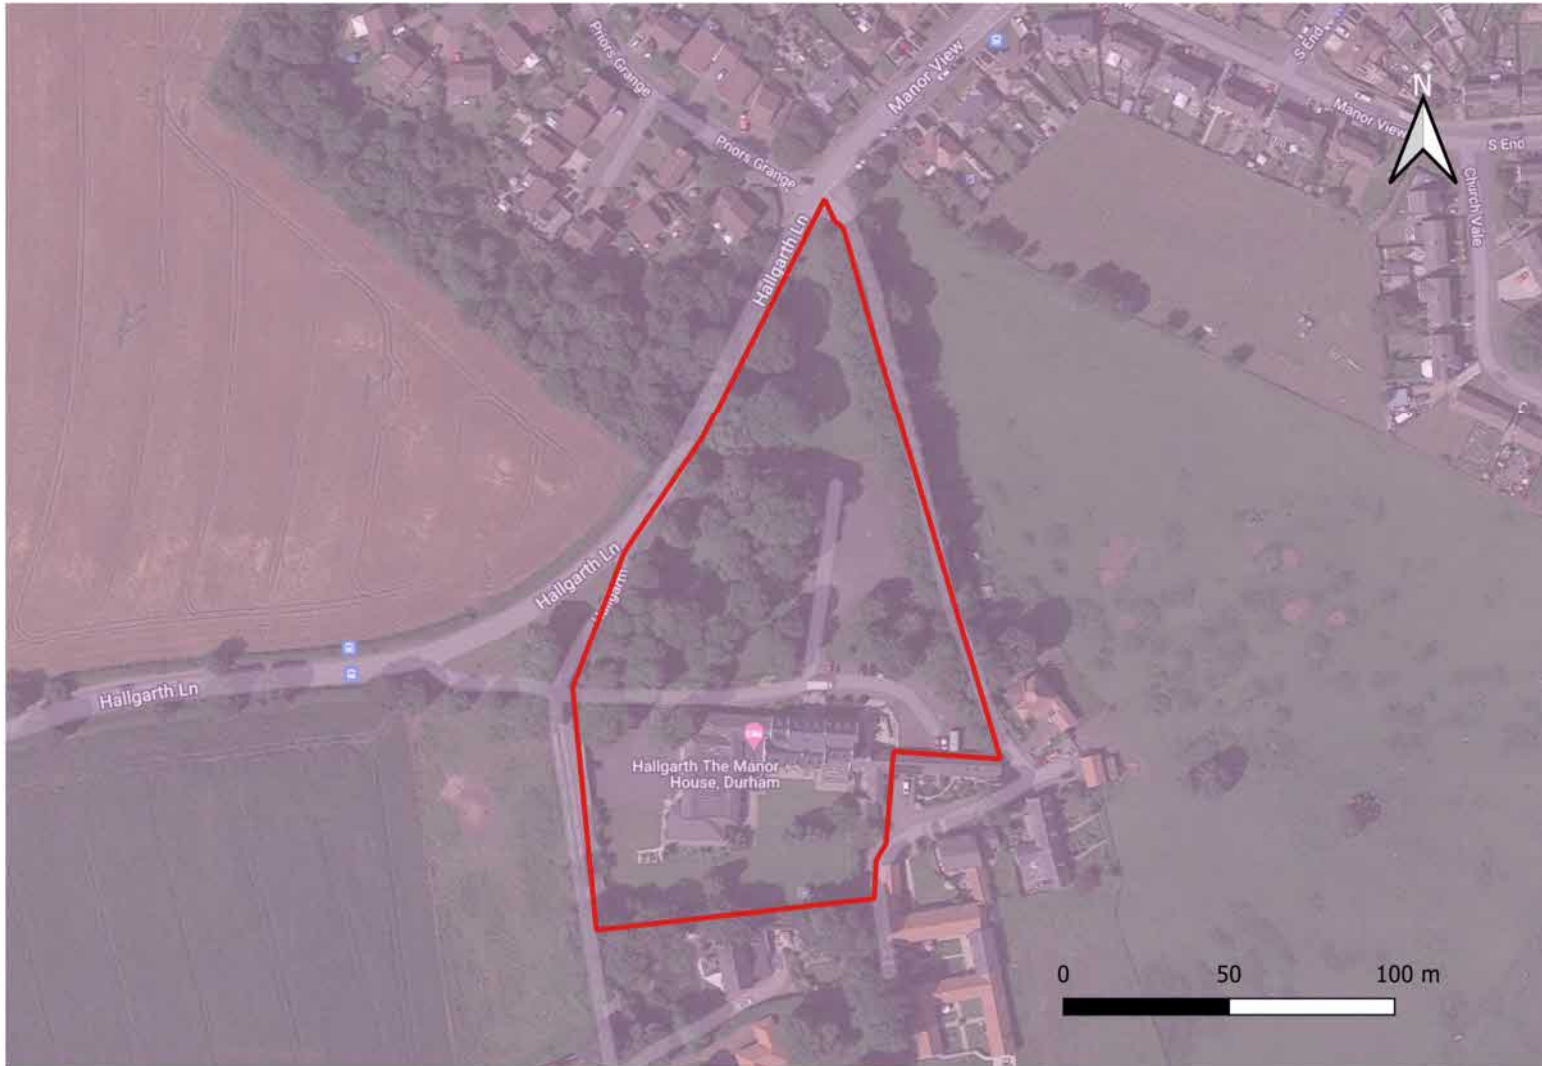
<b>Title</b>	Drift Geology Map
<b>Project</b>	Hallgarth Manor House Hotel, Durham, DH6 1AH
<b>Client</b>	GWA
<b>Date</b>	October 2023
<b>Fig No.</b>	Figure 3
<b>Scale</b>	Do not Scale
<b>Key</b>	<div style="display: flex; align-items: center; margin-bottom: 5px;"> <div style="border: 1px solid red; width: 20px; height: 10px; margin-right: 5px;"></div> <span>Approx. Site Boundary</span> </div> <div style="display: flex; align-items: center;"> <div style="background-color: #d2b48c; width: 20px; height: 10px; margin-right: 5px;"></div> <span>Glaciofluvial deposits</span> </div>

It is expected that, based on available information, ground conditions are likely to be made ground comprising areas of both topsoil and hardstanding. The surface deposits may be underlain by further made ground, likely to consist of construction/demolition waste. The drift deposits on site are likely to comprise of glaciofluvial deposits which consists of sand and gravel, locally with lenses of silt, clay, or organic material. Solid geology of sandstone or mudstone is likely.

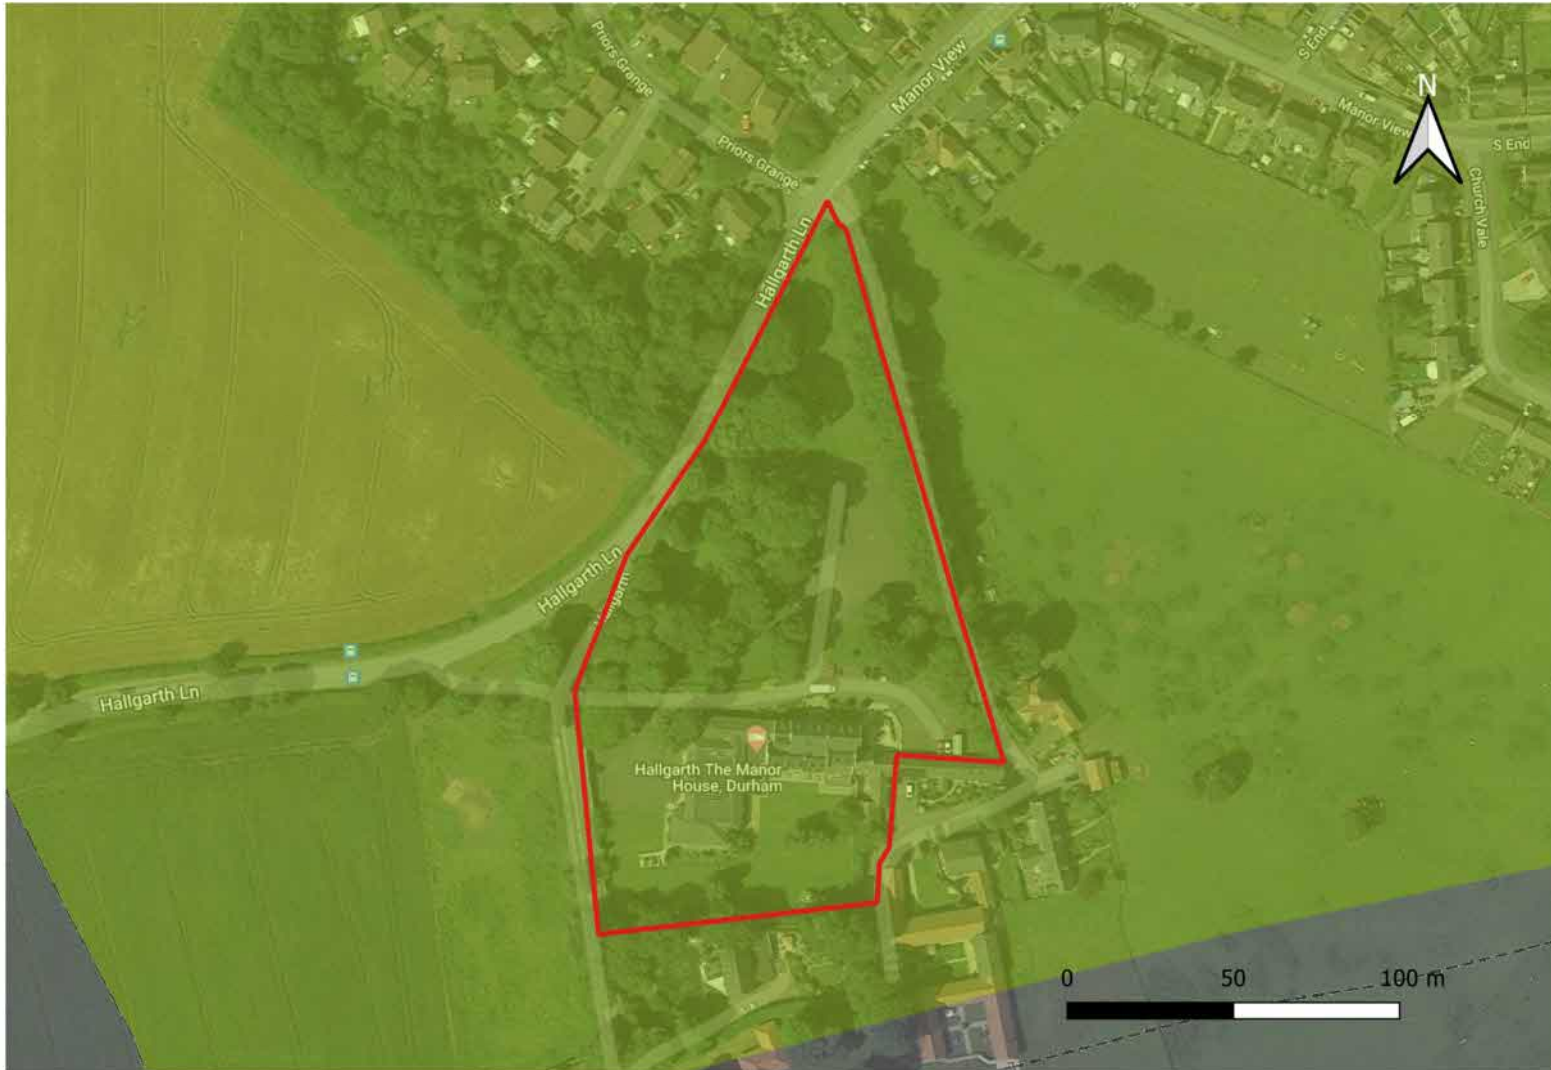
<b>Title</b>	
Solid Geology Map	
<b>Project</b>	
Hallgarth Manor House Hotel, Durham, DH6 1AH	
<b>Client</b>	
GWA	
<b>Date</b>	
October 2023	
<b>Fig No.</b>	
Figure 4	
<b>Scale</b>	
Do not scale	
<b>Key</b>

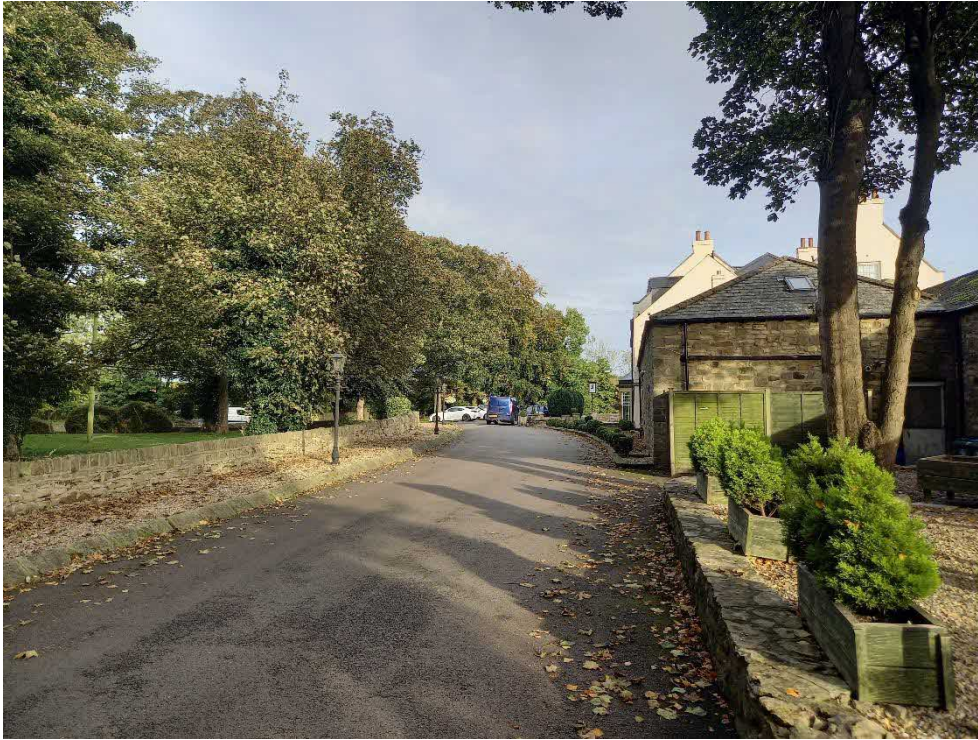
Figure 5 – Entrance to site with macadam drive.

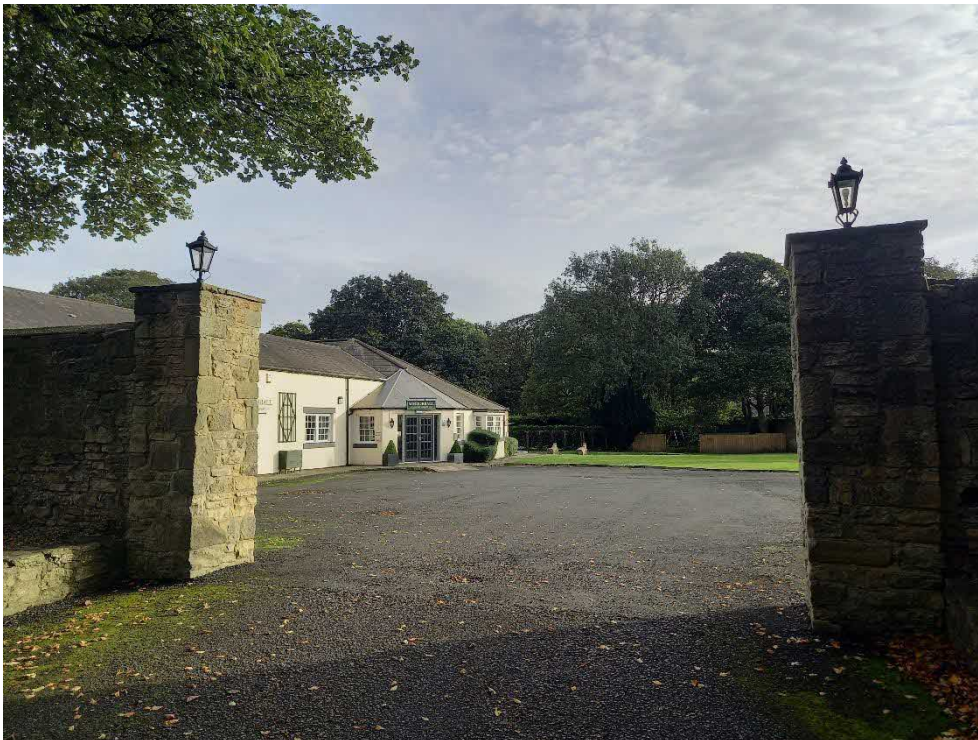
Figure 6 – Large macadam parking area by southern end of eastern site boundary.

**Roads/Parking Areas** may have utilised coal tar, which can result in high levels of PAHs and Phenols and may require disposal as hazardous waste. In addition, historically road construction used ash as a sub-base material, which could be a further source of PAHs.

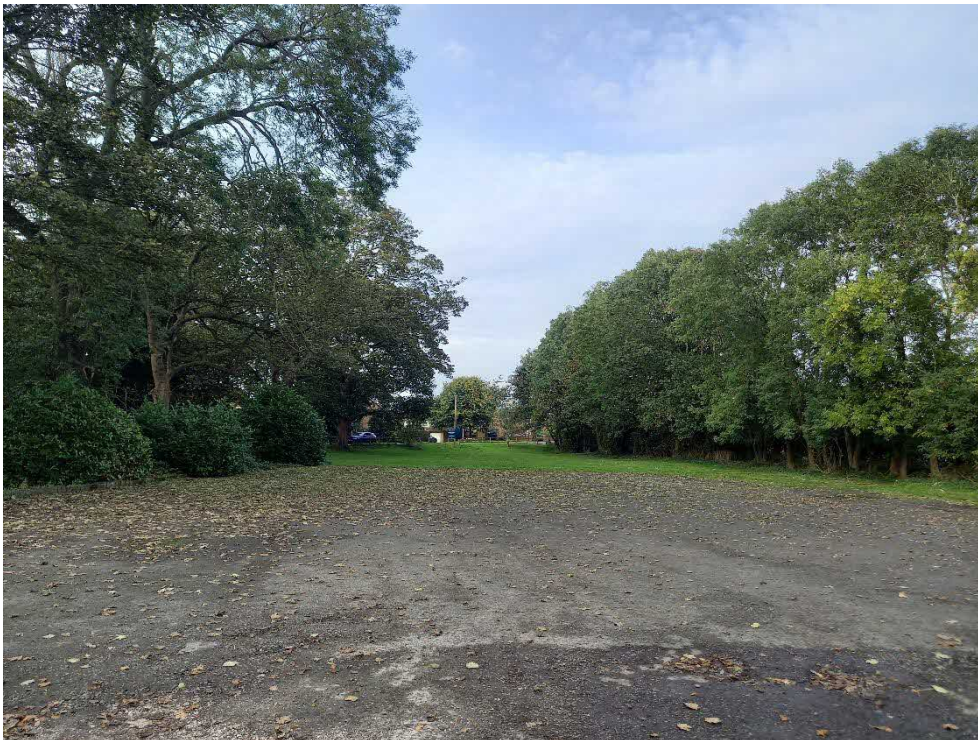
Figure 8 – Hardstanding car parking near the eastern site boundary. View N.
